28 April 2022

Arboricultural Impact Assessment Report regarding seventeen (17) trees located within the vicinity of the proposed Star Centre at Star of the Sea College, 80 Martin Street, Brighton

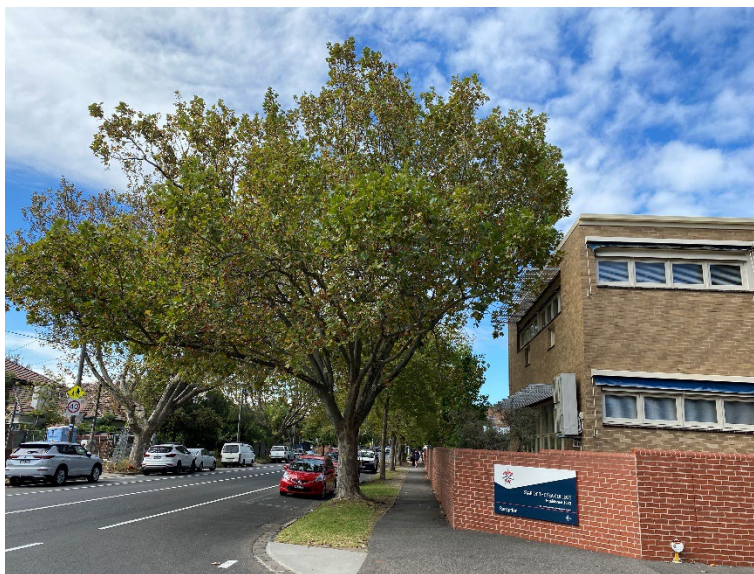
6.3.6 Trees 91–93 were Council owned trees to the north of subject site, within the nature strip of Martin Street. These trees were a mixture of *Platanus* sp. with Tree 91 and 92 being *Platanus orientalis* (Oriental Plane) and 93 being *Platanus x acerifolia* (London Plane). All trees were of semi-mature age class and provided strong amenity to the wider landscape, including shading of the road surface, footpath and school grounds.

6.3.7 The excavation required for the underground carpark would likely impact roots within the TPZ area. As per Bayside City Council's Guidelines for Working Near Council Trees, all roots greater than 50mm in diameter must not be cut (damaged) without endorsement from Council. Given the species and its ability to effectively utilise urban and altered soils for root development, it is likely that roots in excess of 50mm diameter will be present within the construction footprint.

Figure 4. View from the west of Tree 93 *Platanus x acerifolia* in its growing environment. (Ido Monk, April 2022).

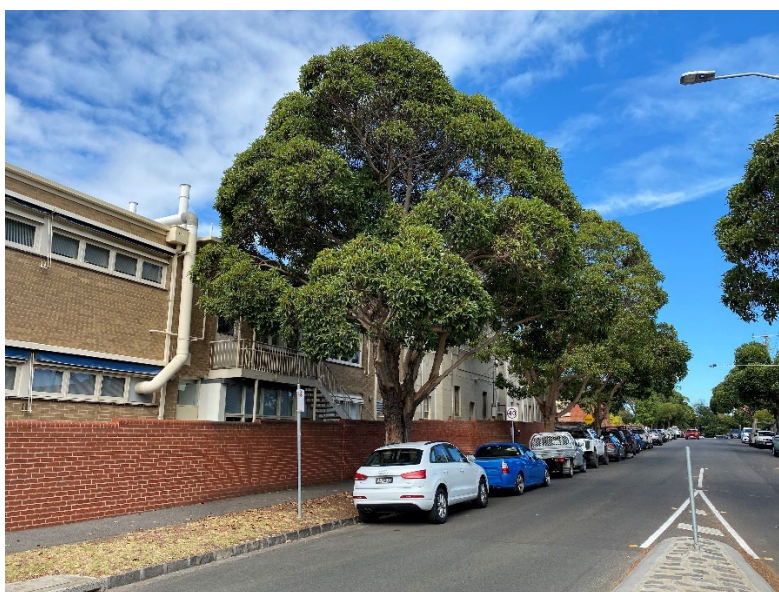
6.3.8 Trees 94, 95 and 96

- 6.3.9 Trees 94–96 were Council owned trees to the west of the subject site, within the nature strip of Murphy Street. All trees within this nature strip were of the species *Lophostemon confertus* (Queensland Box). All trees were of semi-mature age class and provided strong amenity to the wider landscape, including shading of the road surface, footpath and school grounds.
- 6.3.10 The excavation required for the underground carpark would likely impact roots within the TPZ area. As per Bayside City Council's Guidelines for Working Near Council Trees, all roots greater than 50mm in diameter must not be cut (damaged) without endorsement from Council. The species is not known to have strongly opportunistic root systems and given the current building and landscape features between the trees and the subject site, the presence of roots of significance is less likely.

Figure 5. View from the northwest of Trees 94-95 *Lophostemon confertus* in their growing environment. (Ido Monk, April 2022).

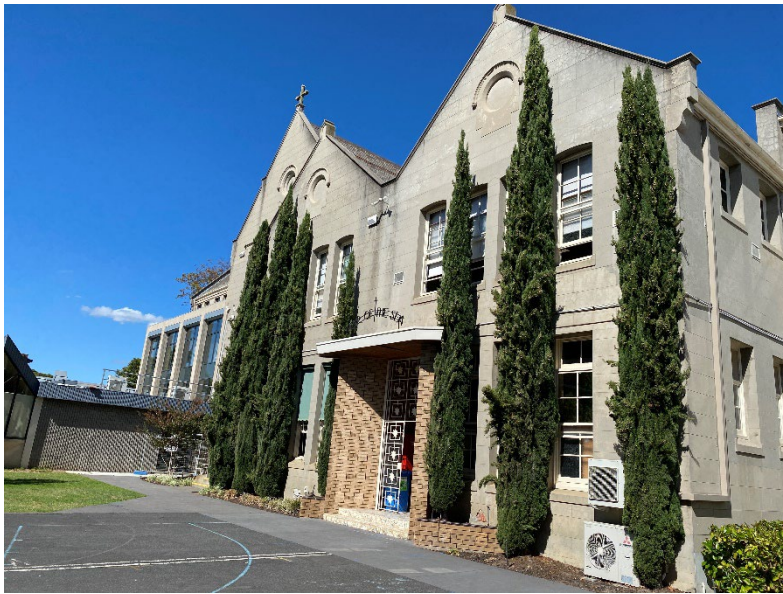
6.3.11 Trees 68, 69 and 70

- 6.3.12 Trees 68-70 were semi-mature examples of the exotic species *Cupressus sempervirens* 'Stricta' (Pencil Pine) located in very close proximity to the existing building within the school grounds. This row of trees formed the western part of the wider planting of the species, providing strong aesthetic and amenity value to the immediate landscape. The location of the trees to the building would likely limit the long-term viability of the trees, as the primary structure would likely conflict with the building itself as they mature.
- 6.3.13 Given the location of the trees, proximity to the existing building and being outside of the construction footprint, their retention could be achieved with generic tree protection measures.

Figure 6. View from the northwest of Trees 68-70 *Cupressus sempervirens* 'Stricta' in their growing environment. (Ido Monk, April 2022).

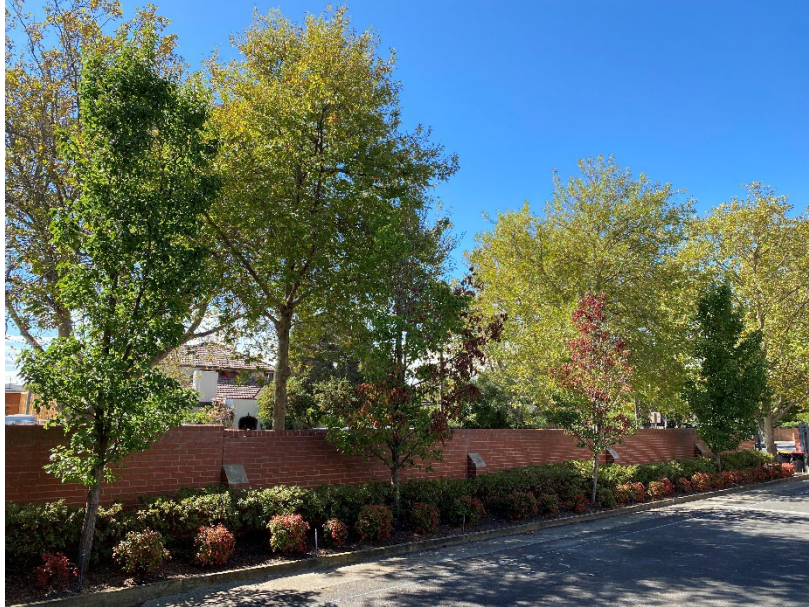
6.3.14 Trees 76, 77, 78 and 79

6.3.15 The row of juvenile *Pyrus calleryana* 'Capital' along the northern boundary fence were within the proposed construction footprint. The excavation required to construct the underground carpark would physically remove the soil supporting these trees and therefore the trees could not be retained.

Figure 7. View from the southwest of Trees 76-79 *Pyrus calleryana* 'Capital' in their growing environment. (Ido Monk, April 2022).

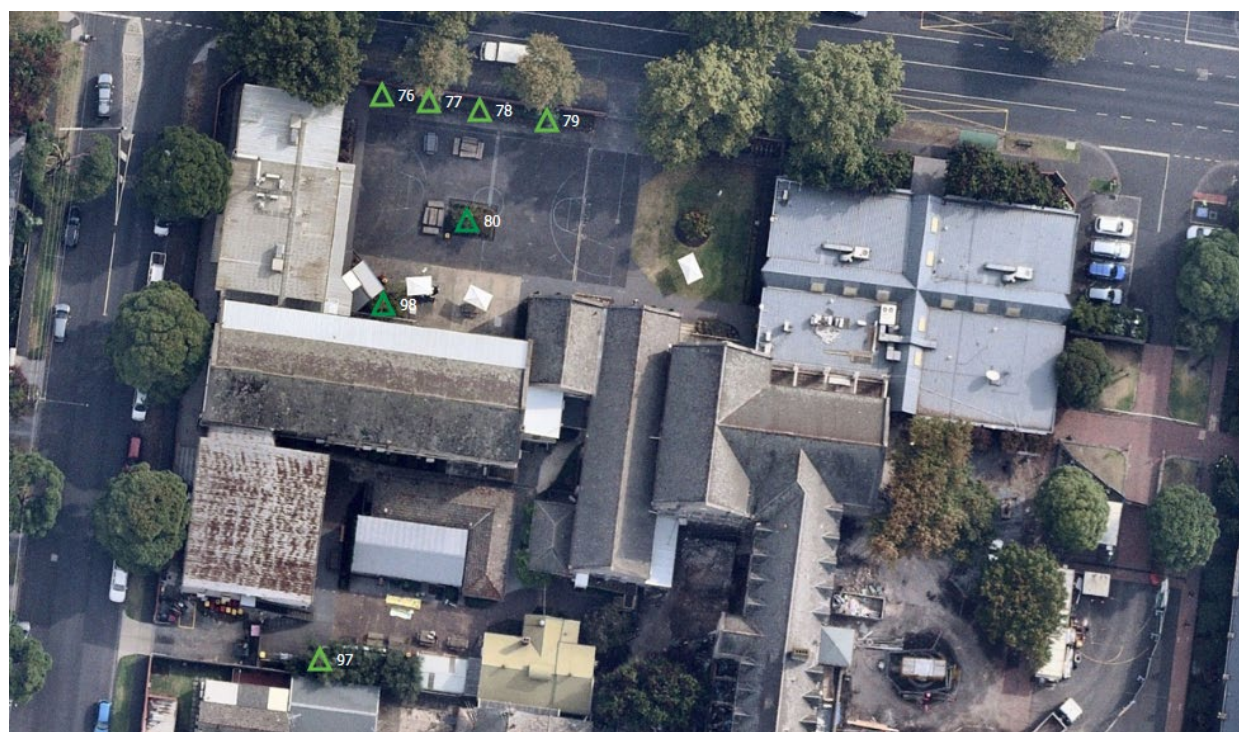
7.1.1 Seven (7) trees would require removal as follows, based on the supplied design proposal. These trees would require removal to allow the proposed development:

Figure 8. Site map showing trees requiring removal. (ArborPlan, April 2022).

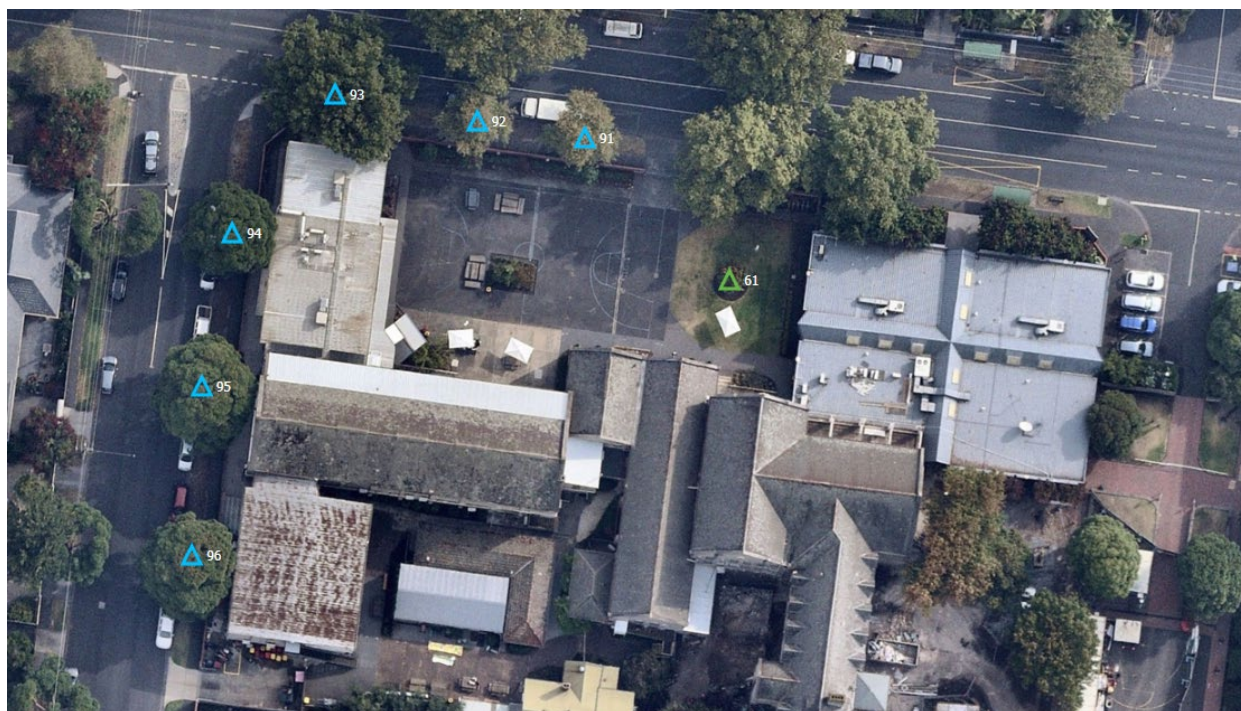
- 7.3.1 Trees 91–96 have proposed excavation with the southern and eastern portion of their TPZ (Figure 9).
- 7.3.2 Preliminary excavation is to be carried out only under arborist supervision to determine the extent of root distribution within the subject site itself and therefore the extent of root pruning that would be required. It is recommended that the excavation be completed post demolition of the existing buildings and be undertaken at, or as close to the site boundary as possible. Roots must be inspected by the project arborist and images and measurement supplied to Council for endorsement.

Figure 9. Site map showing trees requiring specific protection measures. (ArborPlan, April 2022).

- 7.3.3 Works should be undertaken using techniques that are sensitive to tree roots to avoid unnecessary damage. Such techniques include:
- Excavation using a high-pressure water jet and vacuum truck

- Excavation using an Air Spade with vacuum truck
 - Excavation by hand.
- 7.3.4 Machine excavation is prohibited within the TPZs of retained trees unless undertaken at the direct consent of the project arborist.

- 7.3.5 Roots discovered are to be treated with care and minor roots (<40mm diameter) pruned with sharp, sterile handsaw or secateurs. All significant roots (>50mm diameter) are to be recorded, photographed and reported to the project arborist.

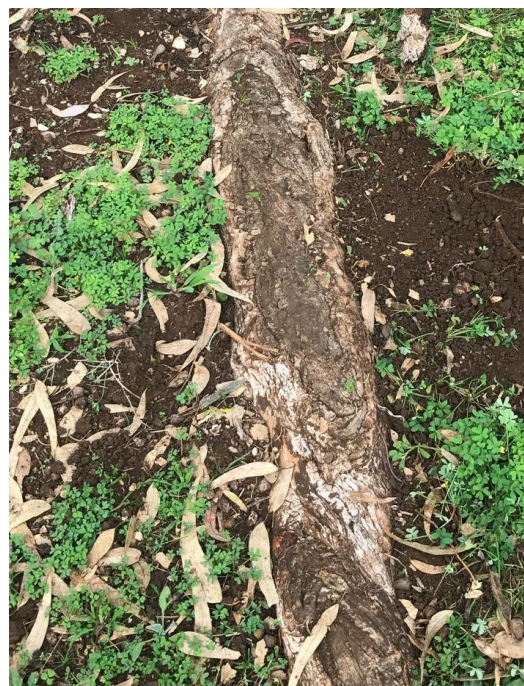
Figure 16. Image showing wound caused to upper portion of surface root by mower. (Luke Dawson, June 2017).
