Tree Condition Assessment for 2 trees located at 70 Hanover Street, Fitzroy

Site address (Tree Location): 70 Hanover Street, Fitzroy
Tree assessment conducted: 3 October 2025
Assessed by: Mark Reynolds (Principal Consulting Arborist – Arbor Survey Pty Ltd)
Under instruction from: Jack De Lutiis (Focus Group Investments)

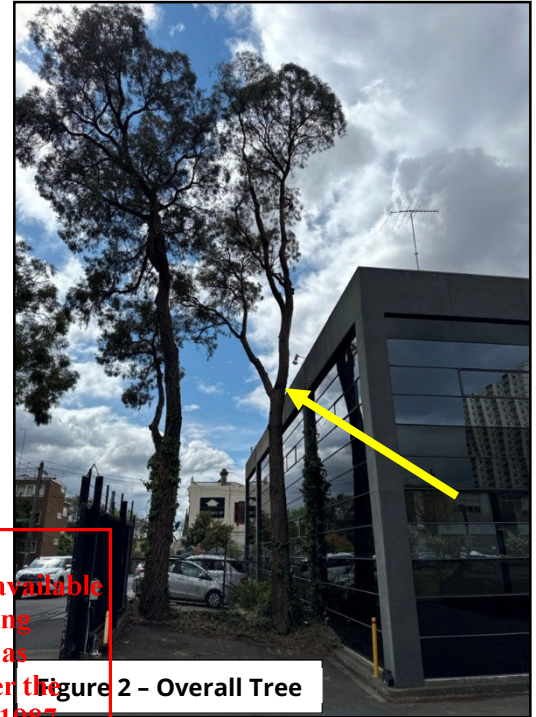
Figure 2 - Overall Tree

The health of the tree is considered to be fair as the foliage density is approximately 50 -70% which is slightly below optimal canopy density. There is evidence of some dieback in the crown which would be expected for a tree of this age and maturity.

The structure of the tree is considered to be poor due to the poor pruning cuts and 'Lions tail' pruning that has been undertaken to allow of clearance from the building. The poor structure rating has been given as the past pruning activities which is not in accordance with the *Australian Standard AS4373-2007 - Pruning of Amenity Trees*. As defined by the Australian Standard, 'Lions Tail' pruning (which is the removal of interior branching) is considered an inappropriate pruning practice.

The tree is one of 2 large trees in this highly built-up area and is considered to have a high amenity rating as it is visible from numerous vantage points along Fitzroy Street, however, this alone is not a valid reason for tree retention.

Given the poor structure of the tree, the inappropriate growing location and the infrastructure damage, this tree has been rated as being of low arboricultural or retention value.

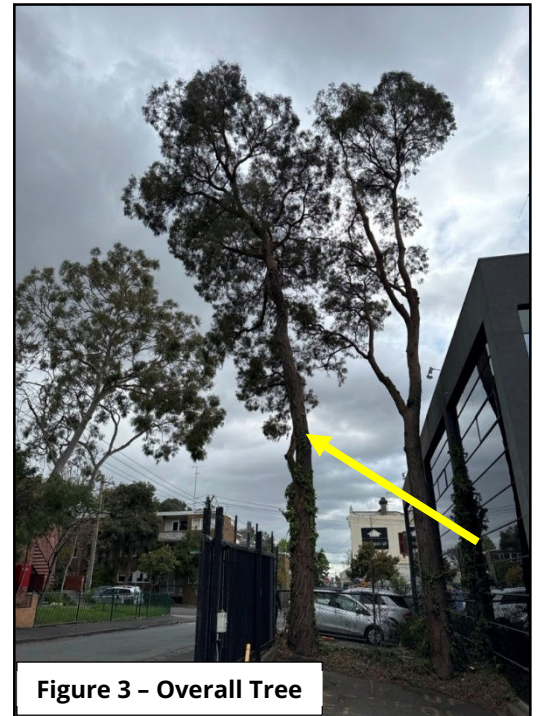
Figure 3 - Overall Tree

As with tree number 1, the health of the tree is considered to be fair as the foliage density is approximately 50 - 70% which is slightly below optimal canopy density. There is also evidence of some dieback in the crown which would be expected for a tree of this age and maturity.

This tree is also rated as being of poor structure for the same reasoning as tree 1 where the tree has been 'Lion's tail' pruned. As with tree 1, there are no opportunities to improve the overall structure due to this poor pruning practice.

Given the poor structure of the tree, the inappropriate growing location and the infrastructure damage, this tree has been rated as being of low arboricultural or retention value.

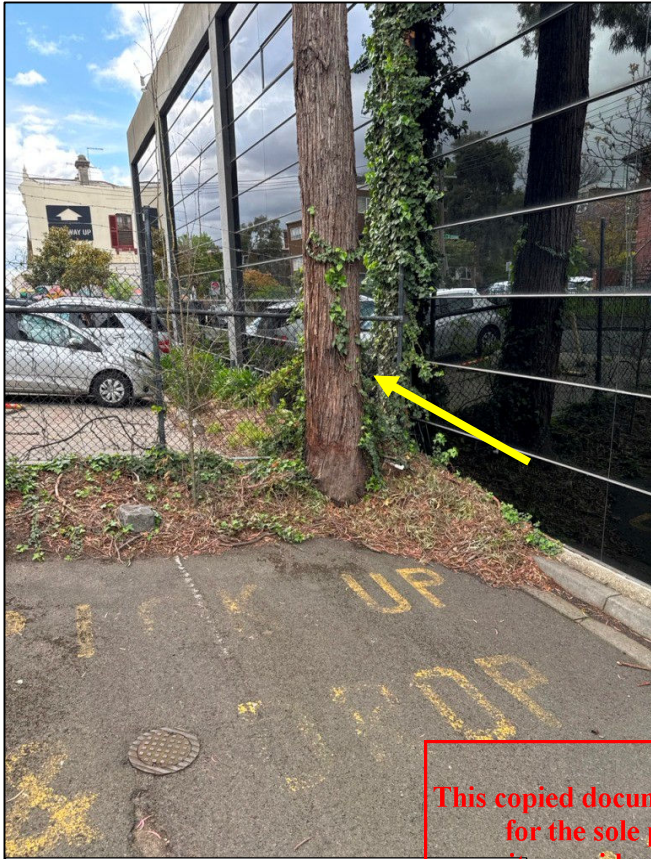
The tree is growing in a very narrow (approximately 1 metre wide) garden bed and is less than 1 metre from the existing building (Figure 4). There is significant infrastructure damage from this tree, specifically to the existing car parking areas to the north and south of the tree and possibly to the building footprint (Figure 5).

Figure 4 - Proximity of Tree 1 to building

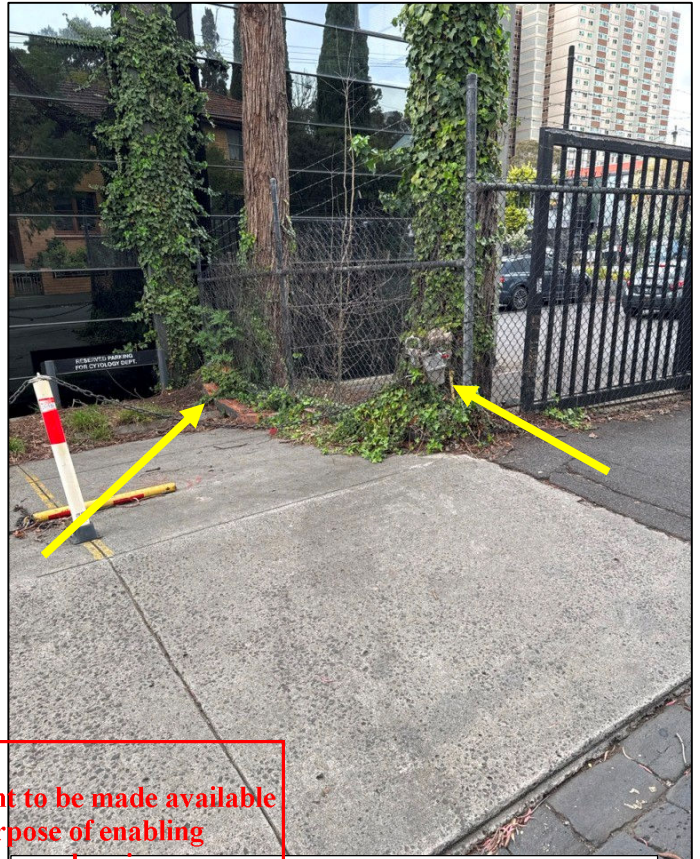
Figure 5 - Damage to infrastructure and Gas meter

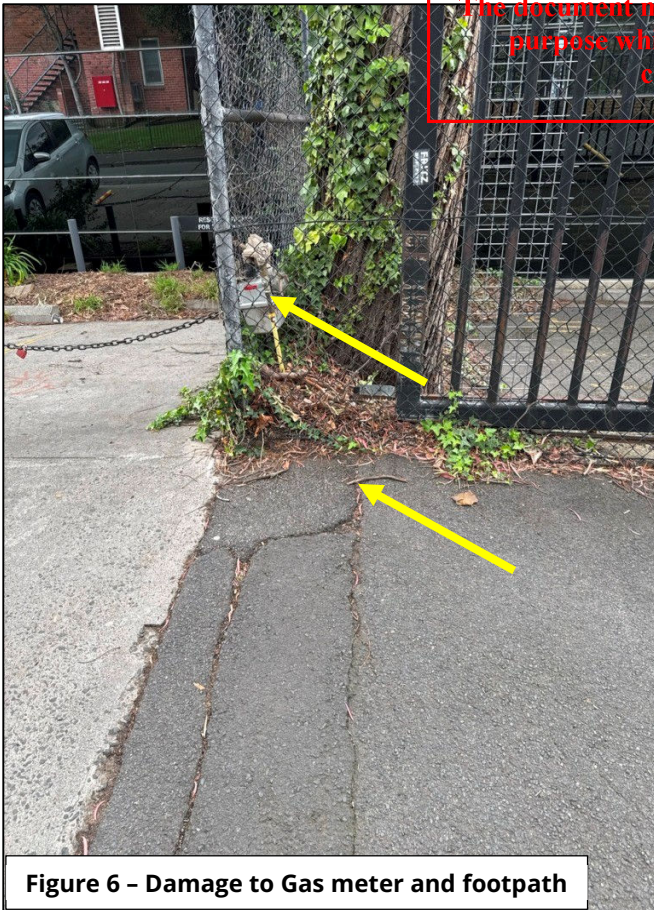
This tree is also damaging infrastructure (footpath, carparking and front sliding gate) and has grown over/ around the gas meter which is visibly damage by the growth of the trunk (Figures 6 & 7). The repair or rectification works to this infrastructure (regardless of any future development on the site) would significantly impact the root system of this tree and tree 1.

Figure 6 - Damage to Gas meter and footpath

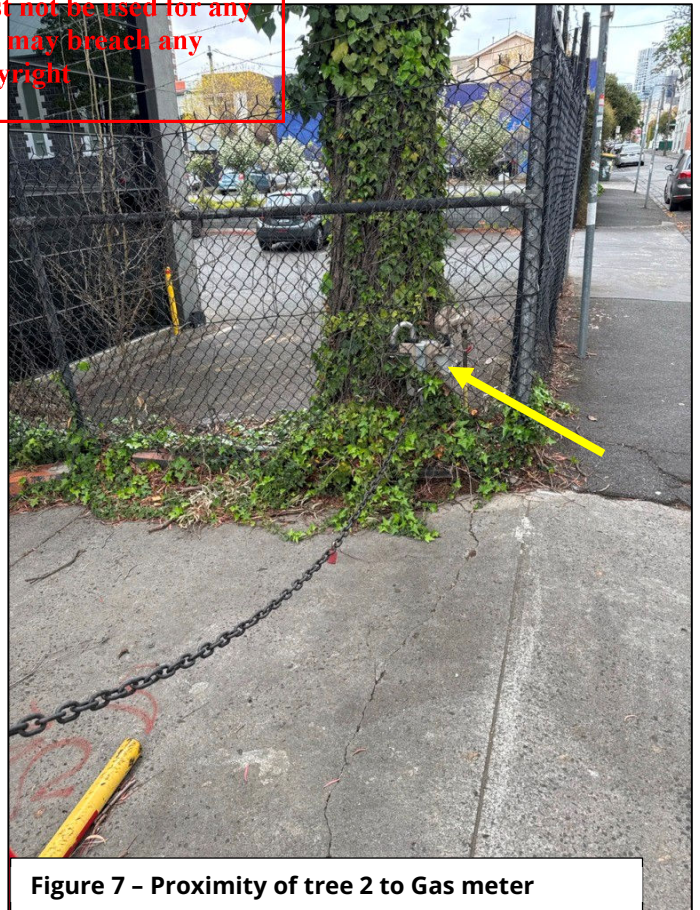
Figure 7 - Proximity of tree 2 to Gas meter
