# PRELIMINARY ARBORICULTURAL ASSESSMENT

March 2024

Salesian College  
Mannix Campus Development  
Swanson Crescent Chadstone VIC 3148

Report prepared by  
Adam Roberts  
(Dip. Hort. Arb.)  
QTRA registered User No 8141  
Arbor Assess  
0421 44 55 11  
[www.arborassess.com.au](http://www.arborassess.com.au)

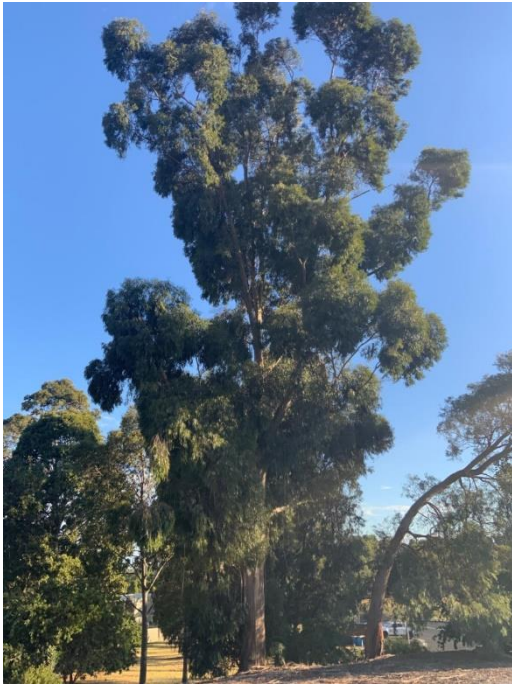
**Figure 1.** Tree #601 High Retention rated River Peppermint Gum in area proposed for new building.

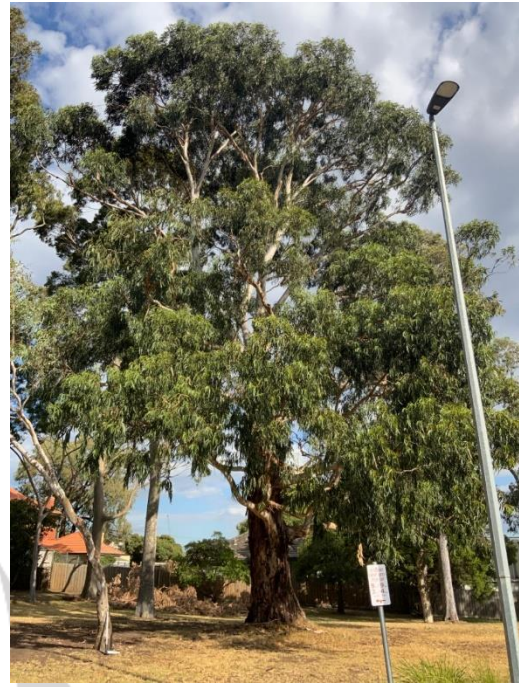
**Figure 2.** Tree #634 Large High rated Eurabbie adjacent to area considered for development carpark.

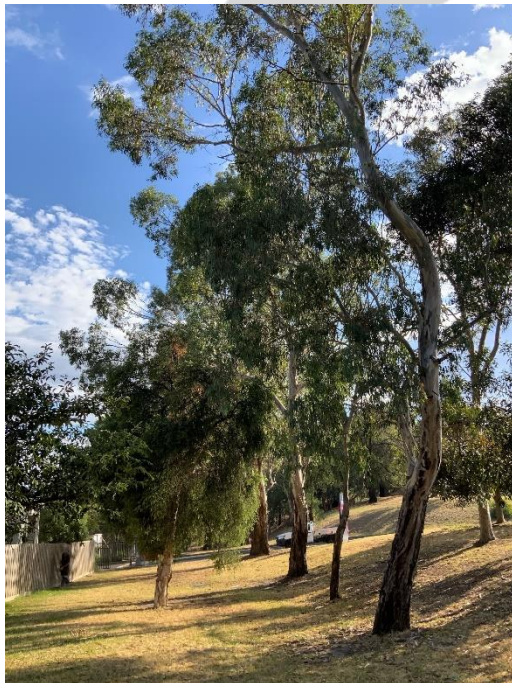
**Figure 3.** Victorian native trees in the proposed carpark area in direct planting rows indicating likely planted origins. Planted trees are exempt from any permit requirements from Native Tree Clause 52.17

While it is difficult to ascertain the original establishment of the vegetation on site, it is considered a mostly planted site, other than the frequent self-seeded weed varieties, which includes Sweet Pittosporum and Desert Ash species. Historical aerial imagery shows garden bed plantings with progressive growth and there is anecdotal evidence of planting programs by priests at establishment of the campus as evidenced with areas of established tree plantings in rows, with adequate space and at relatively even intervals (4.1.2, figure 3).

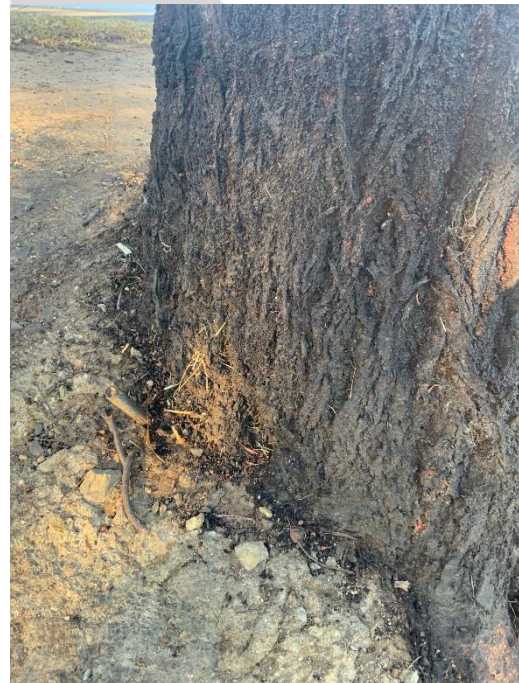
**Figure 4.** Likely planted mature specimen with a steel pipe originating from tree base. Stake possibly used for stability while establishing from planting.

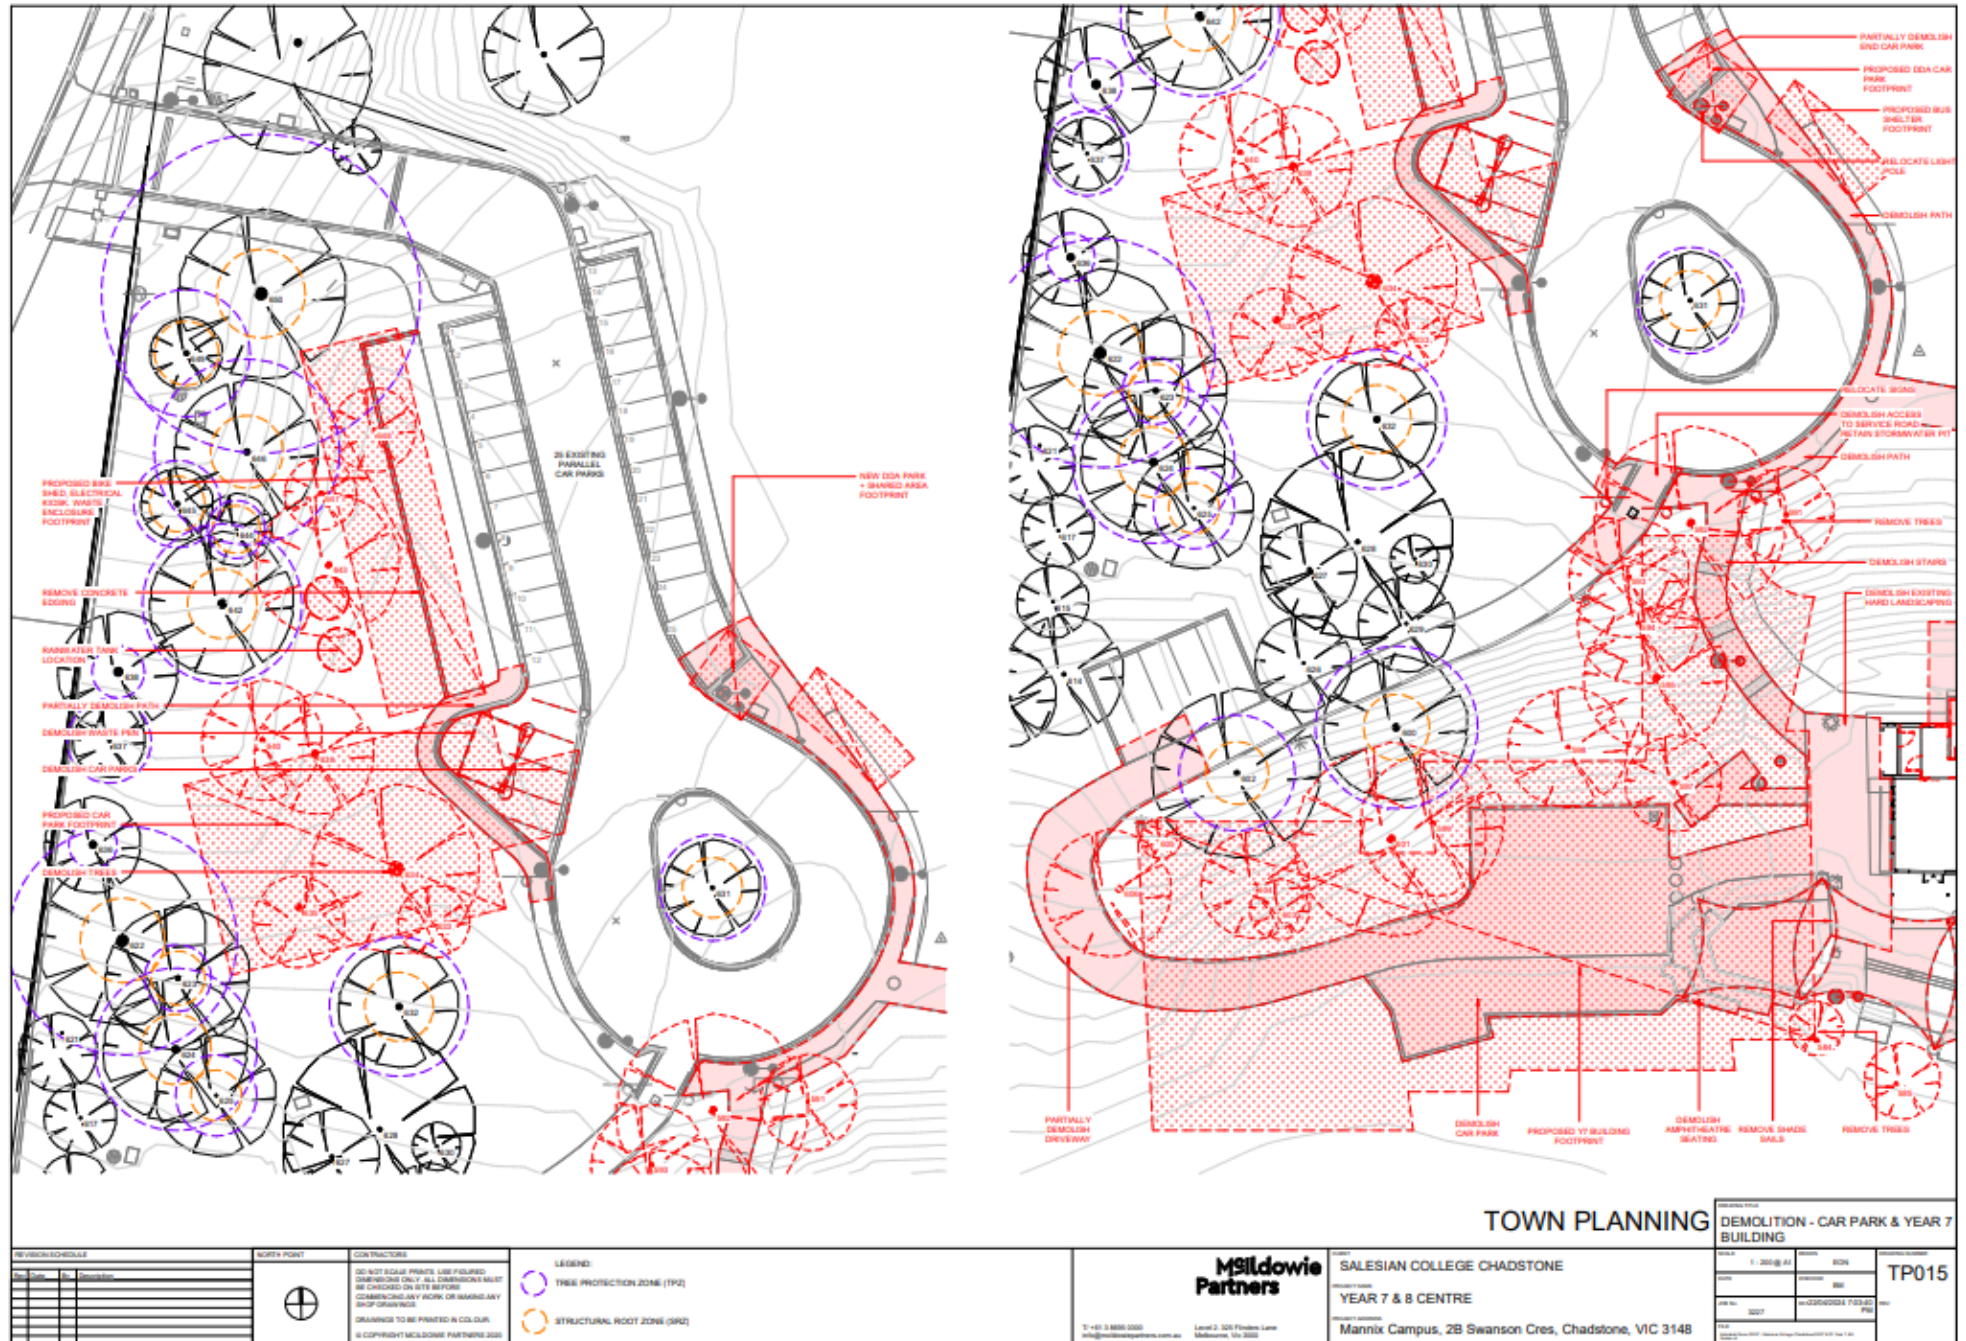
### 6.1.2 Proposed carpark area and western building extension (TPZ in purple)

There are a number of **High** retention rated trees within the proposed development zone, with the proposed car park option to the west of the current carpark and driveway containing 6 trees considered of **High** retention value. These trees have significant canopy size and large trunks, with the associated Tree Protection Zones extending across proposed development areas. TPZ encroachment can be determined using the area calculation where design requires intrusion into only one side of the protection area of these trees.
