# Feathertop Lodge, **Falls Creek**

Preliminary Geotechnica The Representation of the state o Assessment

13 July 2023

Project na	ame	Feathertop Lodge, Falls Creek - Preliminary Geotechnical Risk Assessment					
Documen	t title	Feathertop Lodge, Falls Creek   Preliminary Geotechnical Risk Assessment					
Project n	umber	12612126					
File name		12612126_Feather	topLodge_2023_	GRA.docx			
Status	Revision	Author	Reviewer		Approved for issue		
Code			Name	Signature	Name	Signature	Date
S4	0	A Quealy R Hayes	A Hunter	A.Hur	G Jones	But	14 June 2023
[Status code]							
[Status code]							
[Status code]							
[Status code]

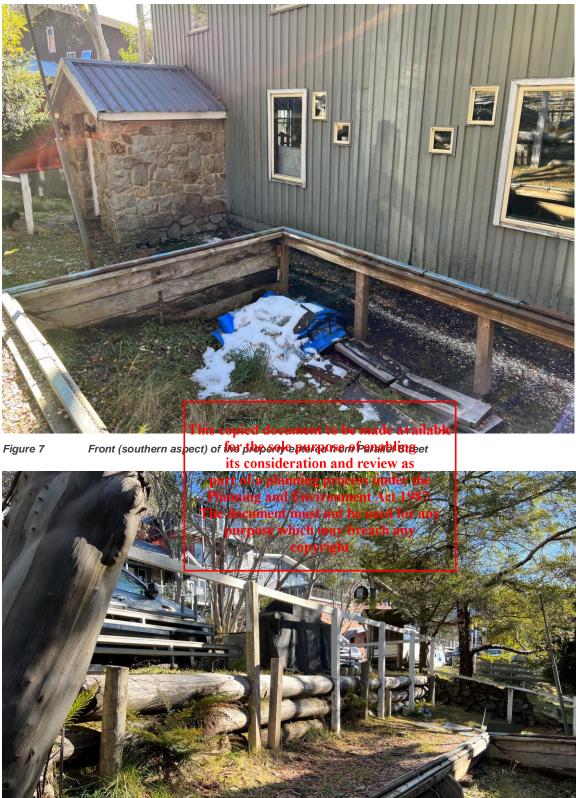
Figure 8

Log retaining wall along the southern boundary of the property. The retaining wall is situated between the front of the property and Parallel Street

Failure of fill batter	Parallel Street batter slope in front (southern aspect) of the building	<b>Unlikely</b> The slopes show no obvious signs of slope instability	<b>Medium</b> Failure could impact the front of the building	Low		N/A	N/A	N/A
Failure of non- engineered retaining walls	Retaining walls along the east and west of the building, and the timber log retaining wall along the front of the building	<b>Possible</b> There are currently no obvious signs of distress or deterioration. However poor construction techniques have been adopted for the retaining walls.	Minor Failure may result in damage to minor infrastructure. Failure may require remediation of slopes, particularly below Parallel St.	Moderate	Where retaining walls remain as part of the redevelopment, consider monitoring for significant distress and/or replacement of the retaining walls with an engineered solutions that is backfilled with suitably controlled fill.	Unlikely	Medium	Low

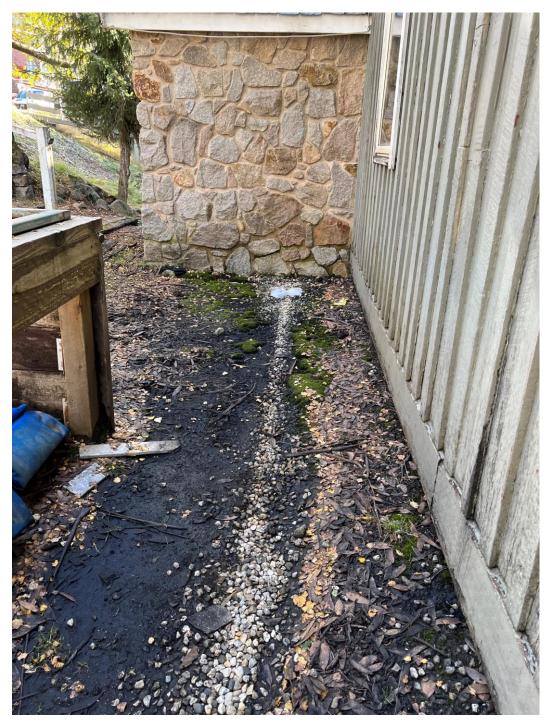
Figure 9

The southern aspect (front) and entryway of Feathertop Lodge. Note the absence of formal drainage and evidence of surface water pooling.

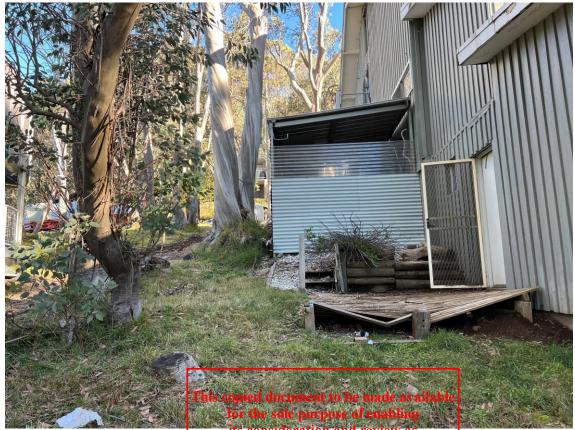
Several established trees are situated along the eastern aspect of the property and likely provide stabilisation to the moderate slope (Figure 10). A small retaining wall, presumably backfilled with uncontrolled fill materials, has been constructed to support the shed structure along the eastern side of the building. It is noted the shed and wooden decking present in Figure 10 will be removed as part of the redevelopment. No formal drainage was observed along the eastern aspect of the property, however, the slope is well vegetated with no obvious signs of instability.

Figure 10 Eastern aspect of Featherton Lordge including the shed, small log retaining wall, decking and side entryway.

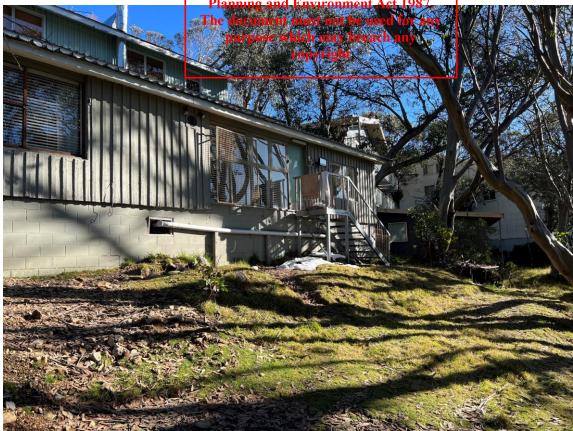
To the north, the property is bounded by the Red Onion Ski Chalet (7 Arlberg Street). The area is generally well grassed with several established trees present, however in the absence of formal drainage, localised zones of erosion and sediment loss were observed forming a hummocky surface (particularly beneath the rear building eaves) (refer Figure 11).

Figure 11 Northern aspect (rear) of Feathertop Lodge.

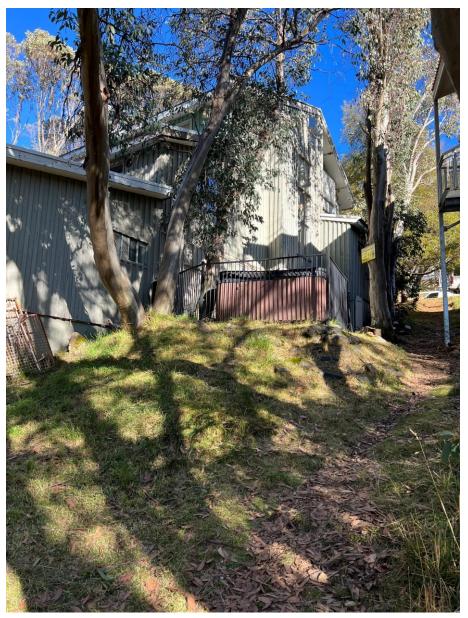
Figure 12

Feathertop Lodge is bound by Banool Ski Club (12 Parallel Street) along the western aspect of the property. An non-engineered retaining wall/fill batter, presumably constructed from uncontrolled materials, underlies the outdoor uncovered spa area (refer Figure 12) with a side entryway situated to the south of the spa. The retaining wall is relatively low well grassed and appears to be in apparent good condition. No formal drainage is evident along the western aspect of the property and localised evidence of sediment loss and erosion was observed.

The western aspect of the property including stone retaining wall underlying the spa.
