ARBORICULTURAL REPORT MOUNT LILYDALE MERCY COLLEGE, 120 ANDERSON STREET, LILYDALE

February 2024

DRAWING
 Impact Assessment Plan

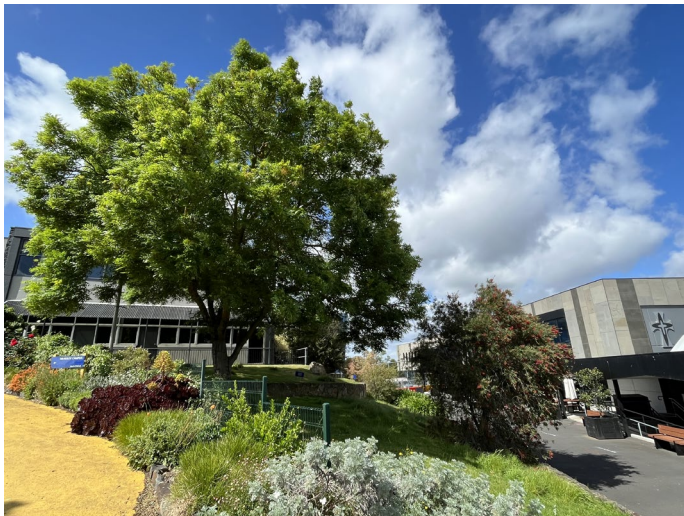
Trees 1 (right) and 2

- 5.4 A landscape plan prepared for the site also indicates removal of Tree 1, Bottlebrush. This tree is also of low arboricultural value.
- 5.5 Tree 6 is below the size that requires a permit for its removal under SLO23.

- 7.1 Protective fencing be erected to isolate Tree 2 from the proposed works. This can be removed for deck construction and landscaping installation.

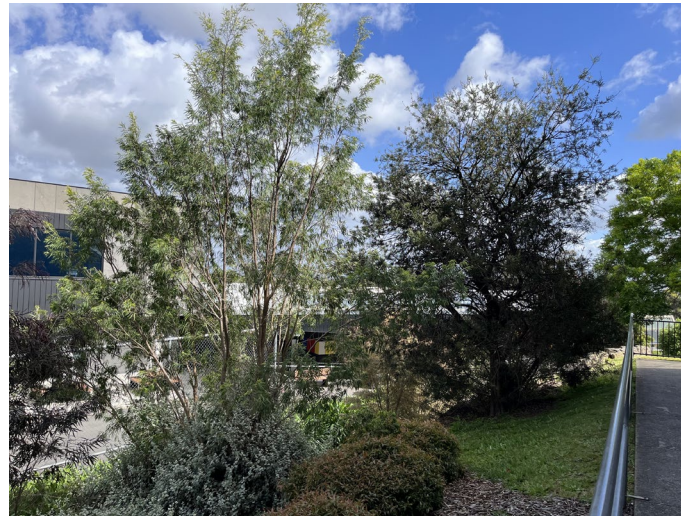
Trees 3 (right) and 4

- 5.3 Trees 3 – 6 are located within the footprint of the proposed building and will therefore require removal. All four trees are of low arboricultural value.

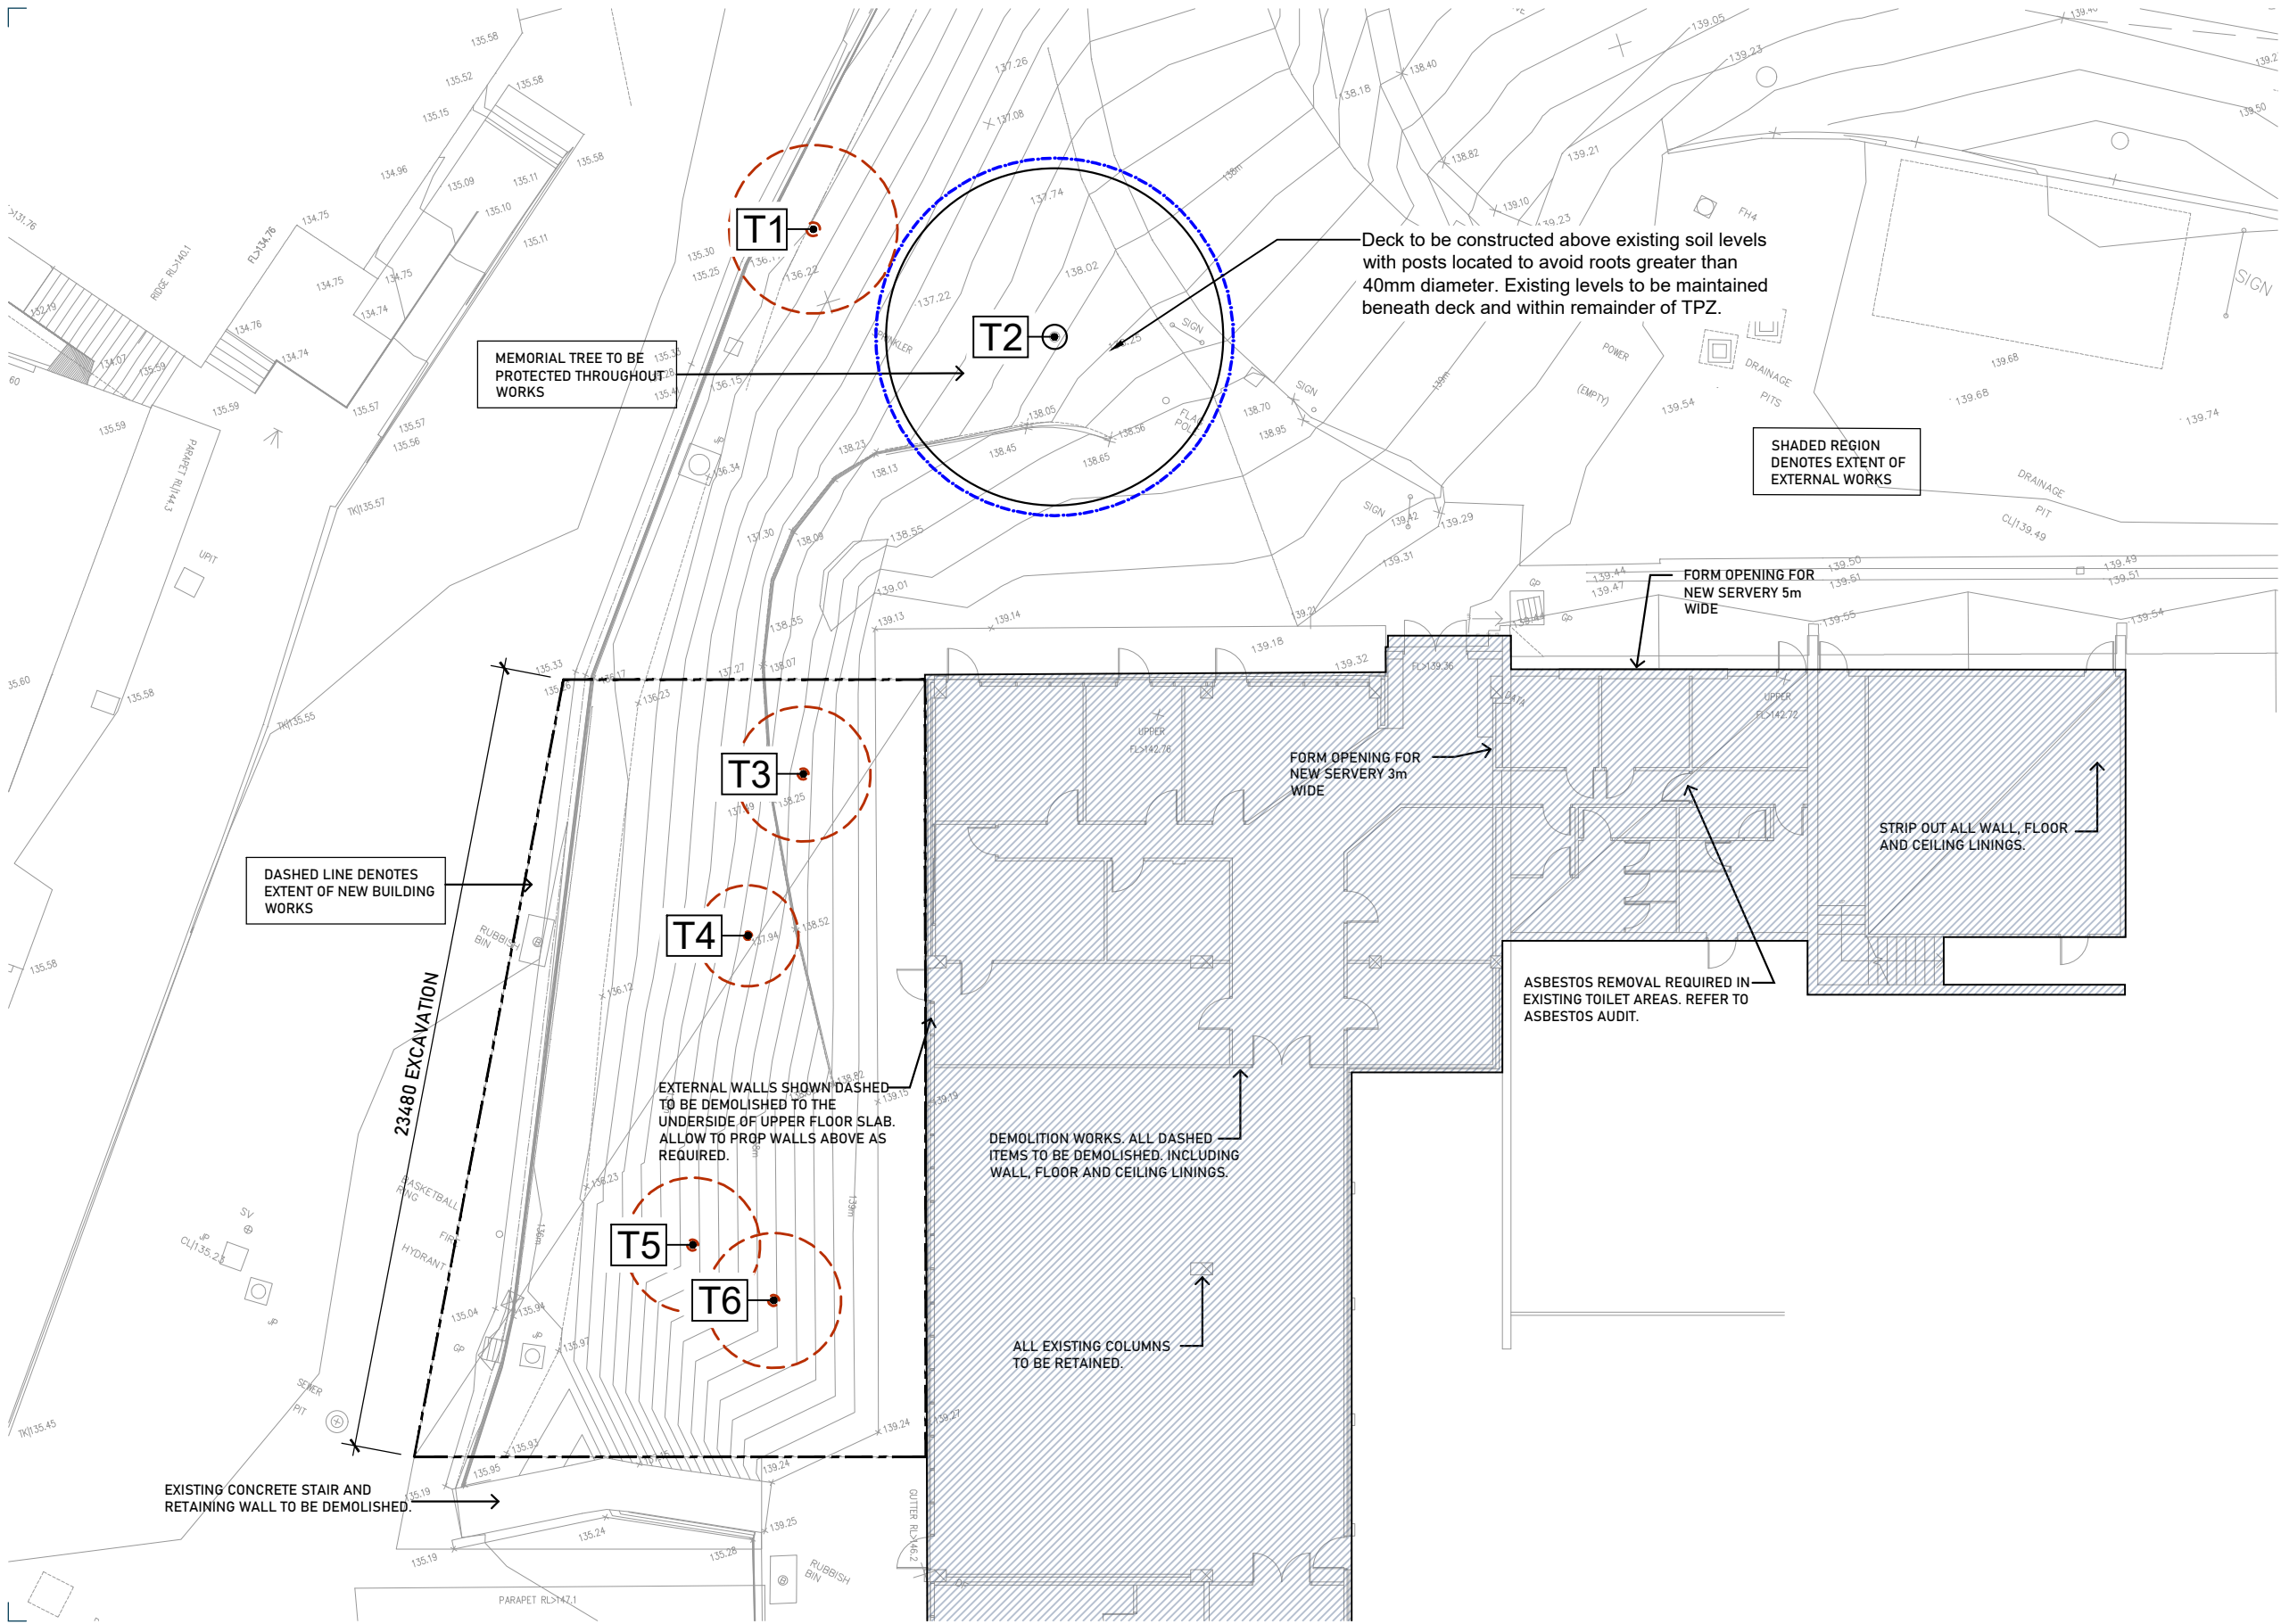
- 5.6 Trees 1, 3, 4 and 5 will all require permits for their removal under SLO23.
- 5.7 A landscape plan prepared for the site proposes a deck around Tree 2. Provided this is constructed completely above existing soil levels with posts located to avoid roots greater than 40mm in diameter, it is not expected to negatively impact the long-term healthy retention of this tree. Existing soil levels must be maintained in the remainder of their TPZs and under the deck itself, this includes no fill greater than 100mm depth.
