Appendix M

# Arborist Assessments

**RE: 013638 – Arboricultural Advice – Normanville Energy Park– Root sensitive electrical works**

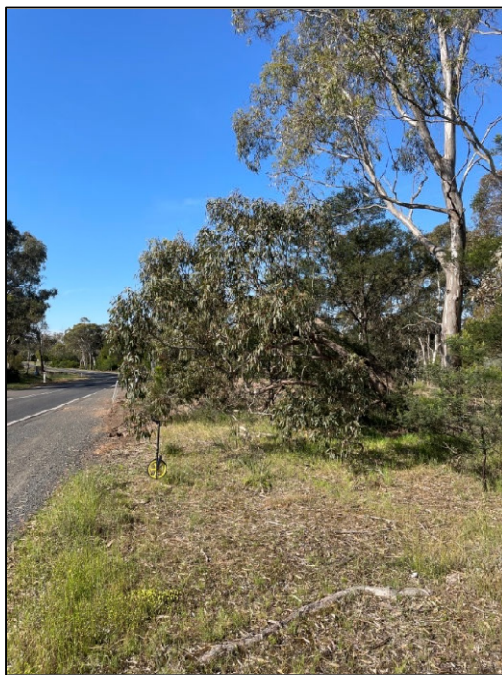
*Image 3. Tree 36 at Site 8 will require some minor reduction pruning. Measurement wheel at approximate location of edge of swept path.*

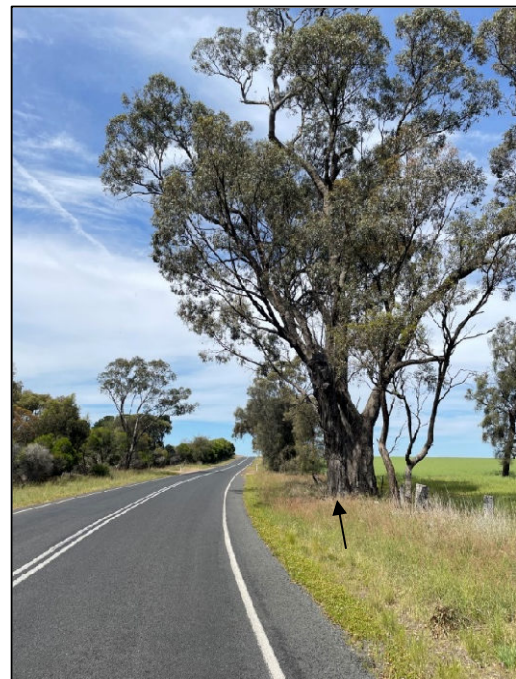
*Image 4. Tree 28 at Site 11 would require major pruning works and is considered lost.*

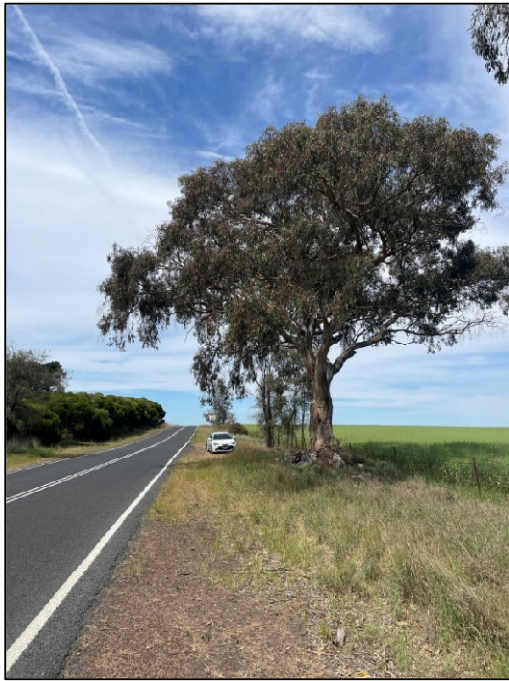
*Image 5. Tree 27 at Site 11 may require some minor clearance pruning.*

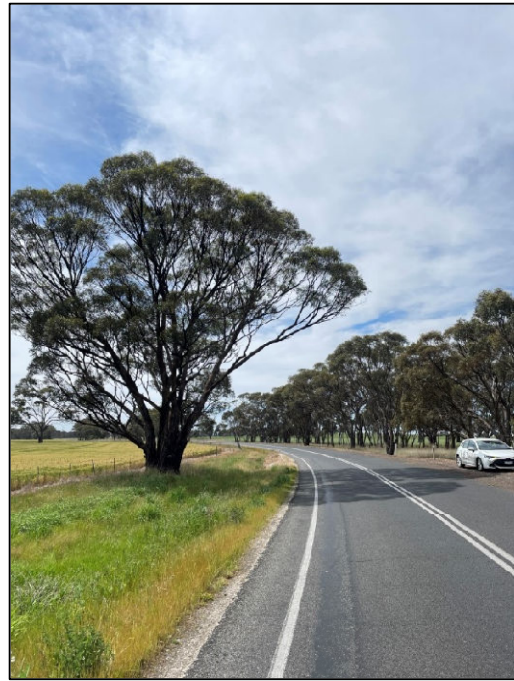
*Image 6. Tree 23 at Site 12 has a lower crown height of >7m so should not require clearance pruning.*

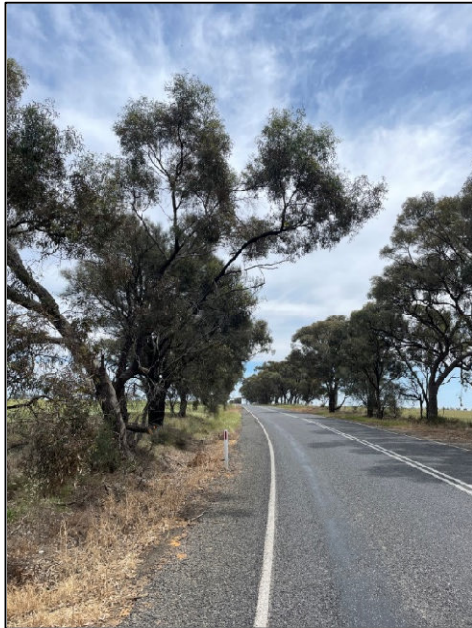
*Image 7. Tree 15 at Site 13 may require some minor clearance pruning.*

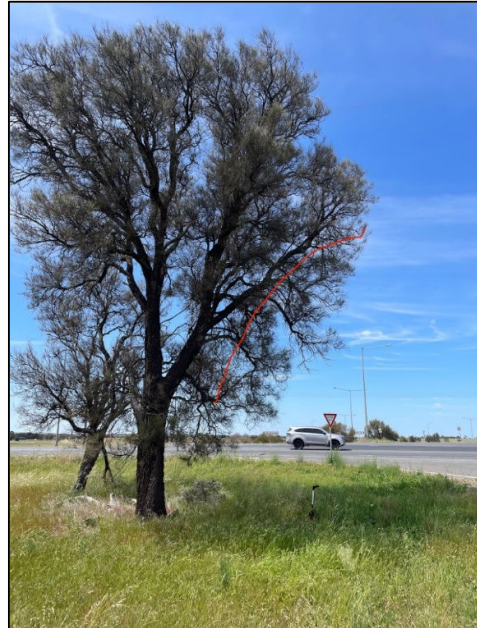
*Image 8. Tree 9 at Site 16 will require an estimated 10-20% reduction (marked in red). Approximate location of swept path shown by measurement wheel.*

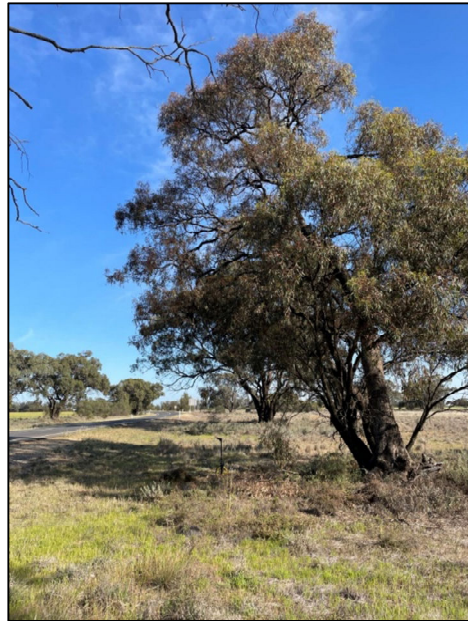
*Image 10. Tree 2 at Site 22 will require 10-15% canopy reduction. Approximate location of swept path shown by measurement wheel.*

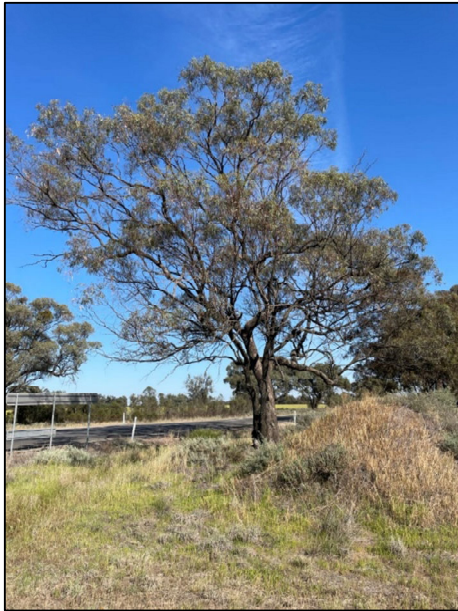
*Image 11. Tree 5 at Site 22 is within the swept path and would be lost.*

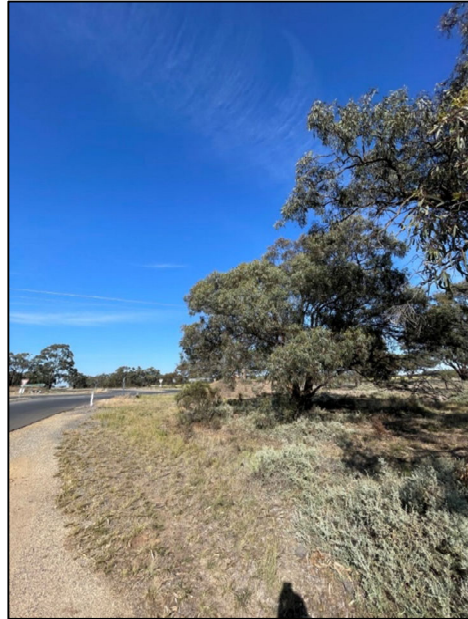
*Image 12. Tree 4 at Site 22 is within the swept path and would be lost.*

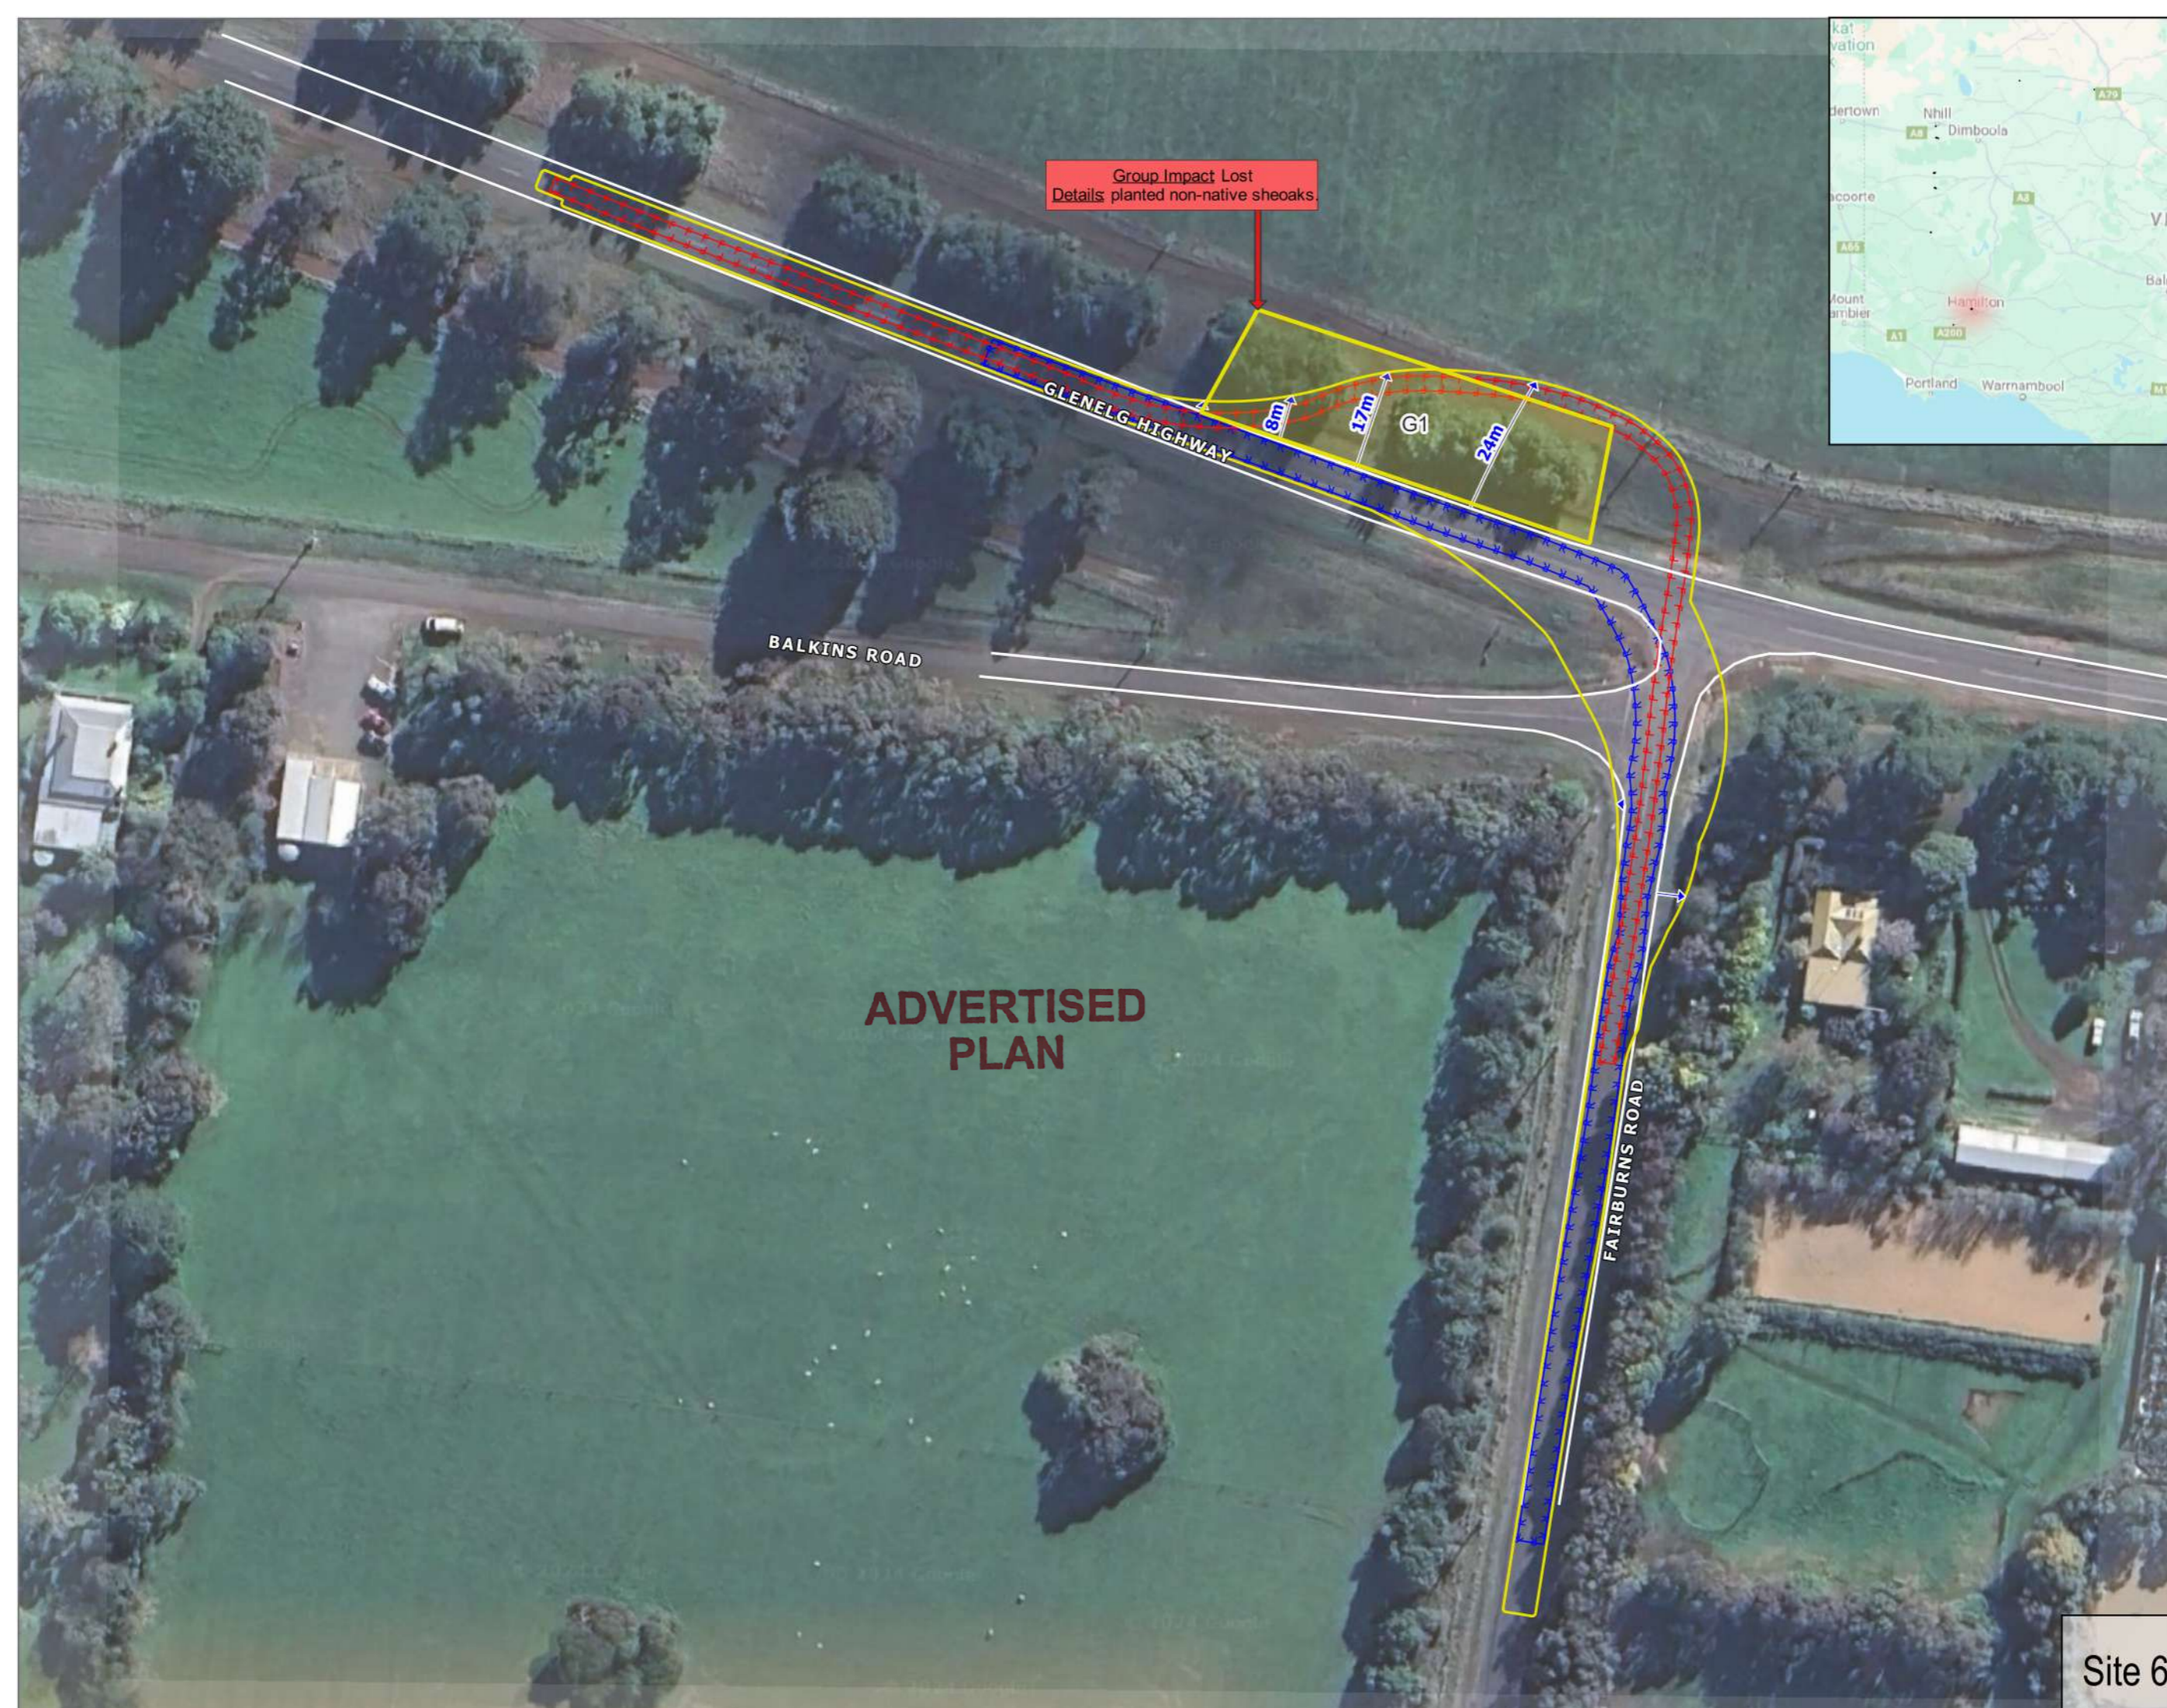
Site 3

Group Impact Lost  
Details planted non-native sheoaks.

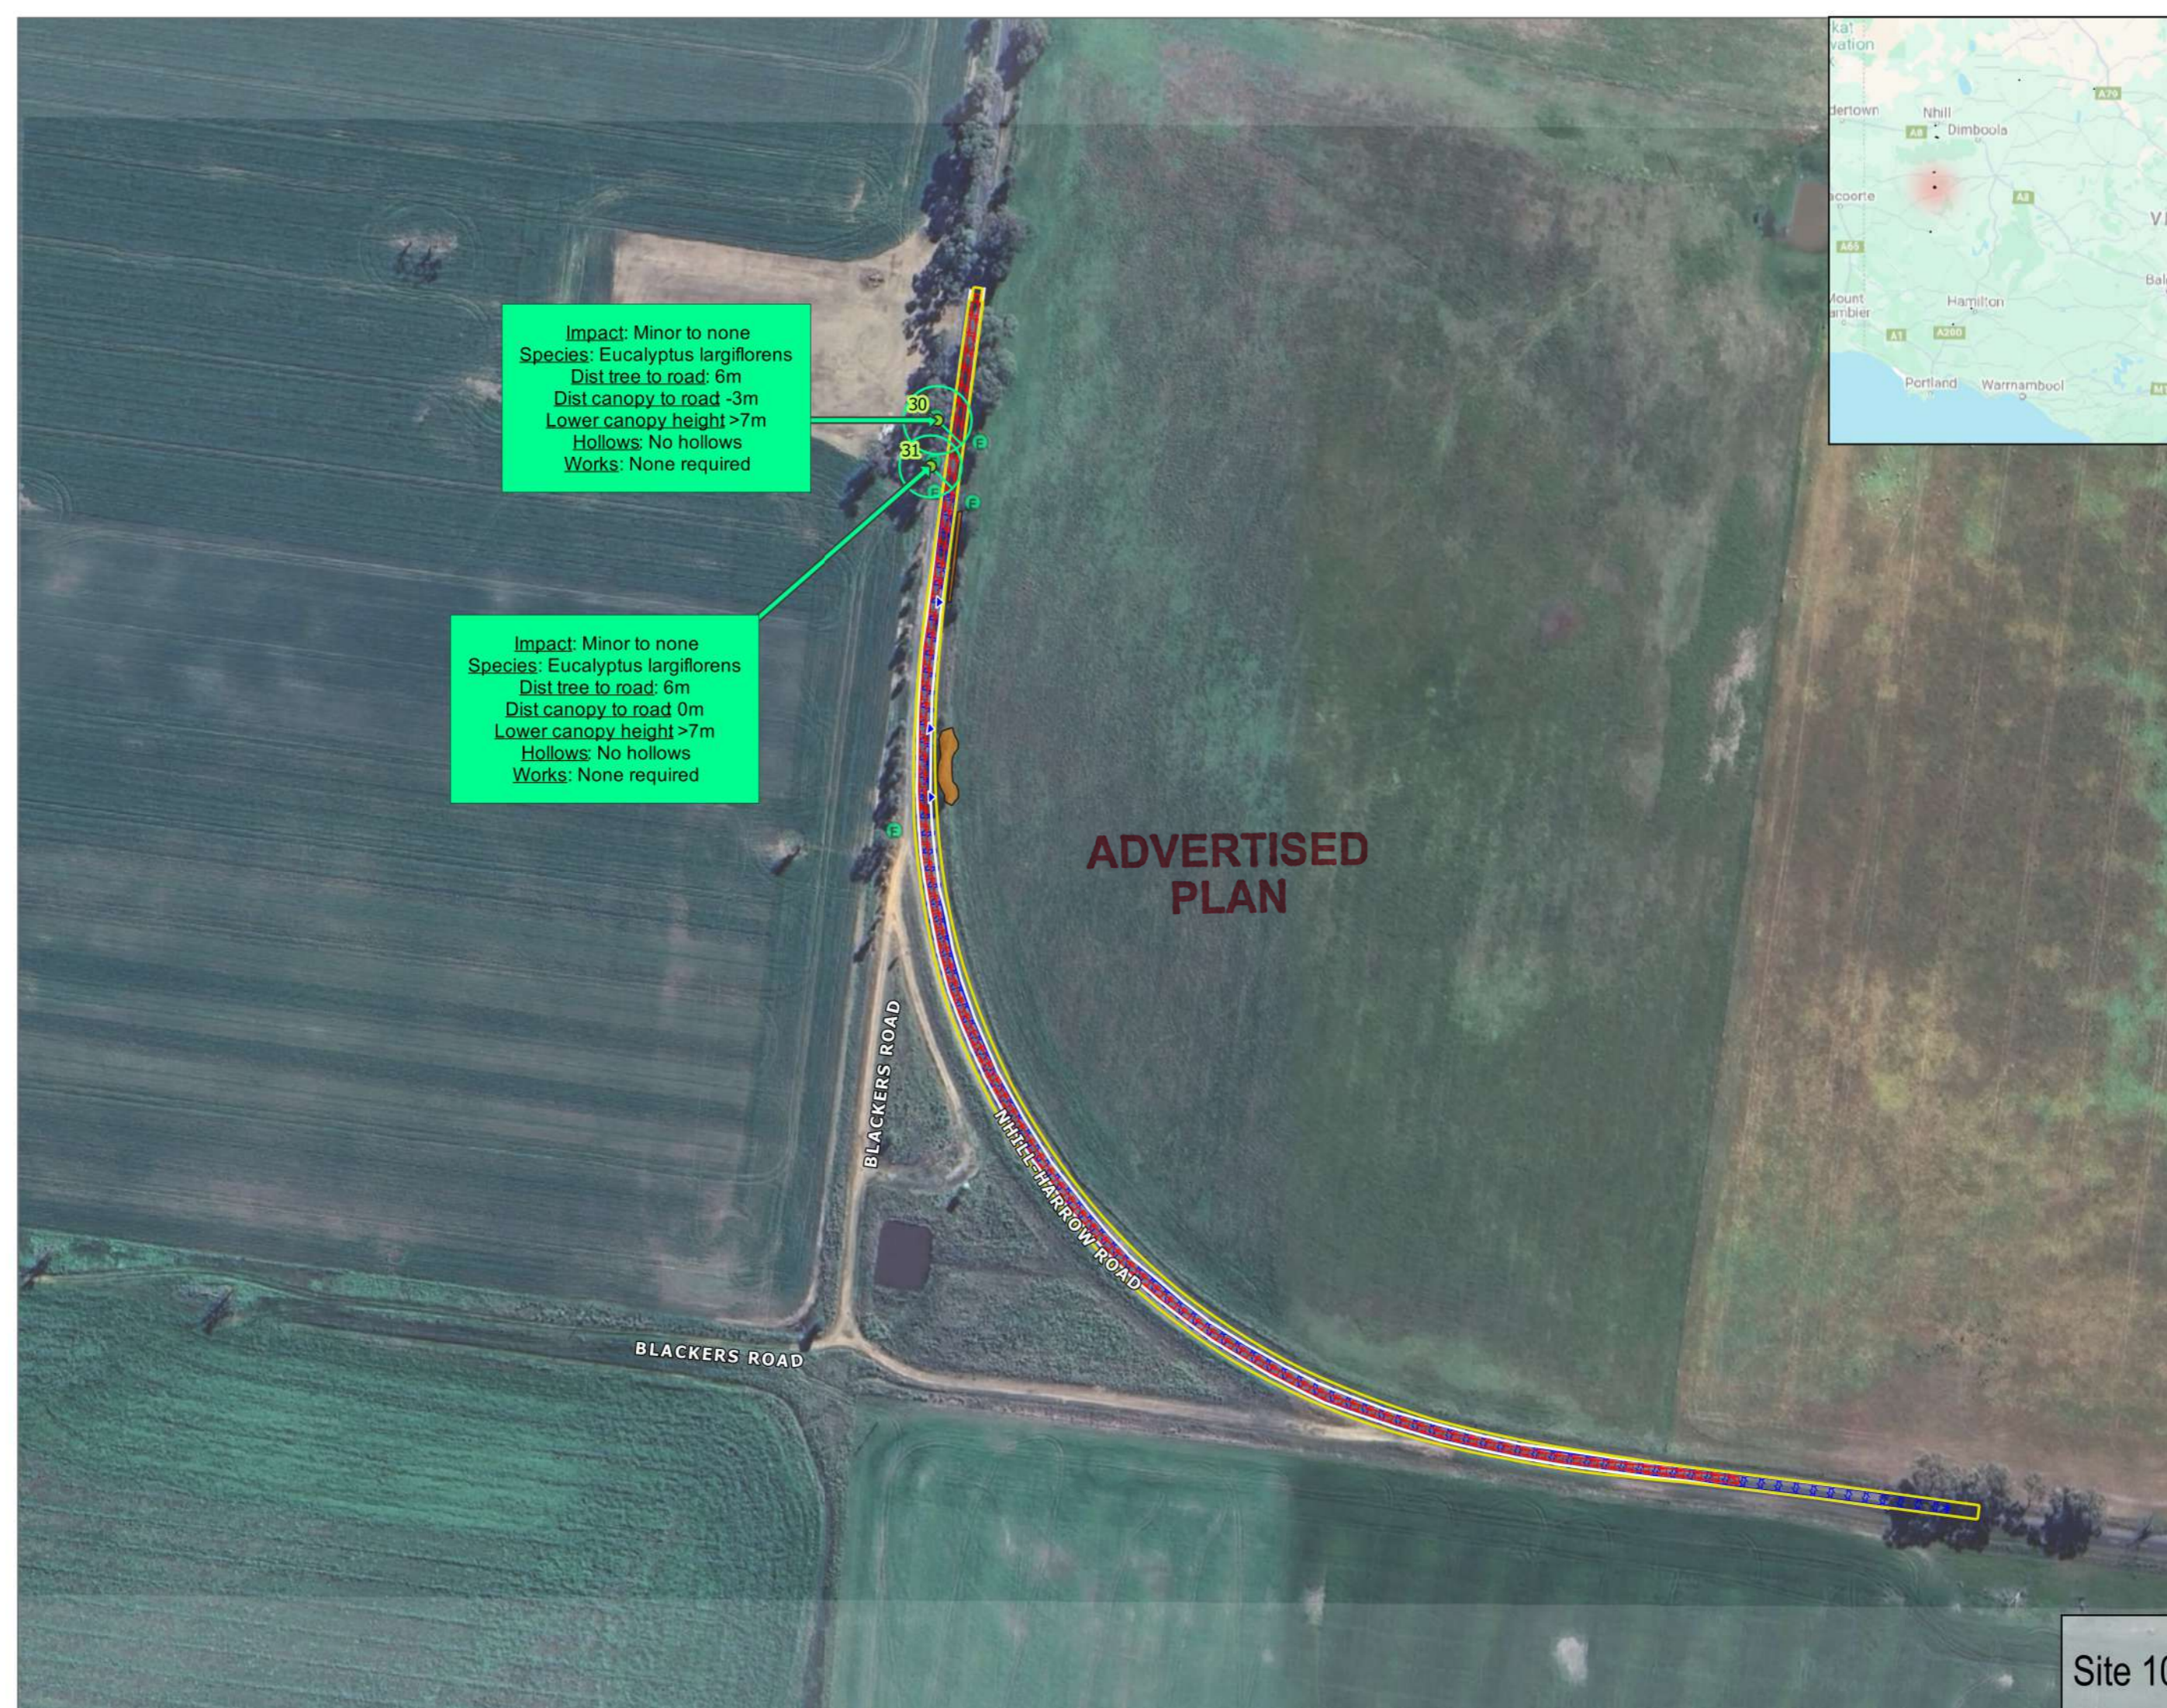
Site 9

Impact: Minor to none  
 Species: Eucalyptus largiflorens  
 Dist tree to road: 6m  
 Dist canopy to road -3m  
 Lower canopy height >7m  
 Hollows: No hollows  
 Works: None required

Impact: Minor to none  
 Species: Eucalyptus largiflorens  
 Dist tree to road: 6m  
 Dist canopy to road 0m  
 Lower canopy height >7m  
 Hollows: No hollows  
 Works: None required

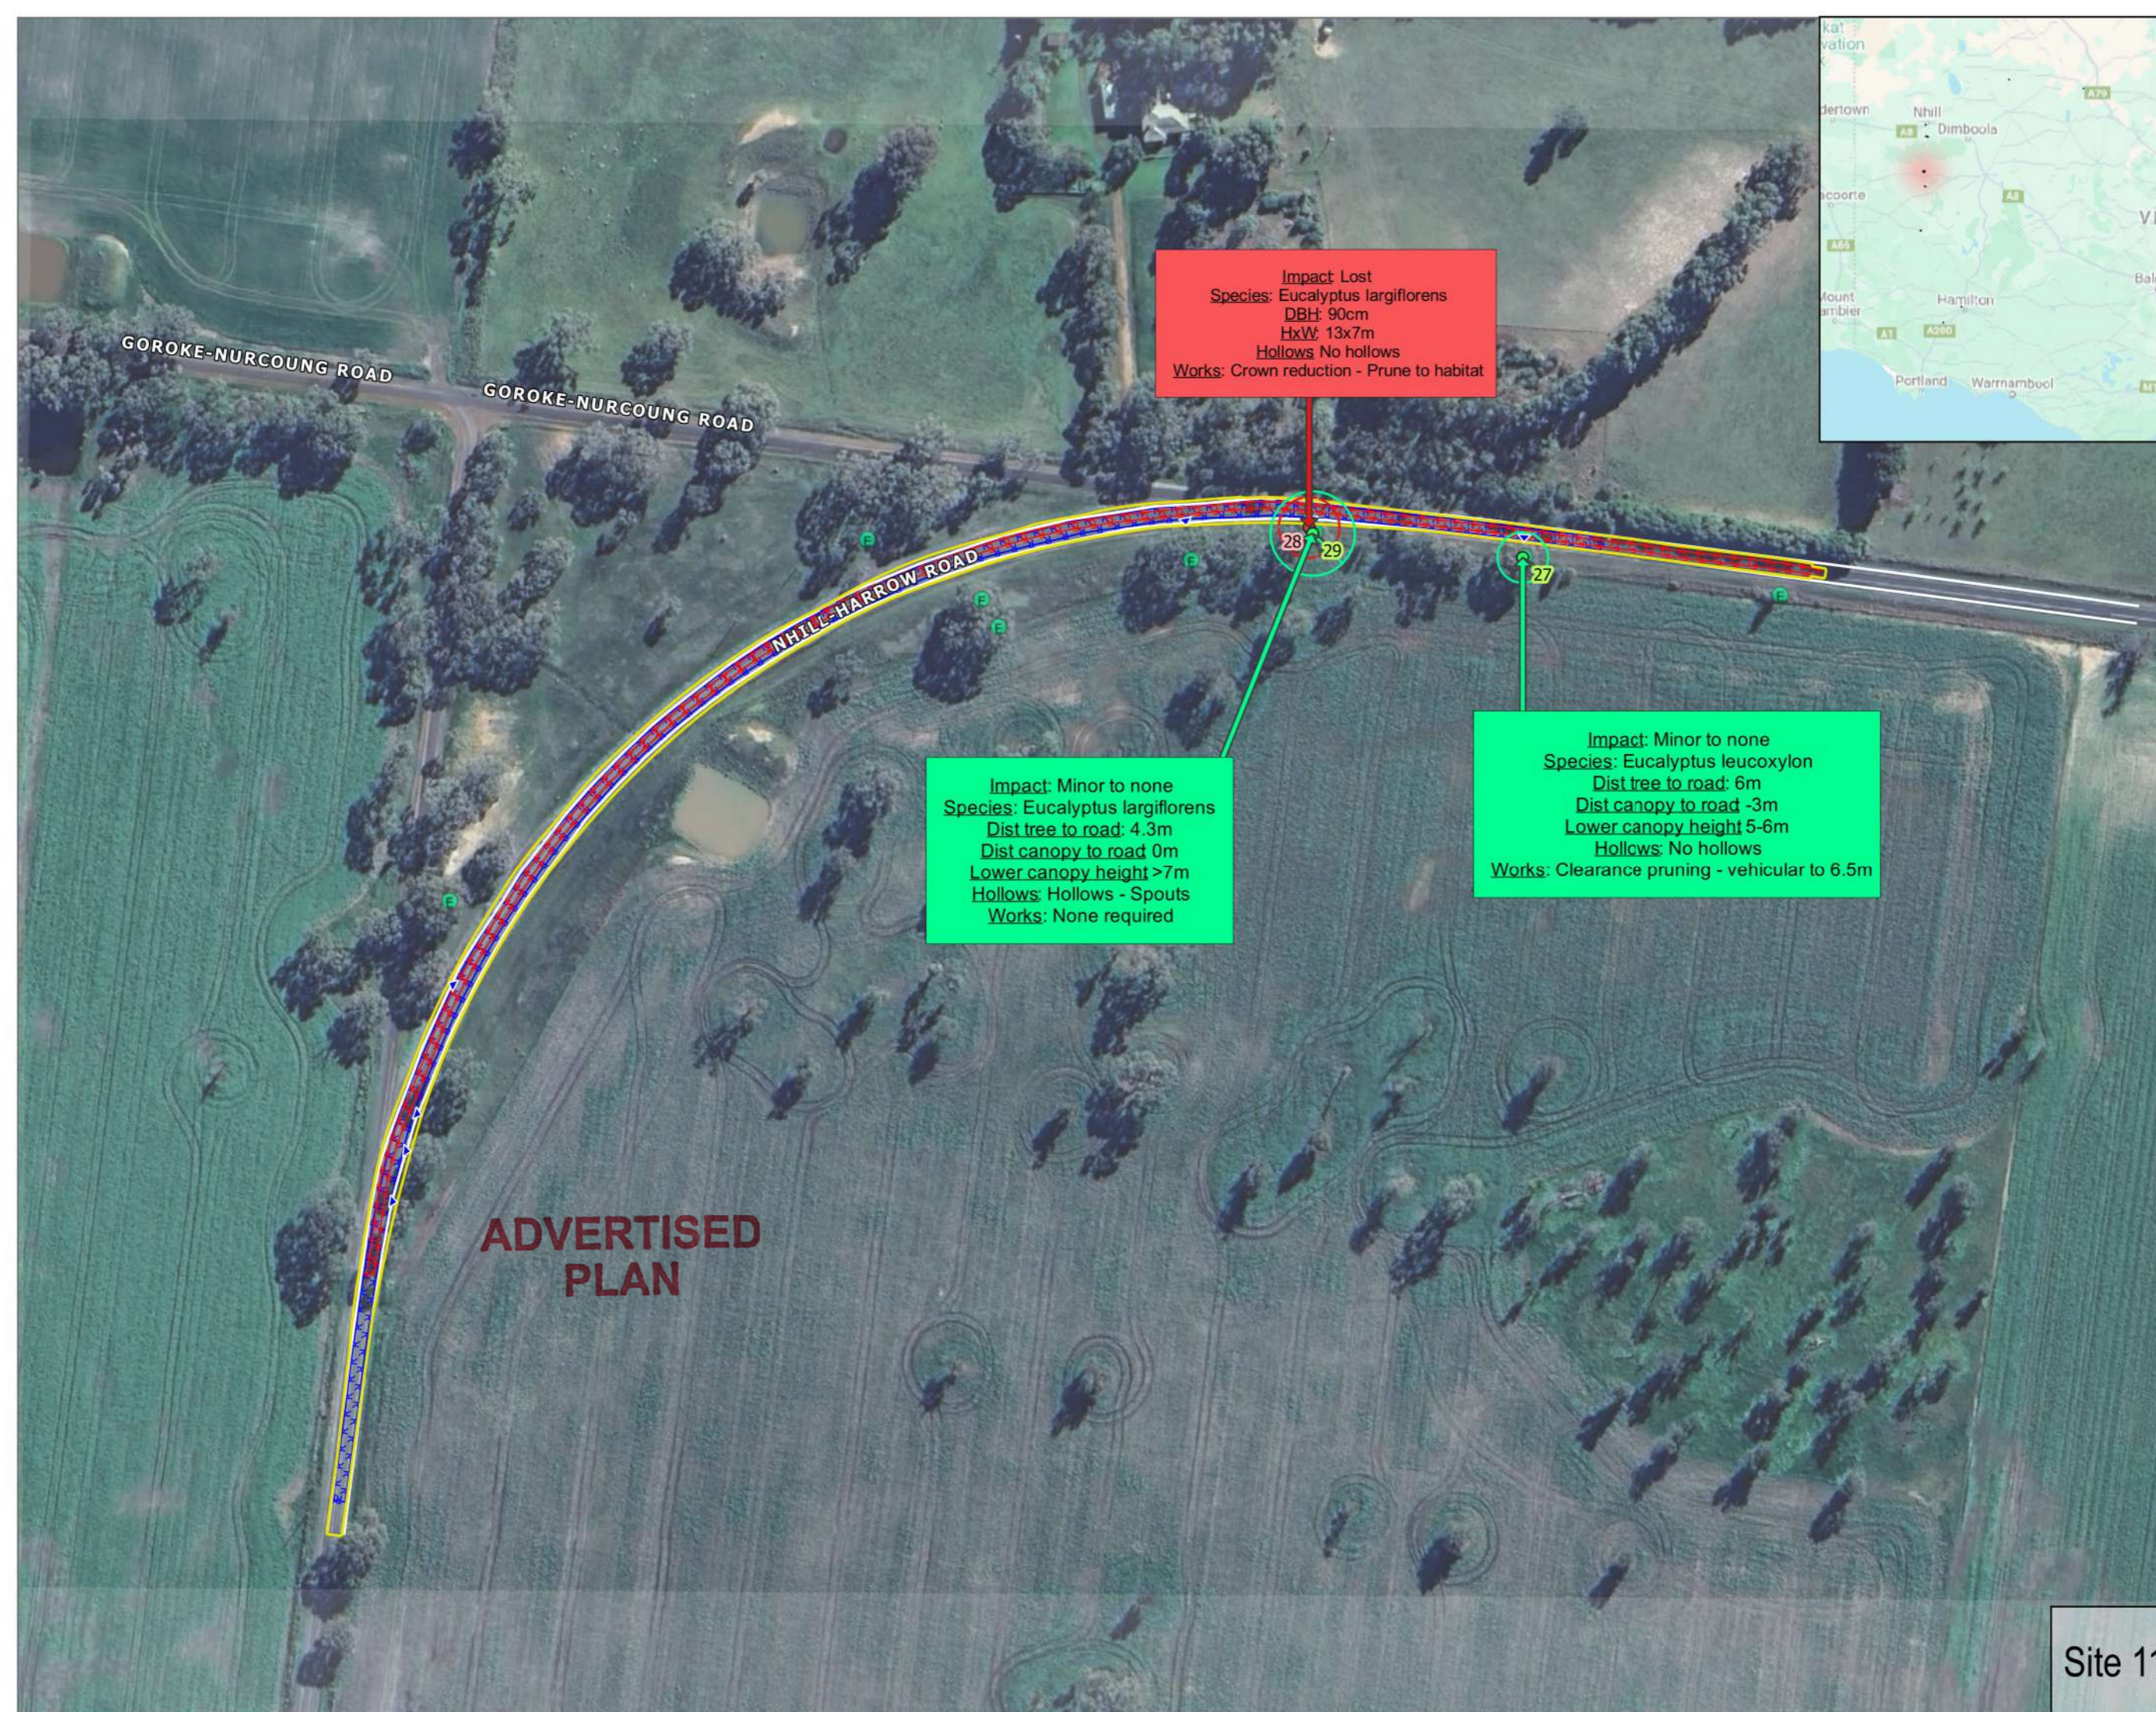
Site 10

Impact: Lost  
 Species: Eucalyptus largiflorens  
 DBH: 90cm  
 HxW: 13x7m  
 Hollows: No hollows  
 Works: Crown reduction - Prune to habitat

Impact: Minor to none  
 Species: Eucalyptus largiflorens  
 Dist tree to road: 4.3m  
 Dist canopy to road: 0m  
 Lower canopy height: >7m  
 Hollows: Hollows - Spouts  
 Works: None required

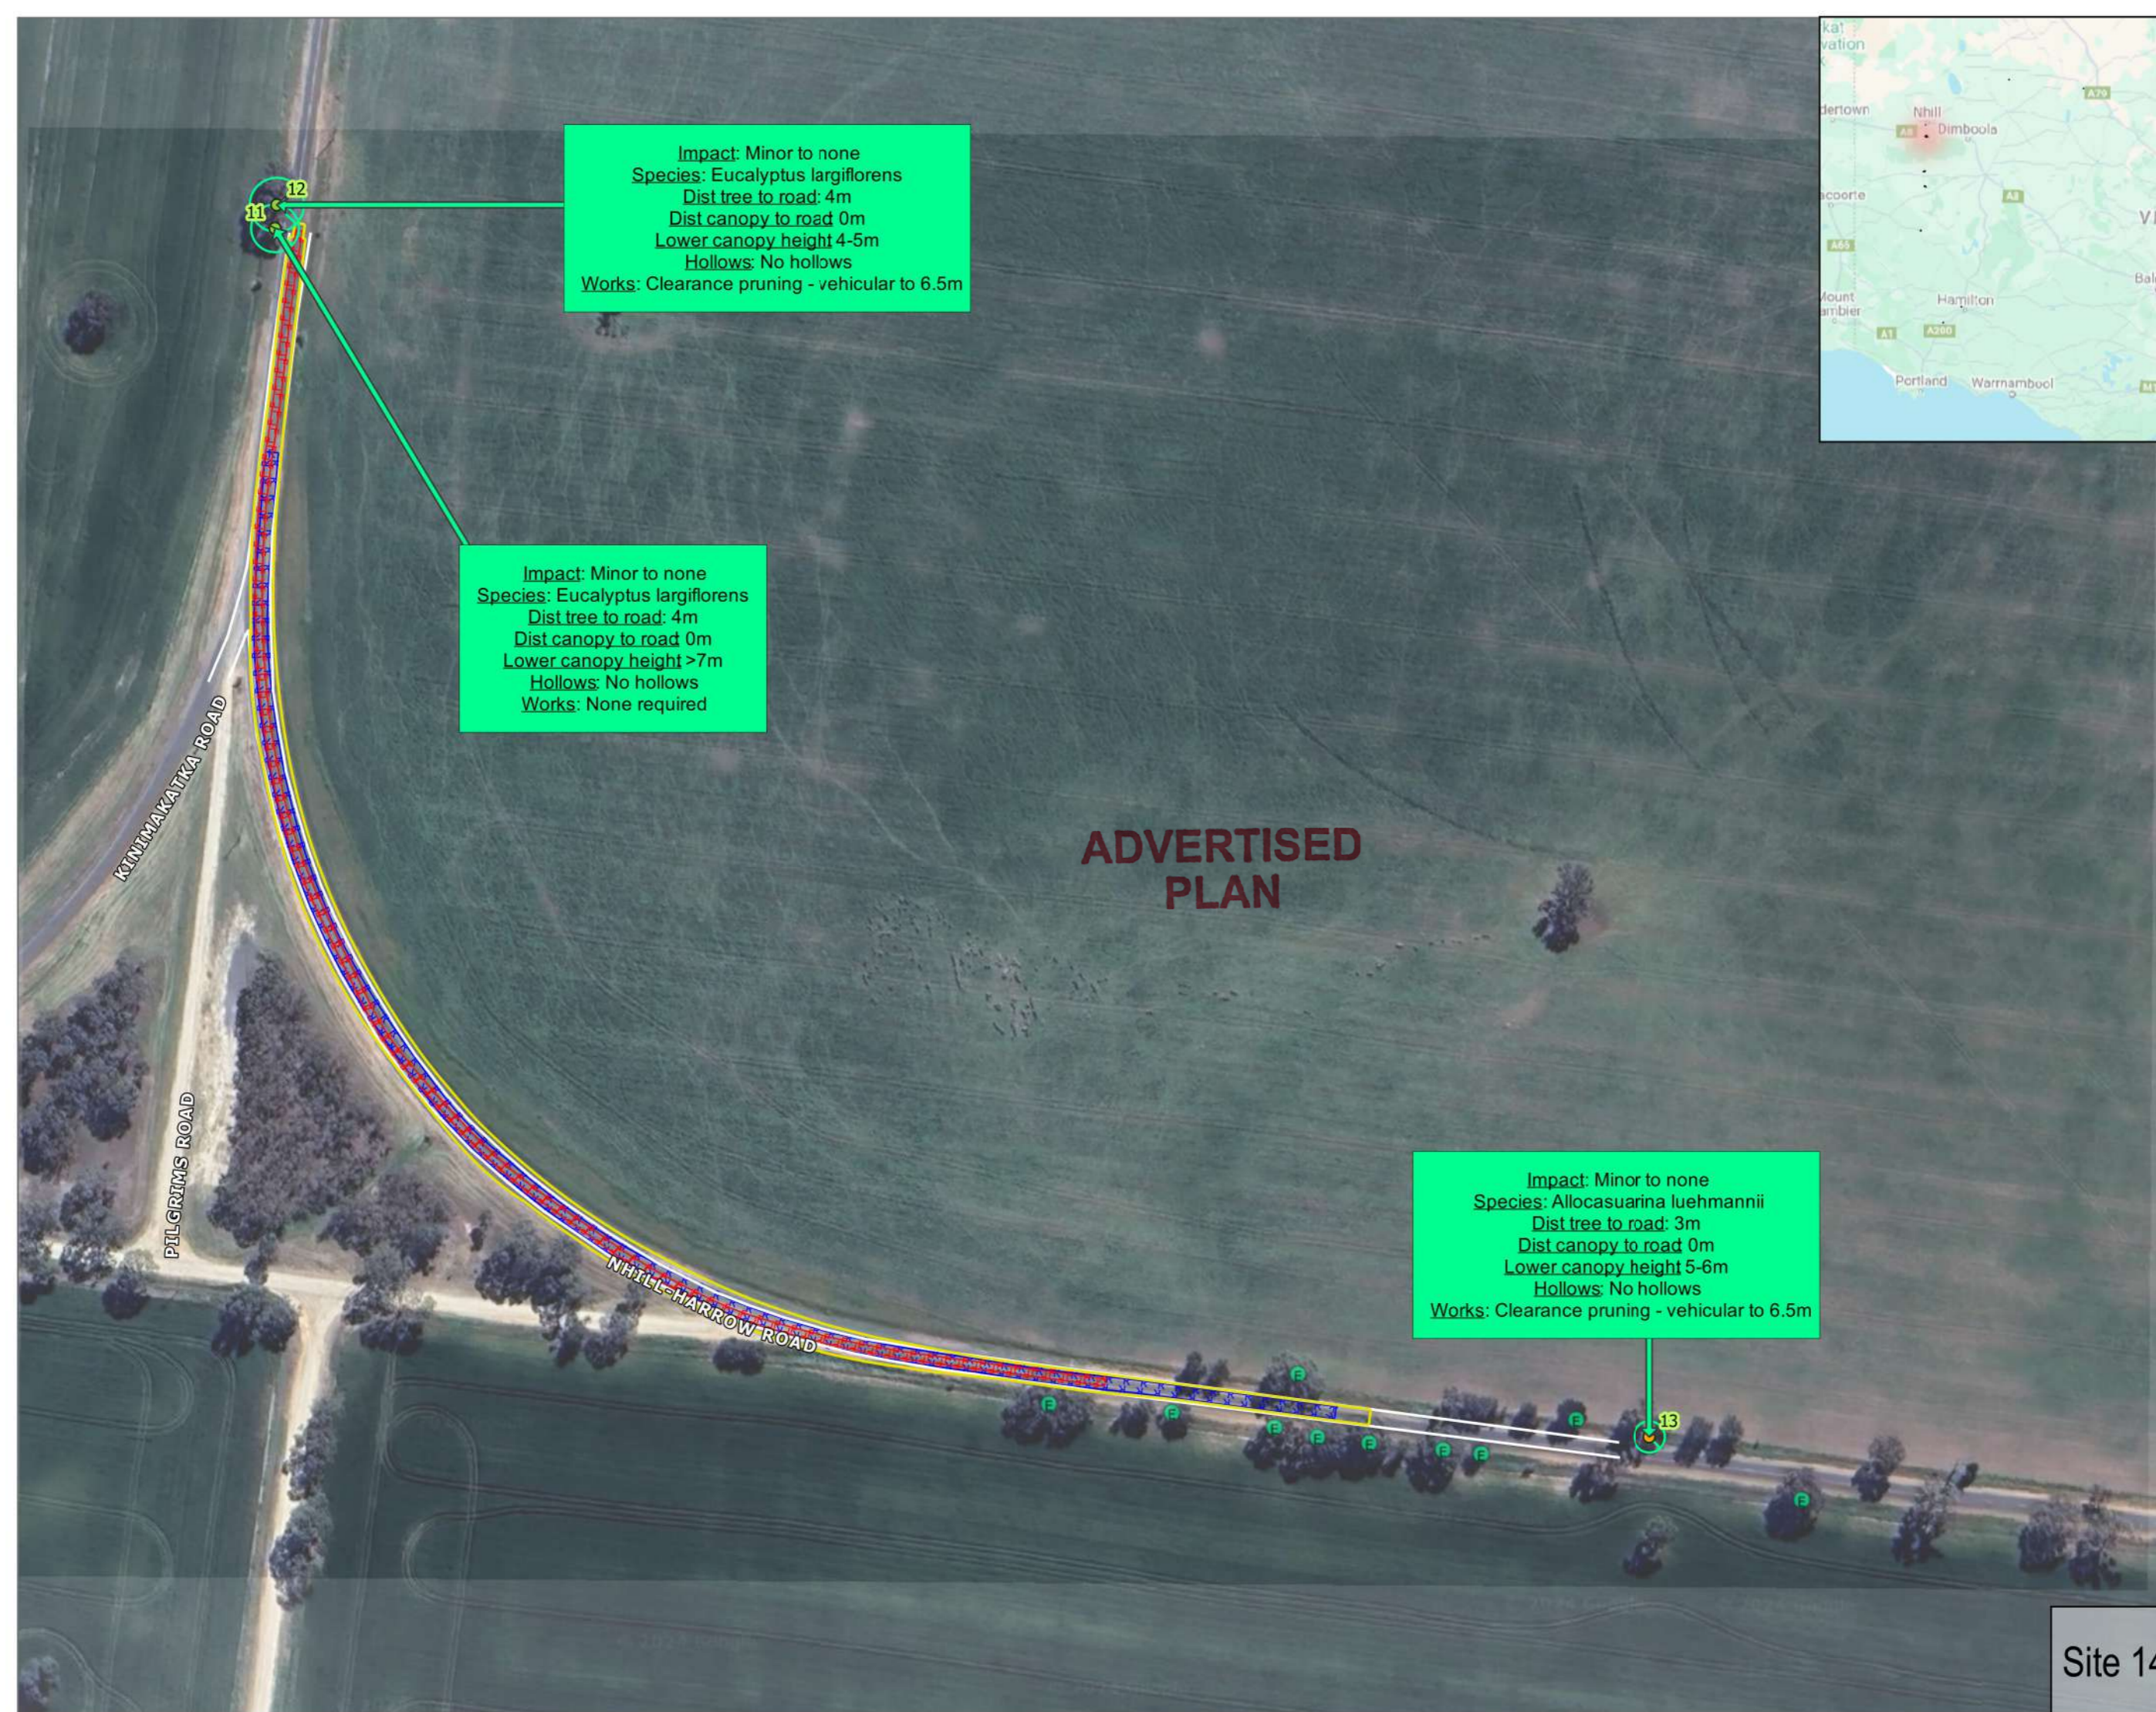
Site 13

Impact: Minor to none  
 Species: Eucalyptus largiflorens  
 Dist tree to road: 4m  
 Dist canopy to road 0m  
 Lower canopy height 4-5m  
 Hollows: No hollows  
 Works: Clearance pruning - vehicular to 6.5m

Impact: Minor to none  
 Species: Eucalyptus largiflorens  
 Dist tree to road: 4m  
 Dist canopy to road 0m  
 Lower canopy height >7m  
 Hollows: No hollows  
 Works: None required

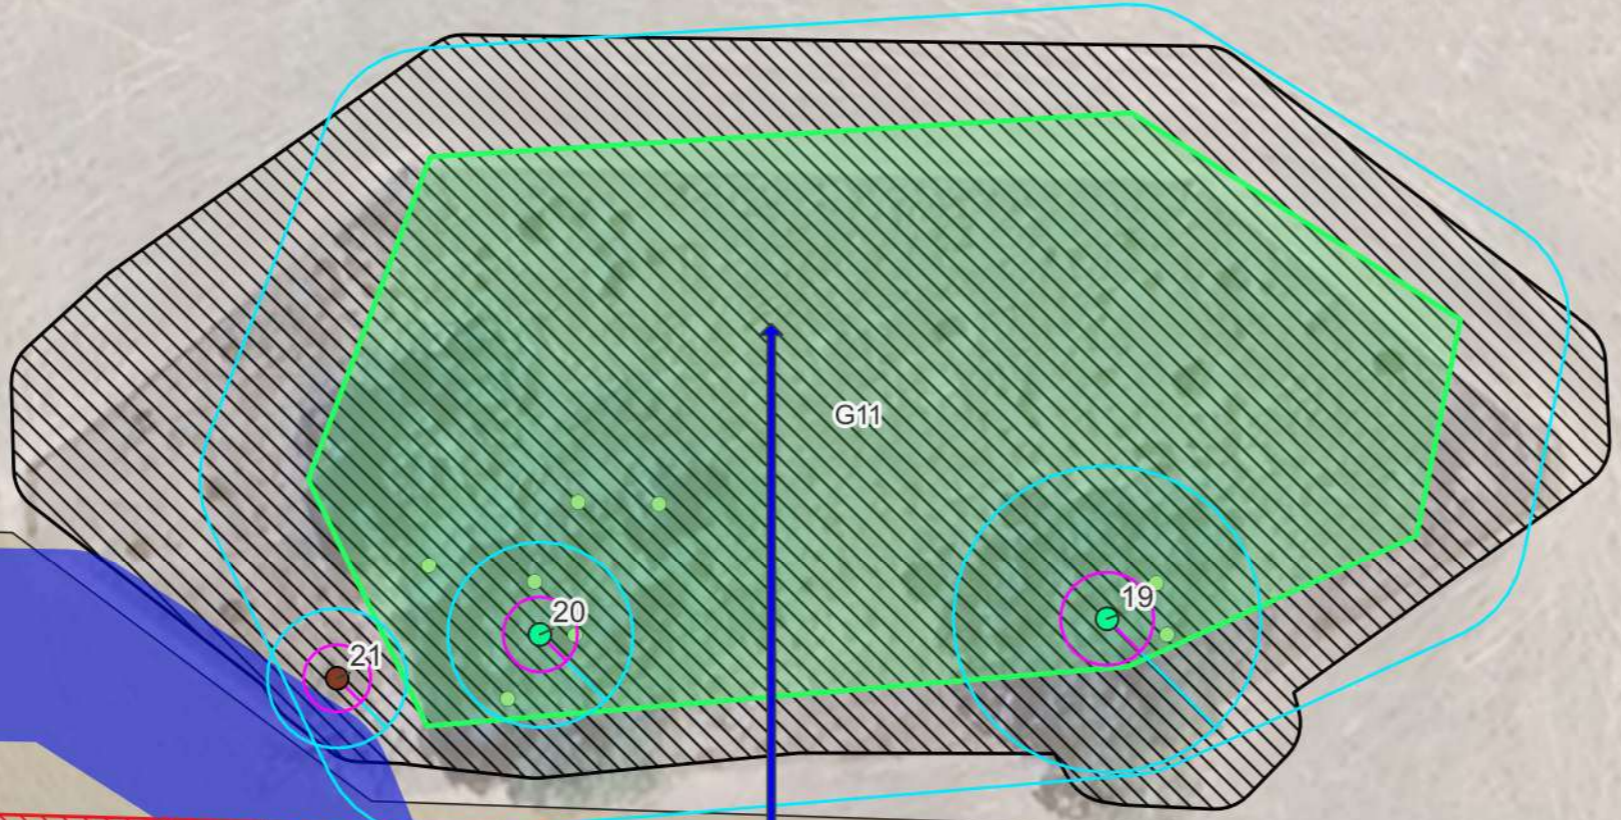
**Canopy impact** Minor  
**TPZ impact** Minor to none  
**Mitigation:** Dead tree 21 may need deadwood pruned back.

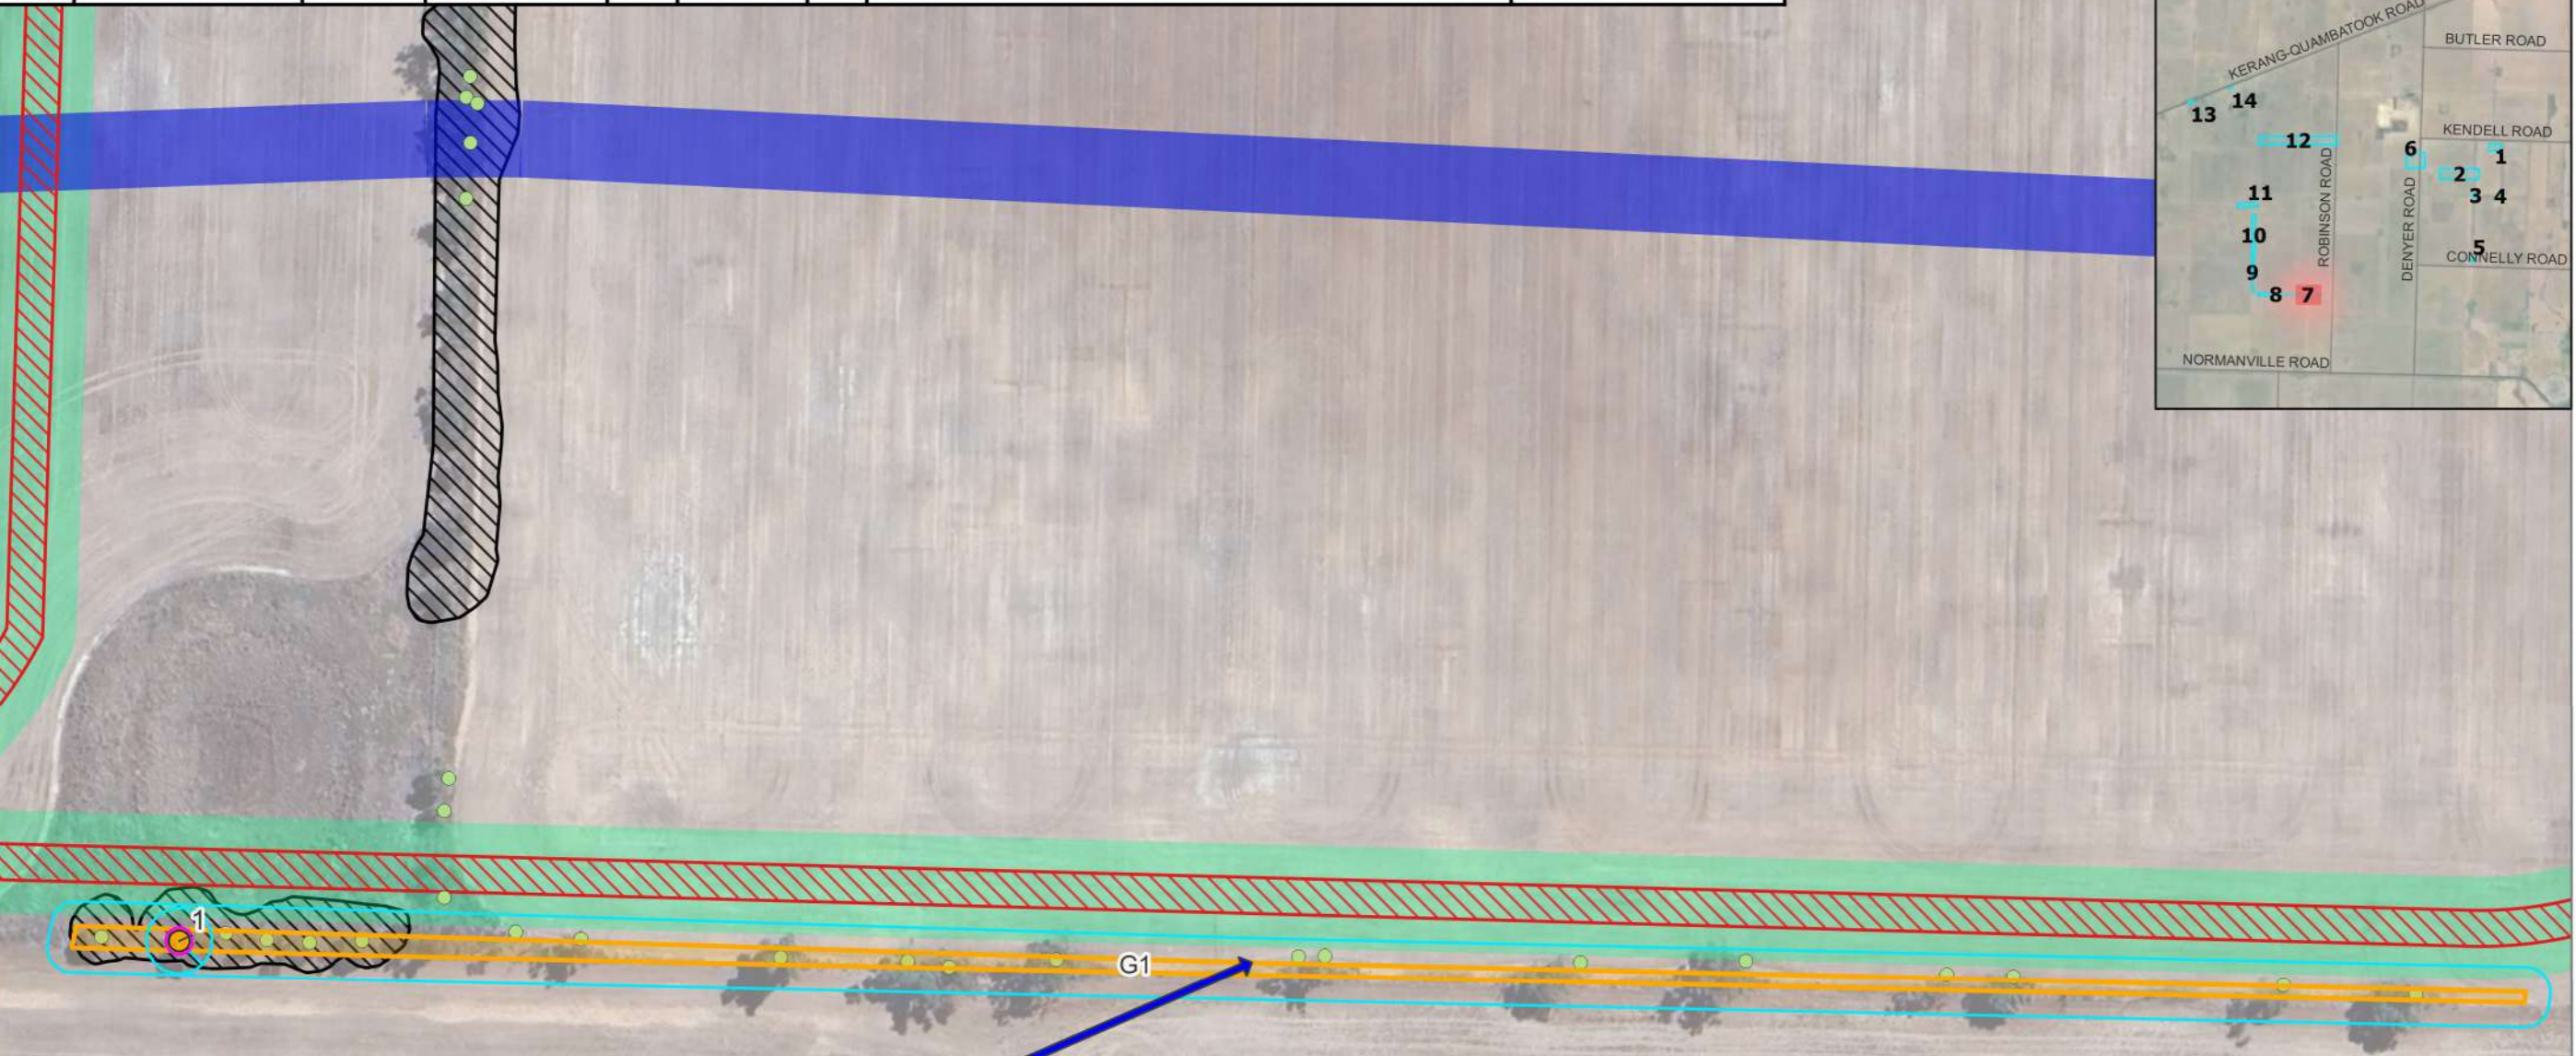
Canopy impact Minor  
 TPZ impact Minor  
 Mitigation: Preserve canopy dripline (5m)
