Appendix M

# Arborist Assessments

**RE: 013638 – Arboricultural Advice – Normanville Energy Park– Root sensitive electrical works**

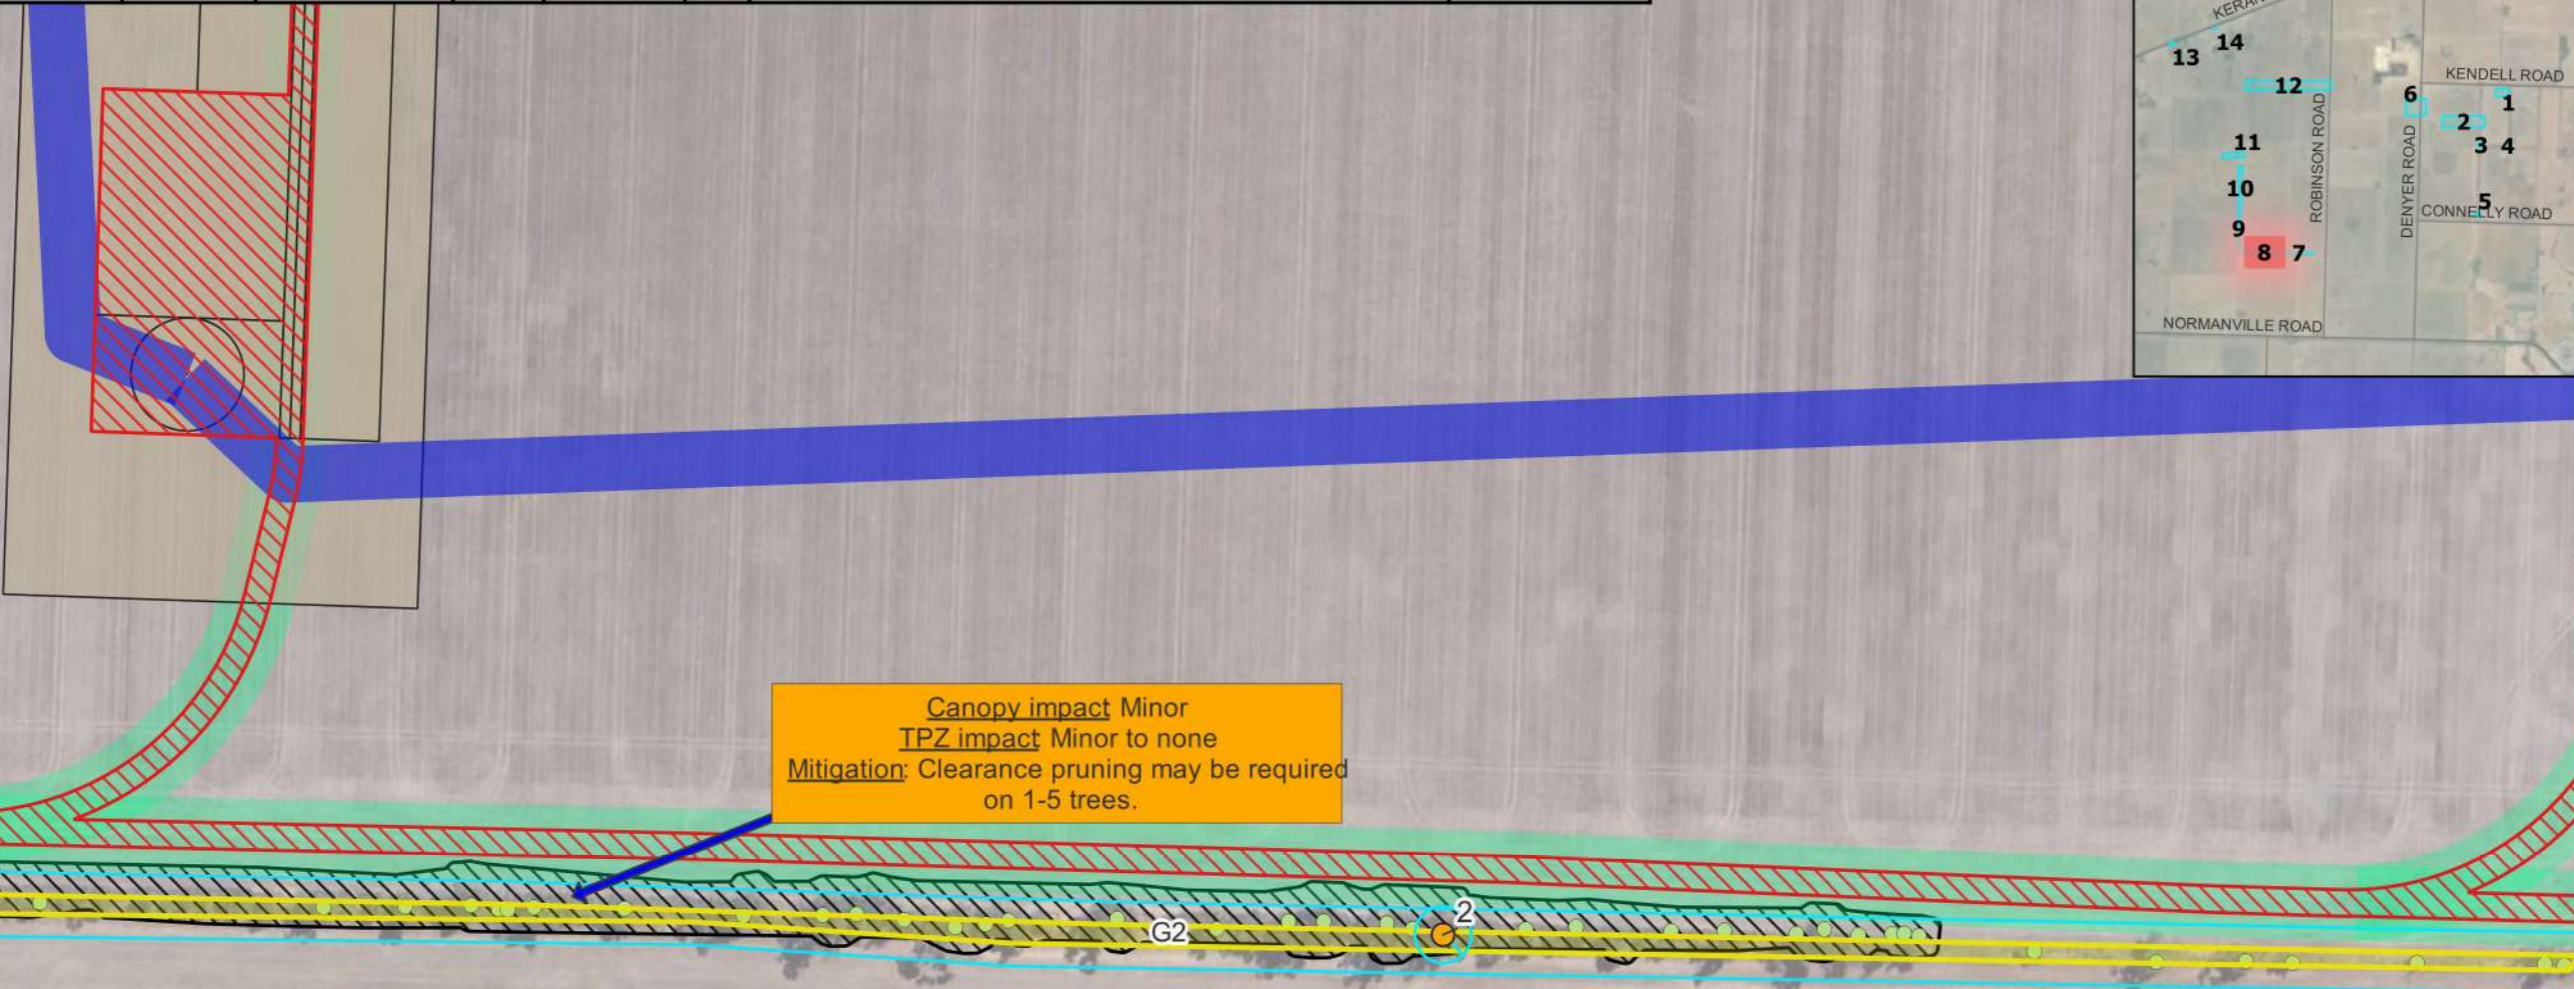
Canopy impact Minor  
 TPZ impact Minor to none  
 Mitigation: Clearance pruning may be required on 1-5 trees.

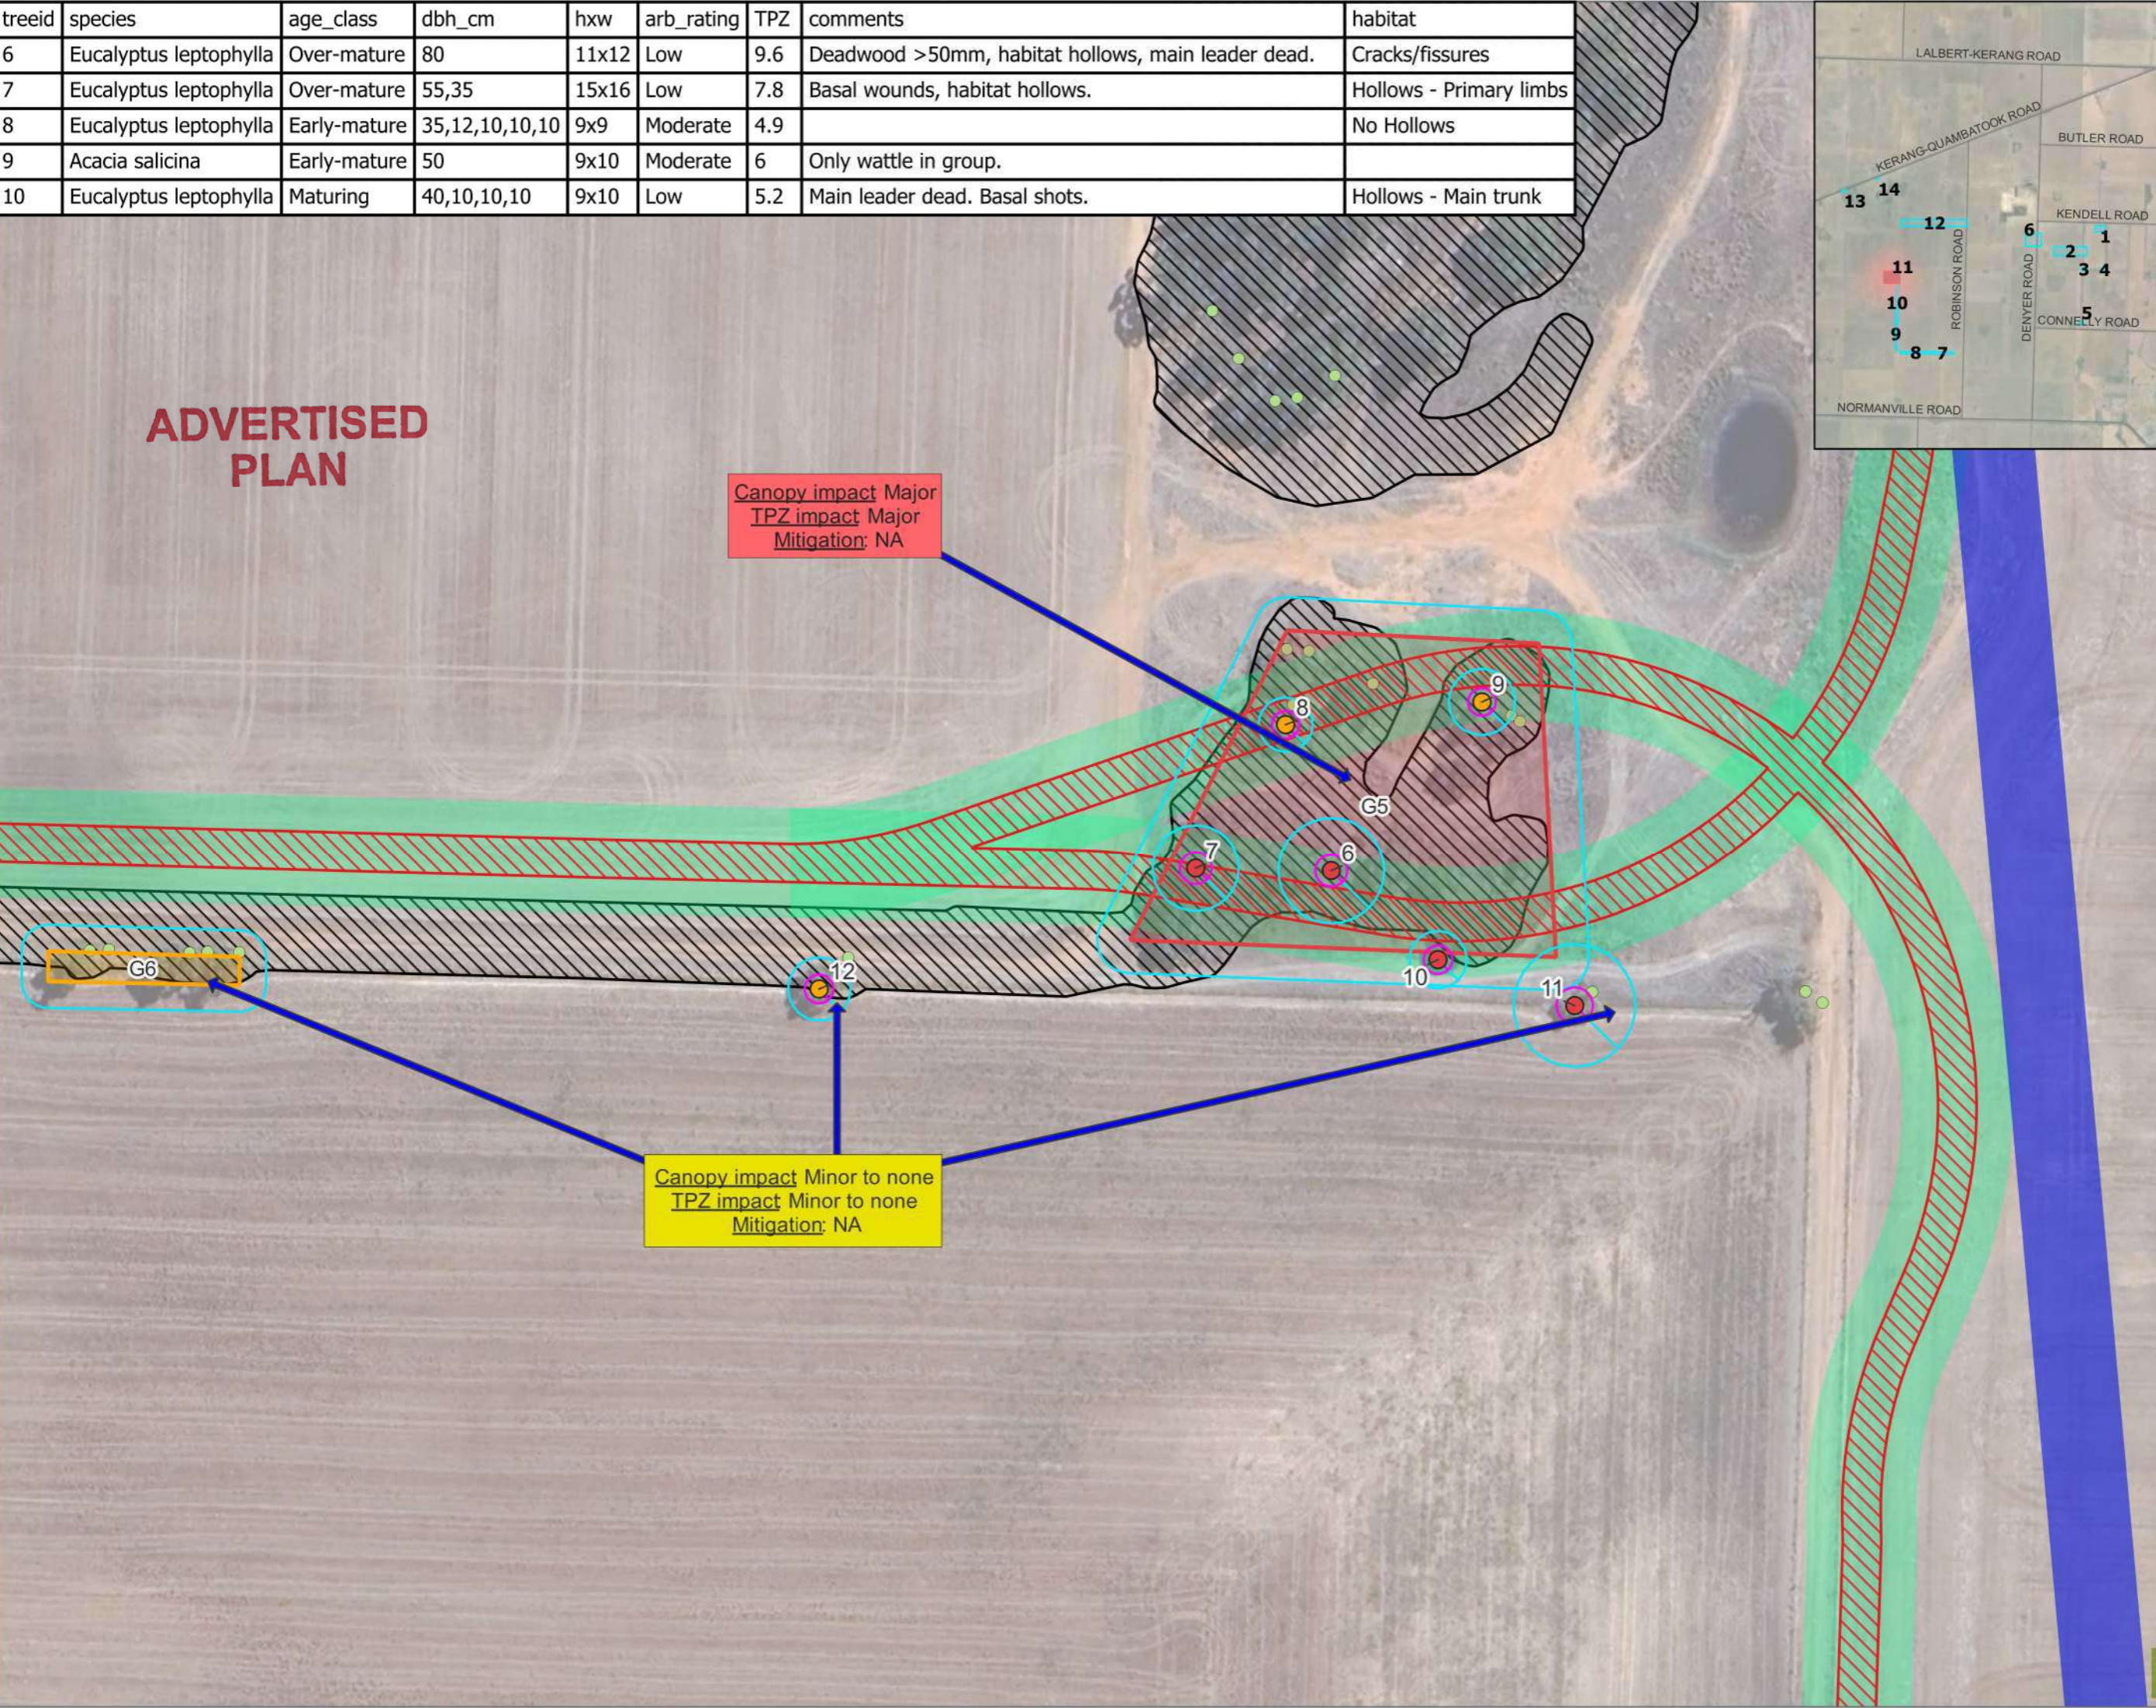
treeid	species	age_class	dbh_cm	hwx	arb_rating	TPZ	comments	habitat
13	Eucalyptus dumosa	Maturing	70,60	7x8	Low	11.1	3m centre of trunk to fence.	Hollows - Main trunk
14	Eucalyptus dumosa	Maturing	30,30,25,25	9x10	Moderate	6.6	Low canopy 3m over fence. typical size lf group.	Hollows - Main trunk
15	Eucalyptus dumosa	Maturing	35,35,30,30,25	9x15	Moderate	8.4	Canopy over fence 7m. low canopy height 4-5m.	Bird nest
16	Eucalyptus dumosa	Maturing	35,35	9x14	Moderate	5.9	Basal wounds.	Bird nest
G8	Eucalyptus dumosa	Maturing	35,35	8x12	Mod.C	5.9		Habitat hollows

Canopy impact Minor  
 TPZ impact Minor  
 Mitigation: Narrow road next to large trees (Trees 13 & 15)

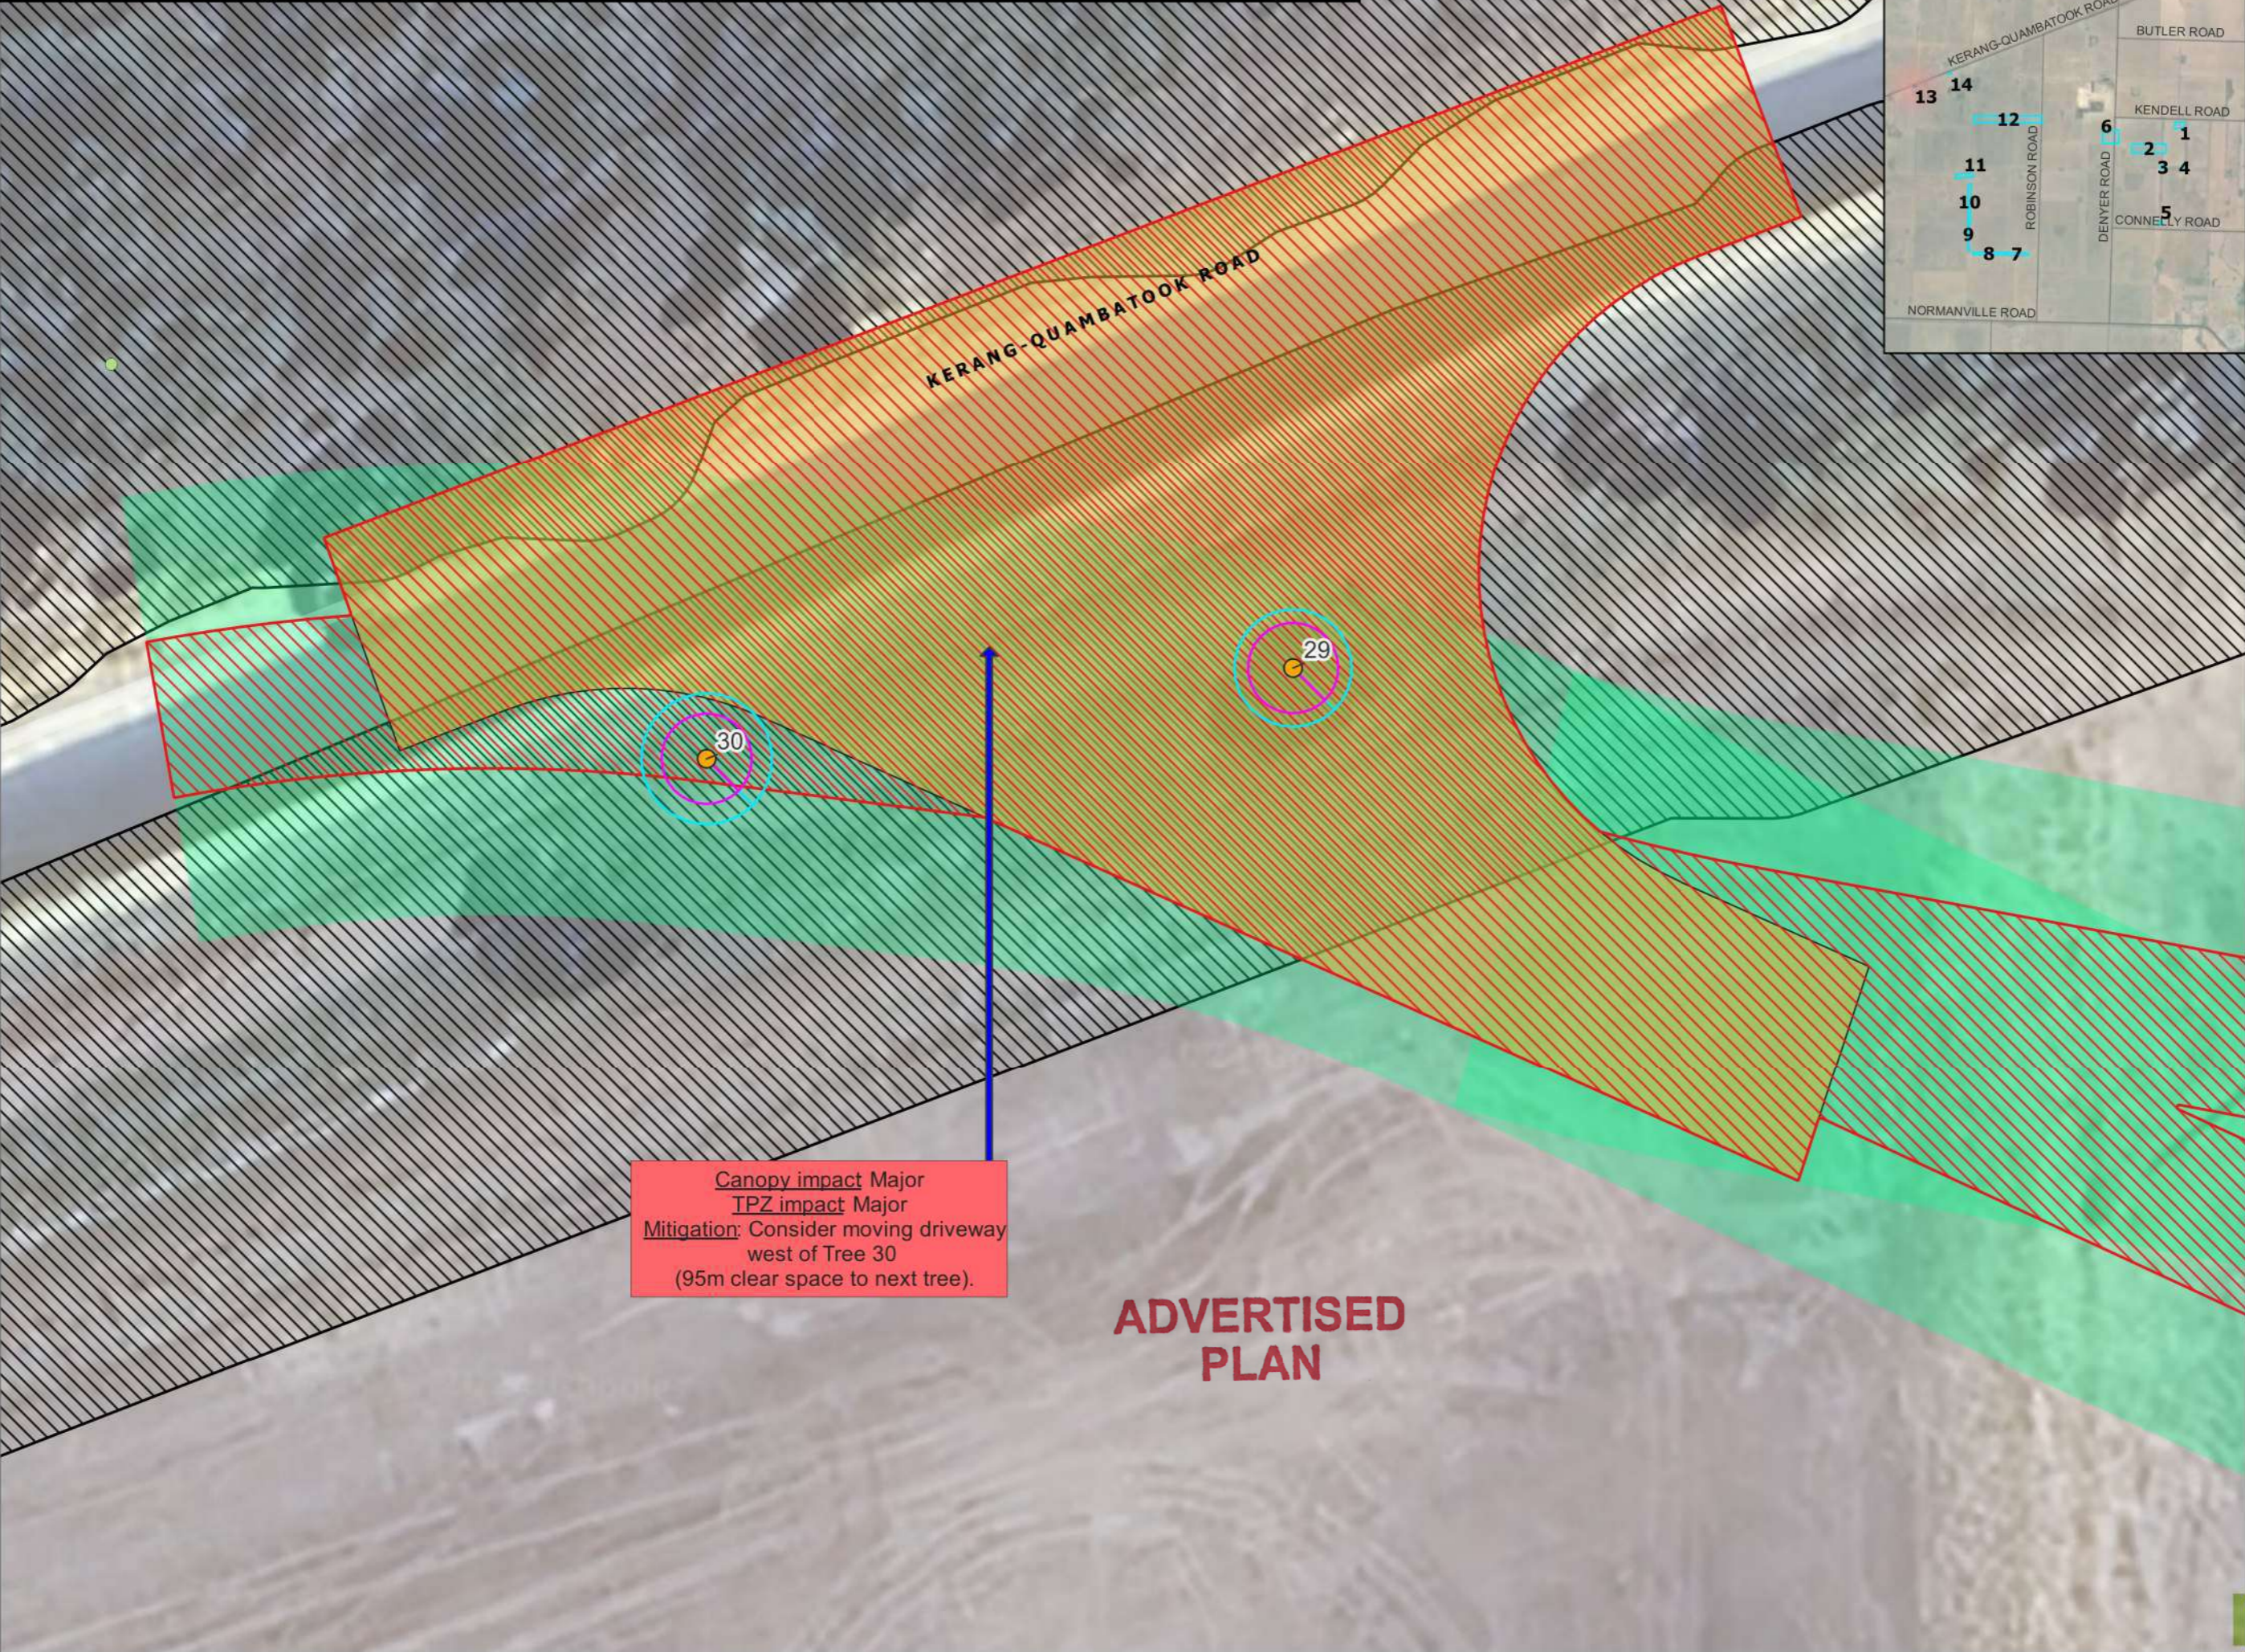
treeid	species	age_class	dbh_cm	hwx	arb_rating	TPZ	comments	habitat
29	Eucalyptus dumosa	Semi-mature	16,14,8	8x6	Moderate	2.6		
30	Eucalyptus dumosa	Semi-mature	20,14	8x7	Moderate	2.9	95m to next tree west.

Canopy impact Major  
 TPZ impact Major  
 Mitigation: Consider moving driveway west of Tree 30 (95m clear space to next tree).
