# ARBORICULTURAL REPORT

24 JESSIE STREET, COBURG.

12 APRIL 2024.

**JOHN PATRICK LANDSCAPE ARCHITECTS PTY LTD**

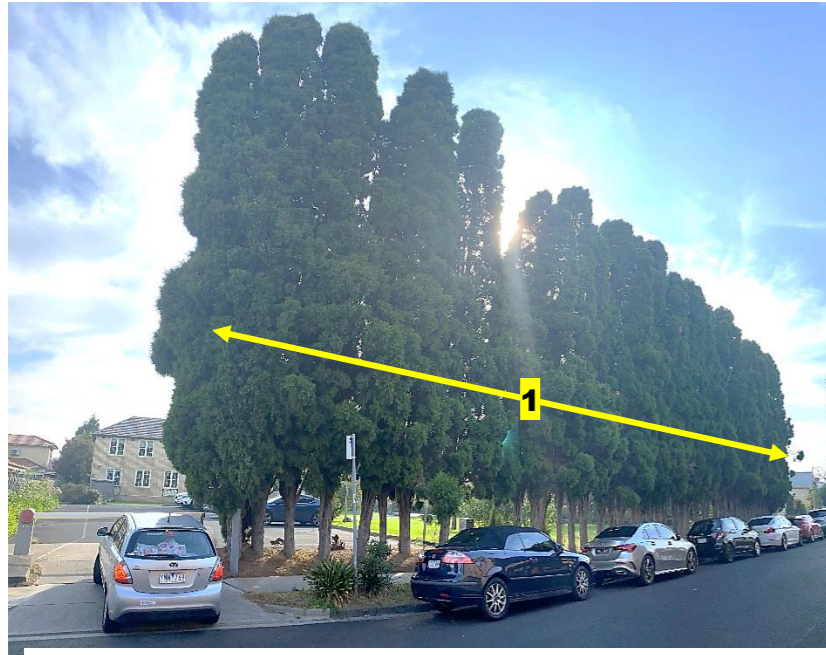
Image 2: Jessie St frontage.

- 5.2 The western most specimen of Tree 1 to be retained is encroached 5.6% by a concrete pedestrian ramp that slopes up 400mm from the footpath to the lobby (Refer Tree Impact Assessment Plan). If constructed above NGL it should not have a significant impact on the retention of the tree.

- 5.3 However, because a section of the row of trees is being removed it will leave the western end specimen to be retained exposed and showing one side dead that has previously been suppressed by trees removed. It is therefore recommended that an additional specimen of Tree 1 be removed from the western end of the row and replaced with a new single specimen of *Cupressus sempervirens* – Pencil Pine to cover up the section of the dead canopy to be retained.

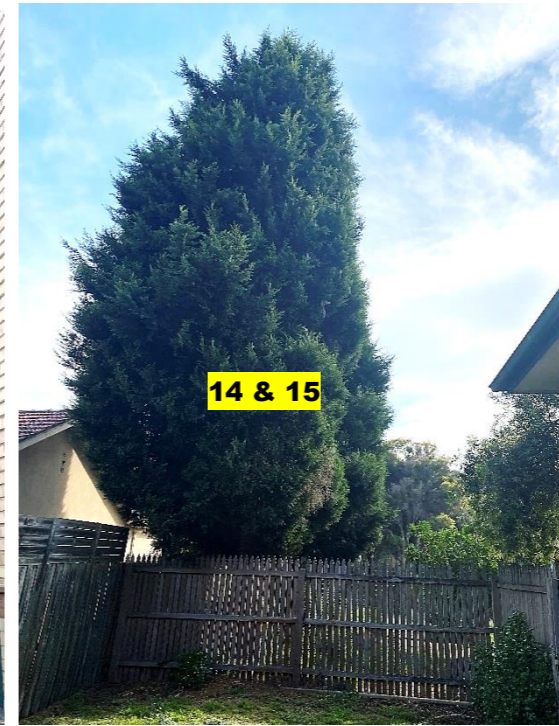
Image 7: Trees 14 & 15 looking nth.

- 4.10 Trees 7, 14 and 15 would require a permit to remove in accordance with the Local law.
- 4.11 Trees 18, 20 and 22 have trunk diameters of greater than 400mm but they are all under 8m high height requirement.

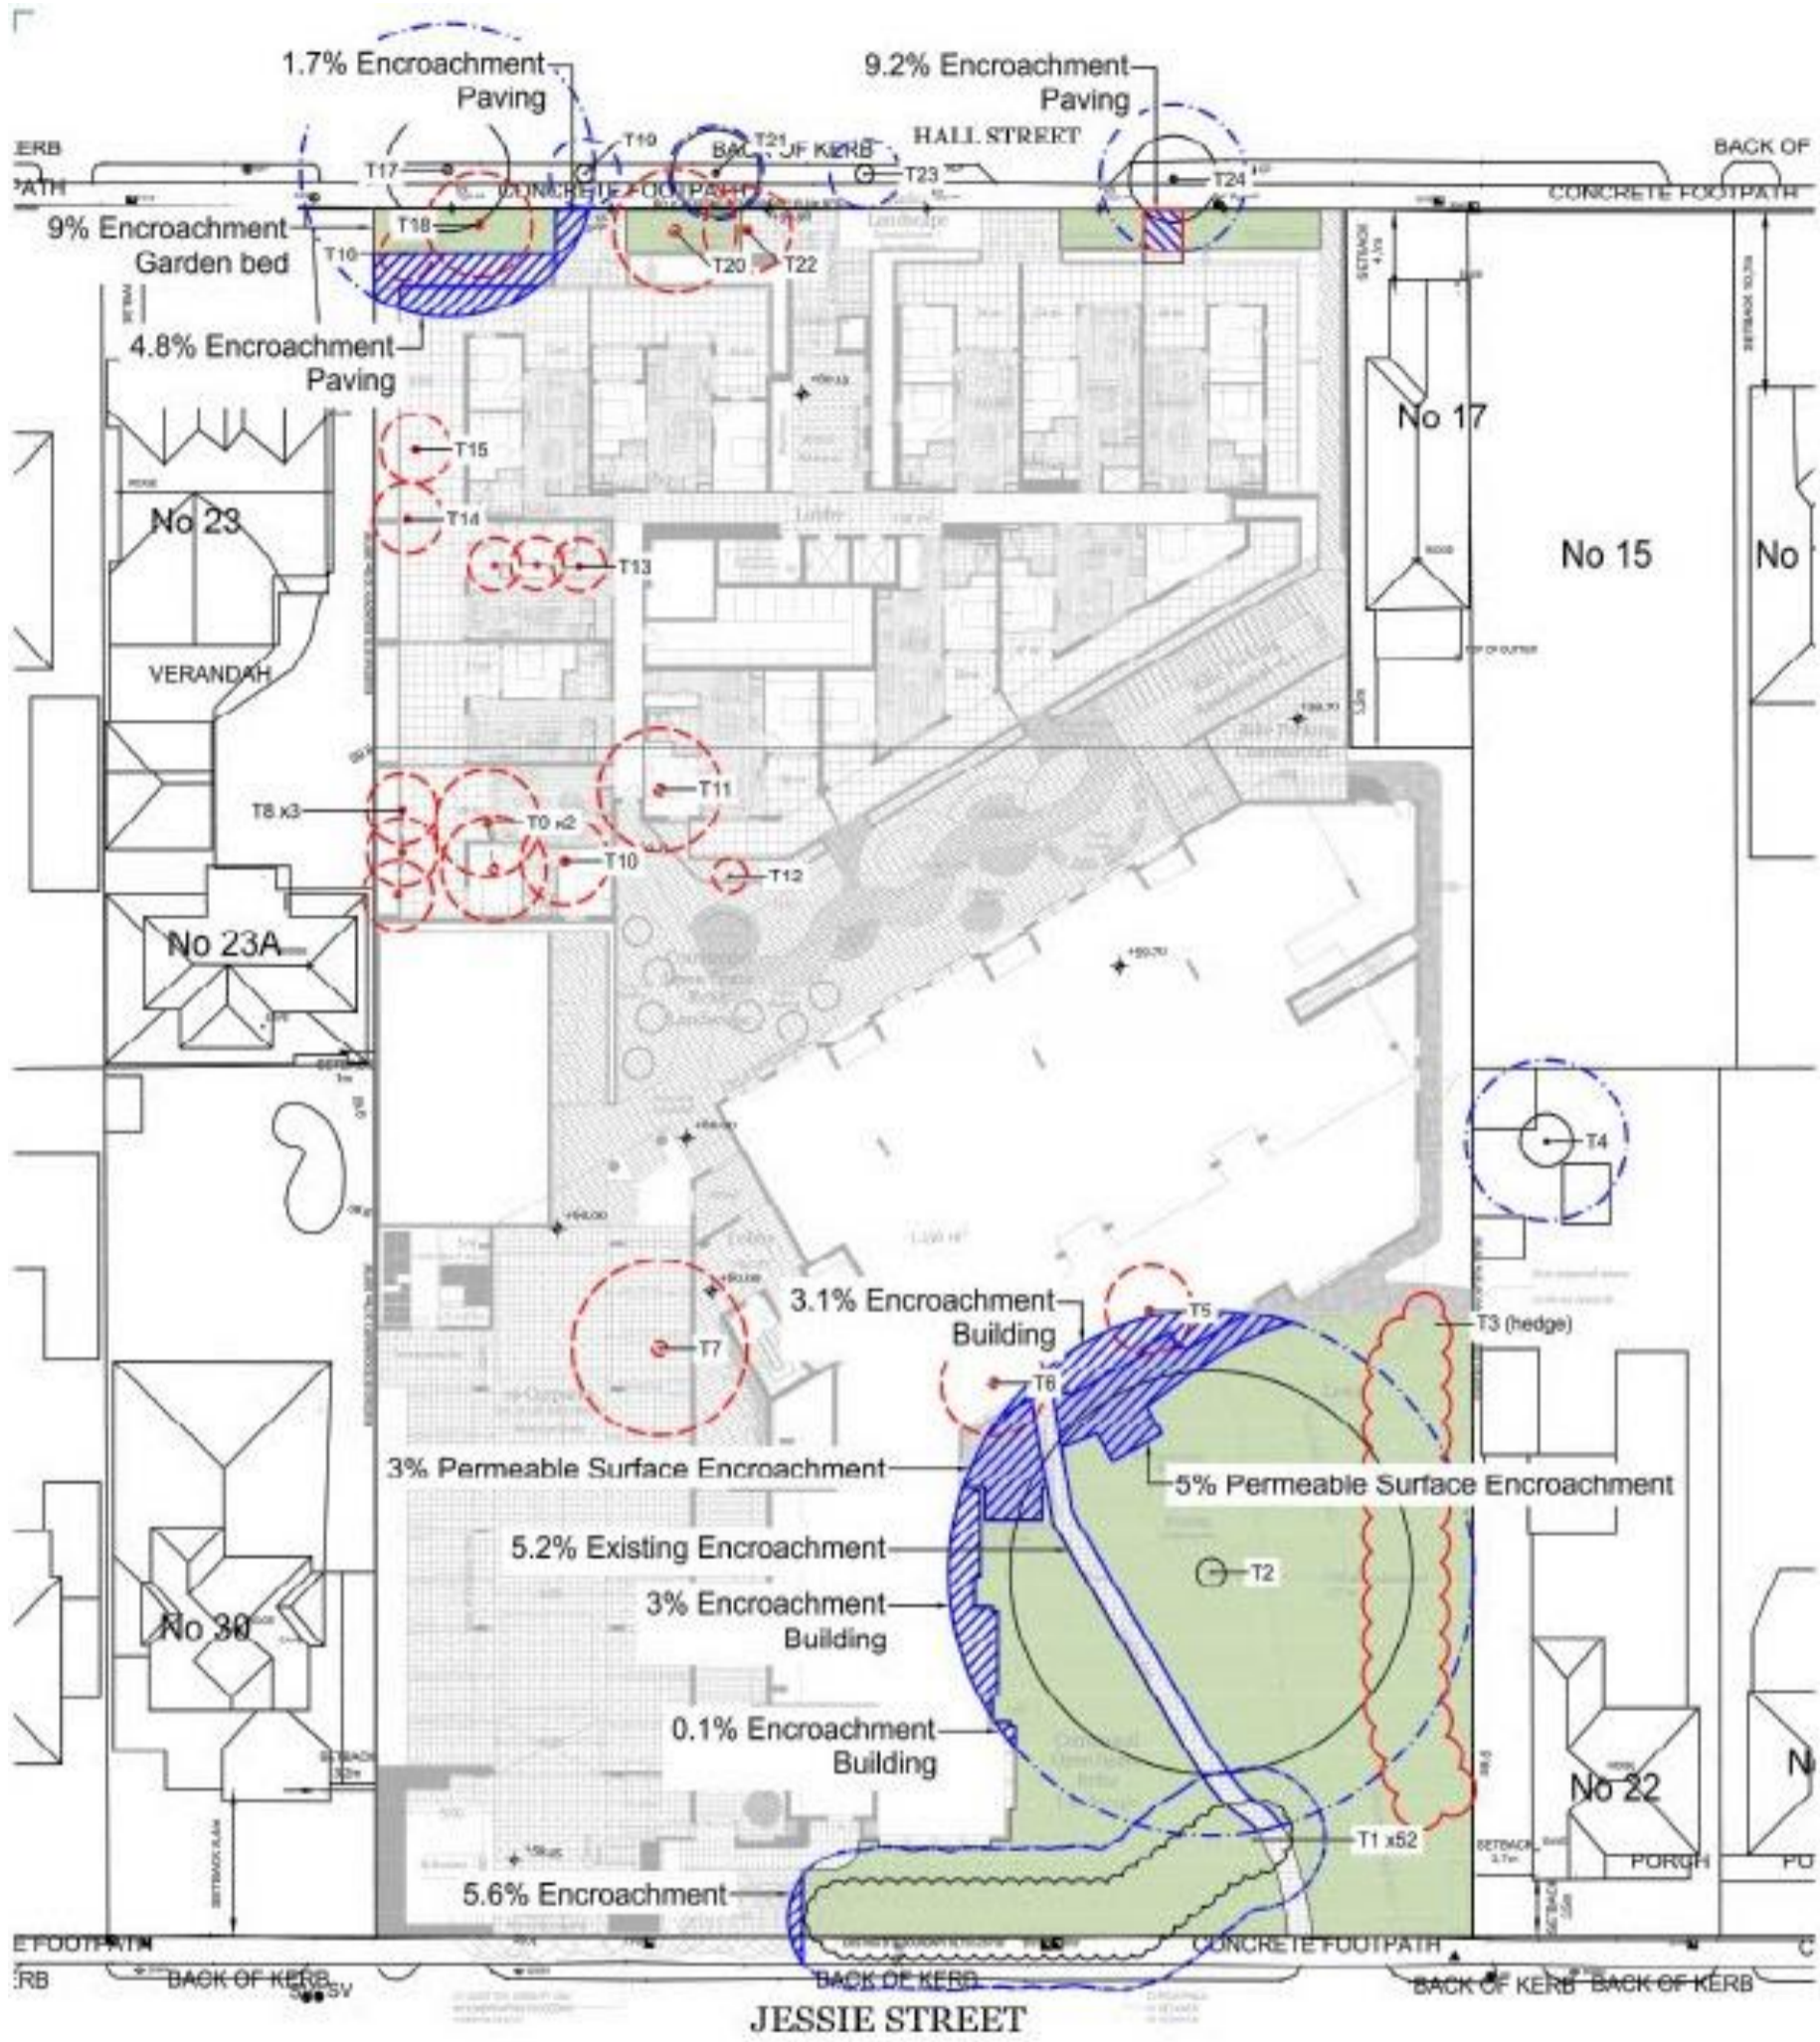
7 TREE IMPACT ASSESSMENT PLAN

- 5.4 Tree 2 the Moreton Bay Fig is the only High Arboricultural Value tree on site. It is of good condition and worthy of retention. It is protected and proposed to be retained. Its TPZ is encroached 6.2% by the new building that is approximately 12.8m from the centre of the tree. This is under 10% in accordance with AS-4970, and if any roots encountered when excavating the footings are cut cleanly with a sharp implement it should not have a detrimental impact on the retention of the tree. The building appears to be located just outside the canopy of Tree 1.

- 5.5 Between the building and Tree 1 there is an additional encroachment of 8% from proposed permeable paving. This should not have a detrimental impact on the Tree 1 if installed at NGL to avoid excavation and the potential for root damage. The permeability must include the sub-base so any rainfall can permeate to roots to assist in sustaining tree health.

- 5.11 Trees 17, 21 and 24 are typical of other native trees in the Hall Street nature strip and are of Medium Arboricultural Value.
- 5.12 Trees 17 has its TPZs encroached 6.5% by paving and an additional 9.0% by a low retaining wall of a planter. The paving is to be installed at or above NGL to minimise excavation and the potential for root damage. The planter only requires a shallow footing and therefore is also not anticipated to detrimentally impacted or suffer any significant root damage.

- 5.13 Tree 24 has its TPZ encroached 9.2% for the entrance paving. Again, the paving is to be installed at or above NGL to minimise excavation and the potential for root damage and not expected to detrimentally impact on the successful retention of the tree.

- 6.7 All paving within TPZs of retained trees must be installed at or above NGL to minimise excavation and the potential for root damage.
