# Summit to Gully Downhill Mountain Bike Trail

## Preliminary Geotechnical Risk Assessment

Falls Creek Resort Management (Alpine Resorts  
Victoria)

12 March 2024

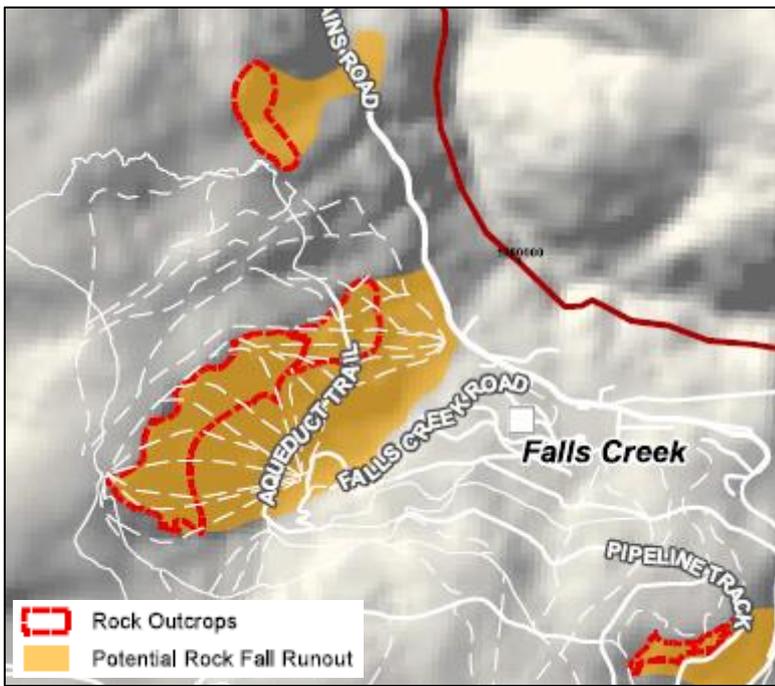
Figure 6 Extract from the Golders (2020) rockfall susceptibility mapping for the area of the proposed trail

The Golders assessment reports that no rockfalls were observed or are known to have occurred in the recent past but there is evidence of boulder detachment and travel in geological time. It concluded that most near surface boulders appear embedded and that the key trigger for failure would be detachment through earthworks or other anthropogenic processes. A 1 in 100 to 1 in 1000 year frequency was adopted for the likelihood of a rockfall hazard.

It is noted that the upper section of the proposed trail is generally located above the outcrops mapped by GEO-ENG and Golders as potential rockfalls hazards. A small section of the trails passes below and in close proximity to these outcrops.

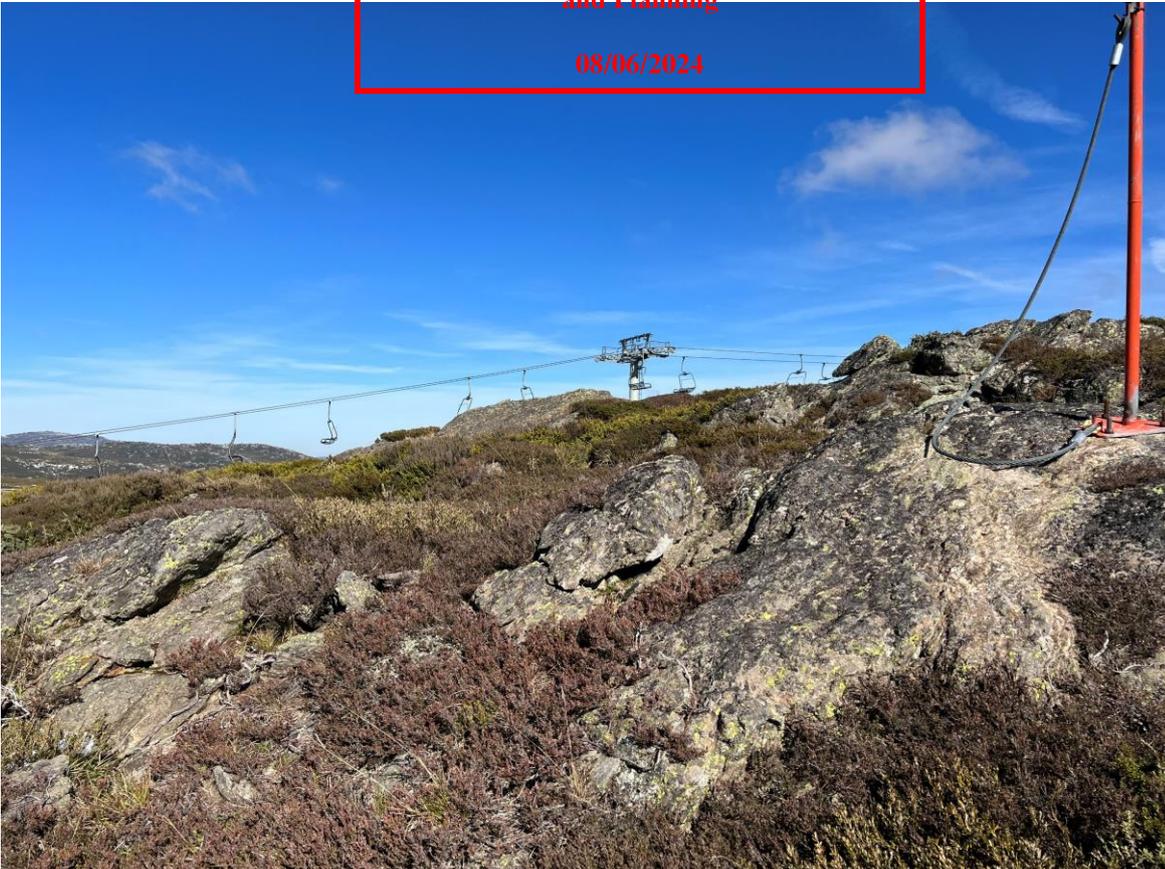
Figure 12 Rocky outcrops (migmatite) proximal to the start of the Summit to Gully MTB Trail

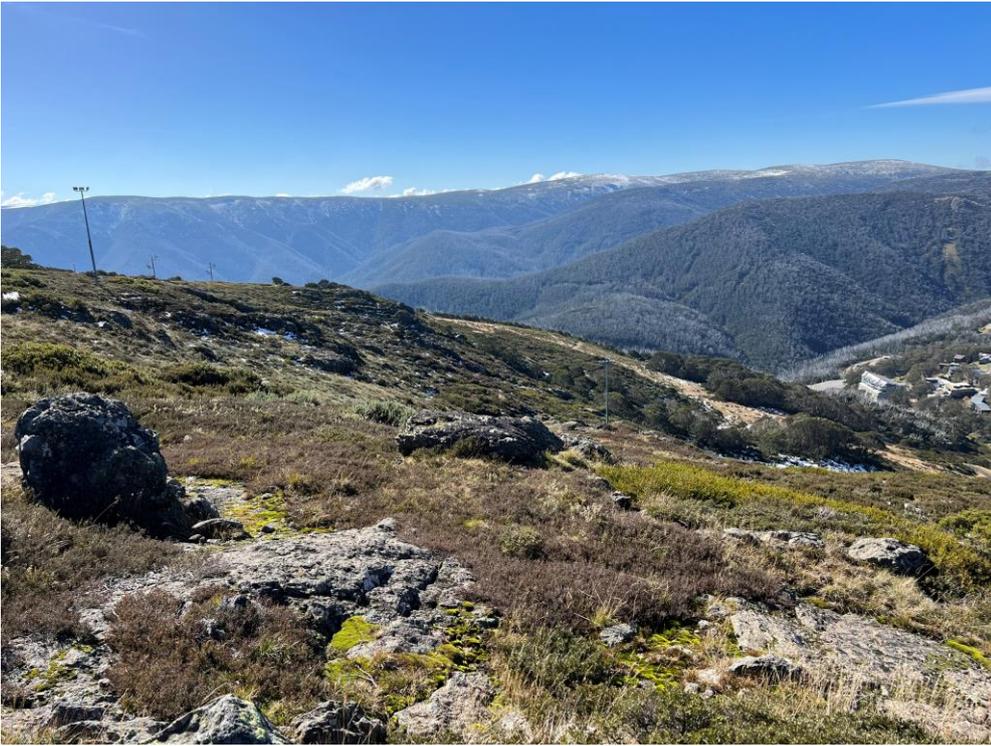
**Figure 13** *Typical rocky terrain along the start of the Summit to Gully MTB Trail*

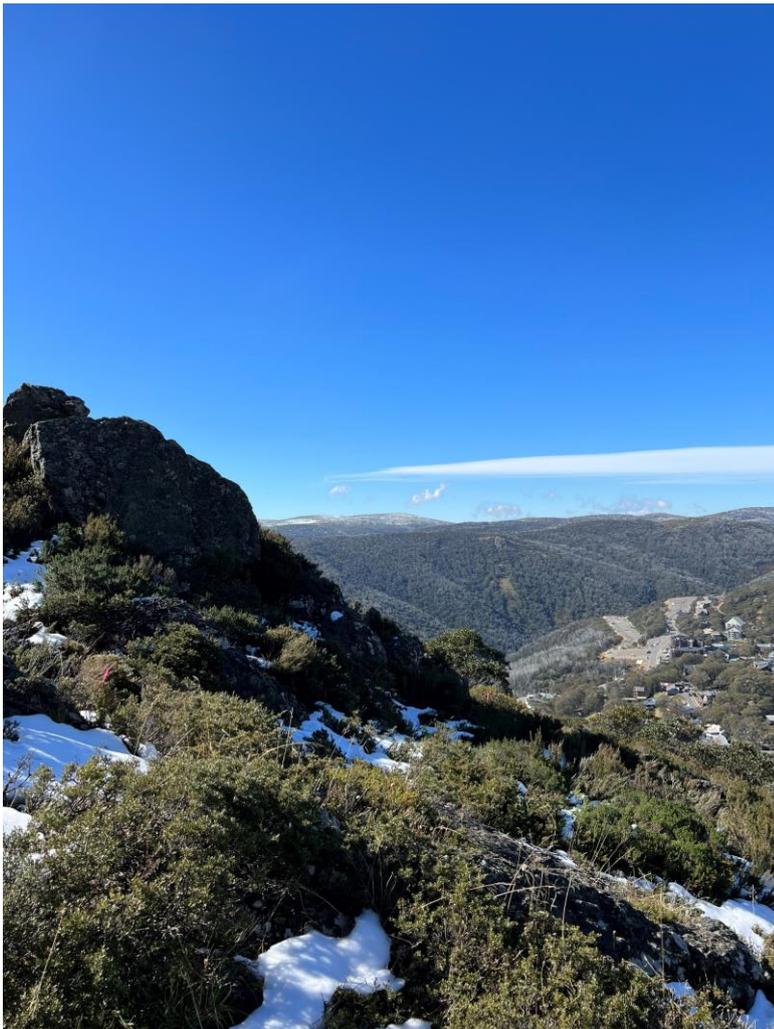
- Outcropping rock is evident across the trail network (mainly upper section) on variable slopes. These outcrops generally occur both upslope and downslope of the proposed trails and where present as loose blocks or boulders held within a soil matrix, may be conducive to detachment.

**Figure 14** *Large rocky (migmatite) outcrop upslope of the proposed Summit to Gully MTB Trail*

- Remove loose boulders exposed in the batter face during construction. These can be used as rock armouring at the base of the batter slope. Ensure loose boulders are not left at the crest of slopes.

- An assessment by a geotechnical practitioner is recommended following construction to assess whether the trail is downslope of any potential high risk rockfall hazards that may require remediation.

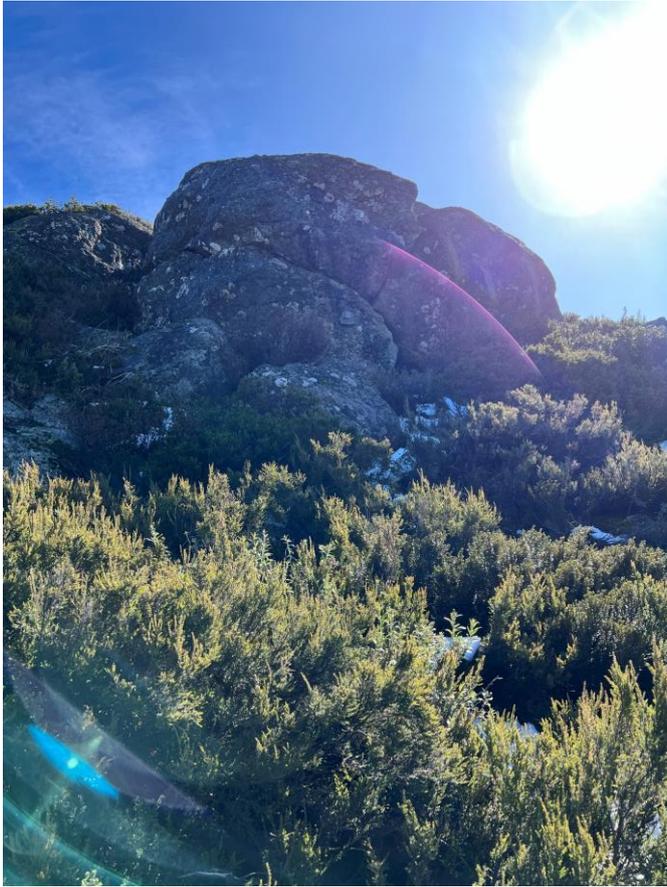
**Figure 15**      *Large rocky outcrop upslope of the proposed Summit to Gully MTB Trail (refer Figure 6)*

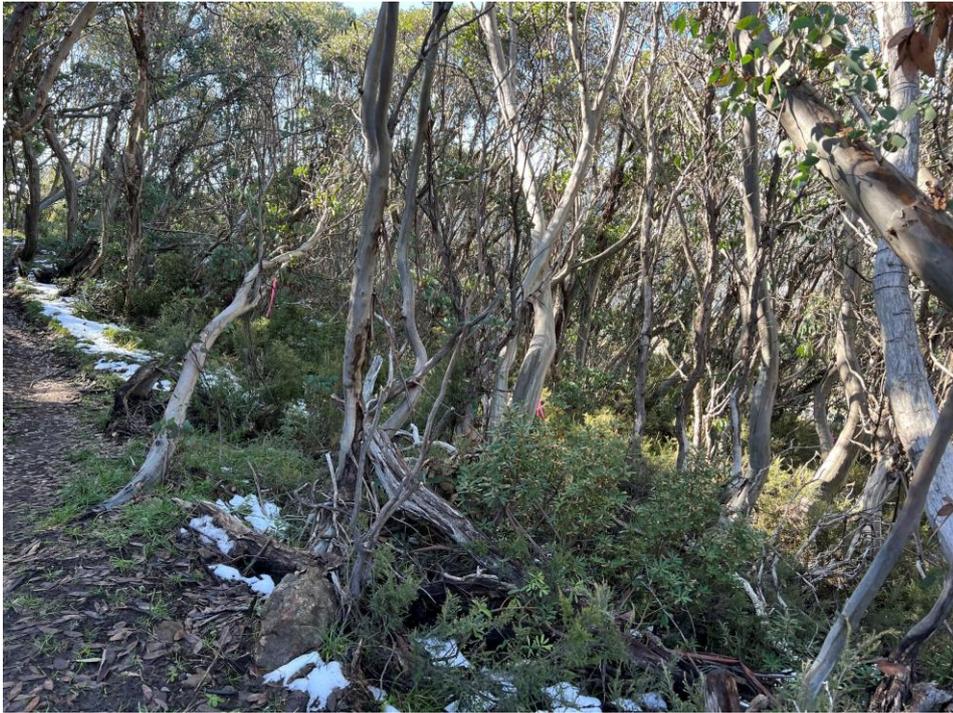
**Figure 17** *Heavily vegetated area towards the south-east of the Summit to Gully MTB Trail. Machine benching construction is proposed for this section of the trail.*

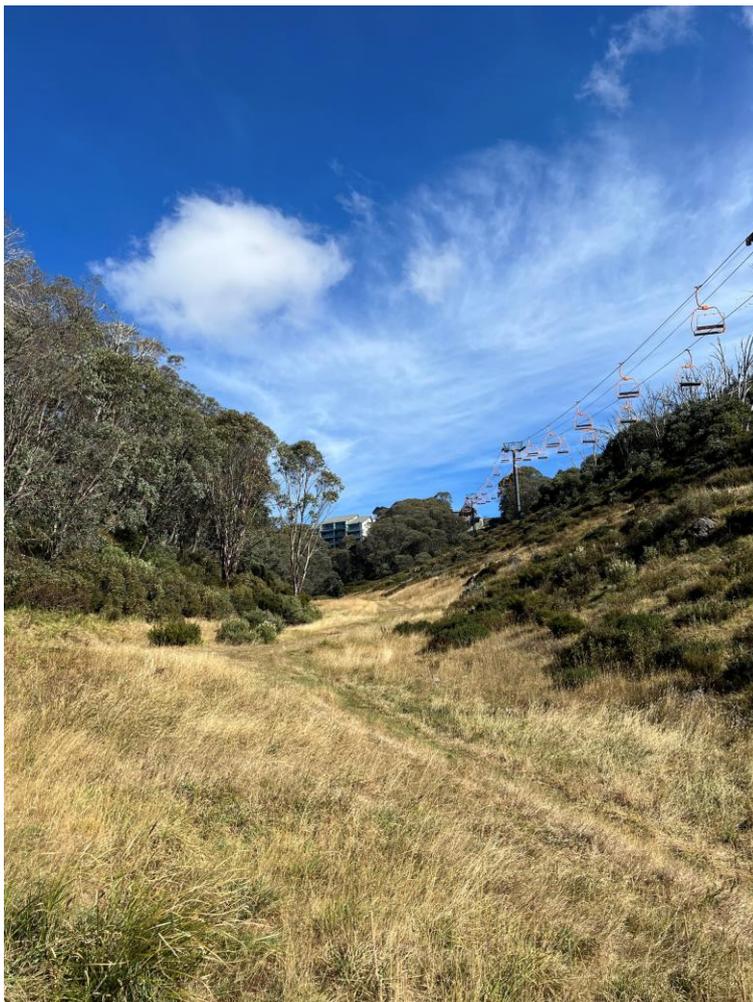
- Lower sections of the Summit to Gully MTB Trail are within the vicinity of drainage areas and small sections of boggy or water-logged ground was observed.

**Figure 18** *The lower section of the Summit to Gully MTB Trail (looking upslope). A large berm is proposed along the eastern section of this area (here left).*
