Arboricultural Impact Assessment

Assessment of trees at 11 Beach Street, Frankston.

Homewood Consulting Pty Ltd

19 April 2024

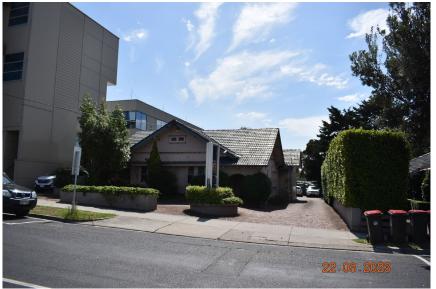
Figure 1: View of the front setback of 11 Beach Street, Frankston

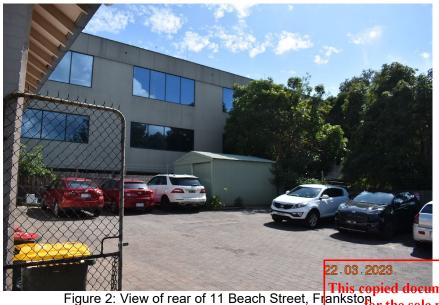
Figure 2: View of rear of 11 Beach Street, Frankstop

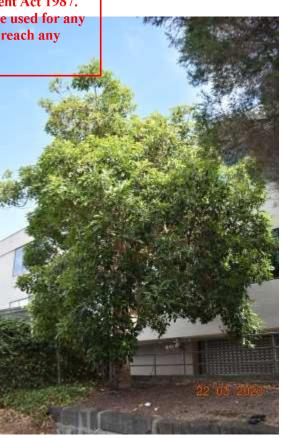
Asset ID:	The document must1purpose which r	
Botanical Name:	Lophostemon confertus copy	right
Common Name:	Queensland Brush Box	
Origin:	Native	
DBH (cm):	41	
Height & Width (m):	8 x 7	
Maturity:	Mature	
Health:	Good	Anter C
Structure:	Fair	/
ULE:	40+ years	1
Retention Value:	Third party ownership	
TPZ radius (m):	4.92	T
SRZ radius (m):	2.53	
Encroachment Percentage:	0%	
TPZ Impact (AS 4970):	No impact	Series and
Comments:		1.1

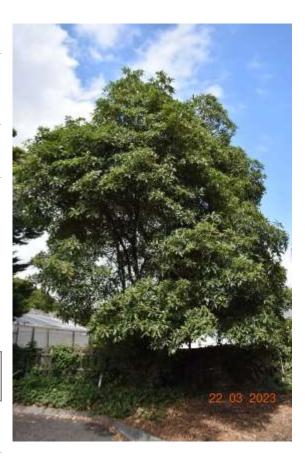
Asset ID:	2
Botanical Name:	Pittosporum undulatum
Common Name:	Sweet Pittosporum
Origin:	Native
DBH (cm):	37
Height & Width (m):	7 x 6
Maturity:	Mature
Health:	Fair
Structure:	Fair
ULE:	20 to 40 years
Retention Value:	Third party ownership
TPZ radius (m):	4.44
SRZ radius (m):	2.25
Encroachment Percentage:	0%
TPZ Impact (AS 4970):	No impact
Comments: Weed specie	s, DAB estimated due to heavy ivy

Weed species, DAB estimated due to heavy ivy cover

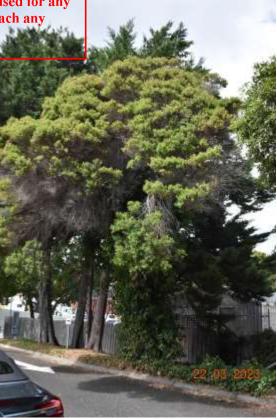
2.5m to rear fence. Heavy ivy cover on trunk - DBH and DAB estimated

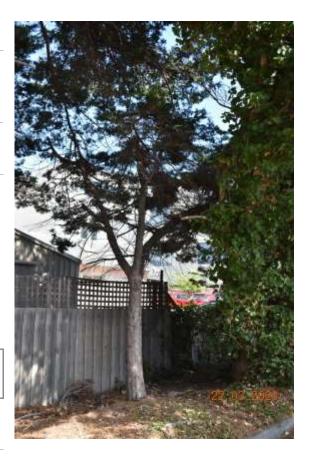
Asset ID:		4
Botanical Name	e :	Hesperocyparis macrocarpa
Common Name	:	Monterey Cypress
Origin:		Exotic
DBH (cm):		19
Height & Width	(m):	5 x 6
Maturity:		Semi mature
Health:		Fair
Structure:		Fair
ULE:		9-20 years
Retention Value	e:	Third party ownership
TPZ radius (m):	:	2.28
SRZ radius (m):	:	1.79
Encroachment	Percentage:	0%
TPZ Impact (AS	6 4970):	No impact
Comments:	Trunk leaning, crown suppressed by adjacent trees

- Trees 2, 4 and 5 have no TPZ impact but require minor canopy pruning to allow for the construction of the upper levels of the proposed building. Pruning will not require removal of more than 15% of the canopy. All pruning works should be undertaken by a qualified Arborist (Level 3 or above) and comply to the Australian Standard 4374-2007 Pruning of Amenity Trees.

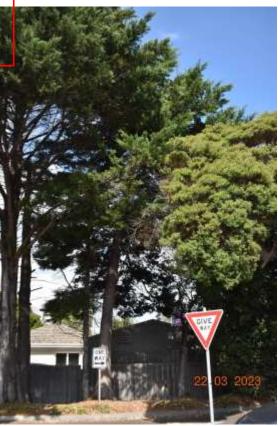
Asset ID:	pur	pose which may breach any
Botanical Name:		Hesperocyparis Hacrocarpa
Common Name:		Monterey Cypress
Origin:		Exotic
DBH (cm):		51
Height & Width (m):	13 x 9
Maturity:		Mature
Health:		Good
Structure:		Fair
ULE:		20 to 40 years
Retention Value:		Third party ownership
TPZ radius (m):		6.12
SRZ radius (m):		3.03
Encroachment P	ercentage:	0%
TPZ Impact (AS 4	4970):	No impact
Comments:

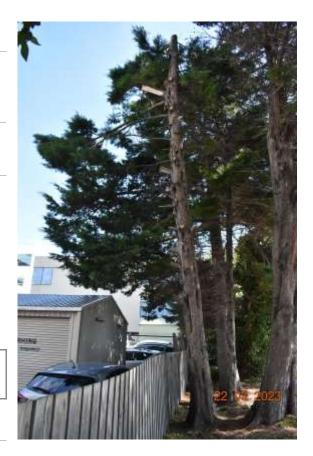
Asset ID:	6
Botanical Name:	Hesperocyparis macrocarpa
Common Name:	Monterey Cypress
Origin:	Exotic
DBH (cm):	45
Height & Width (m):	10 x 6
Maturity:	Mature
Health:	Fair
Structure:	Poor
ULE:	5 to 10 years
Retention Value:	Third party ownership
TPZ radius (m):	5.4
SRZ radius (m):	2.69
Encroachment Percentage:	0%
TPZ Impact (AS 4970):	No impact
Comments:

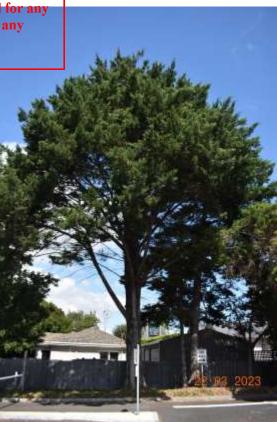
Common Name:	Monterey Cypress
Origin:	Exotic
DBH (cm):	65
Height & Width (m):	15 x 12
Maturity:	Mature
Health:	Fair
Structure:	Fair
ULE:	20 to 40 years
Retention Value:	Third party ownership
TPZ radius (m):	7.8
SRZ radius (m):	3.25
Encroachment Percentage:	0%
TPZ Impact (AS 4970):	No impact
Comments:

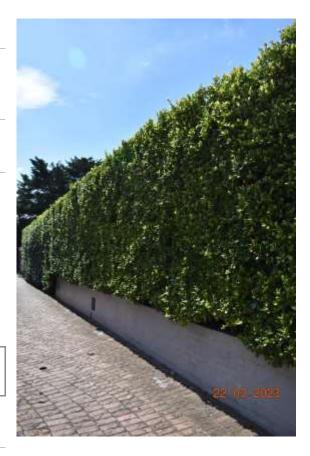
- One tree has a major TPZ encroachment under the proposed design.
 - Tree 8 has an encroachment of 35% and **is expected to remain viable** due to
 - Species tolerance of the trees grouped in Tree 8 to root disturbance. *Ficus microcarpa* var. *hillii* is a vigorous species and is likely to tolerate some level of root disturbance and root pruning.

Asset ID:	8
Botanical Name:	Ficus microcarpa var. hillii
Common Name:	Hill's Weeping Fig
Origin:	Native
DBH (cm):	20
Height & Width (m):	4 x 2
Maturity:	Semi mature
Health:	Good
Structure:	Good
ULE:	9-20 years
Retention Value:	Third party ownership
TPZ radius (m):	2.4
SRZ radius (m):	1.85
Encroachment Percentage:	35%
TPZ Impact (AS 4970):	Major
Comments: Hedgerow clipped to near fenceline, approx 19

Hedgerow clipped to near fenceline, approx 19 individuals

- The existing brick fence and driveway surface limiting root distribution within the proposed area of works. A root investigation using non-destructive digging should be undertaken prior to the commencement of works to confirm the number and size of any roots that may exist along the fenceline, where the edge of the new building foundations are proposed. This will require the removal of the existing brick fence by hand using root sensitive methods and under direct Arborist supervision.

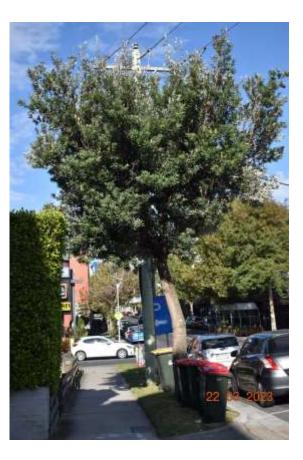
Asset ID:	10
Botanical Name:	Banksia integrifolia
Common Name:	Coast Banksia
Origin:	Native
DBH (cm):	32
Height & Width (m):	8 x 5
Maturity:	Mature
Health:	Good
Structure:	Fair
ULE:	20 to 40 years
Retention Value:	Third party ownership
TPZ radius (m):	3.84
SRZ radius (m):	2.30
Encroachment Percentage:	1%
TPZ Impact (AS 4970):	Minor
Comments:

- **Trees 3 and 10 have a minor TPZ encroachment** (less than 10% TPZ area and no SRZ incursion) from the proposed design. These trees are expected to remain viable with standard TPZ provisions and exclusions and with compensation for the area lost to encroachment.
