Selected Mature Tree Health and Condition Assessment

Prepared for: St Timothy's Catholic Primary School

Site Address: 21 Stevens Road, Vermont

Date Prepared: August 2024

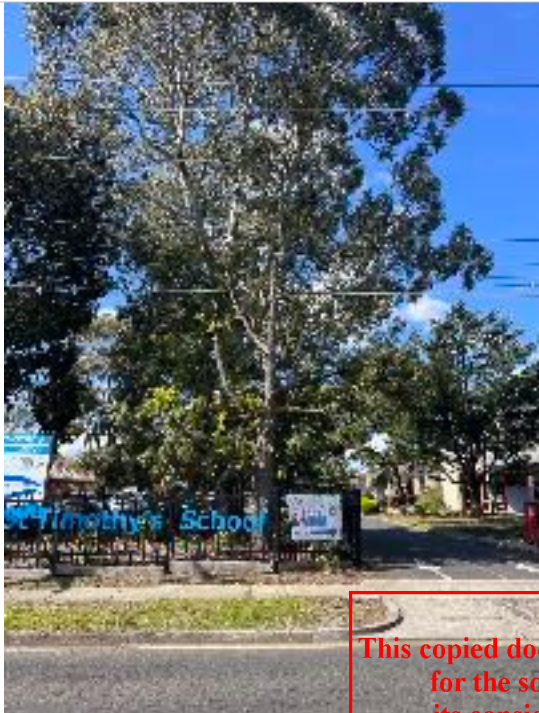
T1: *Grevillea robusta*

Tree Number:	Species Name: Botanical	Species Name: Common	Height (m)	Canopy (m)	DBH (cm)	Age	Health	Structure	Condition	SULE (Safe Useful Life Expectancy)	Audit: August 2024	Suggested Works:	Priority:
1	<i>Grevillea robusta</i>	Southern Silky Oak	6	4	49	Semi - mature	Fair	Fair	Poor	5 - 20 years	Condition has declined since previous audit Heavily lopped by powerlines company Monitor for future removal	Prune/ remove lopped branches in canopy	High
2	<i>Corymbia maculata</i>	Spotted Gum	22	11	93	Mature	Fair	Fair	Fair	5 - 20 years	Deadwood present in canopy Stubs present in canopy Large northern epicormic shoots present Extended eastern lateral branches	Remove deadwood and stubs greater than 40mm in diameter Remove large northwest epicormic back into trunk Replaced support cables Reduce weight to east on extended lateral branches Reduce weight off eastern stem	High
3	<i>Corymbia maculata</i>	Spotted Gum	20	8	43	Semi - mature	Good	Good	Good	21 - 50 years		Lightly reduce weight to south off lowest branch and to east over car park	High

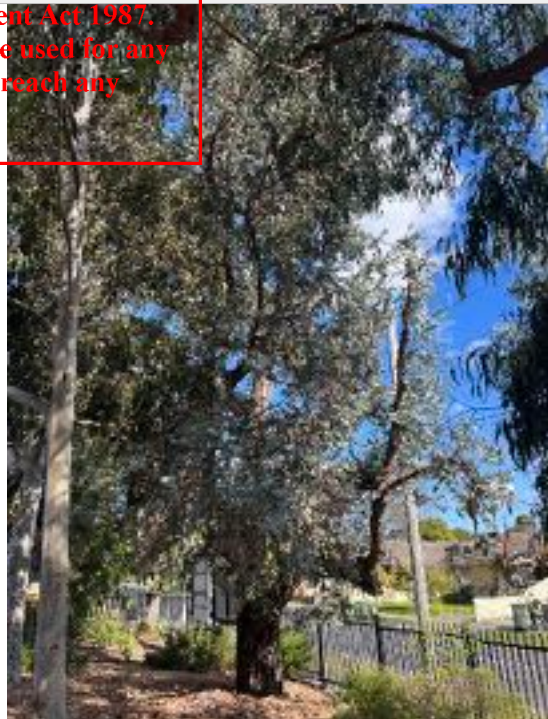
T4: *Eucalyptus cinerea*

4	<i>Eucalyptus cinerea</i>	Stringy Bark	19	10	96	Early - mature	Poor	Fair	Poor	5 - 20 years	Continue to monitor	Continue to monitor	No Works
5	<i>Eucalyptus saligna</i>	Sydney Blue Gum	15	9	22	Semi - mature	Good	Good	Good	Over 50 years	Eastern branch overhanging car park	Remove lowest eastern branch over car park back into trunk	High
6	<i>Eucalyptus obliqua</i>	Messmate stringbark	11	7	39	Early - mature	Fair	Fair	Fair	5 - 20 years	South east stem is over extended over carpark with a poor union	Remove southeast stem back into trunk	High
7	<i>Eucalyptus obliqua</i>	Messmate stringbark	9	5	23 28	Early - mature	Fair	Fair	Fair	5 - 20 years	Fair health and condition	No works required	No Works
8	<i>Eucalyptus obliqua</i>	Messmate stringbark	11	6	35 50	Early - mature	Fair	Poor	Fair	5 - 20 years	Deadwood present in canopy Large fruiting body at base between main unions showing that there is decay present, potentially indicating decline in health	Remove deadwood greater than 30mm in diameter Monitor for future removal	High

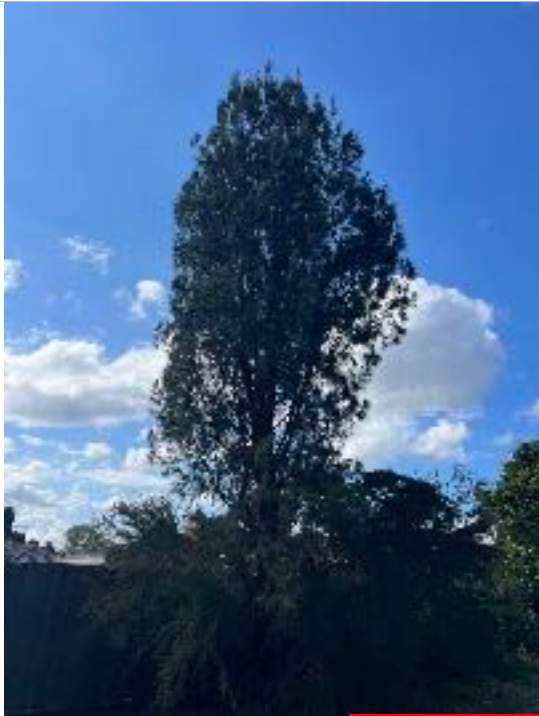
T9: *Casuarina*

9	<i>Casuarina</i>	Sheoak	8	2	18	Semi - mature	Good	Good	Good	21 - 50 years	Good health and condition	No works required	No Works
10	<i>Ficus benjamina</i>	Weeping Fig									Canopy overhanging adjacent car park	Prune canopy away from car park	Medium
11	<i>Eucalyptus obliqua</i>	Messmate Stringybark	6	4	28	Semi - mature	Fair	Good	Fair	21 - 50 years	Canopy impending adjacent property	Remove lowest western branch over car park back into trunk Reduce southeast branches away from property	High
12	<i>Eucalyptus botryoides</i>	Mahogany Gum	16	7	77	Over - mature	Poor	Fair	Poor	0	Large deadwood present in canopy - circumference greater than 40mm in diameter Dead section off the north west limb	Reduce two extended western branches over car park Remove deadwood greater than 40mm in diameter Remove large dead section off northwest limb	High
13	<i>Corymbia maculata</i>	Spotted Gum	21	8	83	Mature	Good	Fair	Good	21 - 50 years	Cable installed previously	Check support cable between main unions Reduce weight off western stem	High

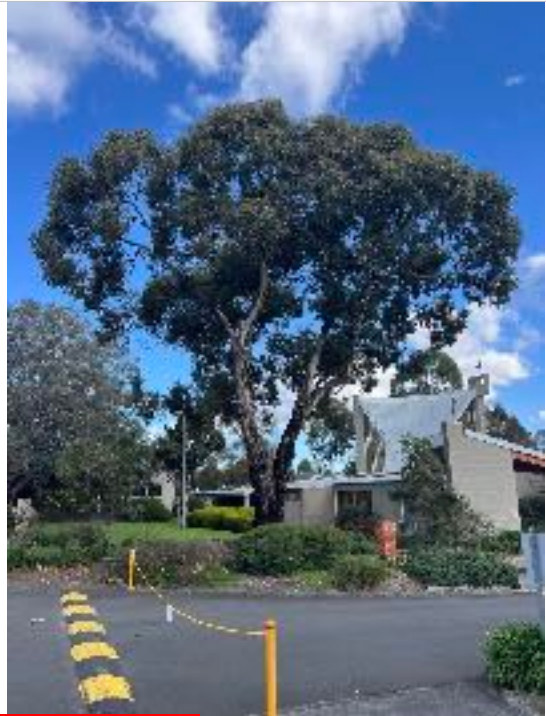
T14: *Eucalyptus cornuta*

14	<i>Eucalyptus cornuta</i>	Yate	16	10	112	Over - mature	Fair	Poor	Fair	5 - 20 years	Over extended branches throughout canopy	Replace support cables Reduce extended lateral branches all around tree where required	High
15	<i>Eucalyptus mannifera</i>	Brittle Gum	14	13	107	Mature	Good	Good	Good	21 - 50 years	Deadwood present in canopy Canopy impending on adjacent structures Over extended lateral north limb	Recommend pruning lowest northern limb hard to union Reduce weight on lateral extended branches throughout canopy Remove deadwood and stubs greater than 30mm in diameter Clear canopy away from buildings and fences by minimum of 1m	High
16	<i>Banksia aemula</i>	Banksia	16	12	80	Over - mature	Fair	Fair	Poor	5 - 20 years	Canopy impending on adjacent structures	Clear away from property by 1m Check and replace cables if required Heavy weight reduction on large east stem with potential of removal into trunk	High

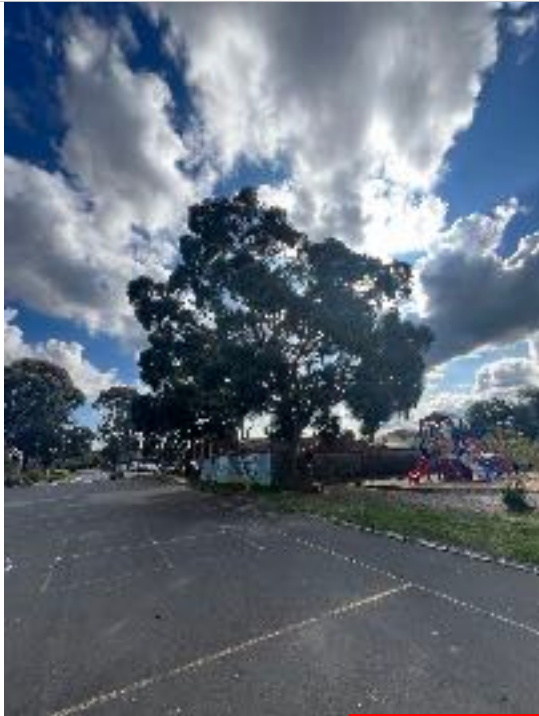
T17: *Corymbia citriodora*

17	<i>Corymbia citriodora</i>	Lemon Scented Gum									Located in adjacent childcare Canopy overhanging play area	Recommend weight reduction over school play area to northeast and south	High
18	<i>Hakea</i>	Hakea	5	5	25	Early - mature	Fair	Fair	Fair	Under 5 years	Hanging branches in canopy Western stem overhanging adjacent fence	Remove broken hanging branches Remove western branch over fence back into trunk	High
19	<i>Hakea</i>	Hakea	5	5	17	Early - mature	Fair	Fair	Fair	5 - 20 years	Fair health and condition	No works required	No Works
20	<i>Eucalyptus viminalis</i>	Rough Bark Manna Gum	14	19	75	Mature	Fair	Fair	Fair	21 - 50 years	Deadwood present in canopy Northwestern stem appears to be in decline Dead section in crown of tree	Reduce extended northern branches Remove dead section in crown of tree Remove deadwood greater than 30mm in diameter Potential installation of support cable	High
21	<i>Eucalyptus viminalis</i>	Rough Bark Manna Gum	14	11	64	Mature	Fair	Fair	Fair	21 - 50 years	Deadwood present in canopy Hanging branches in canopy Trees vigour appears to be in decline	Remove deadwood greater than 30mm in diameter Remove hanging branches Uplift canopy to 2.5 m Weight reduce southeast stem - in particular to southeast and south	High

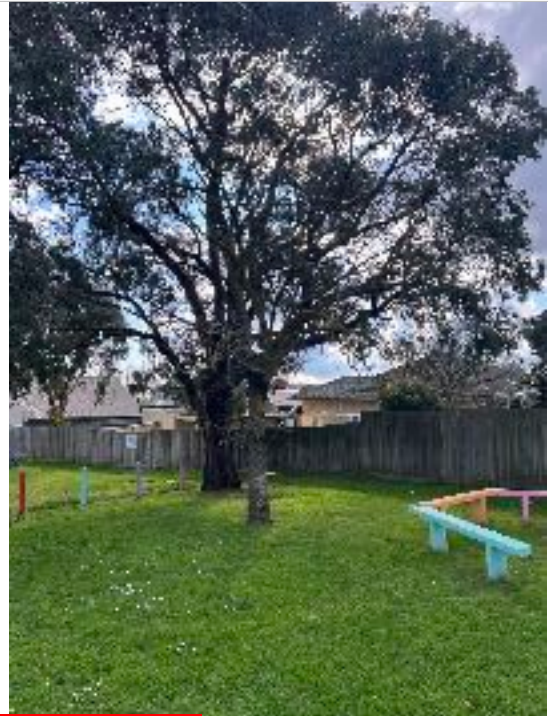
T22: *Fraxinus*

22	<i>Fraxinus</i>	Ash	7	6	34	Semi - mature	Good	Good	Good	21 - 50 years	Deadwood present in canopy Tree appears to be in decline	Remove deadwood greater than 30mm in diameter Monitor for potential future removal	High
23	<i>Fraxinus</i>	Ash	7	6	62	Mature	Poor	Fair	Poor	Under 5 years	Large deadwood present in canopy - circumference greater than 40mm in diameter Tree appears to potentially be in decline - continue to monitor	Reduce height from southwest stem into lower canopy Reduce height from southern stem back into canopy Remove deadwood throughout tree greater than 30mm in diameter Continue to monitor	High
24	<i>Casuarina</i>	Sheoak	18	5	67	Mature	Fair	Fair	Fair	5 - 20 years	Over extended branch to the west	Reduce extended branch to west Slightly reduce weight to north towards play area	Medium
25	<i>Melaleuca quinquenervia</i>	Paper Bark	8	5	62	Mature	Fair	Fair	Fair	5 - 20 years	Fair health and condition	No works required	No Works

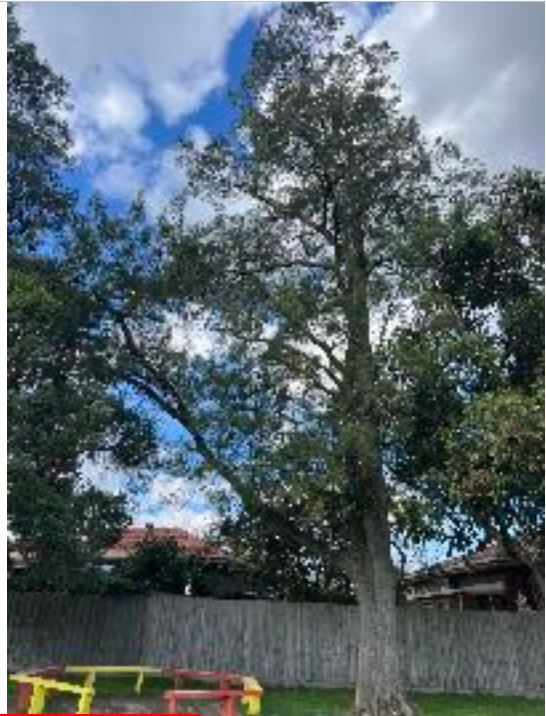
T26: *Casuarina*

26	<i>Casuarina</i>	Sheoak	15	7	71	Mature	Fair	Fair	Fair	5 - 20 years	Tree appears to be showing less vigour Over extended northern limb over seating area	Reduce/remove extended northern limb over seating area with support cable in If stem is retained, replace support cable and reduce end weight Remove extended lateral branch to the west	High
27	<i>Eucalyptus robusta</i>	Swamp Mahogany	9	6	39	Early - mature	Fair	Fair	Fair	5 - 20 years	Long overextended branches to the west and east	Reduce extended lateral branches to west towards oval Remove longest extended branch to east	Medium
28	<i>Eucalyptus nicholii</i>	Narrow leaf Black Peppermint	9	5	107	Early - mature	Fair	Poor	Poor	Under 5 years	Support cables installed - continue to monitor	Check support cables to east over neighbours property Lightly weight reduce canopy to the west	High
29	<i>Lophostemon confertus</i>	Queensland Box	10	5	59	Early - mature	Good	Good	Good	21 - 50 years	Deadwood present in canopy Low canopy Canopy growing into adjacent fence	Remove deadwood greater than 30mm in diameter Remove low eastern branches against fence Uplift canopy to minimum of 2.2m in height	Medium

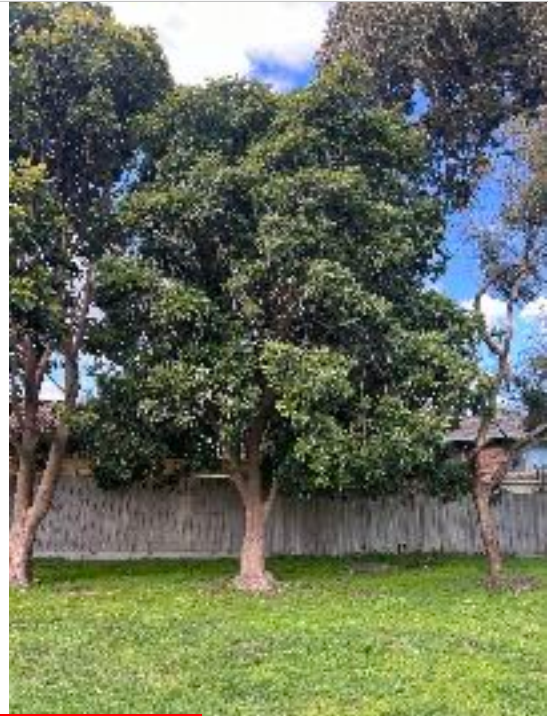
T30: *Lophostemon confertus*

30	<i>Lophostemon confertus</i>	Queensland Box	9	5	40	Early - mature	Good	Good	Good	21 - 50 years	Good health and condition	No works required	No Works
31	<i>Eucalyptus leucoxylon</i>	Yellow Gum	7	4	22	Early - mature	Good	Good	Good	21 - 50 years	Deadwood present in canopy Over extended lateral branch to the south west	Remove deadwood greater than 30mm in diameter Remove extended south west branch	High
32	<i>Corymbia maculata</i>	Spotted Gum	28	10	90	Mature	Good	Fair	Good	21 - 50 years	Over extended lateral branch to the east	Weight reduction of east limb	High
33	<i>Eucalyptus leucoxylon</i>	Yellow Gum	5	5	33	Early - mature	Good	Good	Good	21 - 50 years	Canopy overhanging neighbours property	Lightly weight reduce canopy to the east Clear canopy from neighbours property	Medium
34	<i>Eucalyptus leucoxylon</i>	Yellow Gum	8	6	39	Early - mature	Good	Poor	Good	21 - 50 years	Deadwood present in canopy	Removed deadwood greater than 30mm in diameter	Low

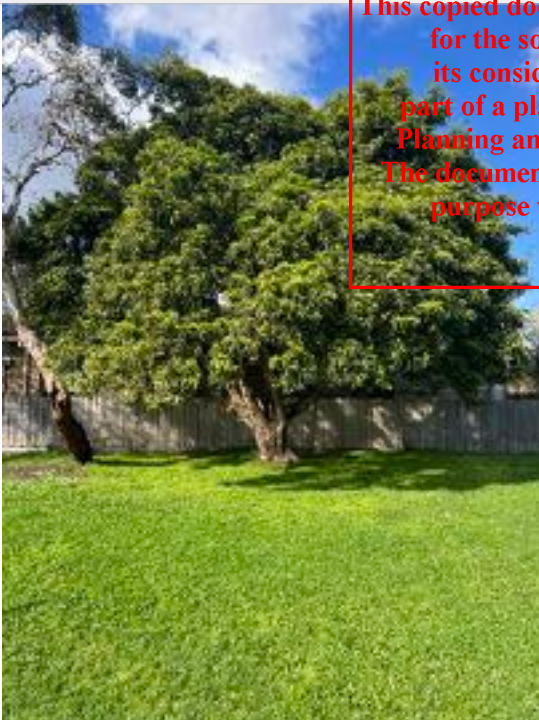
T35: *Pittosporum undulatum*

35	<i>Pittosporum undulatum</i>	Sweet Pittosporum	6	7	68	Early - mature	Fair	Fair	Fair	5 - 20 years	Deadwood present in canopy	Remove low, broken stub Remove deadwood greater than 30mm in diameter	Low
36	<i>Eucalyptus mannifera</i>	Brittle Gum	11	5	43	Early - mature	Good	Good	Good	Over 50 years	Deadwood present in canopy	Remove southern branch closest to antenna Remove low obvious deadwood	Medium
