Rod Kenning King David School 520 Orrong Road Armadale VIC 3143

Ref: Sports Facility project

Arboricultural Assessment and Tree Protection Management Plan for fifteen (15) trees located within the vicinity of proposed Sports Facility project at King David School, 520 Orrong Road, Armadale

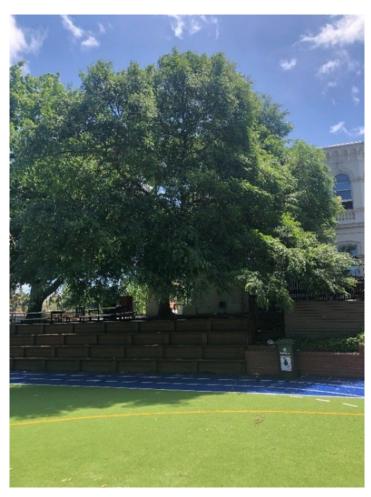
Figure 4. View of Tree 1 at King David School. (Justin Herbert, 4 November 2021).

- 5.5.2 Tree 1 was identified as a semi-mature example of *Ulmus parvifolia* (Chinese Elm) that was situated in the south east corner of the development site. The tree displayed good health and fair structure and had a noticeable presence within the surrounding landscape. It also contributed strongly to the surrounding tree canopy.
- 5.5.3 Due to the current age, health, and structural condition of the tree in combination with its known longevity under cultivation in Victoria, it was allocated a useful life expectancy (ULE) of 25–50 years, during which time its physical size was expected to increase significantly.
- 5.5.4 The tree was subsequently allocated a Category A, High retention value.

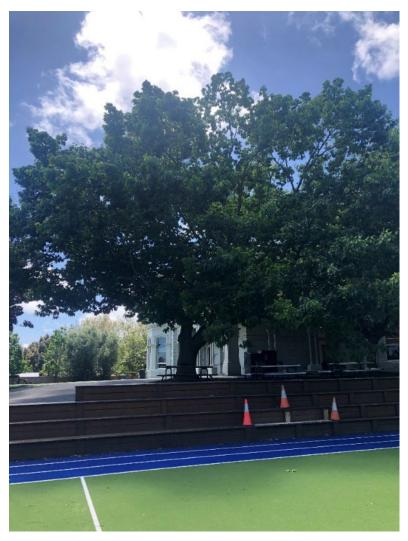
Figure 5. View of Tree 2 at King David School. (Justin Herbert, 4 November 2021).

- 5.5.7 Its structural condition was rated as fair as a result of the presence of deadwood, epicormic growth and evidence of poor pruning practices. The tree's structural condition in regards to branch attachment was rated as good with no previous signs of branch failure observed.

- 5.5.8 Based on the tree's current arboricultural traits and location it was allocated a ULE of 25–50 years, during which time its physical size could be expected to increase significantly however, this would likely occur at a slow to moderate rate. Tree 2 had a noticeable presence within the surrounding landscape and it also contributed strongly to the surrounding tree canopy.

- 5.5.9 The tree was subsequently allocated a Category A, High retention value.

- 8.2.1 An encroachment of approximately 10–20% into the TPZ of Tree 2 is expected as part of the proposed design. With further information on the demolition and construction methodology, greater detail of the specific protection can be provided.
- 8.2.2 In the first instance, the TPZ of Tree 2 is to be extended in a contiguous manner in a direction away from development. Seasoned tree mulch should be spread within the TPZ to a depth of ~75mm mulch should not be in contact with the tree's trunk.
- 8.2.3 In order to off-set any proposed feeder root severance, slow/deep irrigation is recommended during extended dry periods (i.e. periods of 5–7 days or more with no/limited rainfall). A slow/drip irrigation system extending throughout the TPZ is recommended so as to be able to deliver approximately 500–1000 litres of

- 8.2.8 Other proposed surfacing within the TPZ of Tree 2 is to be installed above the existing grade and be of a permeable nature to allow the passage of air and moisture. If the surfacing is to be load bearing, then it is suggested that a geogrid/web or similar is incorporated to ensure the rooting compacted.

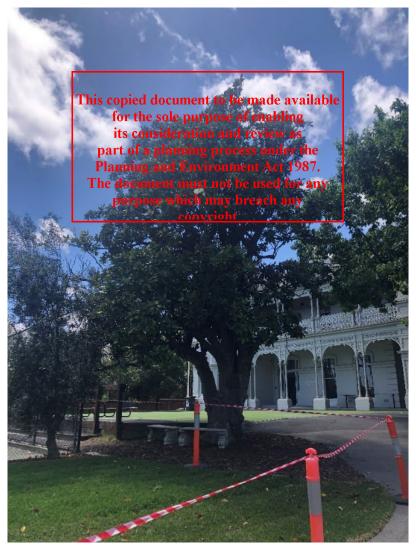
Figure 6. View of Tree 3 at King David School. (Justin Herbert, 4 November 2021).

- 5.5.12 Its structural condition was rated as fair as a result of the presence of deadwood, epicormic growth, wounds and evidence of poor pruning practices. The tree's structural condition in regards to branch attachment was rated as good with no previous signs of branch failure observed.

- 5.5.13 Based on the tree's current arboricultural traits and location it was allocated a ULE of 15–25 years, during which time its physical size could not be expected to increase significantly. The tree had a noticeable presence within the surrounding landscape as a commemorative tree. It also contributed strongly to the surrounding tree canopy.

- 5.5.14 The tree was subsequently allocated a Category A, High retention value.

3	Magnolia grandiflora	Bull Bay	Exotic	1	69	85	8.3	215.38	3.1	5-10	<5	Good	Fair	Mature	Decay; Epicormic growth; Poor pruning Soil compaction; Soil grade changes; Wound(s);	Amenity value/shade; Attractive landscape feature; Dominant landscape feature; Commemorative tree;		А	12	Remove - tree located within proposed development footprint or has major encroachment into its TPZ.
4	Olea europaea	European Olive	Exotic	8	10	12	2.0	12.57	1.5	<5	<5	Good	Fair	Juvenile	15-25 Co-dominant stems; Epicormic growth;	Amenity value/shade; Attractive landscape feature;		С		Remove - tree located within proposed development footprint or has major encroachment into its TPZ.
5	Liquidambar styraciflua	Sweet Gum	Exotic	1	57	74	6.8	146.98	2.9	10-15	5-10	Good	Fair S	Semi-Mature	Disease pathogens; Epicormic growth; Included bark; Previous failure(s); Soil compaction; Soil grade changes; Wound(s);	Amenity value/shade; Attractive landscape feature;	04-11-2021 : Justin Herbert : Recent stem failure has resulted in reduced structure and ULE. Historic evidence of Bleeding Necrosis on lower trunk however now appears inactive. Crown somewhat co dependant with tree 6.	В		Remove - tree located within proposed development footprint or has major encroachment into its TPZ.

- 6.2.1 Under the current design proposal four (4) trees, Tree 3, 4, 5 and 6, would be located within the development/building footprint and cannot be retained. The design would require modification to retain these trees. Proposed removal would require an application to The City of Stonnington for a tree removal/works permit. In addition, one (1) tree, Tree 8, has been recommended for removal irrespective of development.

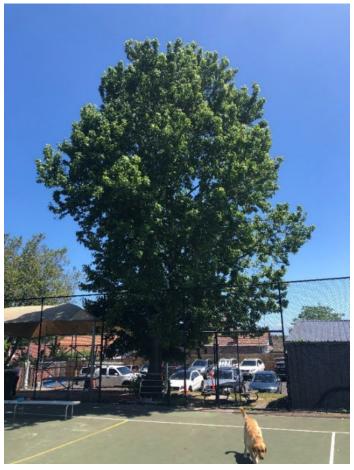
Figure 7. View of Tree 5 at King David School. (Justin Herbert, 4 November 2021).

- 5.5.16 Tree 5 was identified as a semi-mature example of *Liquidambar styraciflua* (Sweet Gum) that was situated to the west of the existing basketball court. The tree presented in good health with good overall foliage cover.
- 5.5.17 Its structural condition was rated fair due to evidence of previous failures and included bark. Based on the tree's current arboricultural traits and location it was allocated a ULE of 10–15 years
- 5.5.18 The tree was subsequently allocated a Category B, Medium retention value.

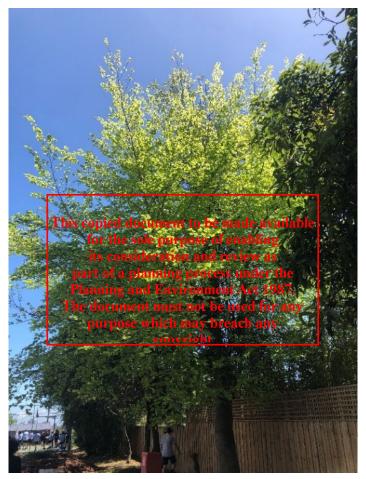
Figure 8. View of Tree 10 at King David School. (Justin Herbert, 4 November 2021).

- 5.5.20 Tree 10 was identified as a semi-mature example of a semi-mature *Fagus sylvatica* (European Beech) that was situated in the north east corner of the proposed construction area. The tree presented in good health with good overall foliage cover.
- 5.5.21 Its structural condition was rated fair due to evidence of previous failures and historical poor pruning. Based on the tree's current arboricultural traits and location it was allocated a ULE of 15–25 years
- 5.5.22 The tree was subsequently allocated a Category B, Medium retention value.

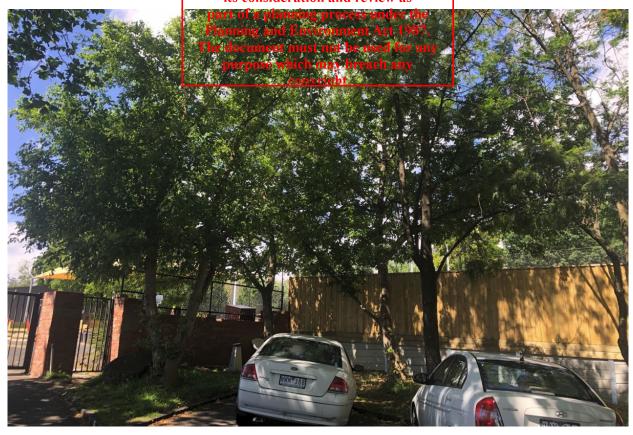
Figure 9. View of Trees 11-15. (Justin Herbert, 3 December 2021).

Trees 11–15 were Council Street trees located in Stawell Street (Figure 9). Tree species were *Acer negundo* (Box Elder) and *Grevillea robusta* (Silky Oak). The trees were in generally fair-good condition and provided shade and amenity to the street and nearby residents, although *Acer negundo* (Box Elder) may be considered undesirable by some due to weed potential via often prolific seed production and viability. Trees 11 and 12 were the closest trees to the existing, and aged, masonry fence (Figure 10) while Trees 12–15 were located adjacent to the concrete retaining wall. Currently, Trees 11 and 12 were not directly affecting the masonry fence via root expansion and growth, however as the trees mature root growth may impact the fence directly, or indirectly via the natural process of soil wetting and drying. Trees 12–15 were not observed to be impacting the concrete retaining wall. Trees 11-15 are unlikely to have their root systems impacted upon during resurfacing works given the grade change between public and private properties as well as the current non within the grassed area
