15 December 2021

Ref: Sports Facility project

Arboricultural Assessment and Tree Protection Management Plan for fifteen (15) trees located within the vicinity of proposed Sports Facility project at King David School, 520 Orrong Road, Armadale

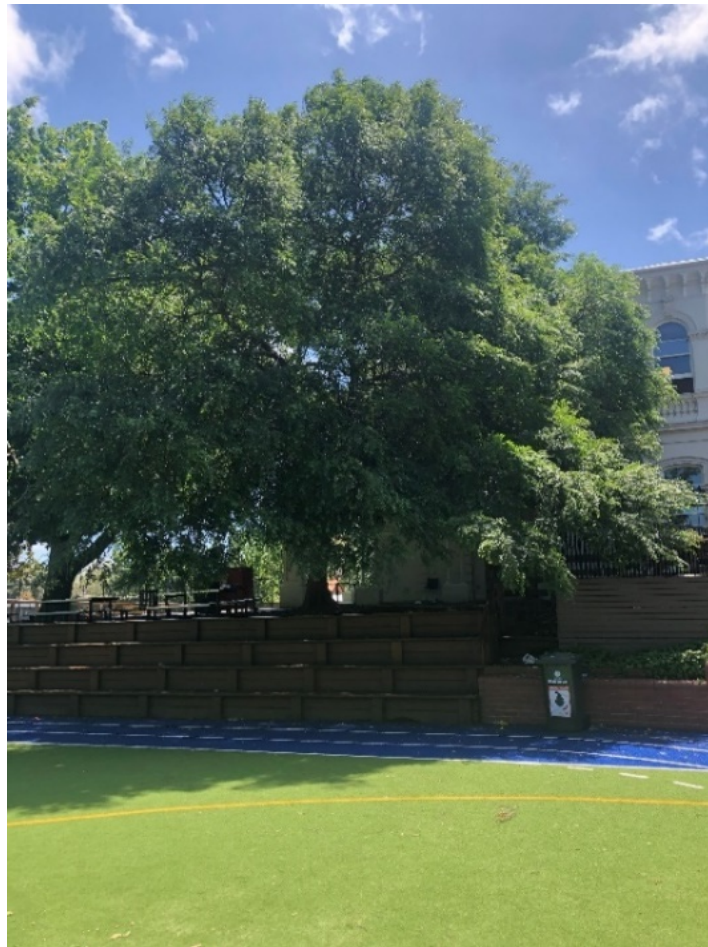
Figure 4. View of Tree 1 at King David School. (Justin Herbert, 4 November 2021).

5.5.3 Due to the current age, health, and structural condition of the tree in combination with its known longevity under cultivation in Victoria, it was allocated a useful life expectancy (ULE) of 25–50 years, during which time its physical size was expected to increase significantly.

5.5.4 The tree was subsequently allocated a Category A, High retention value.

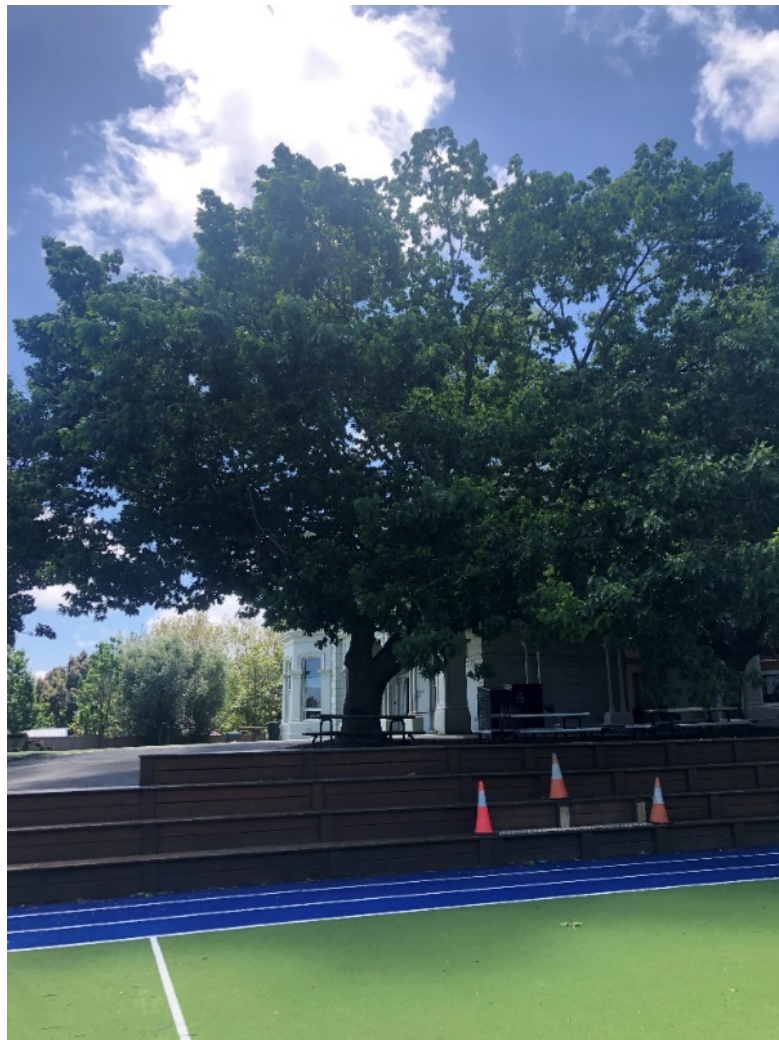
Figure 5. View of Tree 2 at King David School. (Justin Herbert, 4 November 2021).

5.5.7 Its structural condition was rated as fair as a result of the presence of deadwood, epicormic growth and evidence of poor pruning practices. The tree's structural condition in regards to branch attachment was rated as good with no previous signs of branch failure observed.

5.5.8 Based on the tree's current arboricultural traits and location it was allocated a ULE of 25–50 years, during which time its physical size could be expected to increase significantly however, this would likely occur at a slow to moderate rate. Tree 2 had a noticeable presence within the surrounding landscape and it also contributed strongly to the surrounding tree canopy.

5.5.9 The tree was subsequently allocated a Category A, High retention value.

- 8.1.4 Tree 2 would require a combination of specific and generic tree protection measures, due to the tree's proximity to the proposed construction zone, in order to remain viable post project completion.
- 8.1.5 Tree 1, 7, 9 and 10 would require generic tree protection measures to remain viable in the landscape post project completion.
- 8.1.6 Trees 11–15 are Council owned trees and must be subject to appropriate tree protection measures.
- 8.1.7 A summary of the calculated TPZs and SRZs can be found in Appendix E of this report.

- 8.2.3 In order to off-set any proposed feeder root severance, slow/deep irrigation is recommended during extended dry periods (i.e. periods of 5–7 days or more with no/limited rainfall). A slow/drip irrigation system extending throughout the TPZ is recommended so as to be able to deliver approximately 500–1000 litres of water per week as required. The soil should not be allowed to become overly saturated/water logged, refer to Appendix C for further guidance.

- 8.2.4 Excavation is to be carried out only under arborist supervision. No excavation should occur within the SRZ of this tree. It was recommended that the proposed excavation commence at the outer extent of the TPZ and move inwards to minimise root damage to the trees.

- 8.2.8 Other proposed surfacing within the TPZ of Tree 2 is to be installed above the existing grade and be of a permeable nature to allow the passage of air and moisture. If the surfacing is to be load bearing, then it is suggested that a geogrid/web or similar is incorporated to ensure the rooting area below does not become compacted.

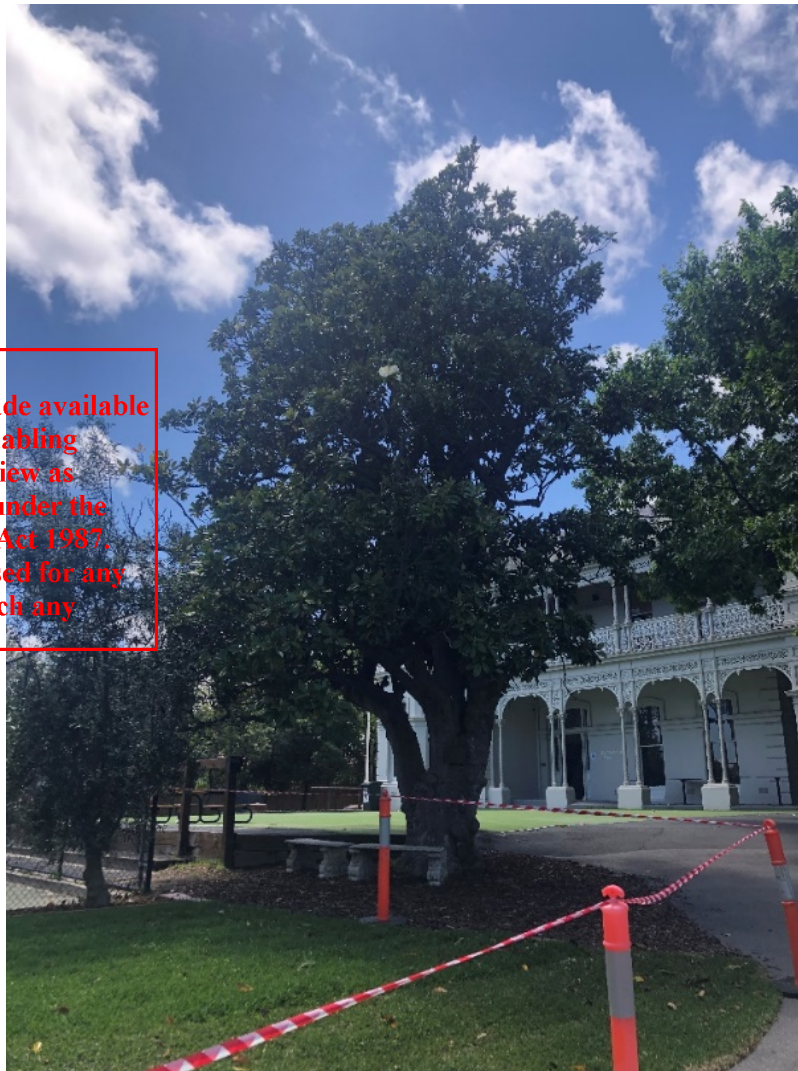
Figure 6. View of Tree 3 at King David School. (Justin Herbert, 4 November 2021).

5.5.12 Its structural condition was rated as fair as a result of the presence of deadwood, epicormic growth, wounds and evidence of poor pruning practices. The tree's structural condition in regards to branch attachment was rated as good with no previous signs of branch failure observed.

5.5.13 Based on the tree's current arboricultural traits and location it was allocated a ULE of 15–25 years, during which time its physical size could not be expected to increase significantly. The tree had a noticeable presence within the surrounding landscape as a commemorative tree. It also contributed strongly to the surrounding tree canopy.

5.5.14 The tree was subsequently allocated a Category A, High retention value.

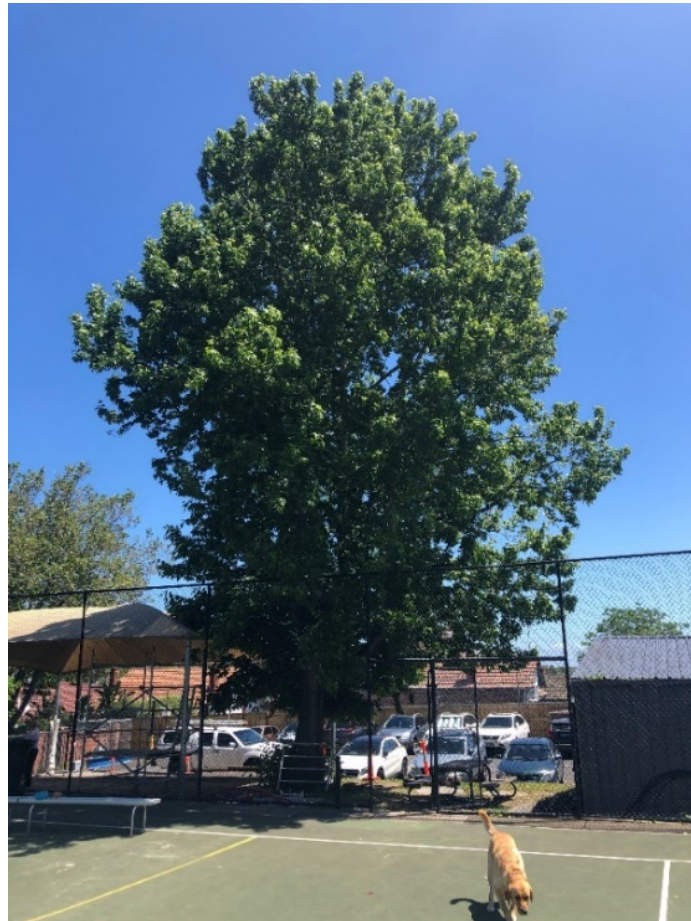
Figure 7. View of Tree 5 at King David School. (Justin Herbert, 4 November 2021).

5.5.17 Its structural condition was rated fair due to evidence of previous failures and included bark. Based on the tree's current arboricultural traits and location it was allocated a ULE of 10–15 years

5.5.18 The tree was subsequently allocated a Category B, Medium retention value.

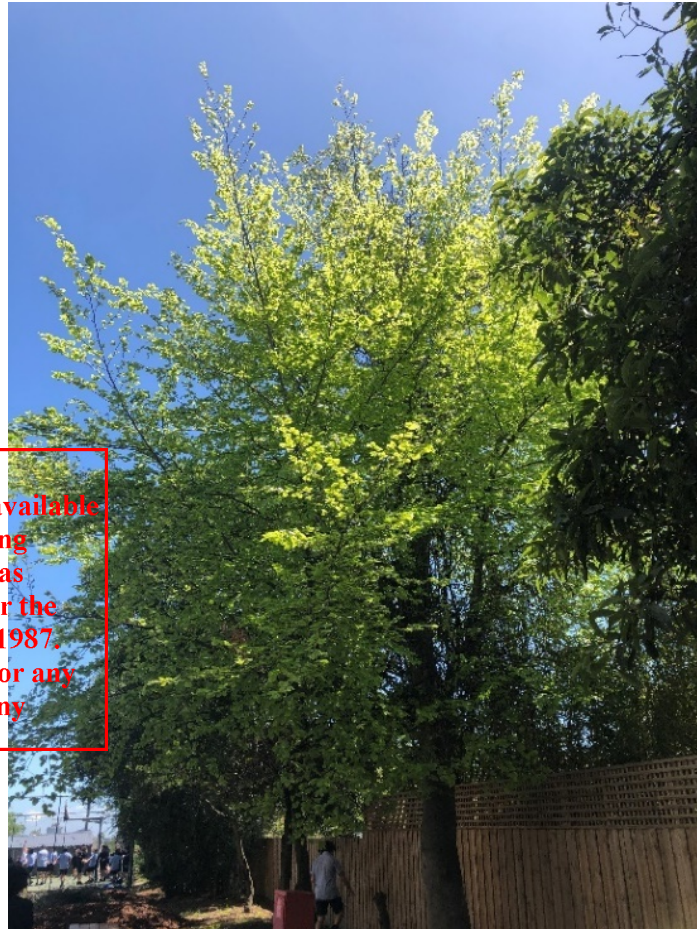
Figure 8. View of Tree 10 at King David School. (Justin Herbert, 4 November 2021).

5.5.21 Its structural condition was rated fair due to evidence of previous failures and historical poor pruning. Based on the tree's current arboricultural traits and location it was allocated a ULE of 15–25 years

5.5.22 The tree was subsequently allocated a Category B, Medium retention value.

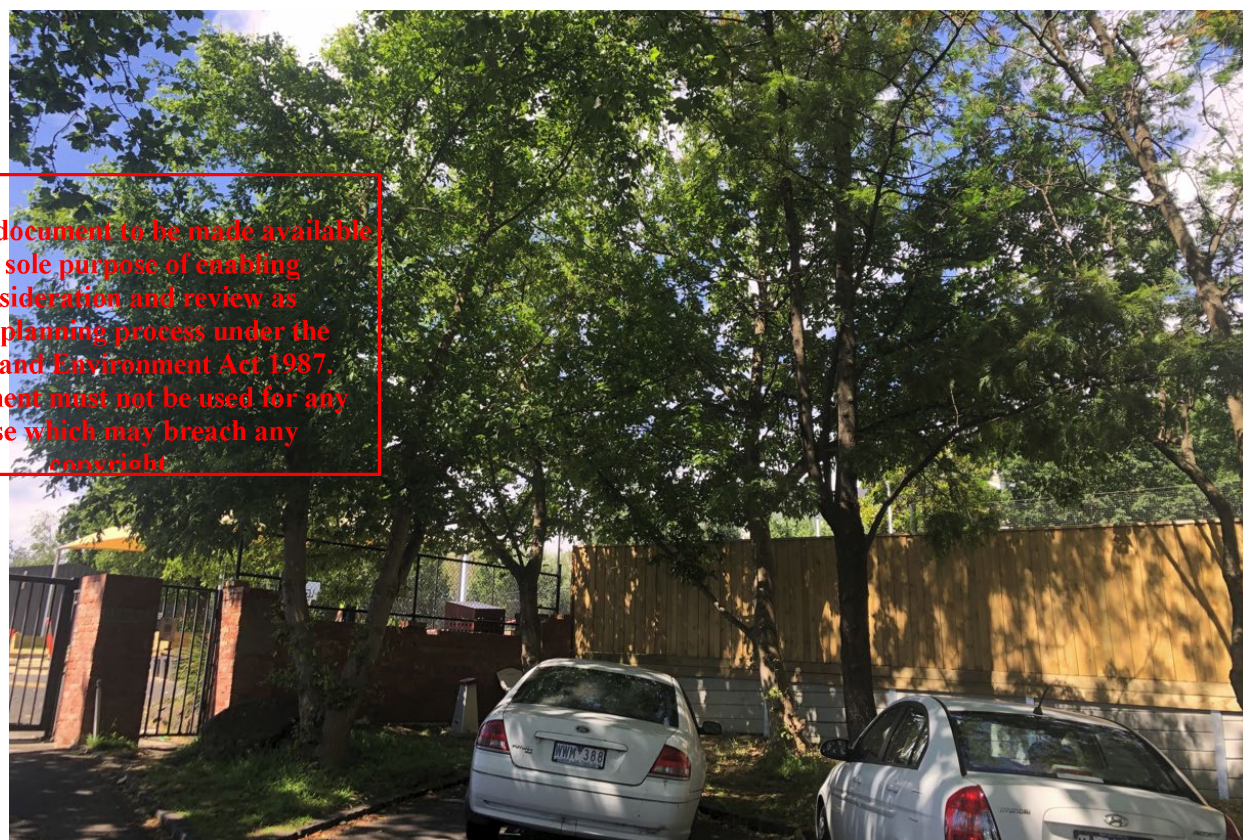
Figure 9. View of Trees 11–15. (Justin Herbert, 3 December 2021).

5.5.32 Trees 11–15 were Council street trees located in Stawell Street (Figure 9). Tree species were *Acer negundo* (Box Elder) and *Grevillea robusta* (Silky Oak). The trees were in generally fair-good condition and provided shade and amenity to the street and nearby residents, although *Acer negundo* (Box Elder) may be considered undesirable by some due to weed potential via often prolific seed production and viability. Trees 11 and 12 were the closest trees to the existing, and aged, masonry fence (Figure 10) while Trees 12–15 were located adjacent to the concrete retaining wall. Currently, Trees 11 and 12 were not directly affecting the masonry fence via root expansion and growth, however as the trees mature root growth may impact the fence directly, or indirectly via the natural process of soil wetting and drying. Trees 12–15 were not observed to be impacting the concrete retaining wall.

5.5.33 TPZ and SRZ distances must be observed with regard to Council tree assets and any proposed work inside these distances must be supervised by a suitably qualified consulting arborist.
