15 October 2025

Ref: 1049.010.LT.STR.001.A

### 253 Barnard Street, Bendigo – Existing Building Structure Condition Assessment

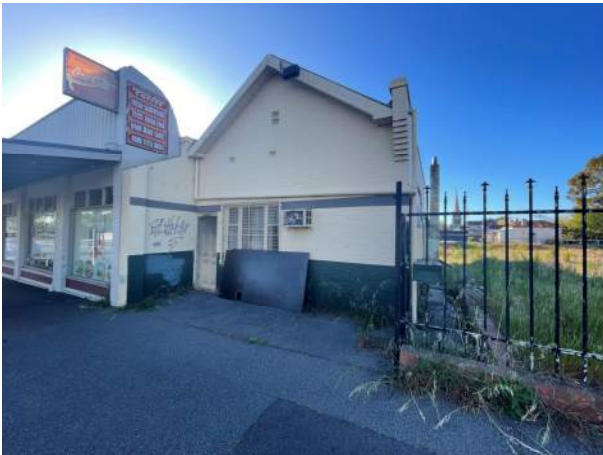
**Figure 2:** Front of existing building facing Barnard Street.

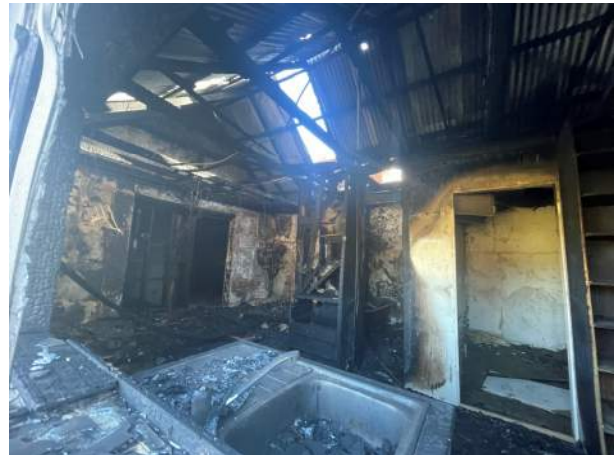
**Figure 3:** Condition of fire damaged part of existing building.

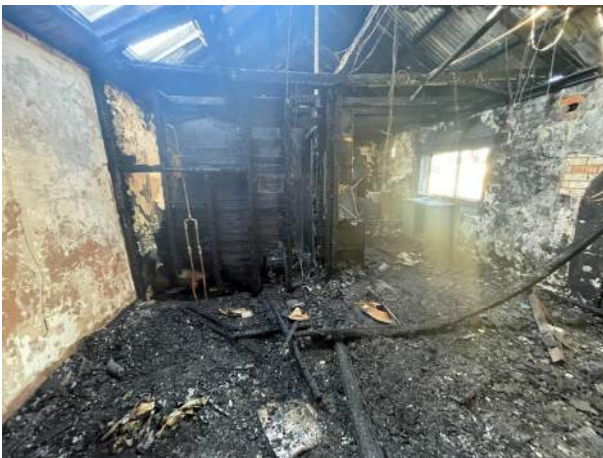
**Figure 4:** Condition of fire damaged part of existing building.

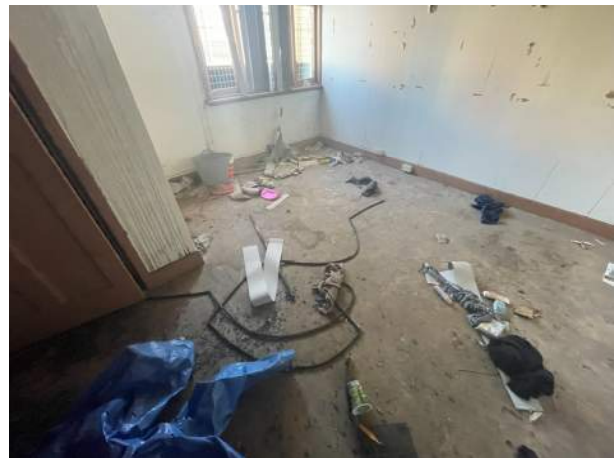
**Figure 5:** Vandalised part of existing building.

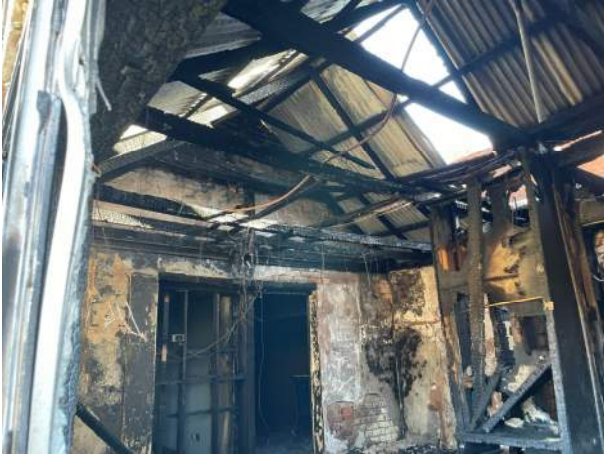
During the inspection SCE was able to visually observe severe damage to the existing timber roof rafters, timber ceiling joist, timber wall framing and timber subfloor to the rear two thirds of the building where a fire occurred in the existing building. Refer to figures 6 through to figure 9 below which show the fire damage to the rear two thirds of the building.

**Figure 6:** Fire damaged timber roof rafters.

Based upon the findings of this condition assessment, we advise that the existing structure has fallen into a poor state of disrepair. The existing building that has been fire damaged is structurally compromised. Where the building has not been affected by fire damage, it has been vandalised and used by squatters. Taking into consideration the extent of the works required to return the existing building to a suitable condition, a large majority of the existing structure will need to be replaced and/or repaired. We believe the extent of works required to return the building to a suitable condition is not economically viable and is therefore recommended that the building is demolished.

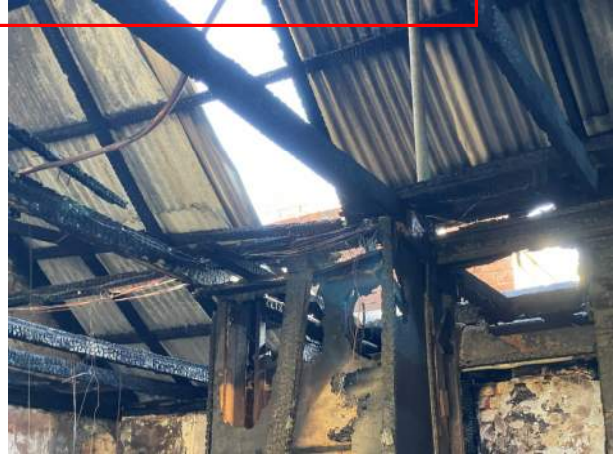
**Figure 7:** Fire damaged timber ceiling joists.

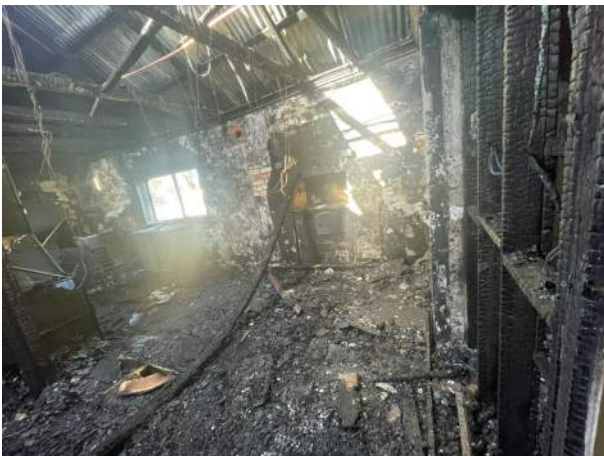
**Figure 8:** Fire damaged internal timber walls.

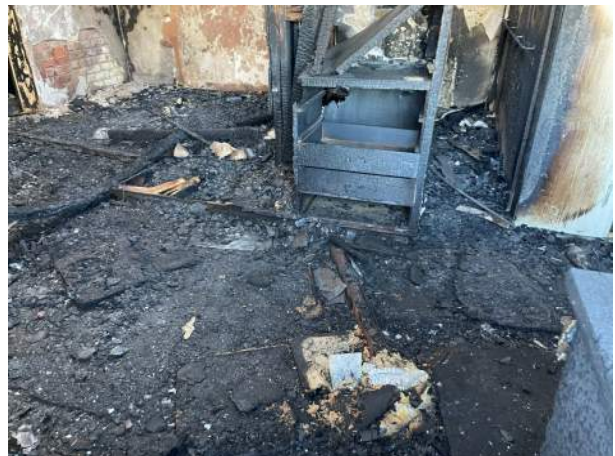
**Figure 9:** Fire damaged timber subfloor.

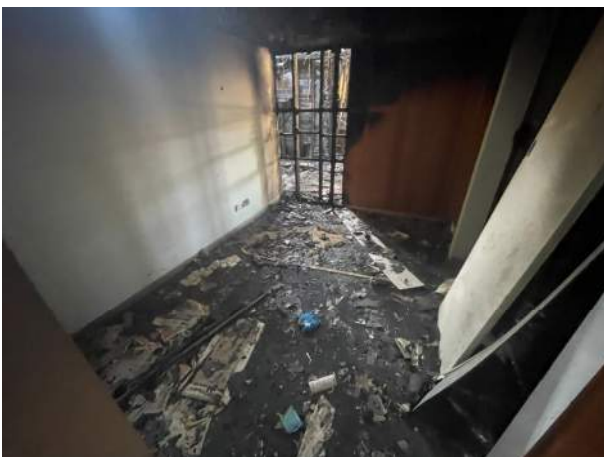
The existing subfloor structure appears to have subsided throughout the front third of the existing building and the timber floor material deflects noticeably when walked on, which suggests that the existing flooring material is compromised. Refer to figures 10 and 11 below.

**Figure 10:** Compromised subfloor.

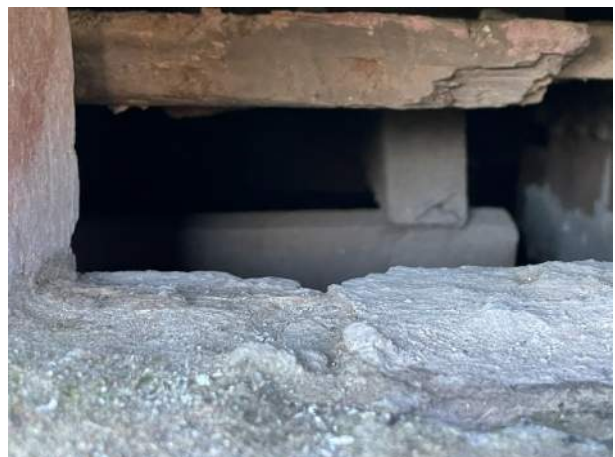
**Figure 11:** Timber subfloor condition.

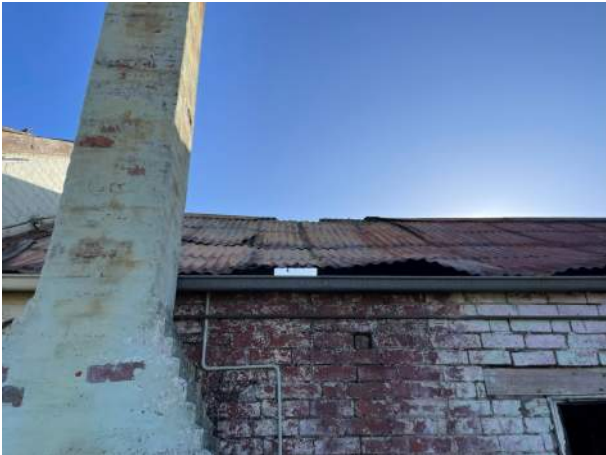
Significant signs of mortar loss and cracks were identified in the external double masonry wall. Cracks of this nature typically indicate footing movement and the observed mortar loss between masonry units is typically a result of mortar that deteriorates over time. Refer to figure 12 and 13 below.

**Figure 12:** Cracking and mortar loss in masonry walls.

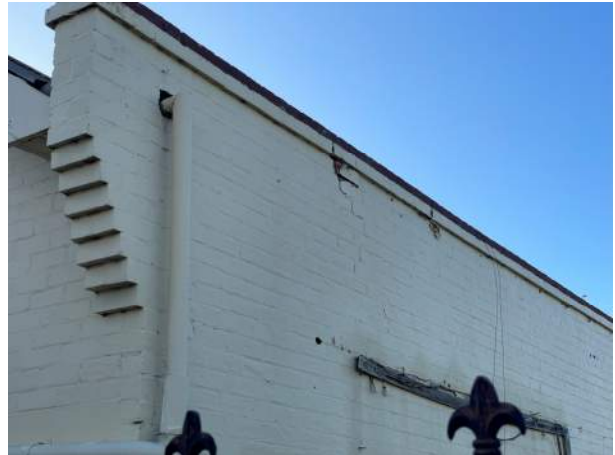
**Figure 13:** Cracks in masonry wall.
