AUDIT FINDINGS AND RECOMMENDATIONS

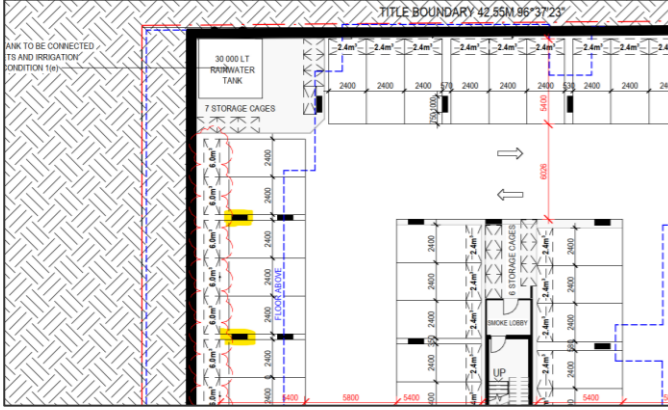
Audit Findings	Recommendations (P) Primary (ST) Step Towards (S) Supporting (N) Non Safe-System	Level of Risk	Safe System Energy	Revised / Updated Audit Finding Based on Review of P10 Plans	Designer/Project Manager Response
Findings from Endorsed RSA (200032RSA003A-F) – Based on revision P6 plans					
<p>1. The locations of columns with respect to car parking spaces (those along the western side of the car park in particular) as shown on the architectural plans do not accord with the car parking clearance envelope requirements of AS/NZS 2890.1:2004. While not a significant safety concern, this could make the spaces more difficult to access, and could affect door opening.</p> <p>Examples of non-conforming column locations are shown below. Please note that this does not show all non-conforming columns.</p>

<p>Review the design of the car park and column locations, having regard to Figure 5.2 of AS/NZS 2890.1:2004 (N)</p>	<p>Note</p>	<p>Not Applicable</p>	<p>Columns have been relocated clear of door opening areas.</p> <p>Finding is resolved.</p>	<p>N/A</p> <div style="border: 2px solid red; padding: 10px; text-align: center; color: red; font-weight: bold;"> <p>ADVERTISED PLAN</p> <p>This copied document to be made available for the sole purpose of enabling its consideration and review as part of a planning process under the Planning and Environment Act 1987. The document must not be used for any purpose which may breach any copyright</p> </div>

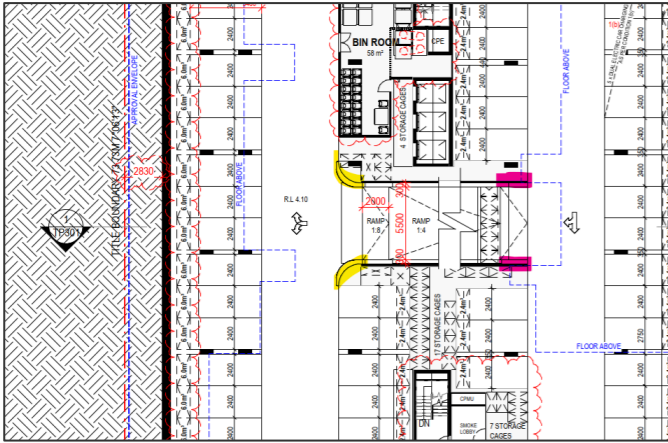
<p>2. Radii are provided at the bottom of ramps between levels, but not at the top (yellow highlight vs pink highlight below). This could affect the ability to accommodate passing movements at the top of the ramp. Additionally sightlines may be affected by the wall either side of the ramp.</p>

<p>Confirm by means of a swept path assessment to confirm that circulating vehicle movements can be suitably accommodated. (P)</p> <p>Review sightlines at this location and adjust wall if needed and if possibly to improve sightlines. (P)</p> <p>If the walls cannot be adjusted, supplementary convex mirrors should be provided to assist with sightlines. (S)</p>	<p>Rare Insignificant Negligible</p>	<p>Within Tolerable</p>	<p>Radii have not been provided however ramp has been increased from 5.5 m to 6.7 m. Swept paths should be checked to ensure appropriate design vehicle movements can be accommodated.</p> <p>Convex mirrors are not shown at all intersections. Review sightlines and add convex mirrors if necessary.</p>	<p>Swept path assessment confirms that circulation can be provided for concurrent B85 and B99 design vehicle movements.</p> <p>Convex mirrors should be provided at each side of the ramp on all basement levels.</p>

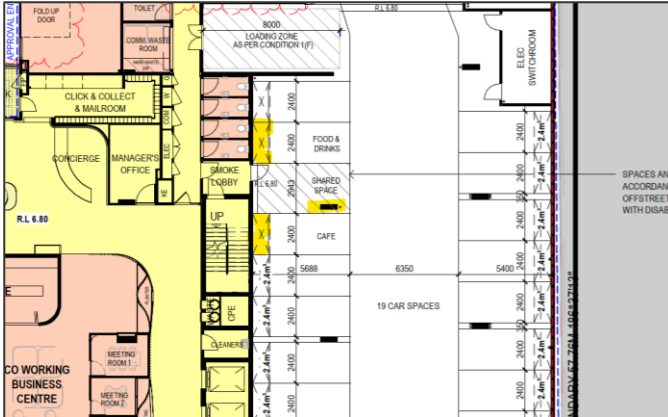
Audit Findings	Recommendations (P) Primary (ST) Step Towards (S) Supporting (N) Non Safe-System	Level of Risk	Safe System Energy	Revised / Updated Audit Finding Based on Review of P10 Plans	Designer/Project Manager Response
<p>5. The spaces for the café and food and drink premises feature a shared area between them, so that they could be used by people with disabilities, should they have the need to.</p> <p>While not necessarily a safety concern, there it is suggested that storage cages over the end of these spaces could make them more difficult to use for people with disabilities. Additionally while Australian Standard 2890.6:2022 does allow for a column to be located within the shared area, the column shown on the plans does not fall within the area permitted under the standard.</p>

<p>Consider the design of these spaces with regard to the requirements of AS 2890.6:2022. (N)</p>	<p>Note</p>	<p>Not Applicable</p>	<p>Storage cages no longer provided in these spaces.</p> <p>Column is still located within the shared area and should be addressed.</p>	<p>If structural design permits, the column should be relocated centrally within the hatched area.</p> <p>This is considered a building compliance matter, and does not materially impact safety.</p>
