ARBORIST REPORT

## ARBORICULTURAL IMPACT ASSESSMENT

PREPARED FOR: CORIO SKI CLUB

ADDRESS: 6 DELETITE LANE, MT BULLER  
3723.

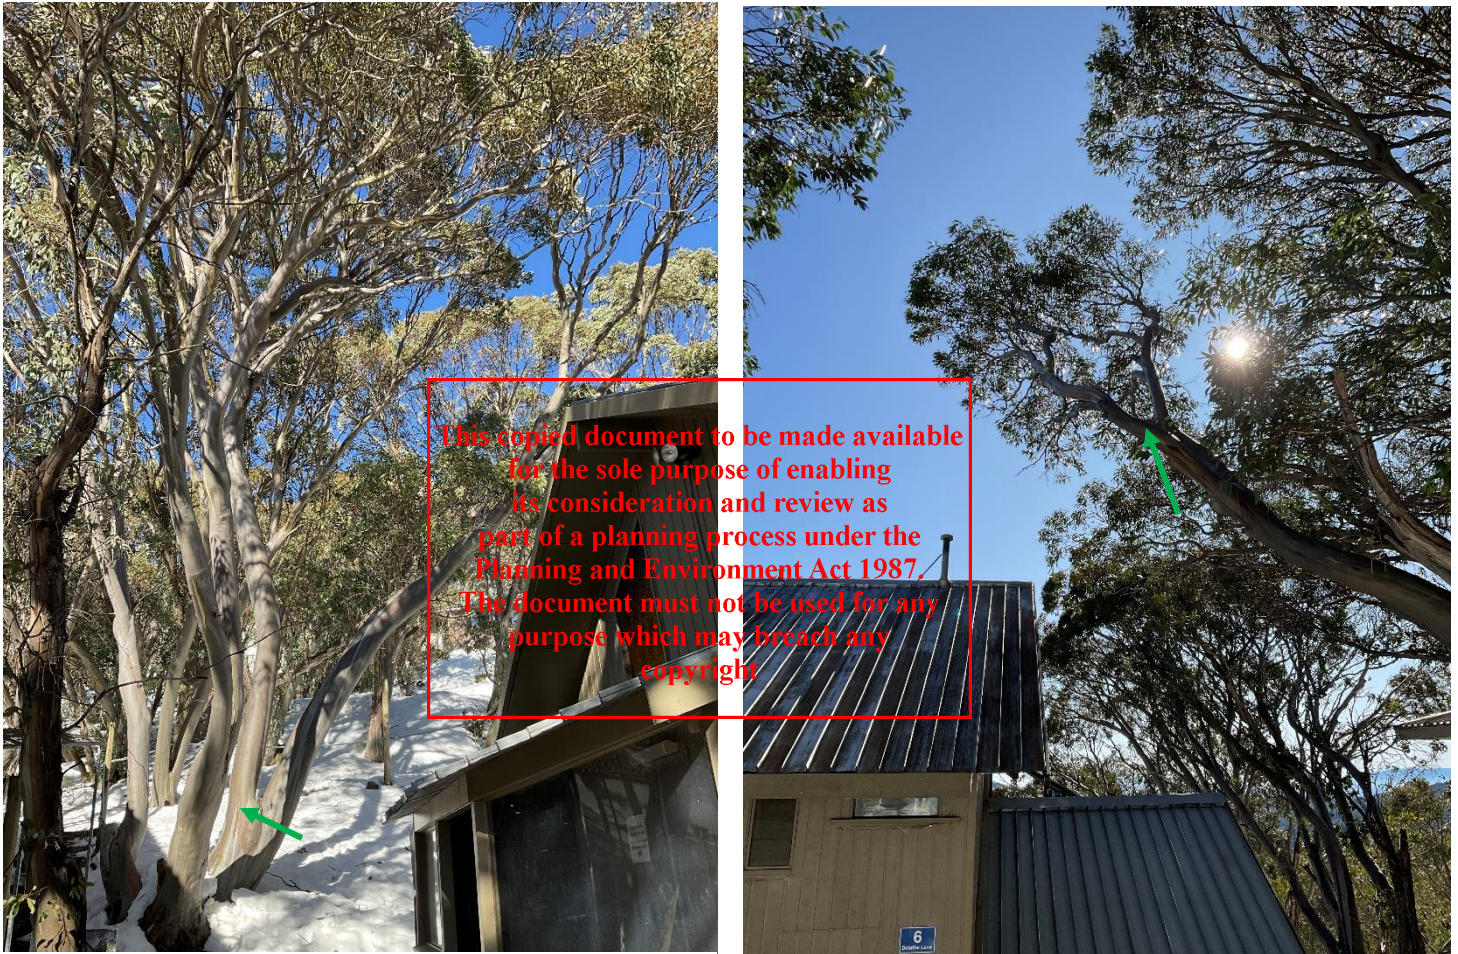
Figure 4 and 5 Shows T1 and overextended branch over lodge.

T1 contains multiple trunks x 3, and has a large, overextended branch to the west growing directly over the roof of the lodge. At present the tree is located only 4.7m from the SE corner of the lodge, with the eastern trunk located directly on the eastern boundary of the site.

With the construction of the proposed new front entrance and access path, a major combined encroachment into the trees TPZ of 51.54% could occur. However, the proposed new access path will be constructed with tree sensitive methods such as “bark” laid on the ground surface which will help reduce compaction from pedestrians and will negate the need to excavate soil completely, so no root damage will occur.

A major encroachment of 35.76%, will occur with the proposed development, and to reduce the impacts of these works it is recommended that any roots revealed during excavation within the TPZ are to be pruned in accordance with AS4372-2007 Pruning of Amenity Trees by a qualified arborist using clean sharp hand tools.

To compensate for the loss of root mass it is recommended that Canopy Reduction Pruning is done as per the (Australian Standard 4373-2007 Pruning of Amenity Trees Clause 7.3.2 Reduction Pruning). This is to be done by pruning the ends of the branches back to internal lateral branches or stems, by approx. 10 to 15%, with no cuts larger than approx. 75mm. Especially the overextended branch, to the west growing directly over the roof of the lodge, which should be reduced back to the lowest available growth point, as soon as possible.

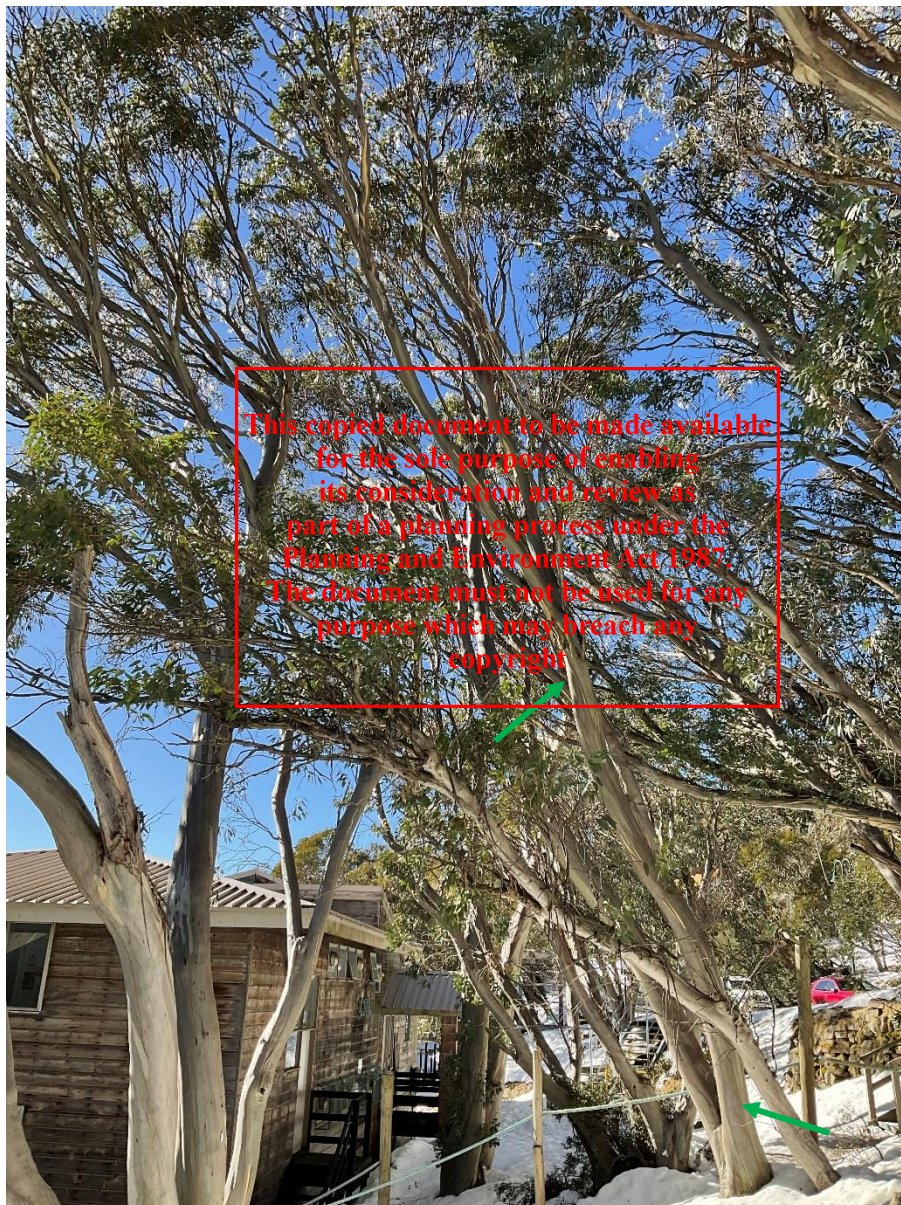
Figure 6 T2 to the south of the proposed new access path.

T2 contains minor deadwood and is leaning to the north. It is situated just off site over the eastern boundary. There will be a major encroachment of 14.52% into its TPZ, due to the new access path

however I believe the tree can still remain viable for the following reasons: the path will be constructed with tree sensitive methods such as “bark” laid on the ground surface which will help reduce compaction from pedestrians and will negate the need to excavate soil completely, so no root damage will occur.

A major encroachment of 14.52%, will occur with the proposed development, and to reduce the impacts of these works it is recommended that any roots revealed during excavation within the TPZ are to be pruned in accordance with AS4372-2007 Pruning of Amenity Trees by a qualified arborist using clean sharp hand tools.

To compensate for the loss of root mass it is recommended that Canopy Reduction Pruning is done as per the (Australian Standard 4373-2007 Pruning of Amenity Trees Clause 7.3.2 Reduction Pruning). This is to be done by pruning the ends of the branches back to internal lateral branches or stems, by approx. 10 to 15%, with no cuts larger than approx. 50mm. Especially the overextended trunk over the proposed new access path.

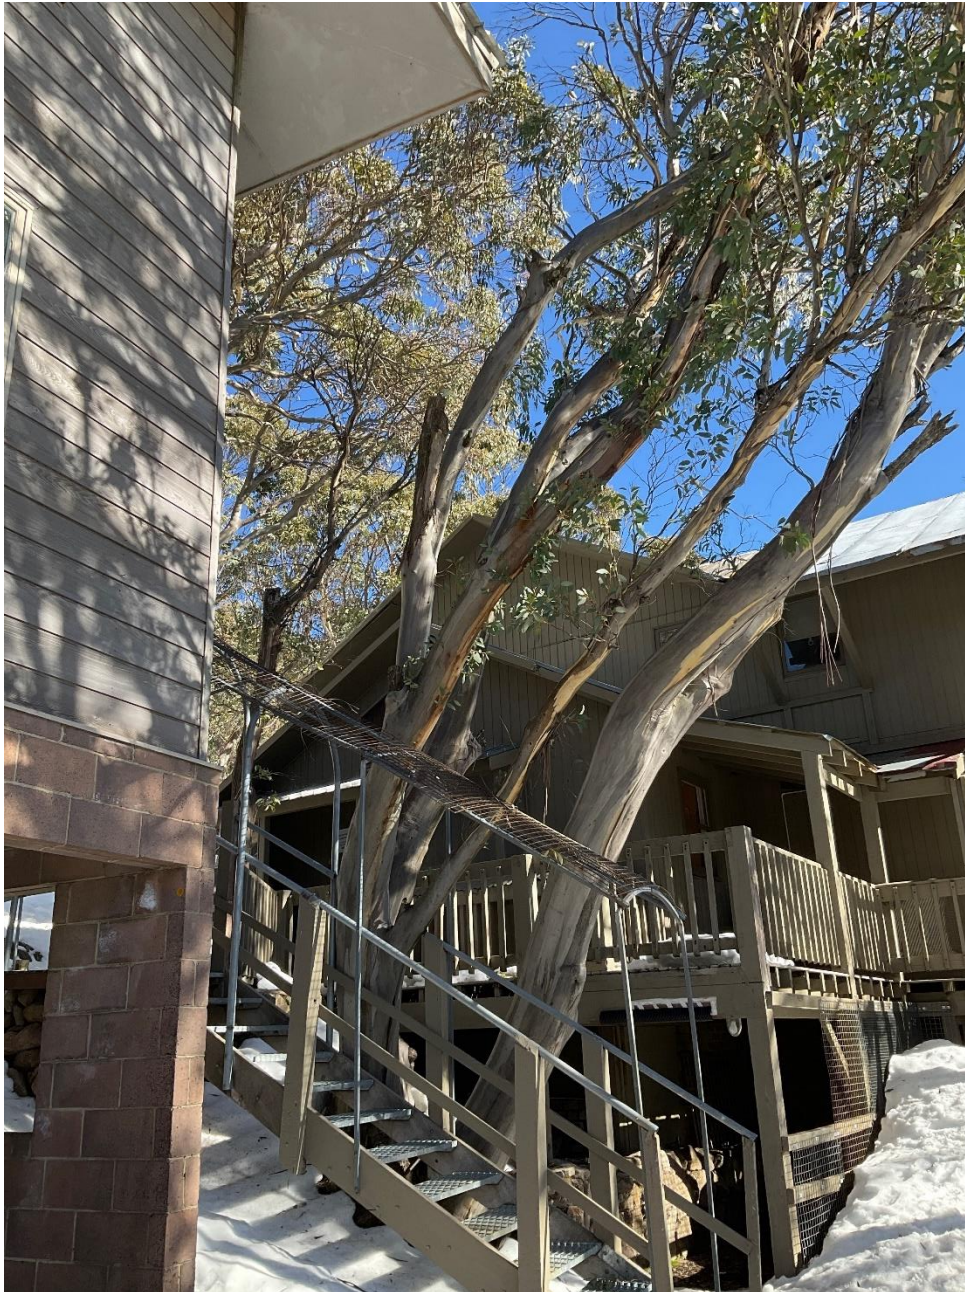
An existing major encroachment of 29.4% already exists. The new proposed works will not encroach anymore into the trees TPZ, however care will need to be taken during works so the tree is not damaged, especially the tree’s trunk and root system. Some remedial pruning is required to ensure the tree remains viable.

Figure 7 T25 eastern side of lodge.

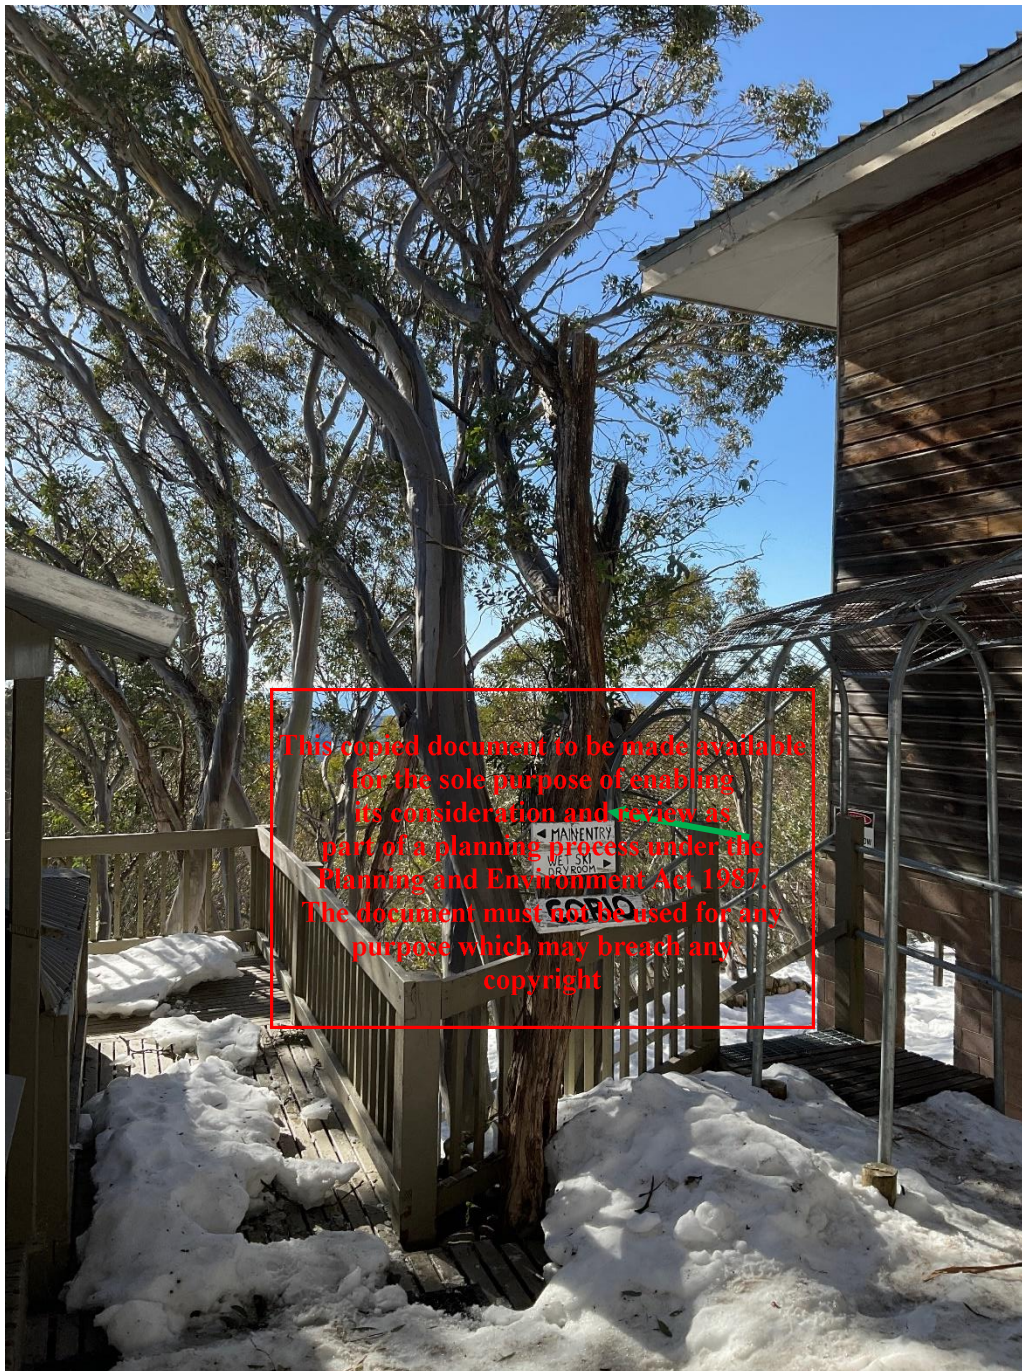
T26 presented in low health and vigour, with very poor structure.

Figure 8 T26 with Nil retention value.

T26 upper canopy is completely dead, with only a narrow strip of conductive tissue being alive on the north side, of the trunk. There are also small epicormic shoots present, which indicates this tree is under stress. Signs have been attached to the tree.

- One tree has been recommended for removal T26, as it has Nil retention value, and is not worthy of being a constraint to a development design proposal.

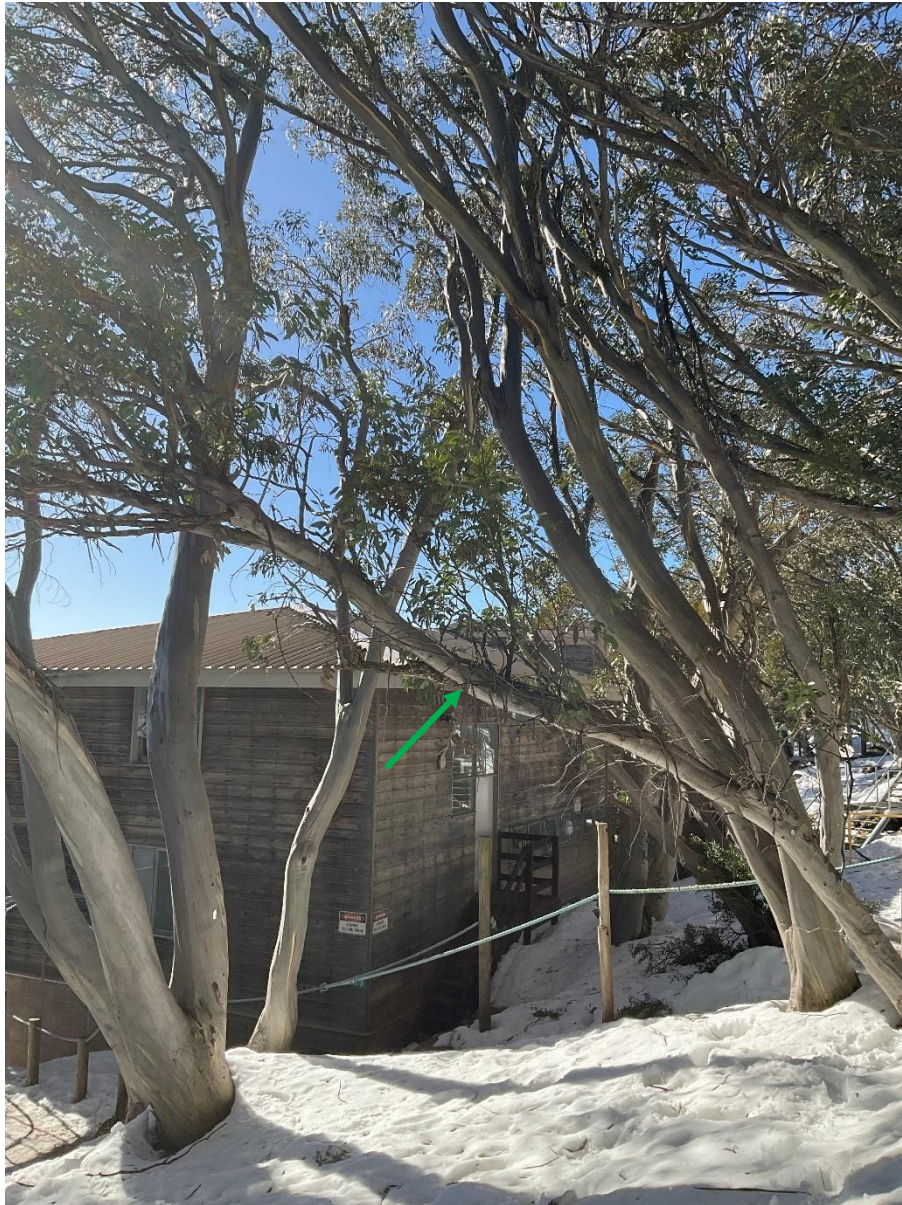
A minor encroachment of 6.39% will occur due to the construction of the proposed new access path, however I believe the tree can still remain viable for the following reasons: the path will be constructed with tree sensitive methods such as "bark" laid on the ground surface which will help reduce compaction from pedestrians and will negate the need to excavate soil completely, so no root damage will occur.

Figure 9 T3 leaning to the north, directly over the proposed new path.

A major encroachment of 29.4%, will occur with the proposed development, and to reduce the impacts of these works it is recommended that any roots revealed during excavation within the TPZ are to be pruned in accordance with AS4372-2007 Pruning of Amenity Trees by a qualified arborist using clean sharp hand tools.

To compensate for the loss of root mass it is recommended that Canopy Reduction Pruning is done as per the (Australian Standard 4373-2007 Pruning of Amenity Trees Clause 7.3.2 Reduction Pruning). This is to be done by pruning the ends of the branches back to internal lateral branches or stems, by approx. 10 to 15%, with no cuts larger than approx. 75mm. Especially the overextended trunk over the proposed new access path.

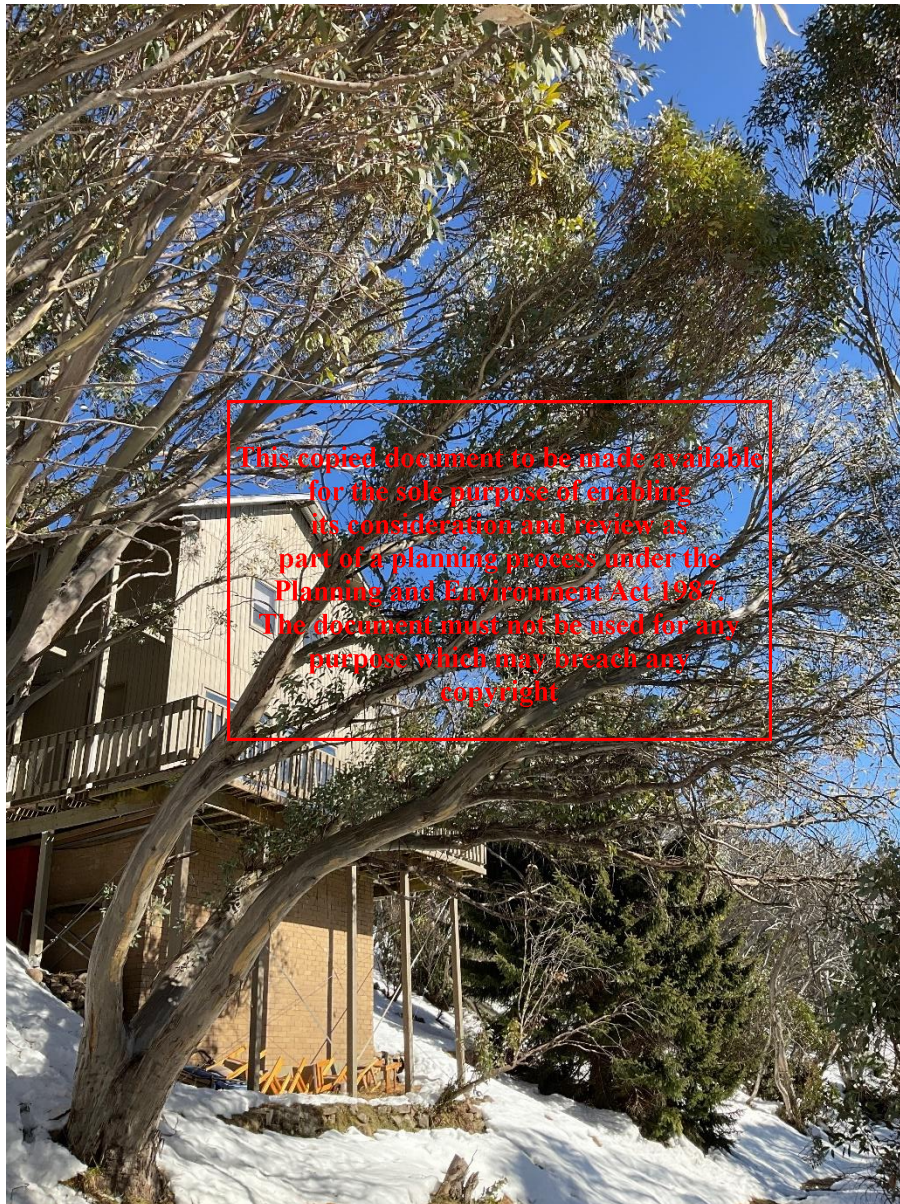
The tree is weighted and leaning to the north due to being suppressed by larger trees, surrounding it to the south, and possibly phototropic leaning out to the north in search of more available light. There will be a minor encroachment of 5.6%, which is preexisting due to the current building.

Care will need to be taken not to encroach any further and cause damage to the tree.

Figure 10 T21 located on the northeast corner of the lodge.

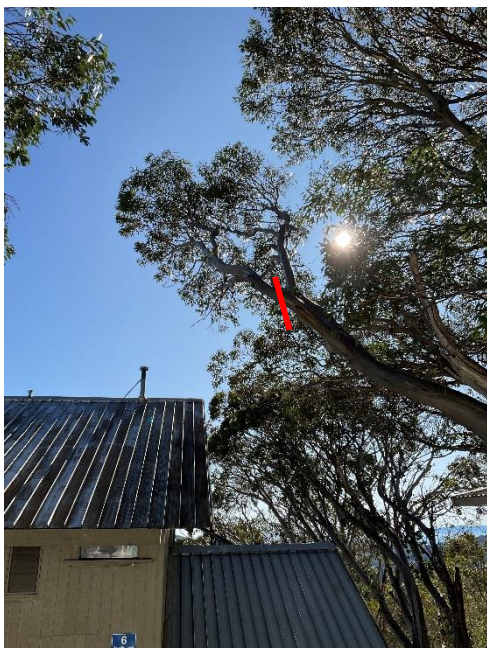
T1 - Approx location of pruning.
