**PRELIMINARY GEOTECHNICAL
ASSESSMENT FOR CORIO SKI LODGE,
6 DELATITE LANE, MT BULLER**

PSA0277-01_Corio Ski Lodge Prelim Geotech
11 July 2023

**RE: PRELIMINARY GEOTECHNICAL ASSESSMENT FOR CORIO SKI LODGE, 6
DELATITE LANE, MT BULLER**

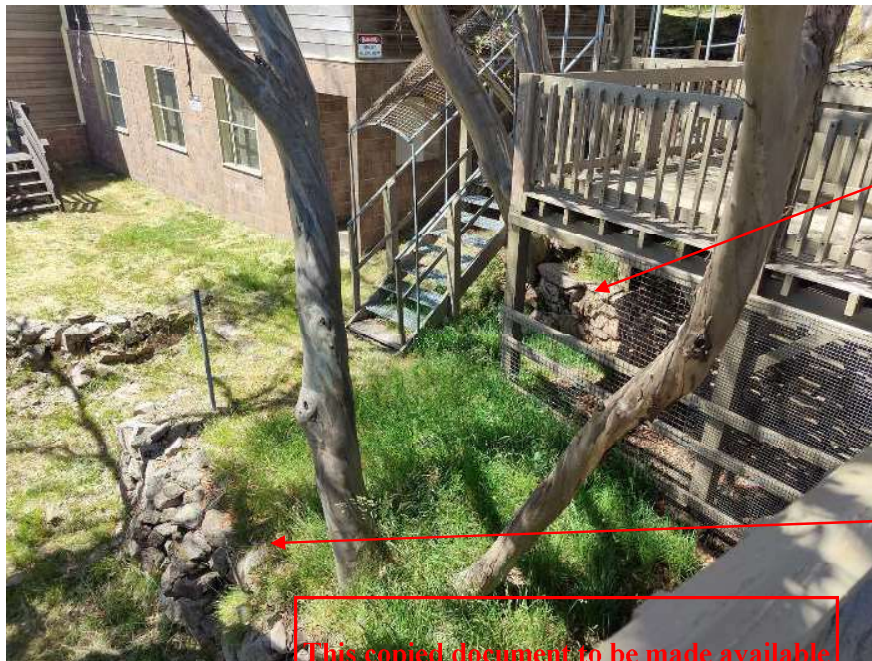
Plate 1. Northern side of property looking southeast.

Cut batter approx. 0.75m high, rock reinforced.

Fill batter approx. 0.75m high, rock reinforced.

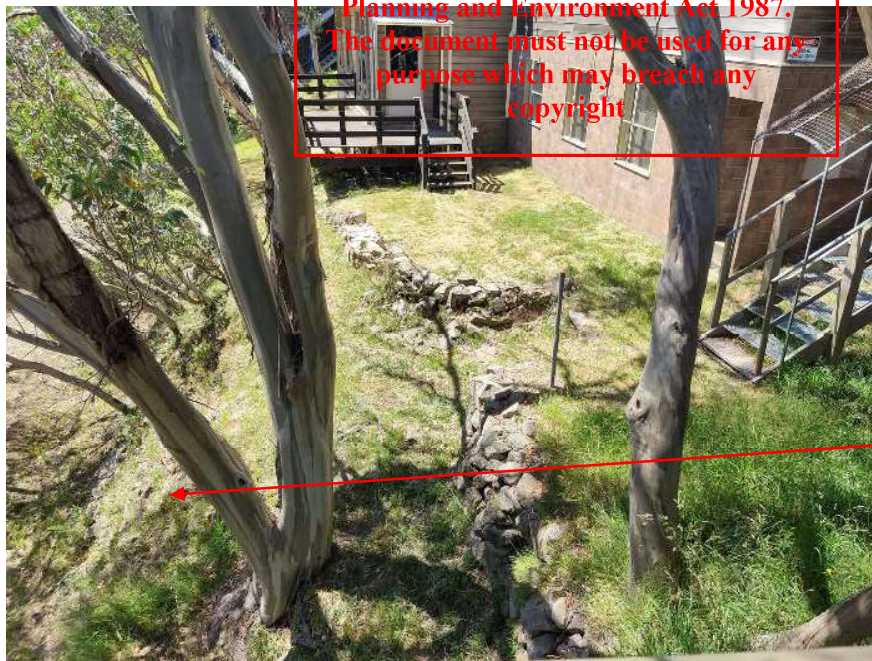
Fill batter approx. 1.55m high, rock reinforced.

Plate 2. Northern side of property looking east. Note leaning trees.

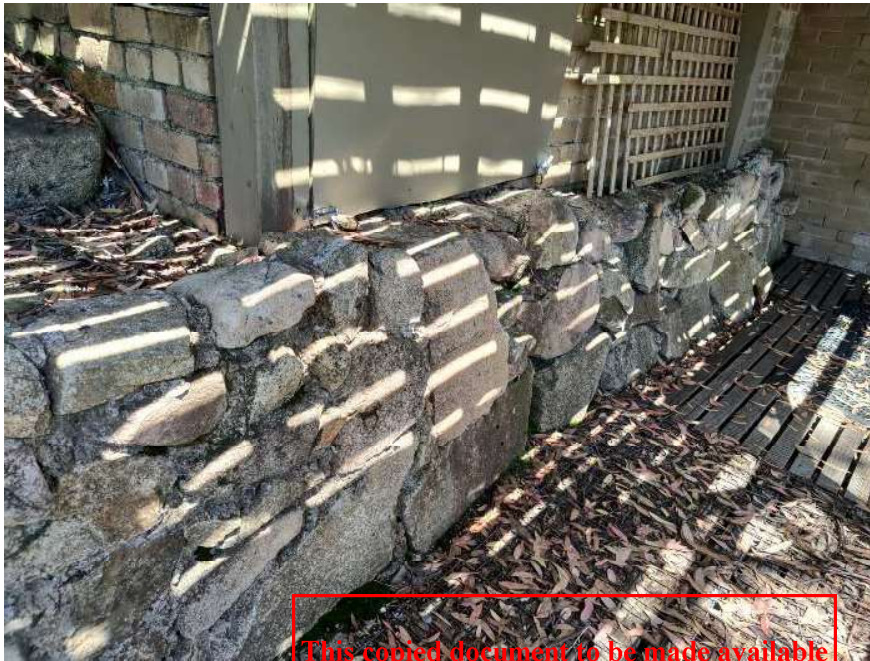
Plate 3. Eastern side at front of property looking west. Rock wall showing no evidence of distress.

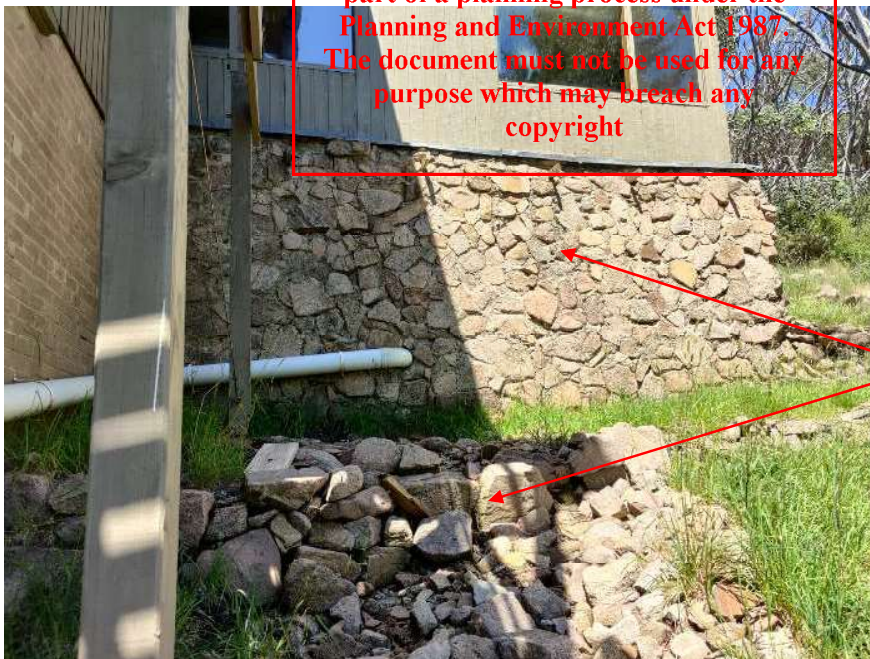
Plate 4. Northern side of property, eastern end looking south.

Rock facing under house and cut face. Facing showing no signs of distress.

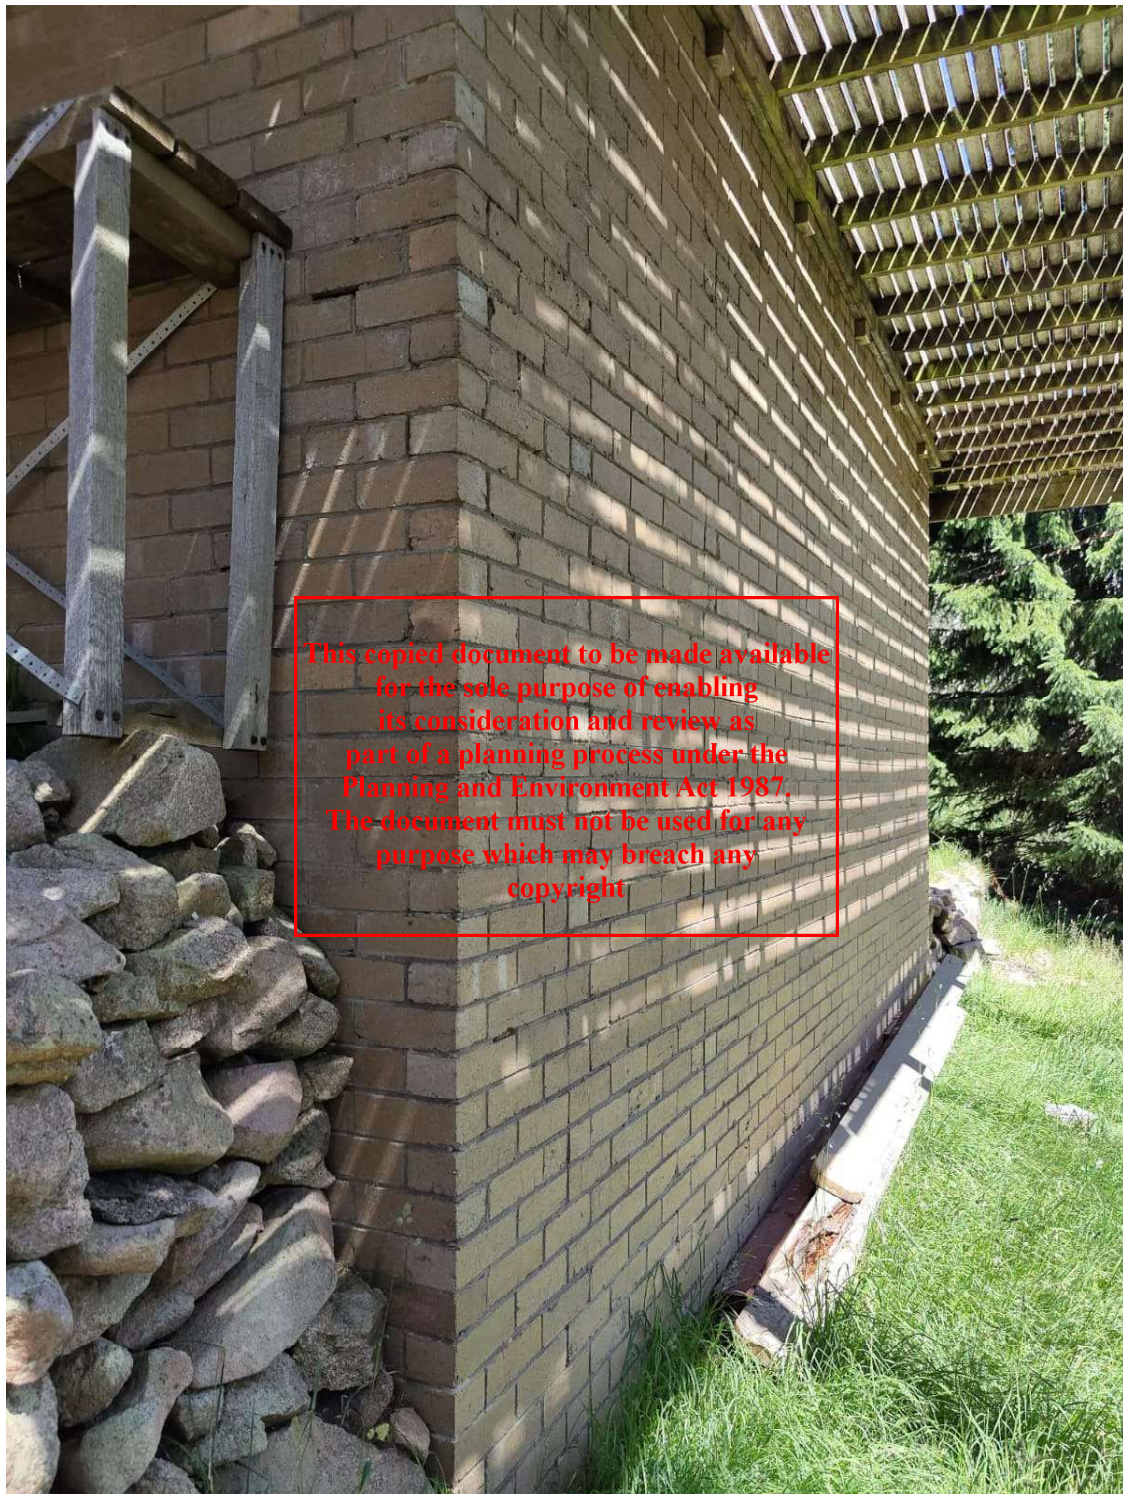
Plate 5. Northern side of property central area, looking southeast. Brick facing showing no signs of distress.

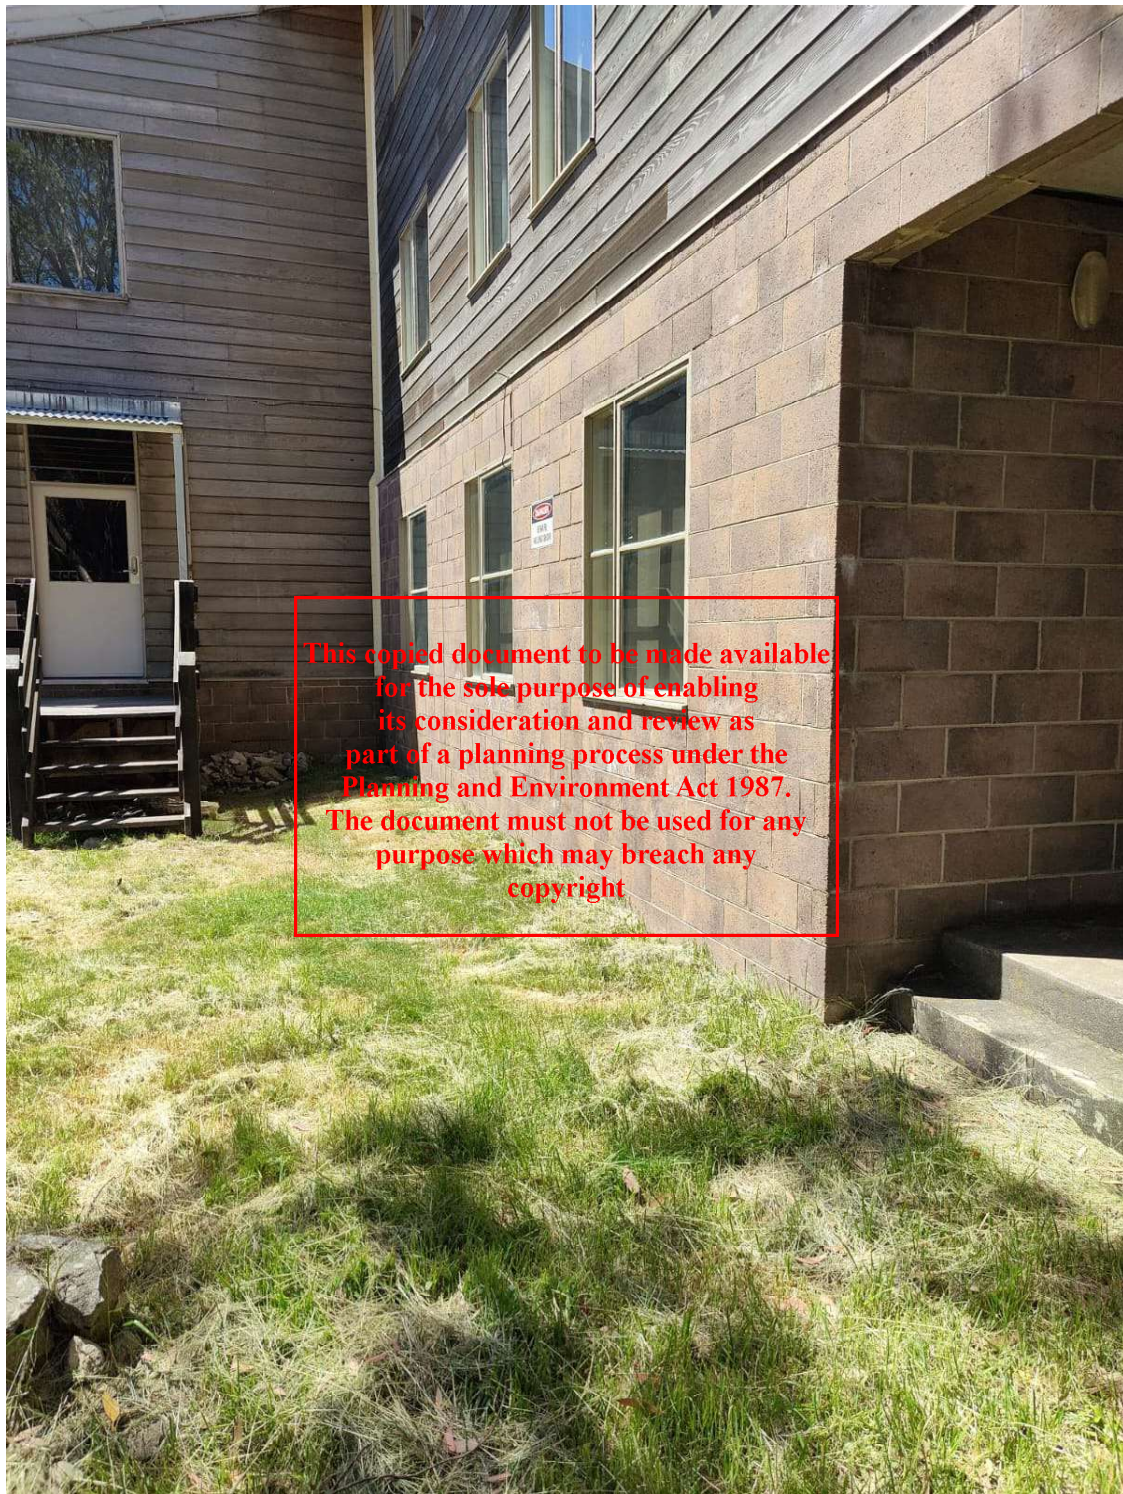
Plate 6. Western side of CSIR Lodge immediately east of Corio Lodge looking east. No evidence of distress in brick walls.

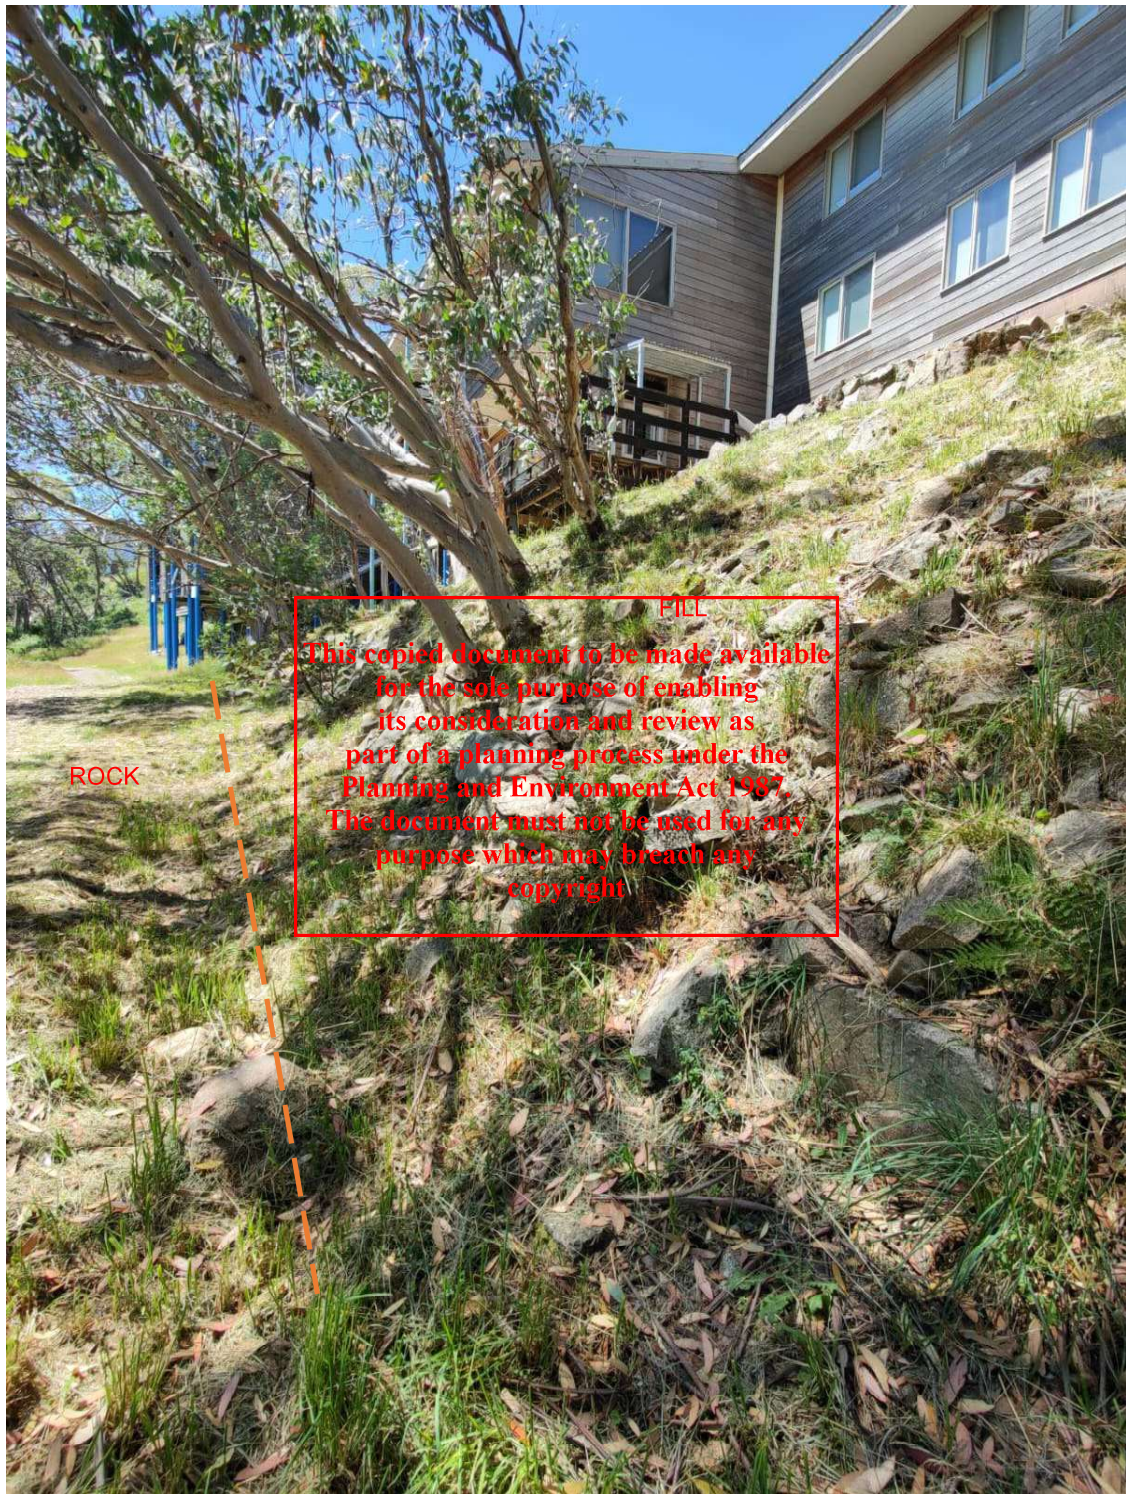
Plate 7. Northern side of property looking east with rock'/fill interface shown.

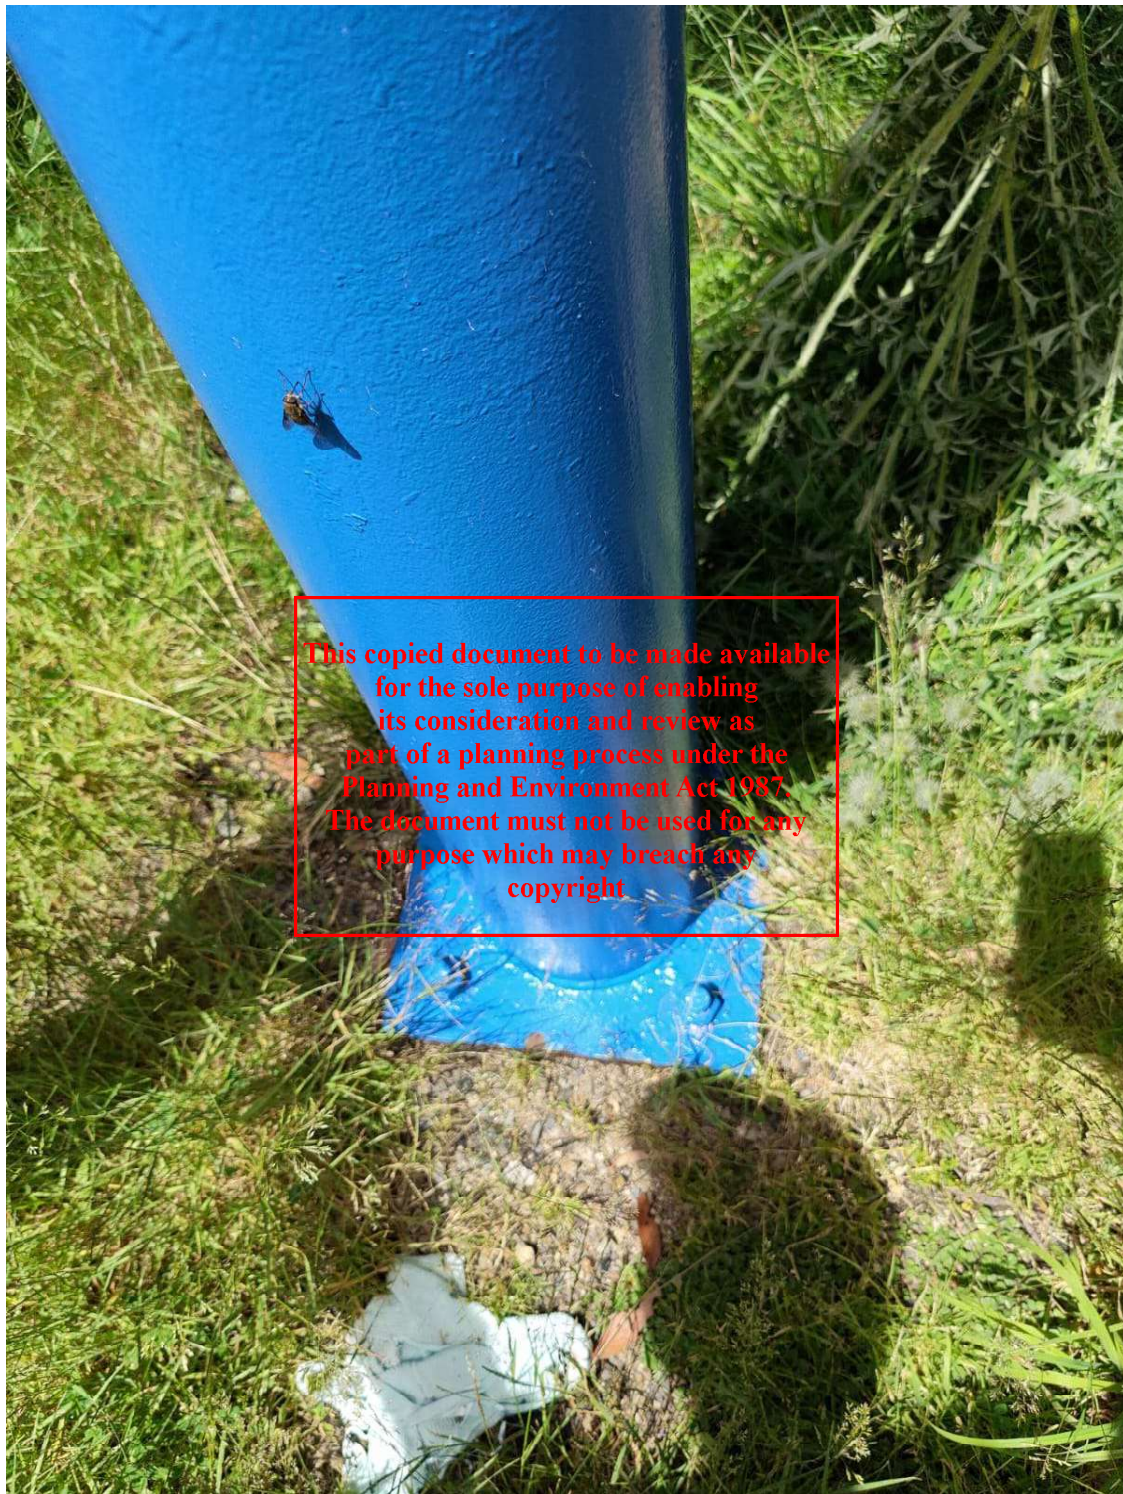
Plate 8. Balcony support on adjacent CSIR Lodge bolted into rock.
