Arboricultural Assessment and Report

North Richmond Masterplan

29 July 2021
Tree Logic Ref. 011189

Prepared for MGS Architects
Prepared by Manori Senanayake – Consultant,
Tree Logic Pty. Ltd.

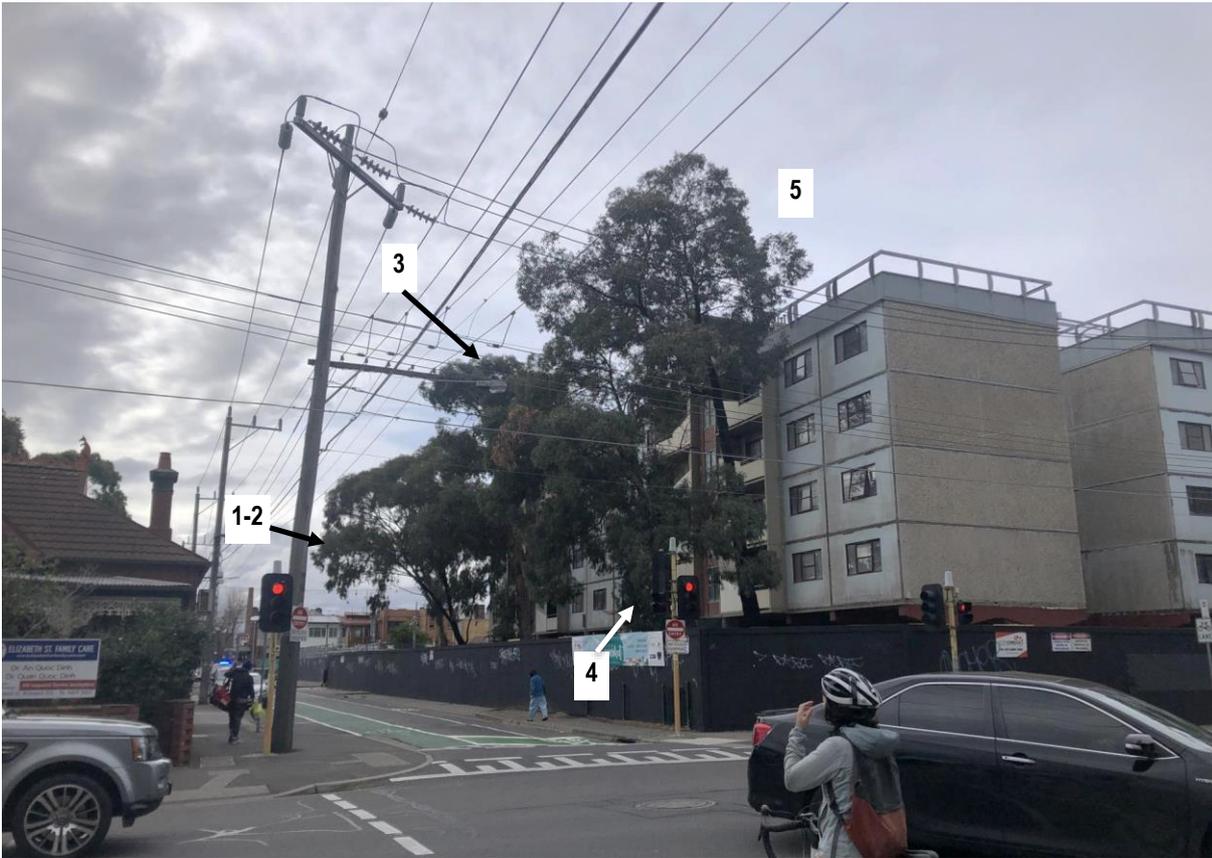
Separately, it was also noted that Trees 1-5, west of the housing block facing Lennox Street, had developed a westerly crown bias to varying degrees (Images 1-2). It would be reasonable to assume that the structure and pattern of response growth in these trees has developed in response to existing configurations, and that the demolition of the housing block will represent a sudden and acute change in wind load to these trees (particularly Trees 2, 3 and 5).

Image 1: Trees 1-5 (rear to front) along Lennox Street, looking north, showing varying degrees of crown bias away from buildings. These trees will experience an acute and significant change in wind loads after the buildings are demolished.

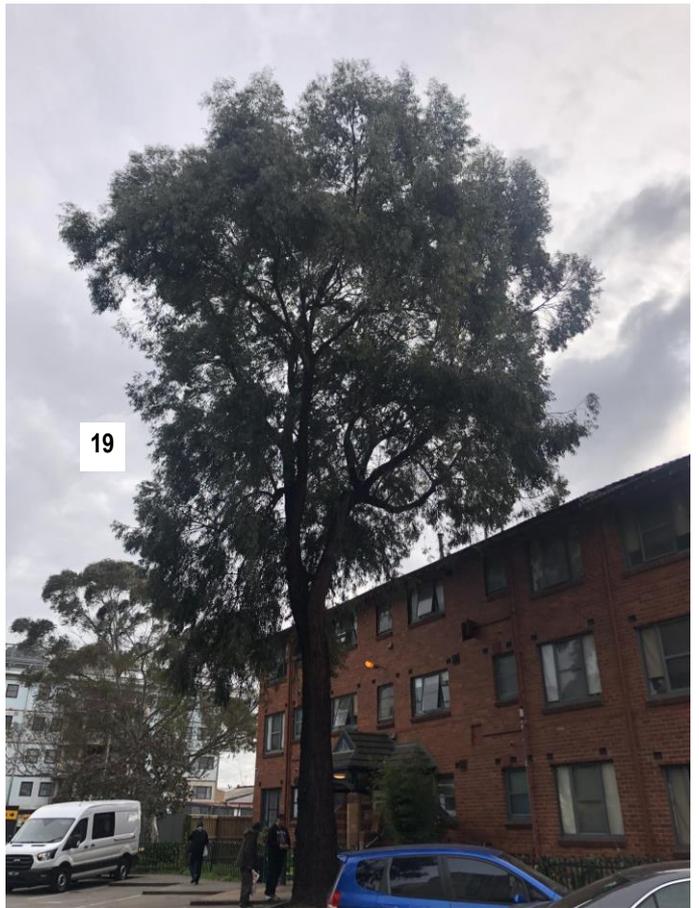
Image 5: Tree 19, Mod. A Red Ironbark south of Elizabeth Street flat, facing northeast. Tree is growing in relatively constrained space but no major infrastructure damage observed.

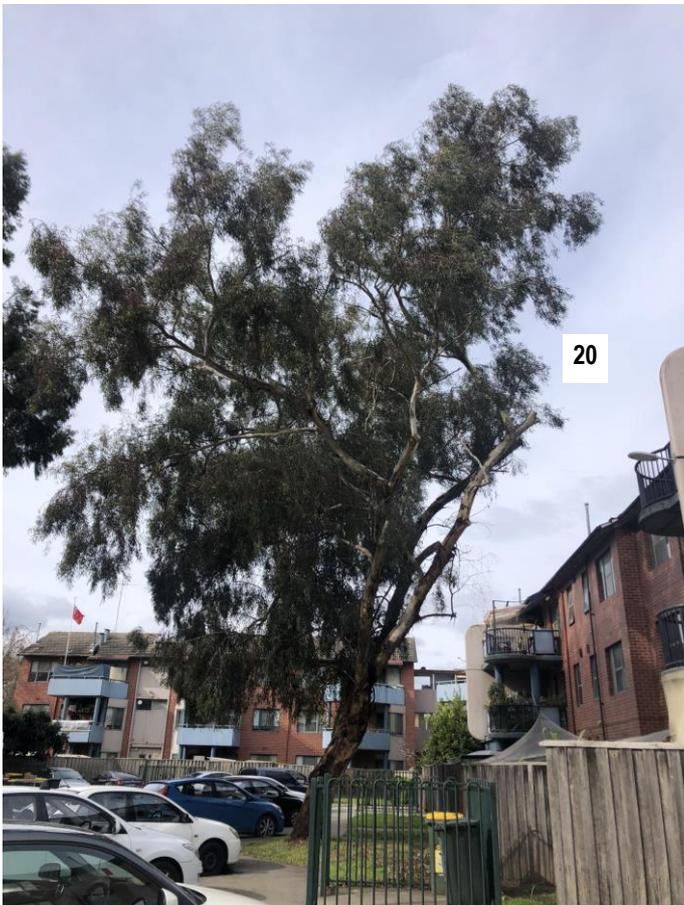
Image 6: Tree 20, Mod. B Yellow Box north of Elizabeth Street flat, facing east. Tree has been recently heavily pruned over flats, though still over-extended in east/west direction.

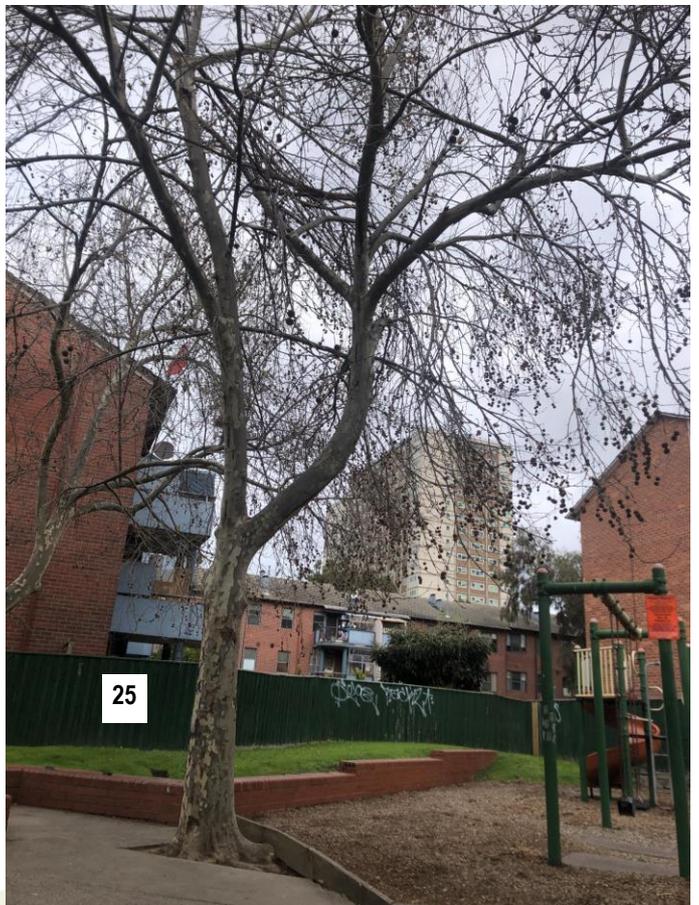
Image 7: Tree 25, Mod. C London Plane near Elizabeth St flats playground. Tree could be of higher amenity value but more growing space is desirable. Crown maintenance and some structural pruning recommended.

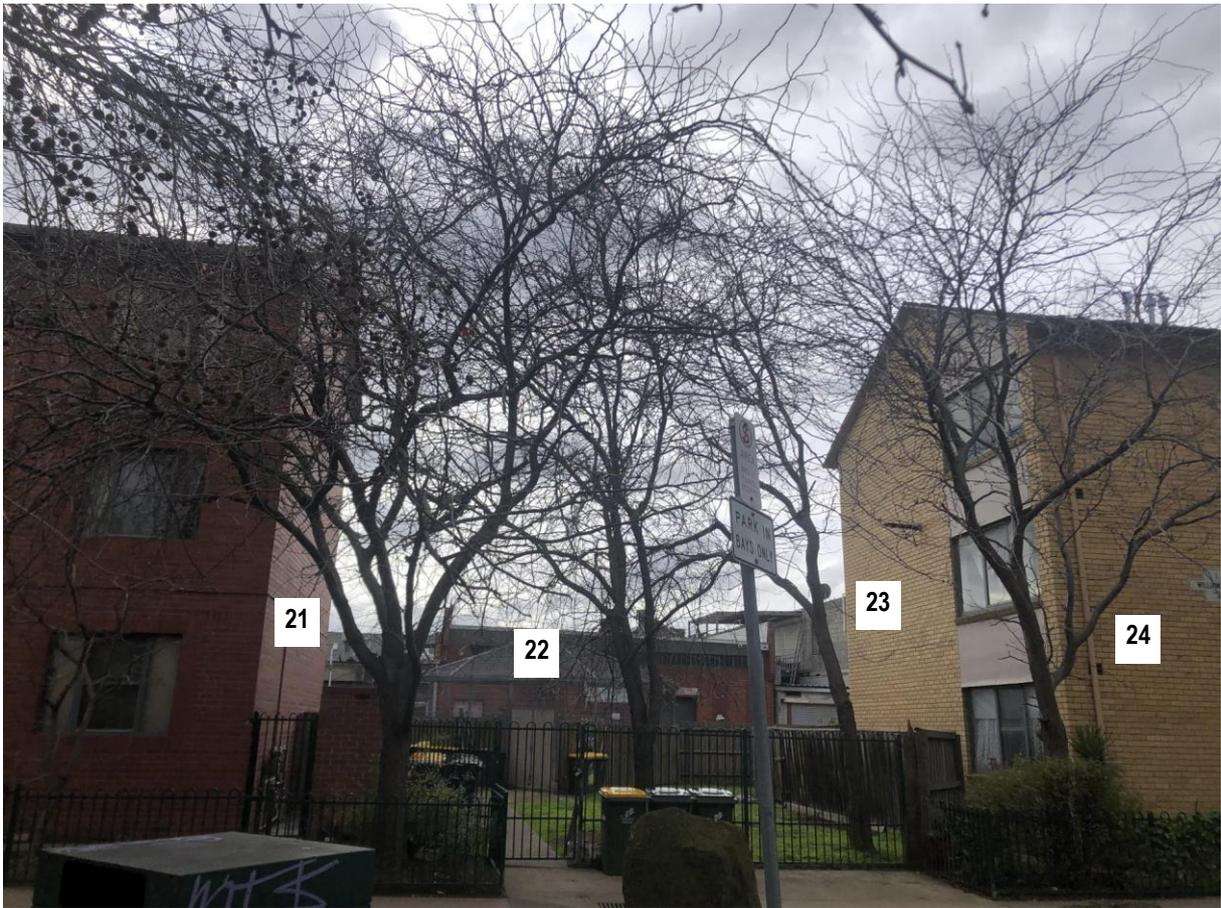
Image 8: Trees 21-24, Mod. B/C Honey Locust near Elizabeth Street flats, facing north. If retained, trees are strongly recommended to be retained as a group despite individual differences in ratings.

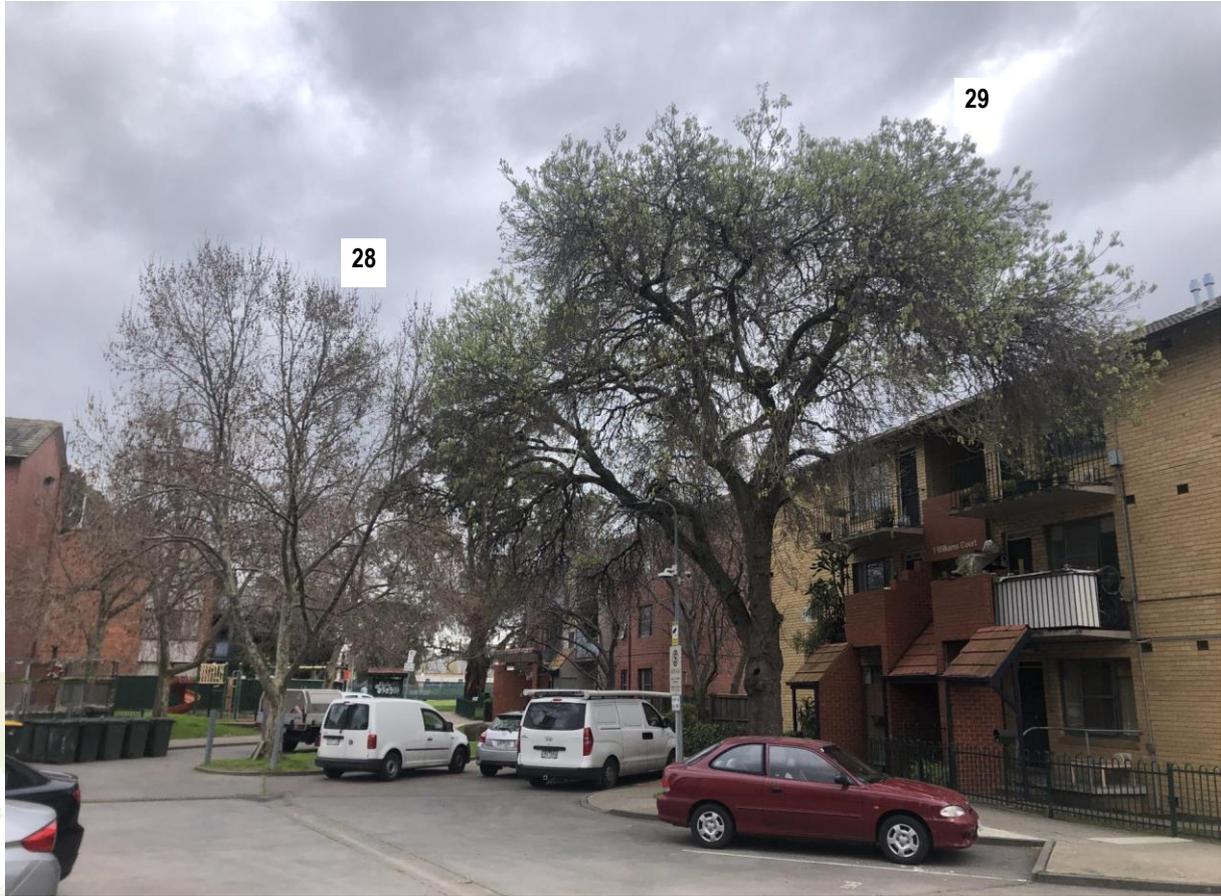
Image 9: Trees 28 (Mod. B London Plane) and 29 (Mod. A Desert Ash) near Elizabeth Street flats, facing west. Tree 29 growing in constrained area but with remarkably good size, form and fair foliage/bud density.

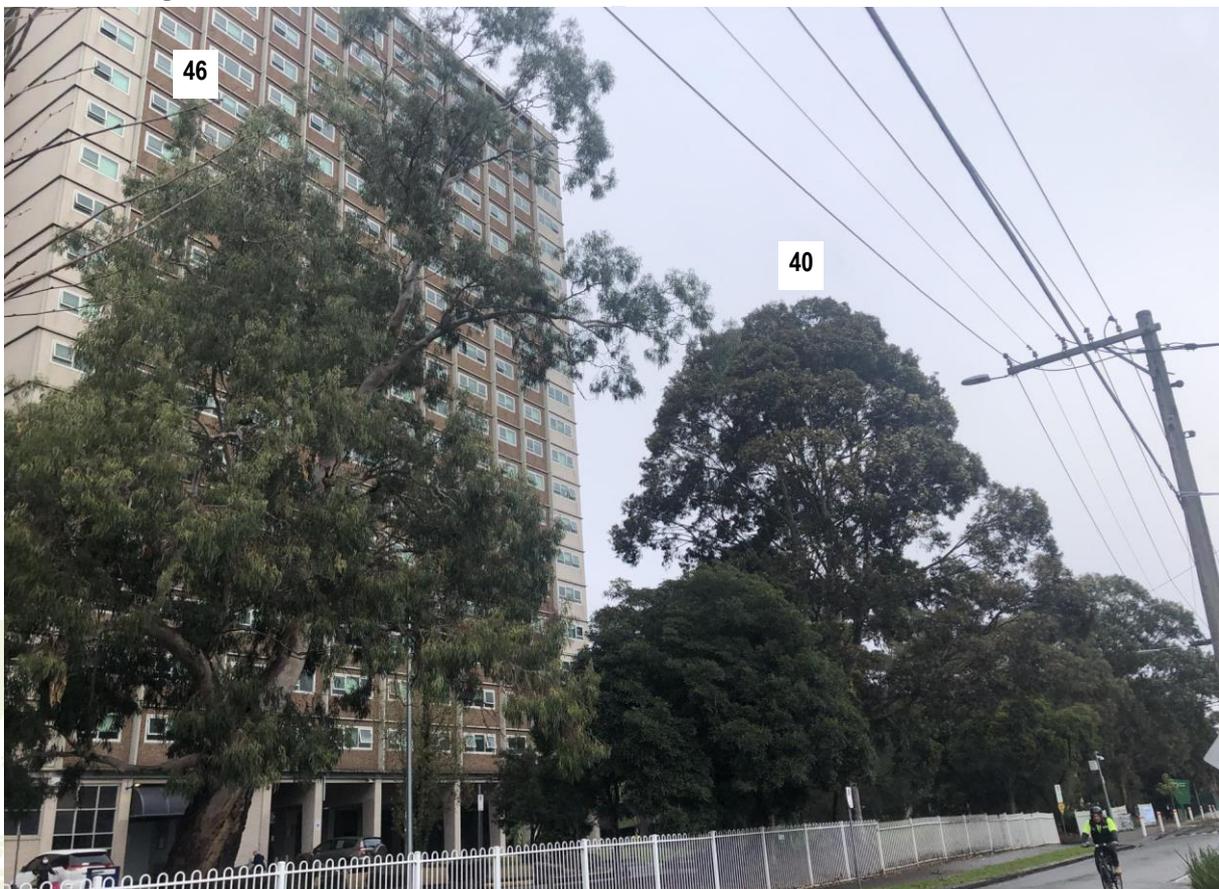
Image 12: Row of trees along Lennox Street frontage facing southeast, showing continuous visual canopy coverage, including Tree 46 (Mod.A Manna Gum) and Tree 40 (Mod.A Spotted Gum) as more prominent specimens.

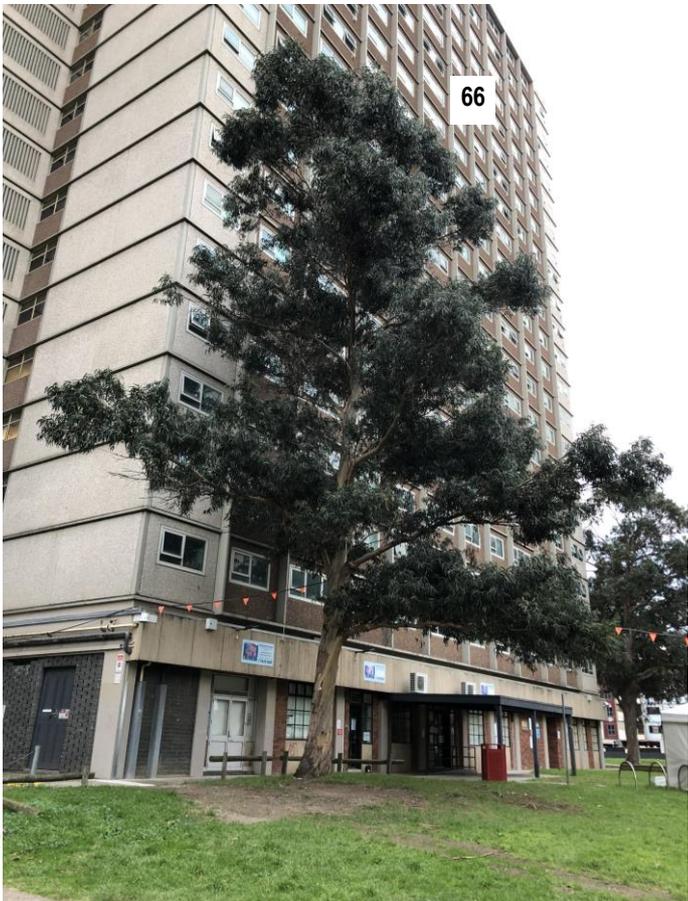
66

Image 15: Tree 66, Mod. B Southern Blue Gum adjacent to northwestern tower, facing north. No fungal brackets visually observed.

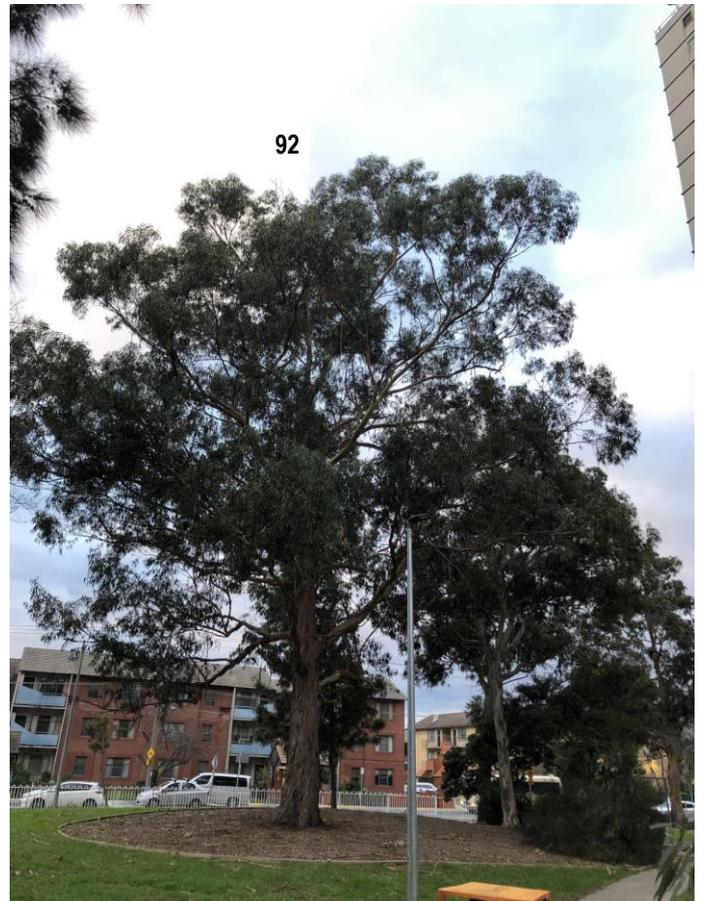
92

Image 16: Tree 92, one of two Mod. A Southern Blue Gums exhibiting above average condition although incipient fungal decay may not be ruled out. Facing north.

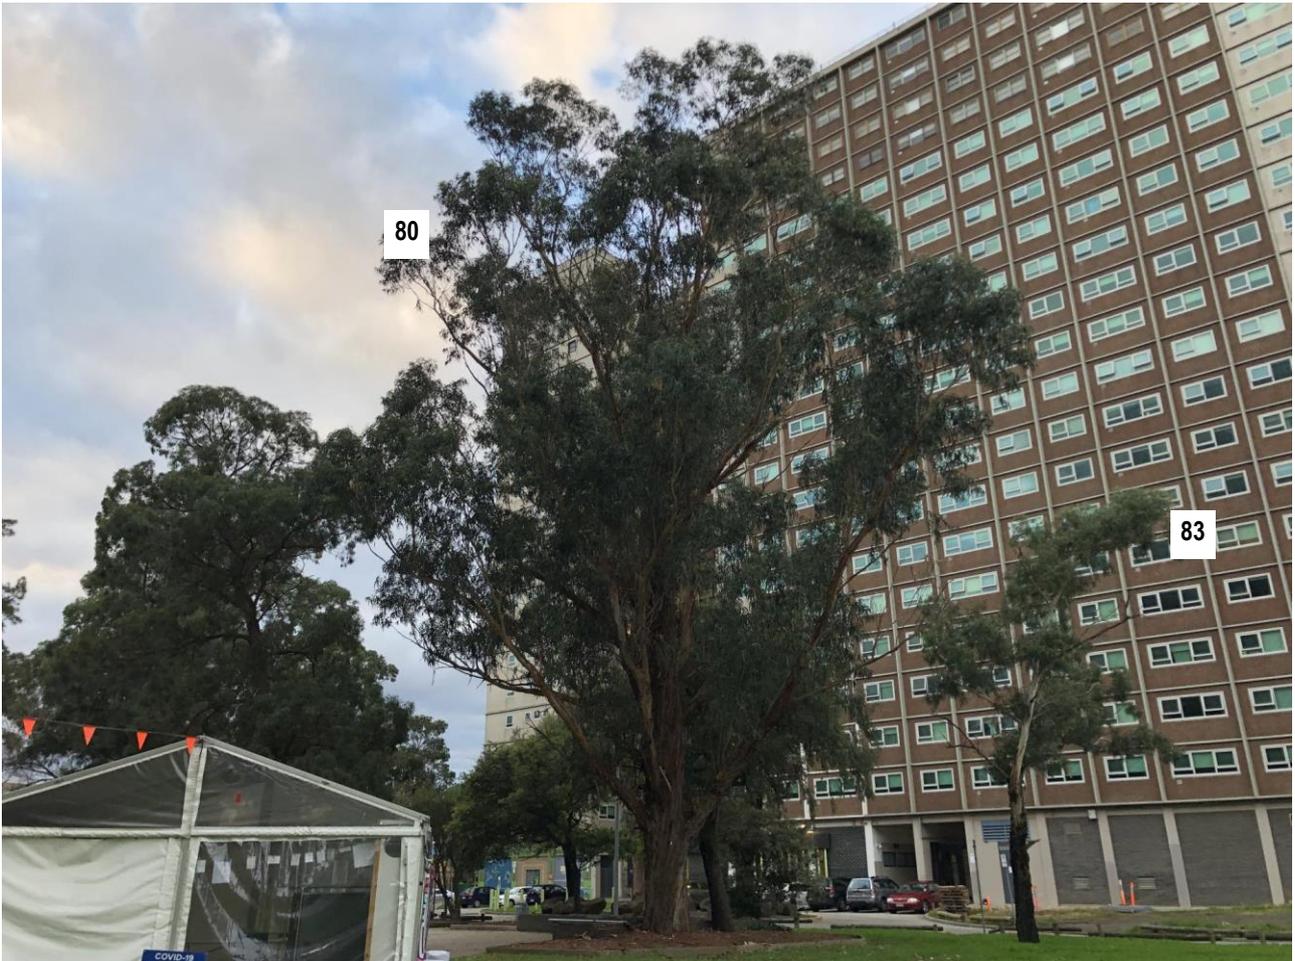
Image 17: Trees west of north-central tower including Trees 80 (Mod. B Southern Blue Gum, no fungal brackets visible) and Tree 83 (Mod.C Manna Gum), facing northeast.

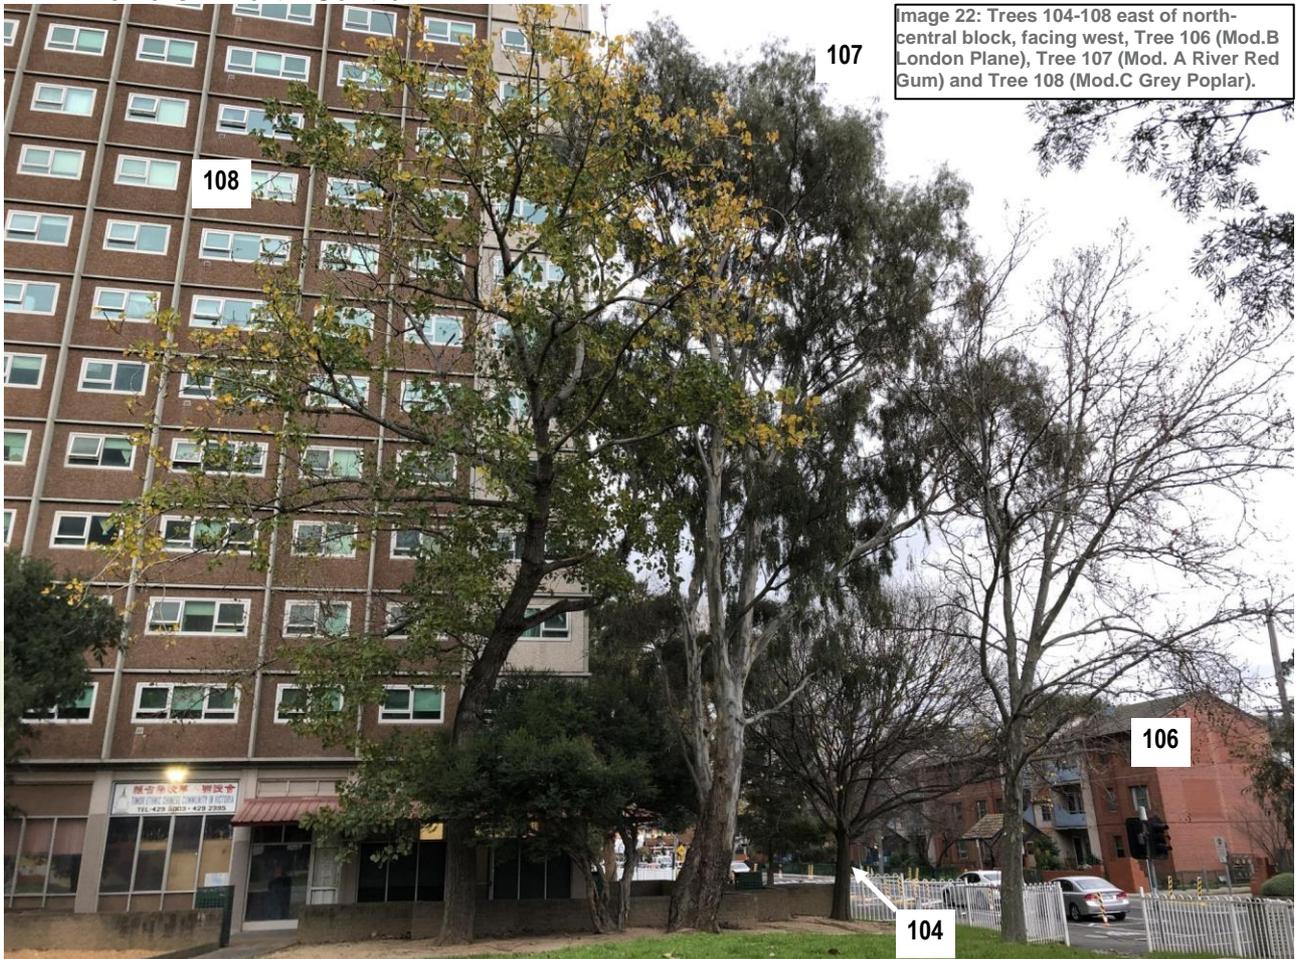
Image 22: Trees 104-108 east of north-central block, facing west, Tree 106 (Mod.B London Plane), Tree 107 (Mod. A River Red Gum) and Tree 108 (Mod.C Grey Poplar).

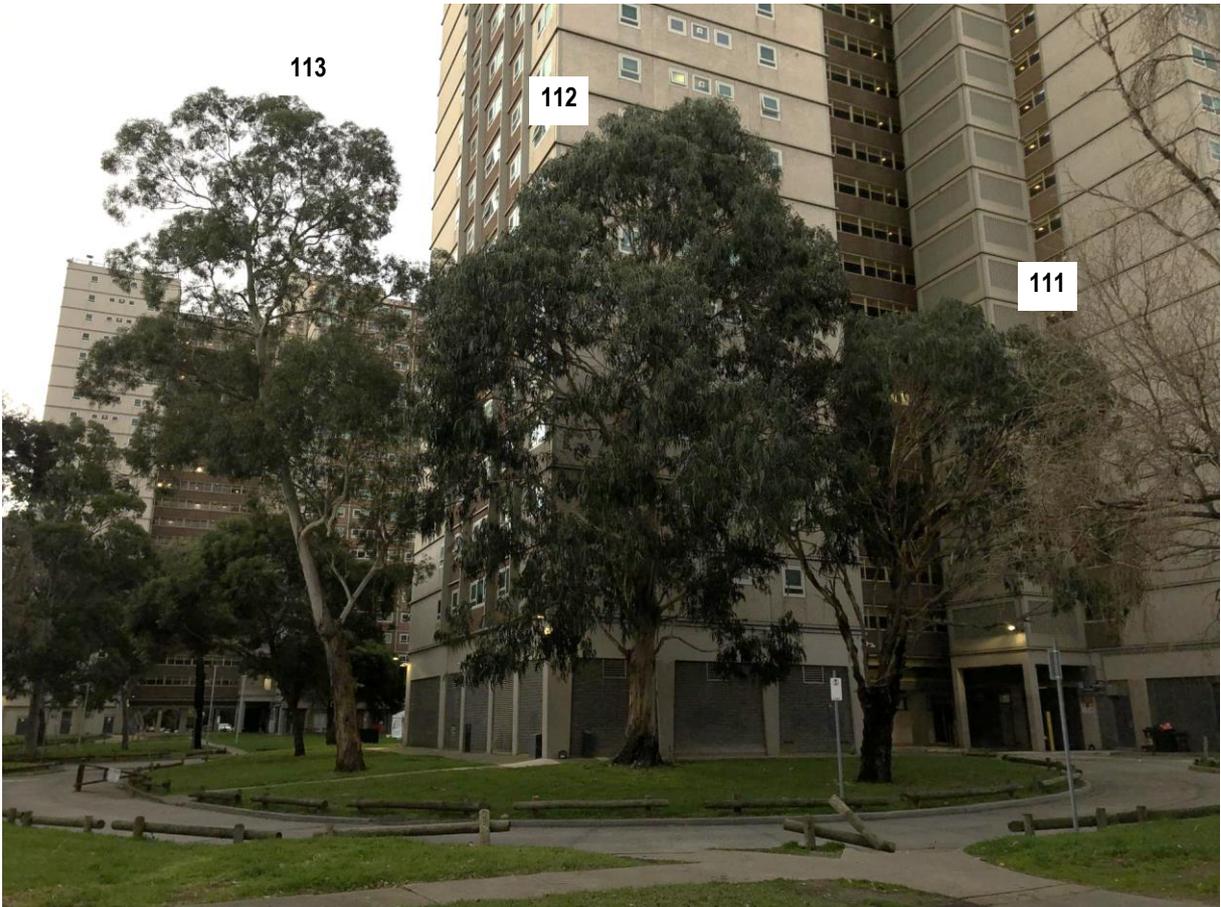
Image 23: Trees 111 (Low-rated Southern Blue Gum), 112 (Mod.B-rated Southern Blue Gum) and 113 (Mod.B-rated Manna Gum) southeast of north-central tower block. Facing west.

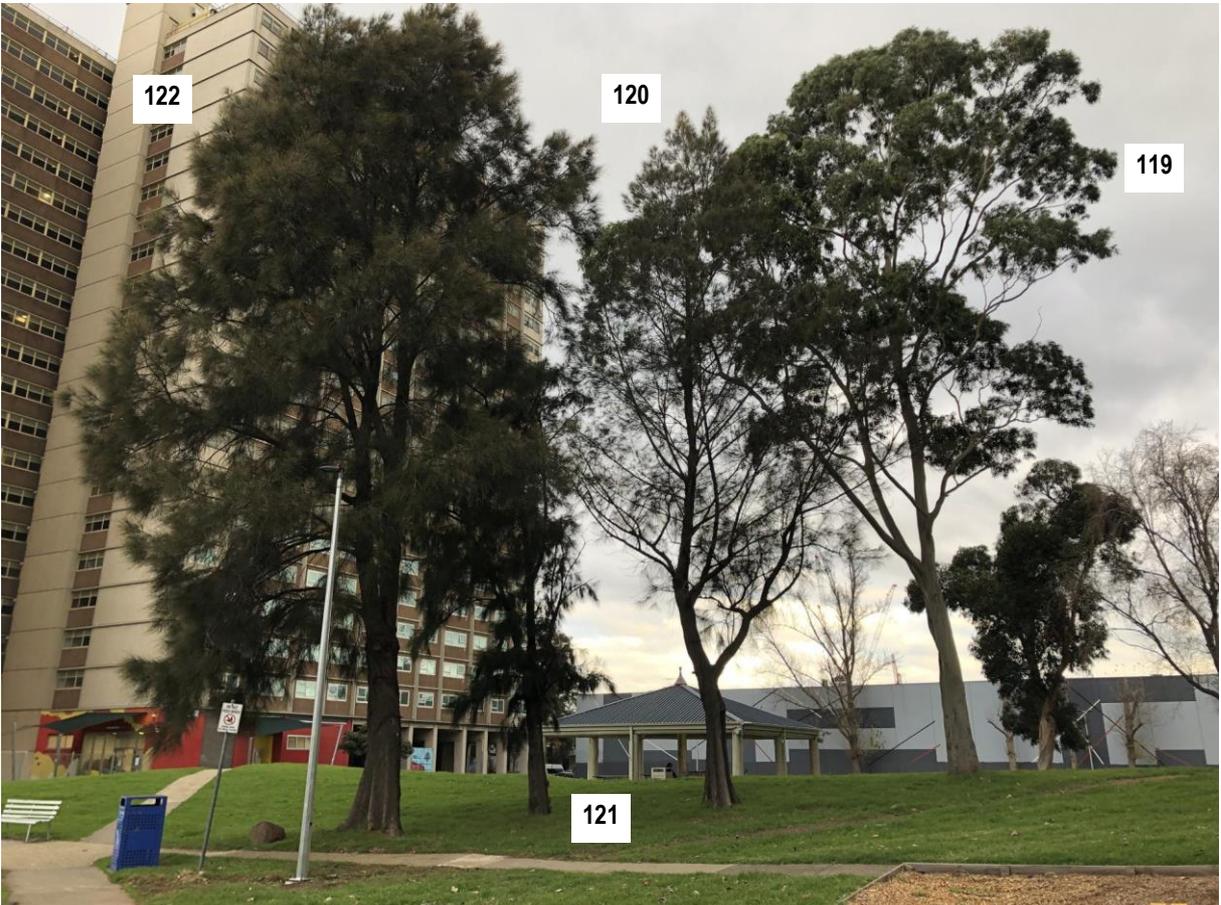
Image 24: Trees 119-122 in north-central open space, facing south. Including Trees 119 (Mod.B Spotted Gum) and 122 (Mod.A Swamp She-oak). Trees to rear of image are declining/lopped Grey Poplars north of multistorey carpark (257-260).

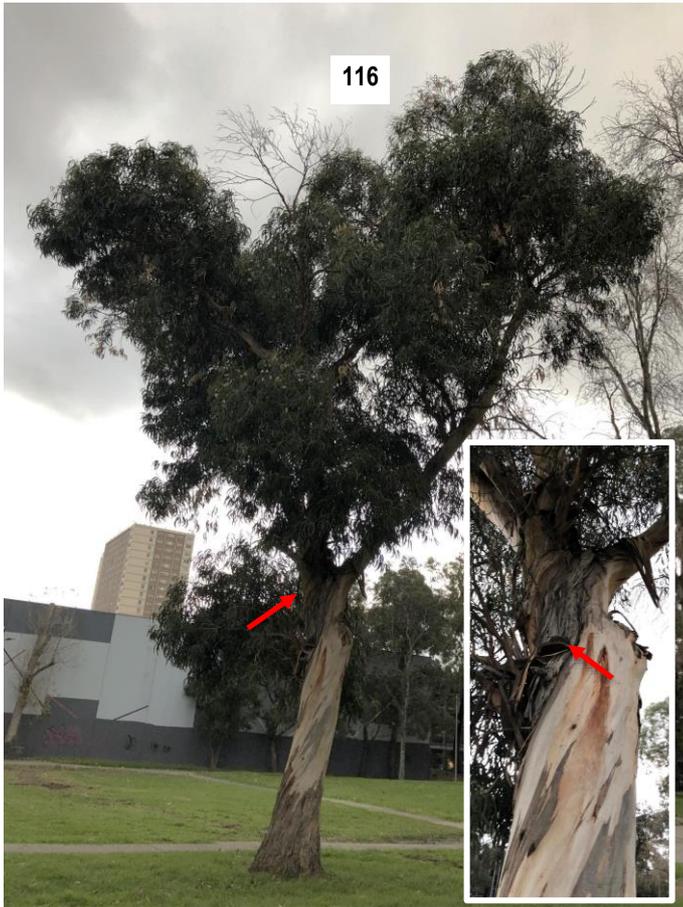
116

Image 25: Tree 116, Mod.C-rated Southern Blue Gum in north-central open space facing south, inset shows past decay and fungal brackets at old tearout site. Tree has dense but reduced canopy with tip dieback.

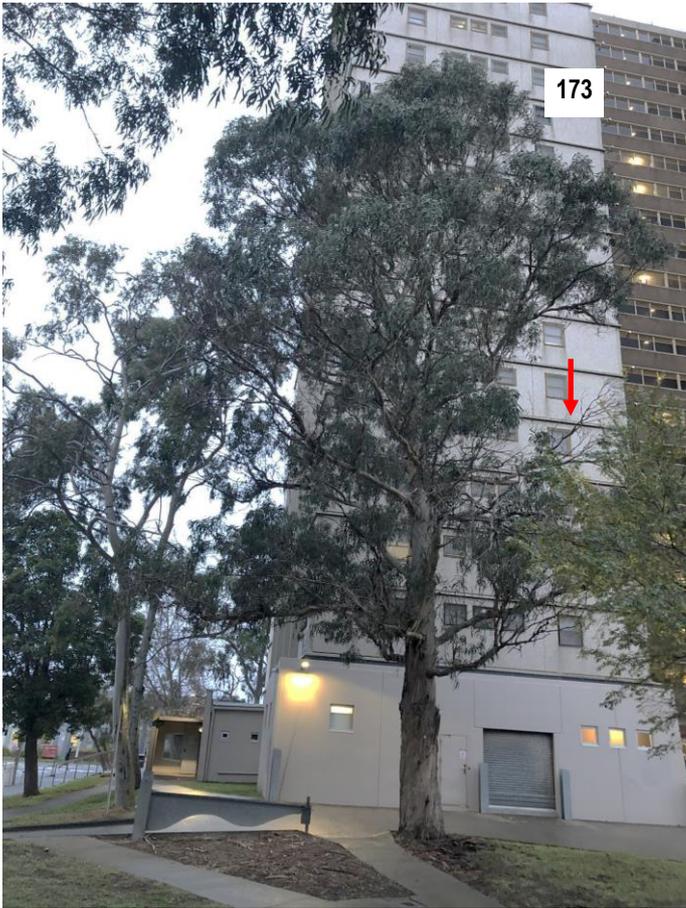
Image 35: Tree 173, Mod.C-rated Southern Blue Gum west of northeastern tower block, facing east. Dieback (red arrow) associated with fungal bracket and decay to south of trunk.

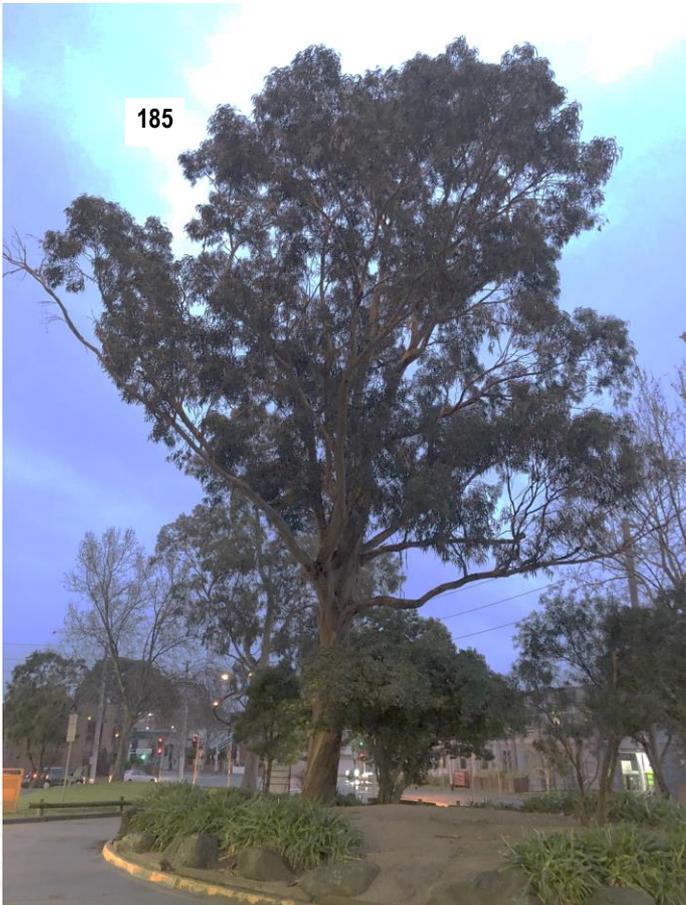
Image 37: Tree 185, Mod.C Southern Blue Gum with lower canopy deadwood and past reduction pruning; decay considered likely

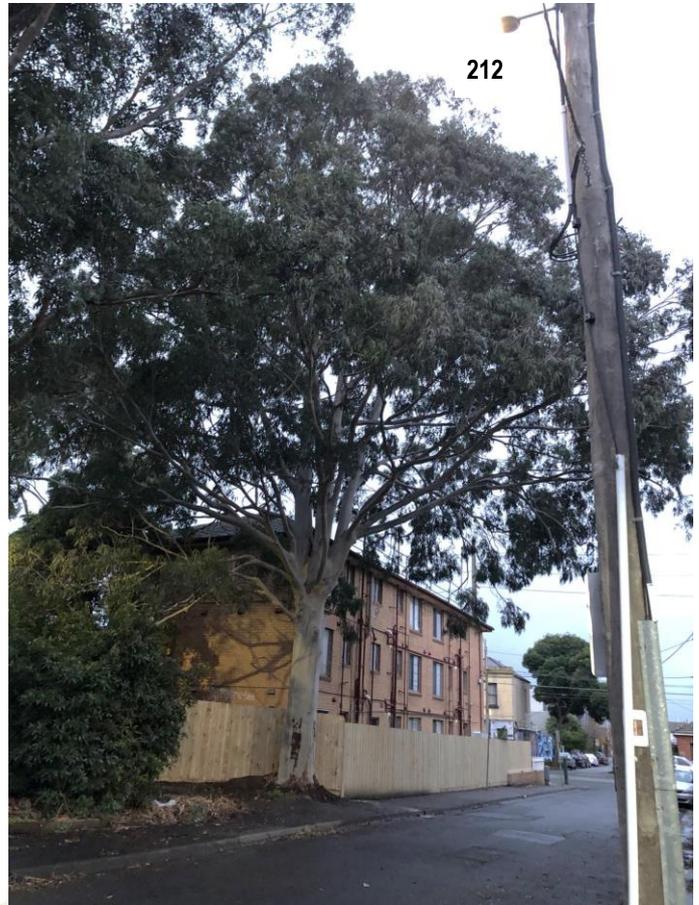
Image 38: Tree 212, High-rated Sydney Blue Gum – in highly constrained area but marked contribution to landscape with some pavement heaving but no significant/dangerous visible infrastructure damage.

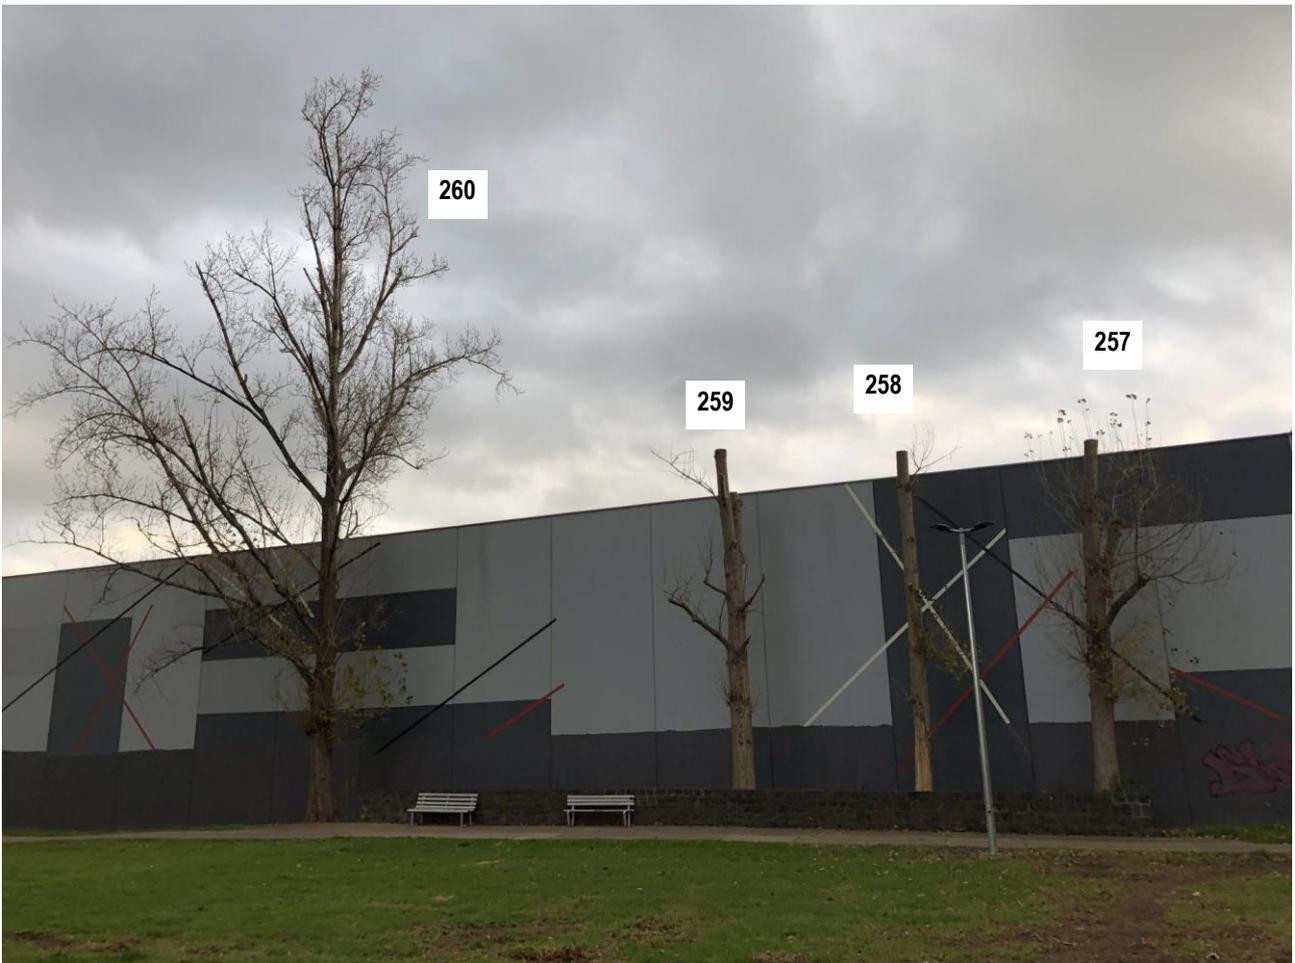
Image 42: Trees 257-260, lopped and declining Grey Poplars north of central carpark/building. It is assumed that Trees 257-259 are to be eventually removed due to ongoing branch failures which is not uncommon in the species.

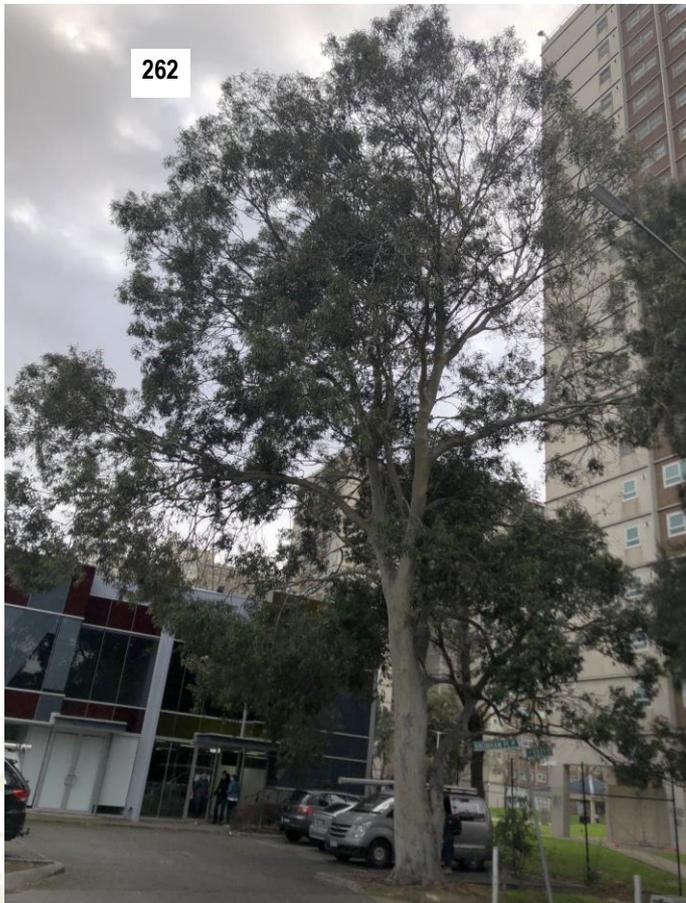
Image 43: Tree 262, Mod.B Spotted Gum in narrow space adjacent to or within neighbouring property cnr Bromham Place/Risley Street, facing west

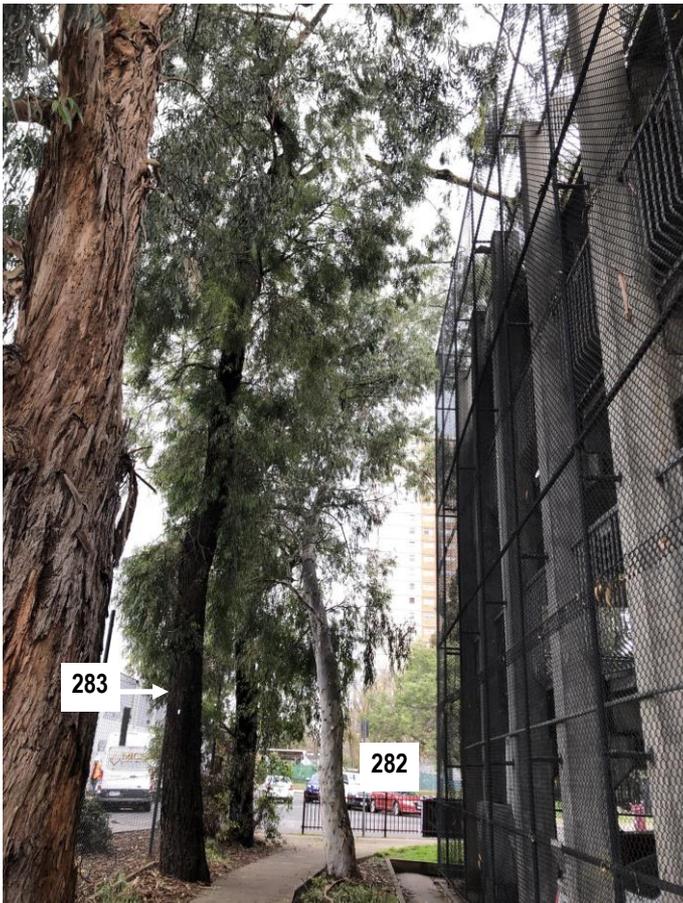
Image 51: Trees southeast of western multistorey carpark in narrow site – Tree 283 (Mod. C Red Ironbark) with recent failures. Facing south.

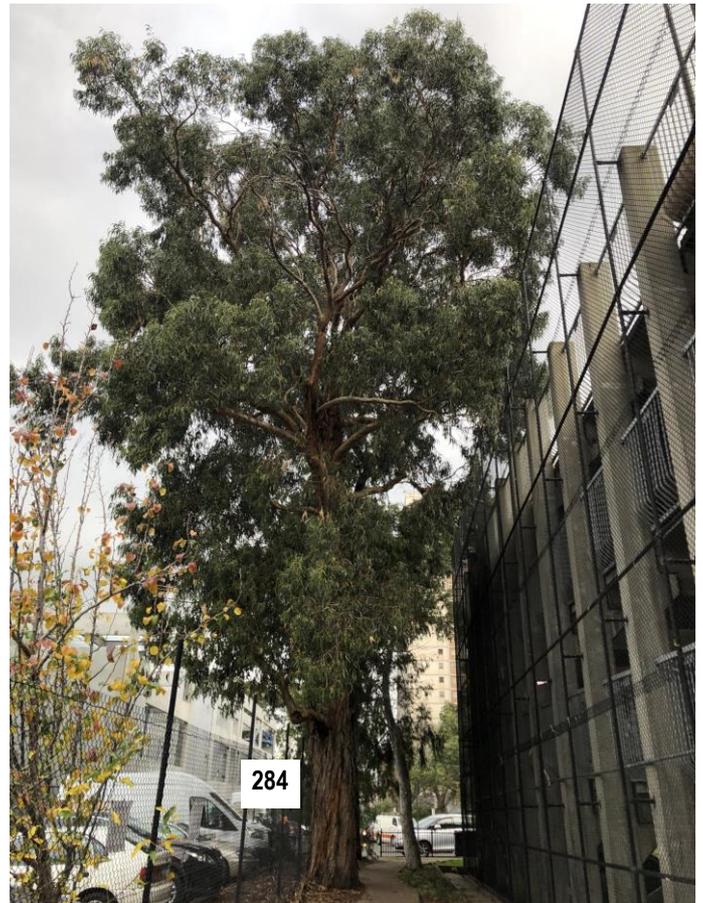
Image 52: Tree 284, Mod. B Southern Blue Gum southeast of western multistorey carpark, facing south. Remarkable condition despite constraints.

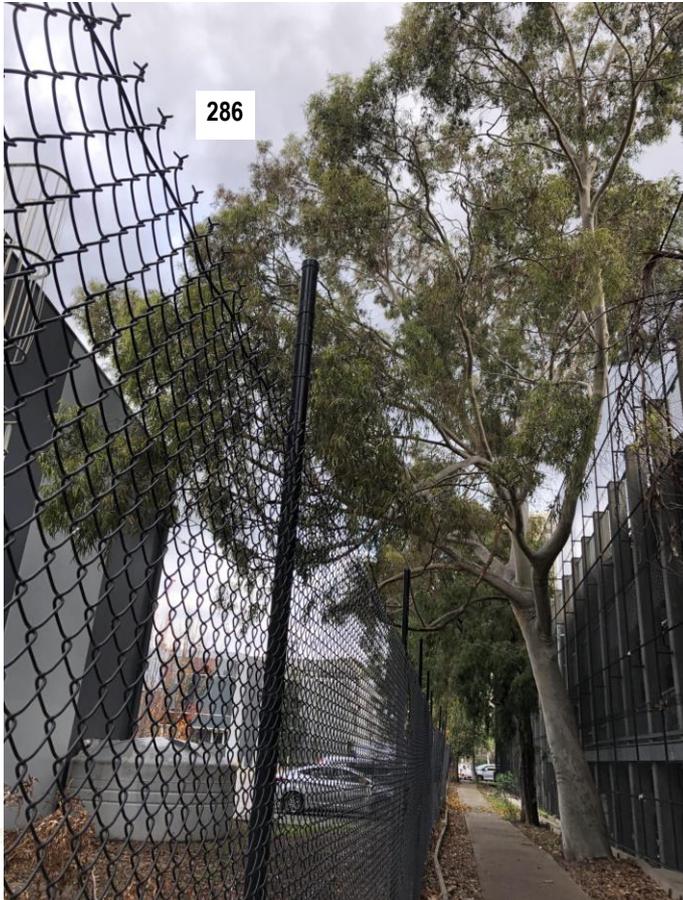
Image 53: Tree 286, Mod. B Lemon-scented Gum northeast of western multistorey carpark, with limbs extending into neighbouring property. Facing south.

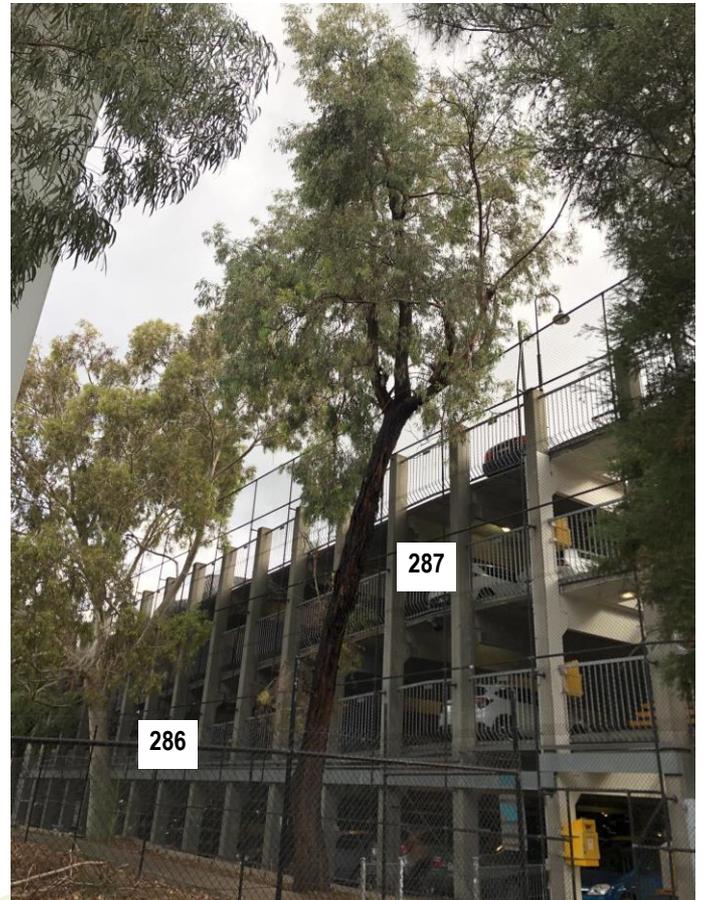
Image 54: Tree 287, Mod.C Red Ironbark northeast of western multistorey carpark, top-heavy form with previous failures. Facing southwest.

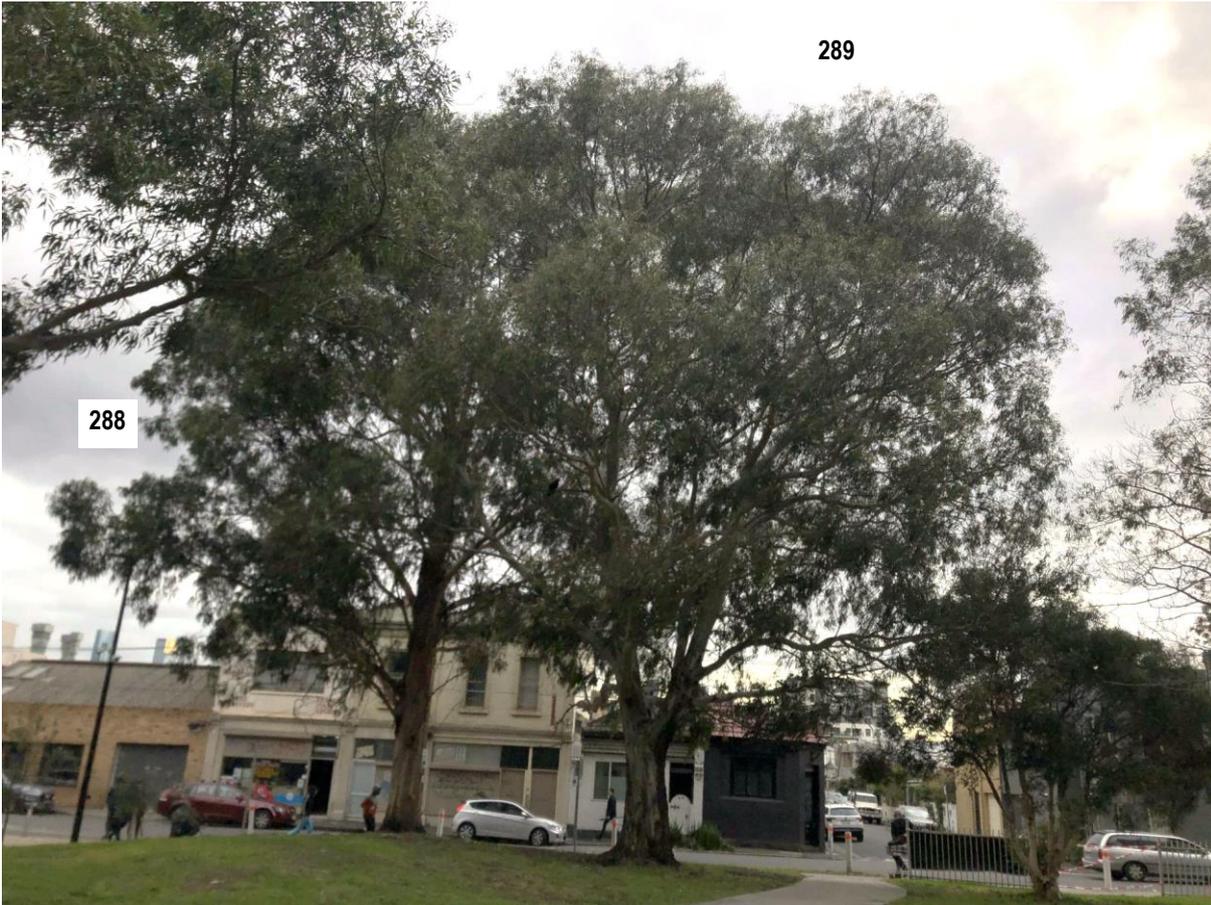
Image 55: Trees 288 (Mod. A Southern Blue Gum) and 289 (High-rated River Red Gum) northwest of Health Centre along Lennox St frontage. Facing west. Trees are well located, in superior condition and highly significant in landscape.

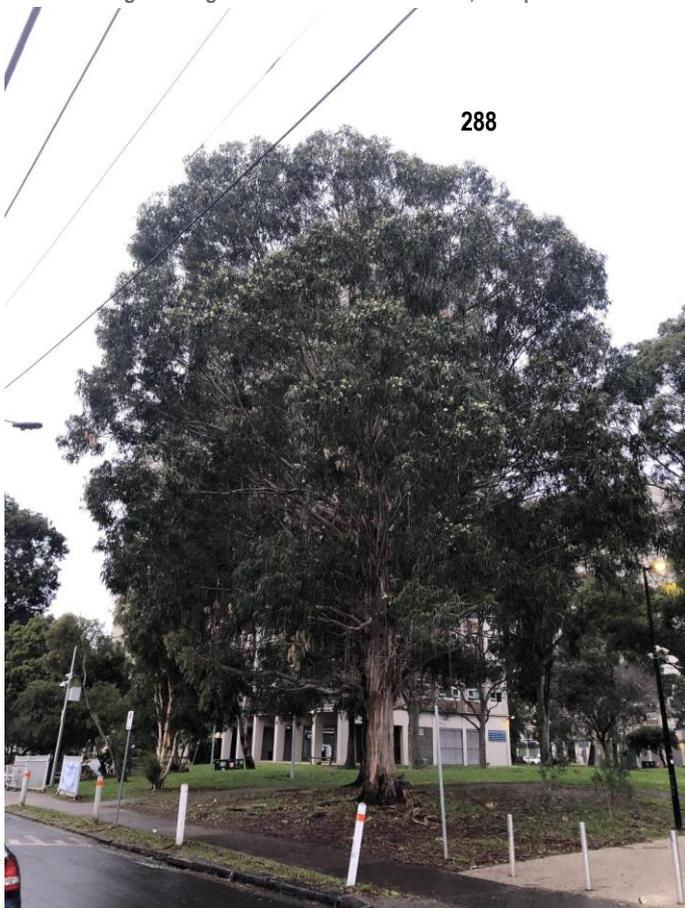
Image 56: Tree 288, one of two Mod.A rated Southern Blue Gums. Facing northeast. Superior canopy density and form, no fungal brackets observed.
