Arboricultural Assessment and Report

North Richmond Masterplan

29 July 2021
Tree Logic Ref. 011189

Prepared for MGS Architects
Prepared by Manori Senanayake – Consultant,
Tree Logic Pty. Ltd.

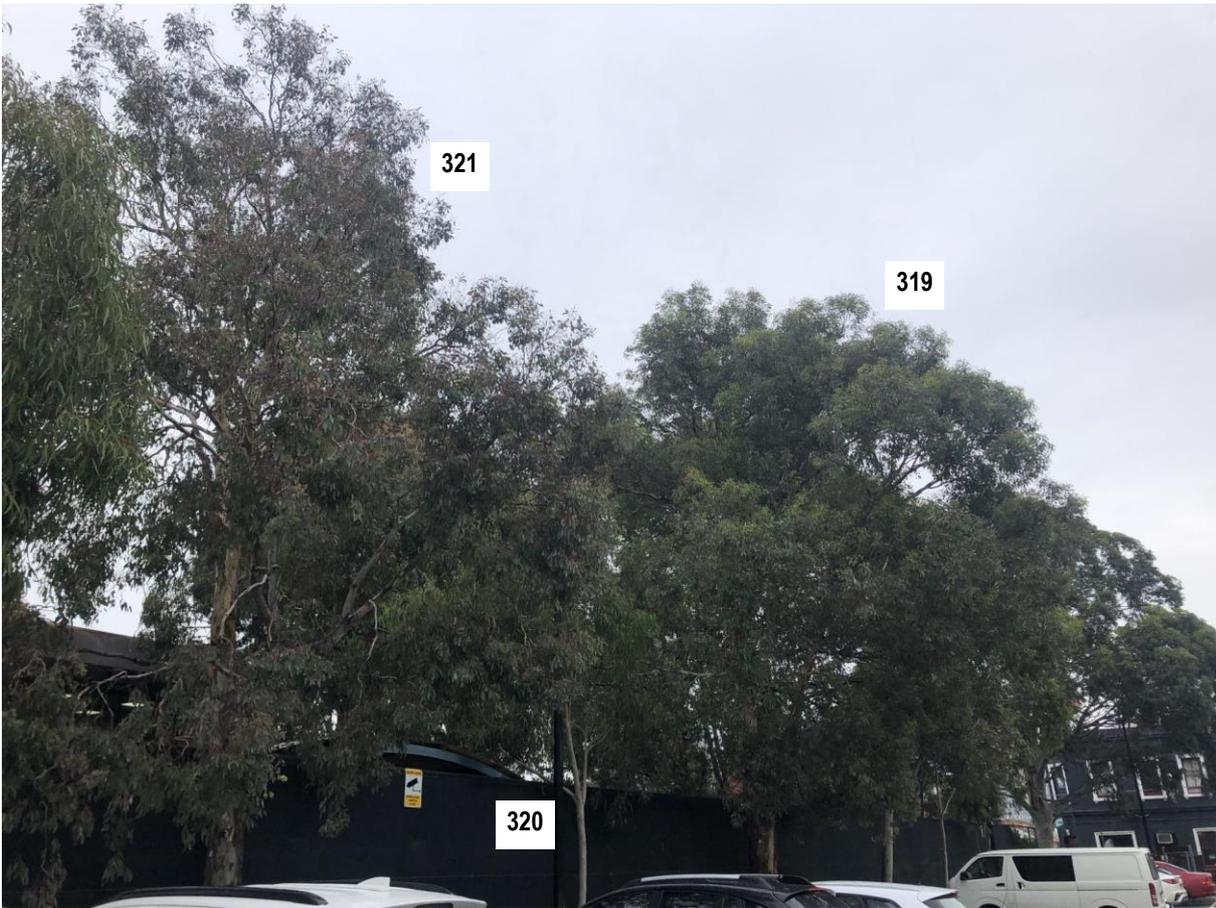
Image 61: Row of trees on southern edge of Health Centre carpark, along northern boundary of primary school facing southwest. Including Tree 319 (Mod. B Red Box) and 321 (Mod.C Red Box). Lemon-scented Gums interplanted (e.g. Tree 320) generally less vigorous.

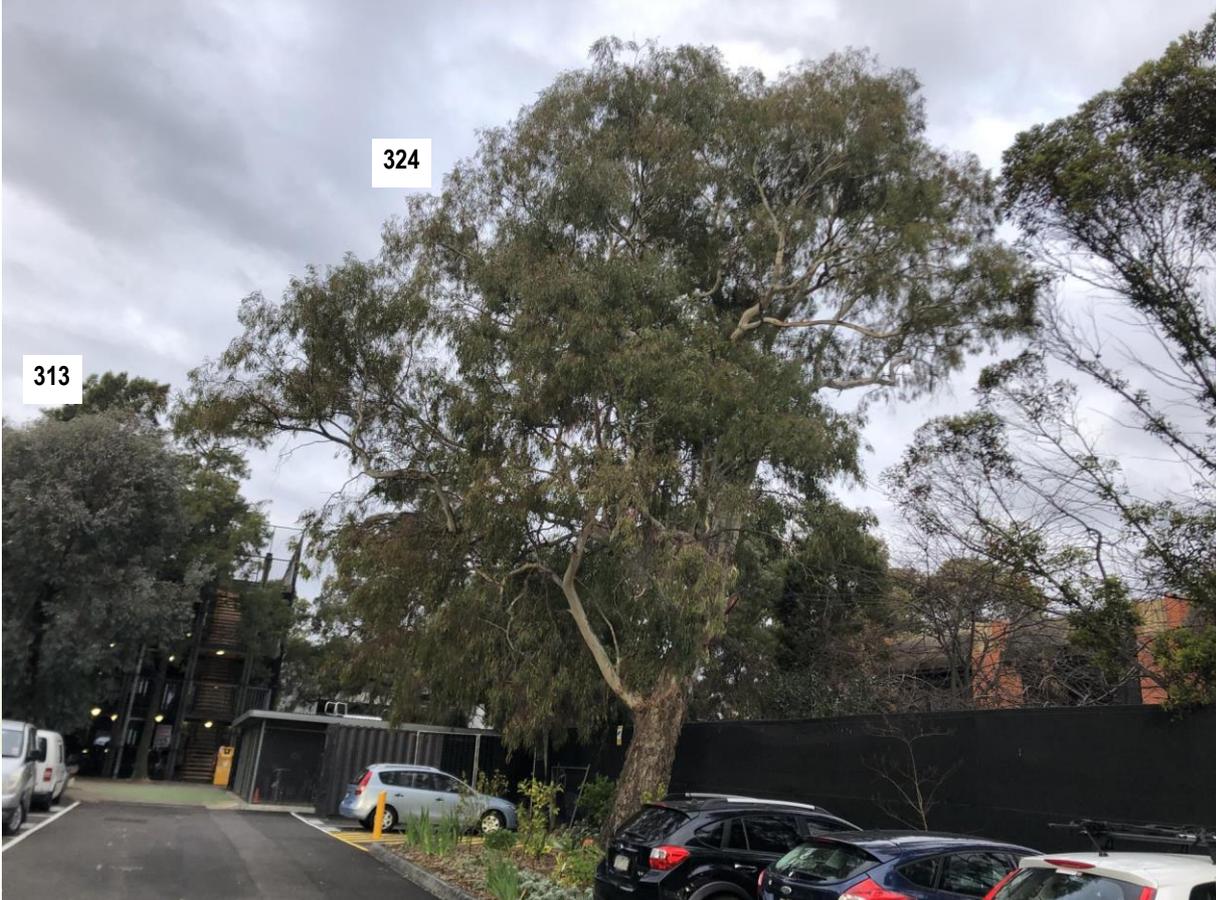
Image 62: Tree 324 (Mod. A River Red Gum), in larger planting area along southern edge of Health Centre carpark, adjacent to northern boundary of primary school. Tree recently showing signs of lerp/sooty mould but likely seasonal. Facing east.

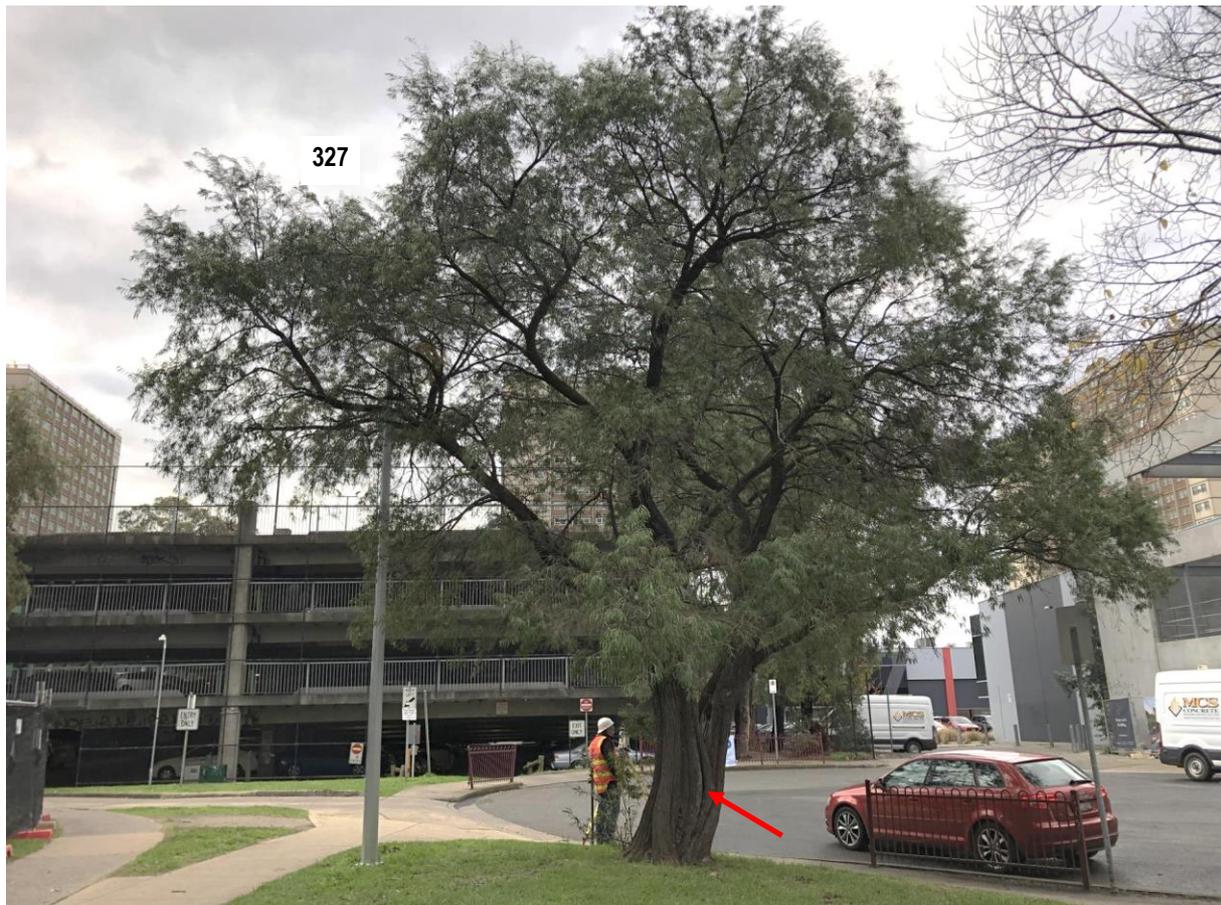
Image 63: Tree 327, Mod. C-rated Willow Myrtle northeast of school adjacent to Vere Street. Facing north. Canopy in fair condition with moderate amenity value however main stem has old, slowly progressing split. Cabling or bracing recommended to mitigate failure.

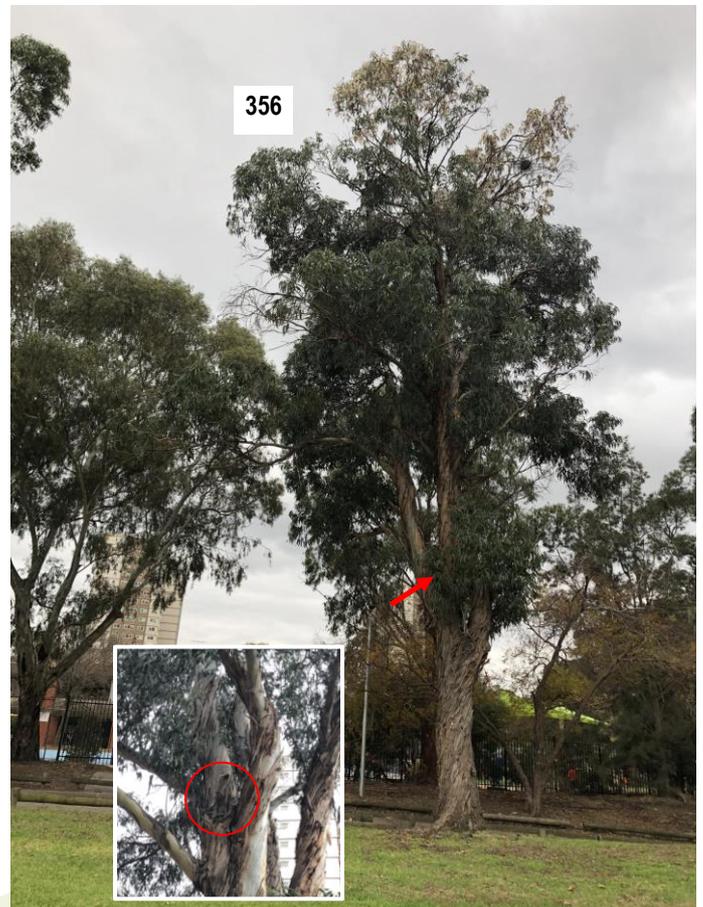
Image 70: Tree 356, Southern Blue Gum south of driveway along southern boundary of primary school, crown reduced over road with apical dieback showing progression of fungal decay (brackets inset) in the species.

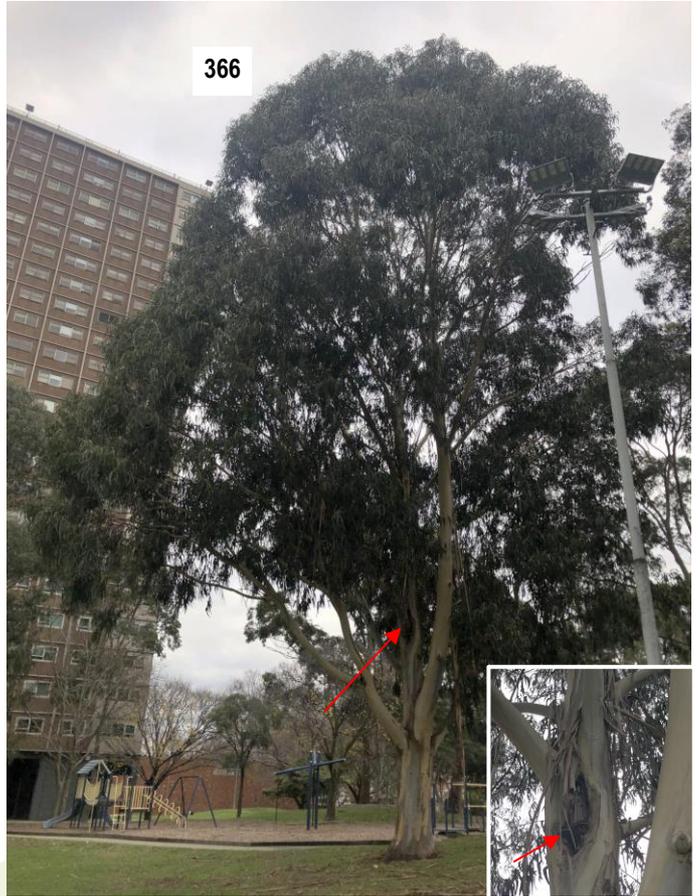
Image 74: Tree 366, Mod. B Southern Blue Gum in southern open space, facing west. Fungal bracket observed; risk should be managed to preserve amenity while possible.

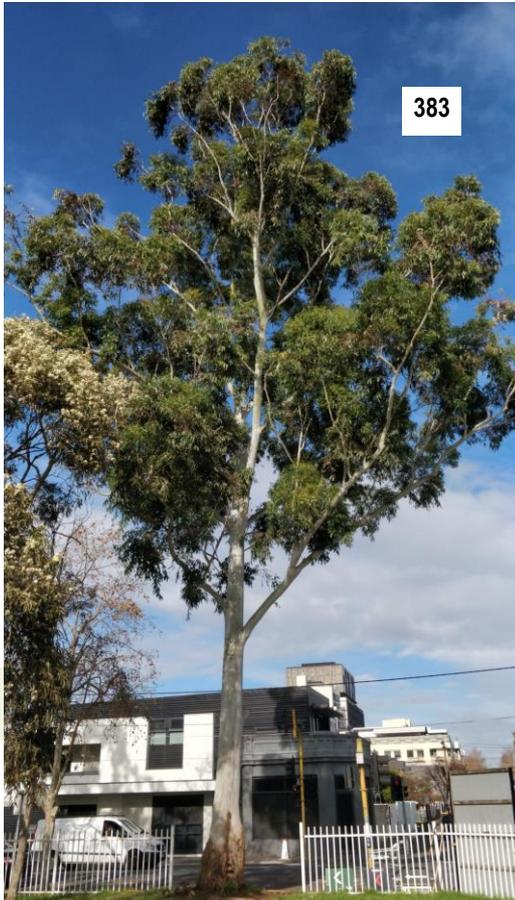
Image 77: Tree 383, Low-rated Sydney Blue Gum at corner of Lennox and Highett Street. Tree has good canopy health and significant landscape value however extent of fungal decay at base seems significant.

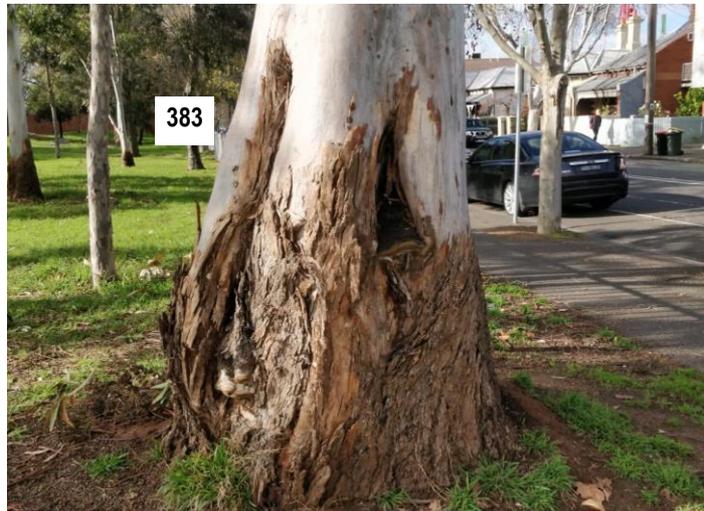
Image 78: Base of Tree 383 showing fungal brackets and decay/hollows. Tree has developed substantial response growth and could in fact have reasonable structural integrity; the decay may have been present for many years. However, without further inspection it is difficult to determine the true progression of decay.

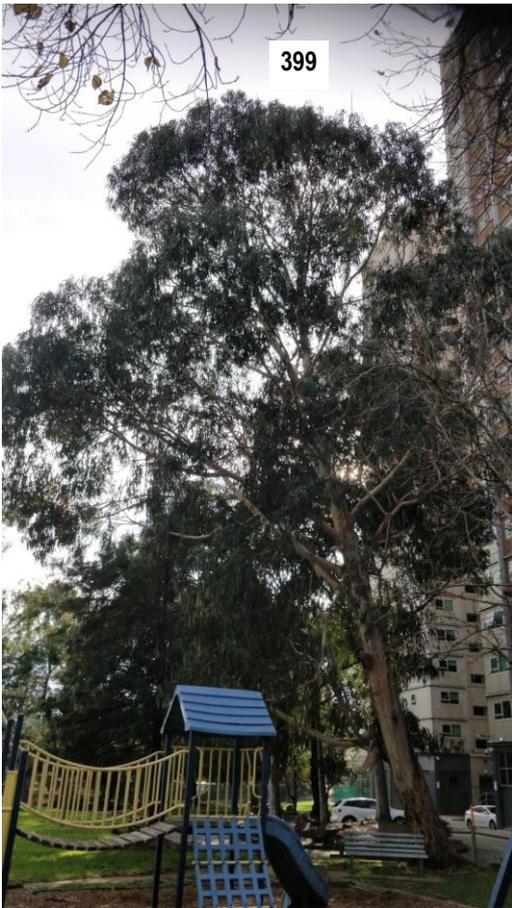
Image 83: Tree 399, Mod. B Southern Blue Gum northeast of southern playground, immediately next to pavement causing heaving. No fungal brackets observed. Facing north

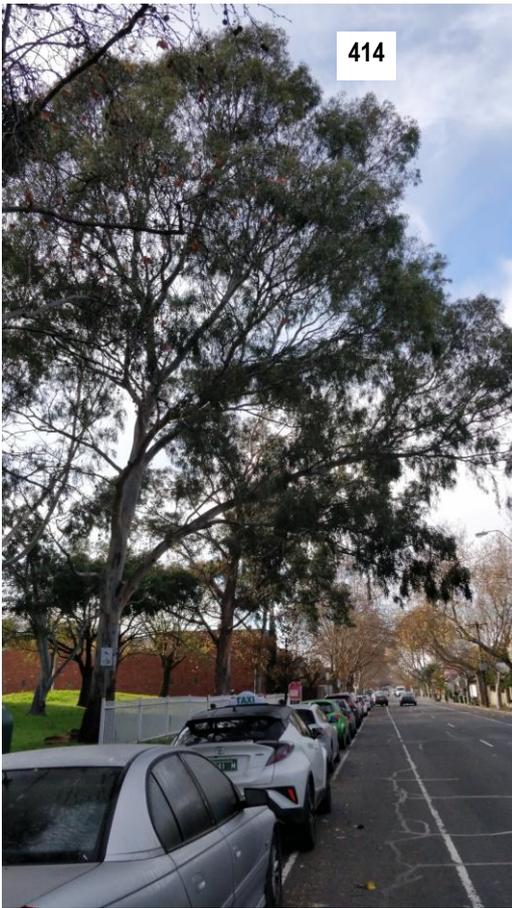
Image 86: Tree 414, Mod. B River Red Gum in southern open space along Highett Street frontage, facing east. Over-extended limb over road recommended for pruning.

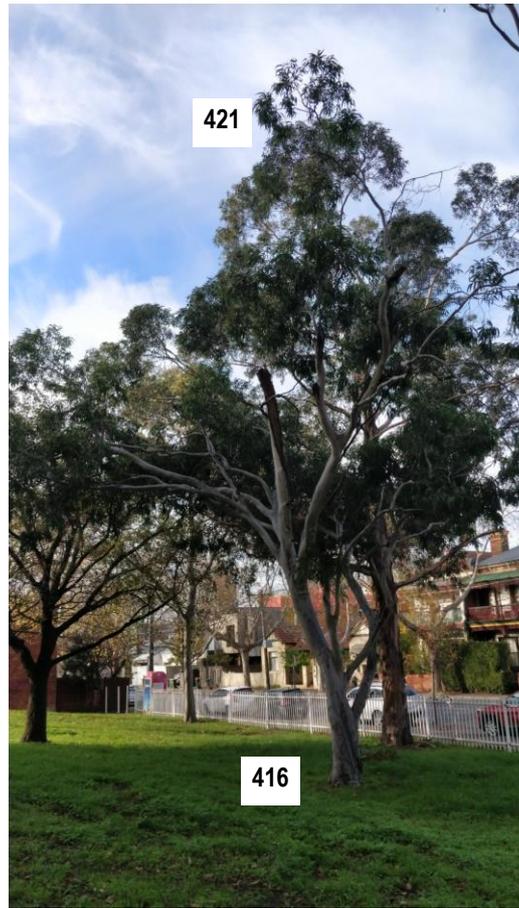
Image 87: Tree 416 to front showing Spotted Gum with multiple failures in southern open space, facing southeast.

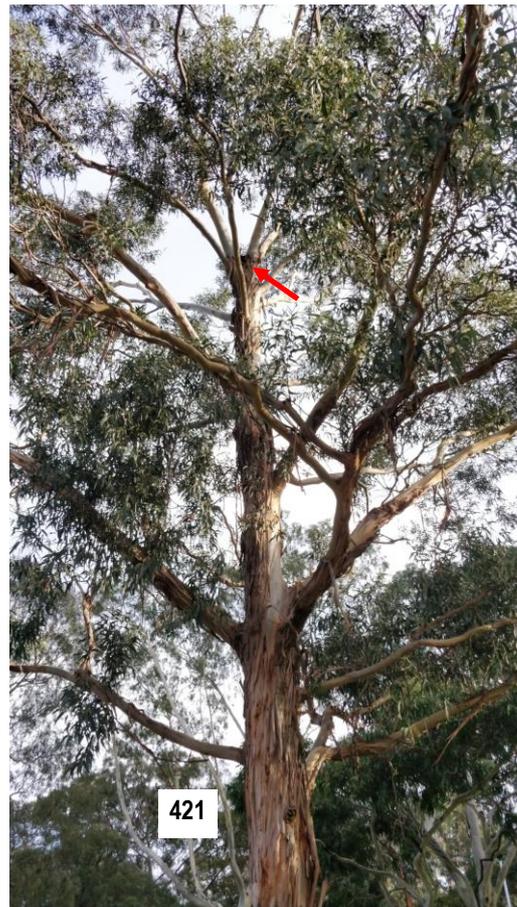
Image 91: Closeup of Tree 421 showing fungal bracket at apex – top down decay and dieback likely
