PRELIMINARY GEOTECHNICAL AND FOUNDATION ASSESSMENT FOR WINTERBROOK LODGE, MT BULLER

PSA0266-01_Winterbrook Lodge, Mt Buller 16 November 2022

RE: PRELIMINARY GEOTECHNICAL AND FOUNDATION ASSESSMENT FOR WINTERBROOK LODGE, MT BULLER

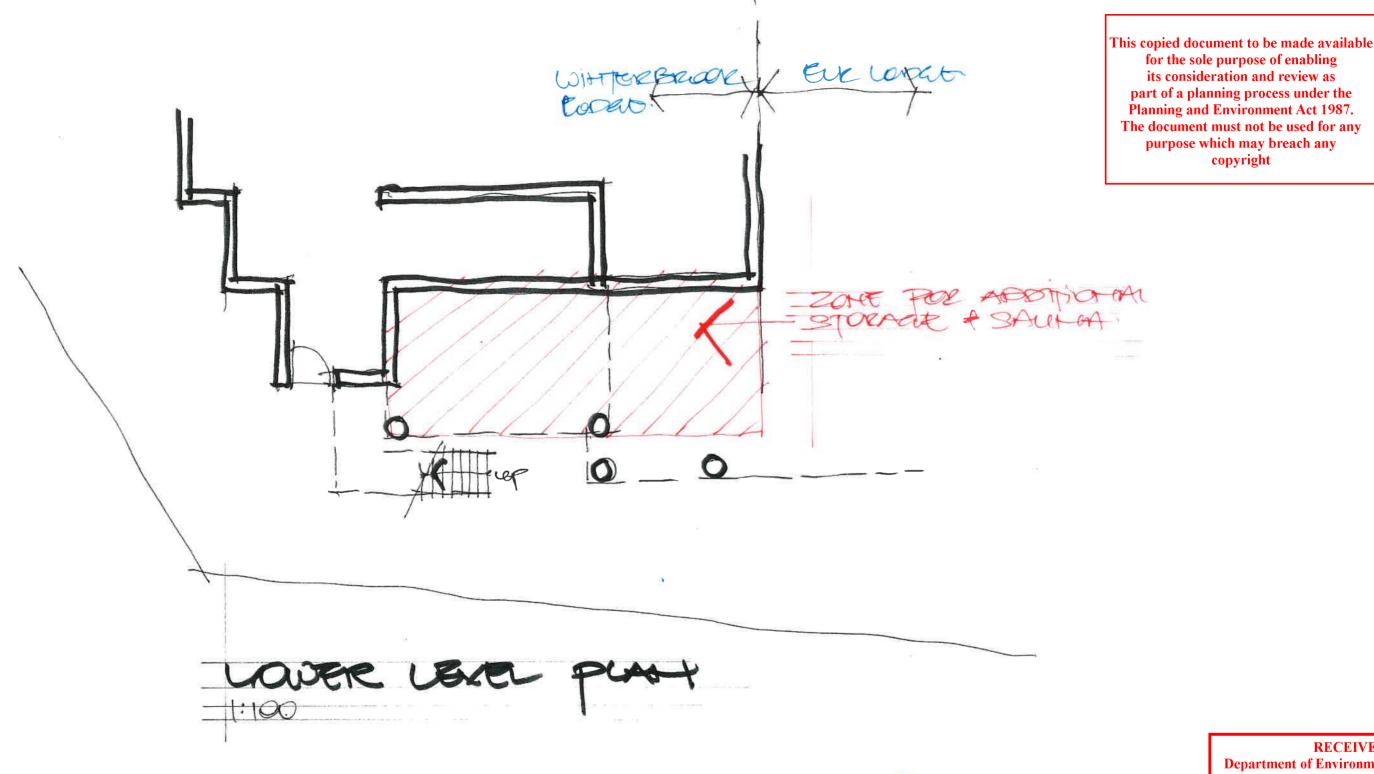
PSA0266-01 Figure 1

Figure 1: Lower-Level Plan

It is understood that it is proposed to construct an additional storage area and sauna under the existing building (Refer Figures 1 and 2).

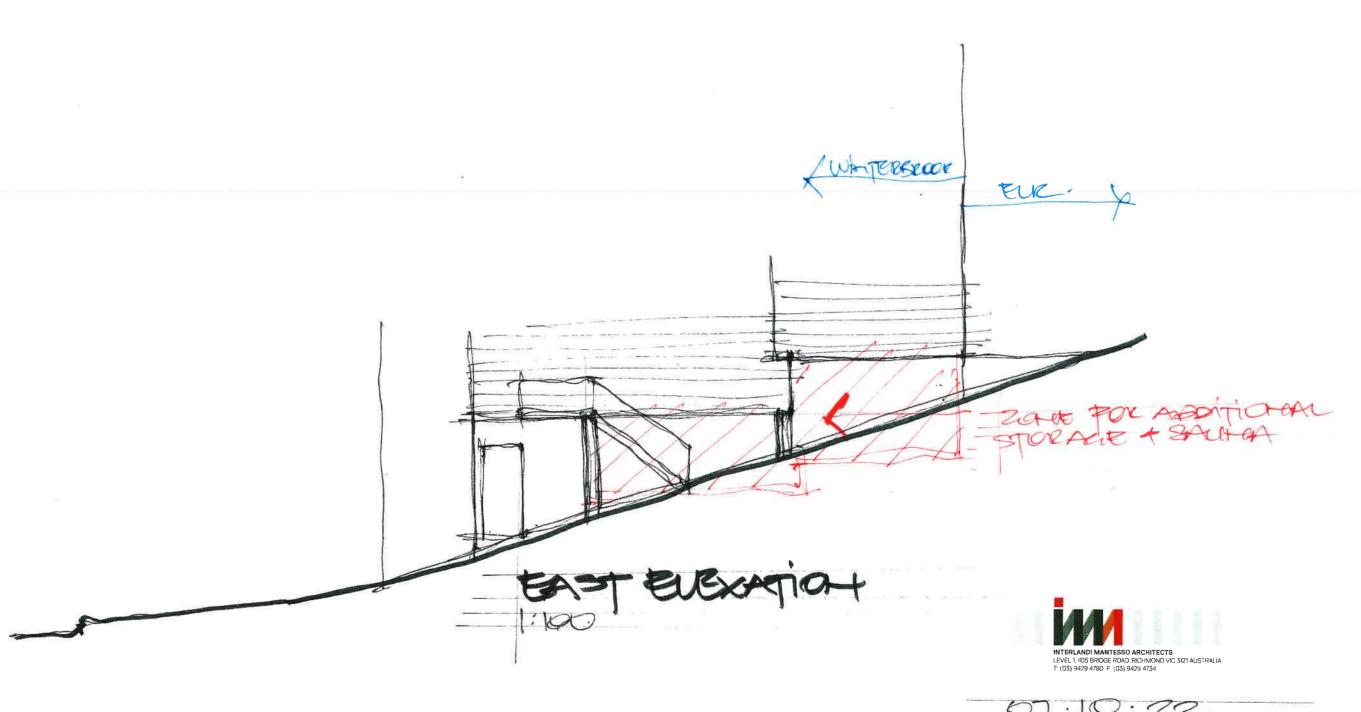
PSA0266-01 Figure 2

Figure 2: East Elevation

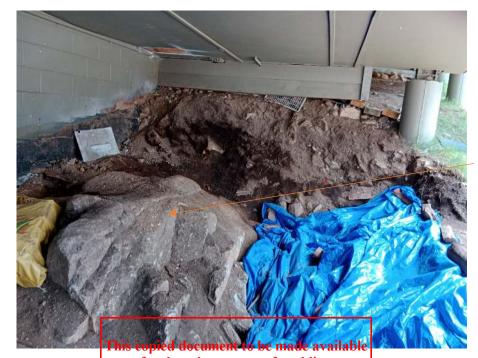
The Geological Survey of Victoria 1:250,000 series Warburton sheet indicates that the surface geology at the site comprises Devonian age granite. This is consistent with our site observations, which noted surface outcrops in the proposed development area (refer to Appendix A – Site Photographs).

Granite outcrop

Plate 1. Looking northwest from white steps and state of lodge its consideration and review as

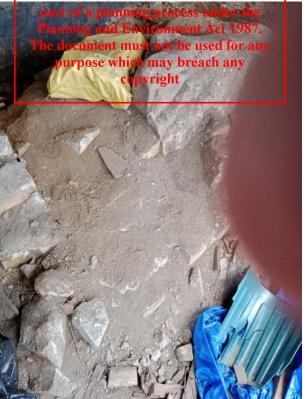
Plate 2. Detail of granite outcrop shown in Plate 1

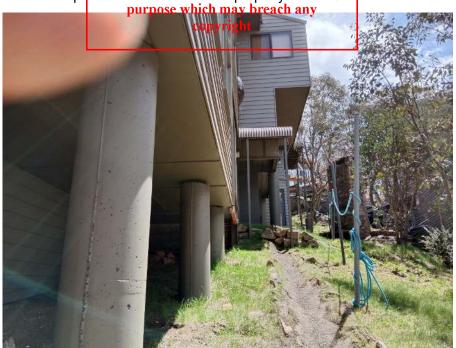
Plate 4. View looking northwest along the edge of the lodge

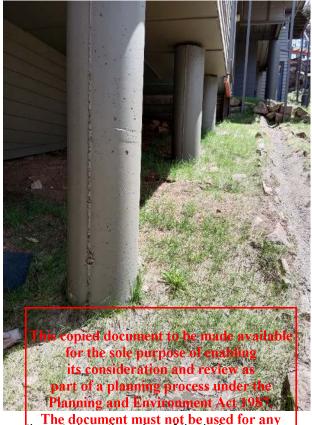
Plate 5. View looking northwest along the edge of the lodge purpose which may breach any

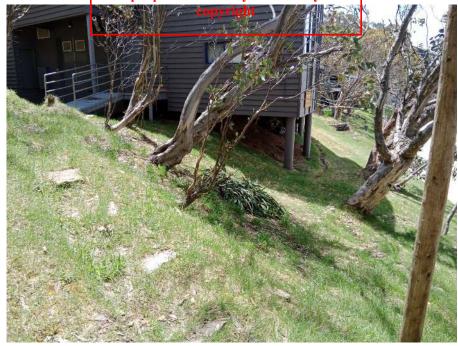
Plate 6. Looking east along The Avenue from Winterbrook steps. Note granite outcrop.

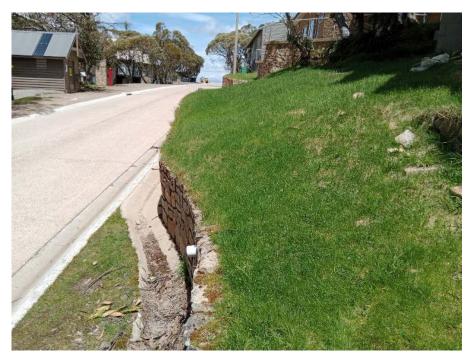
Plate 7. Looking west along The Avenue from Winterbrook steps. Note granite outcrop.
