## **GEOTECHNICAL ASSESSMENT AND LANDSLIDE RISK ASSESSMENT REPORT**

Our Ref 20250524

Date 27 March 2026

**SITE: CABIN 1A WHITEHORSE VILLAGE ROAD, MOUNT BULLER.**

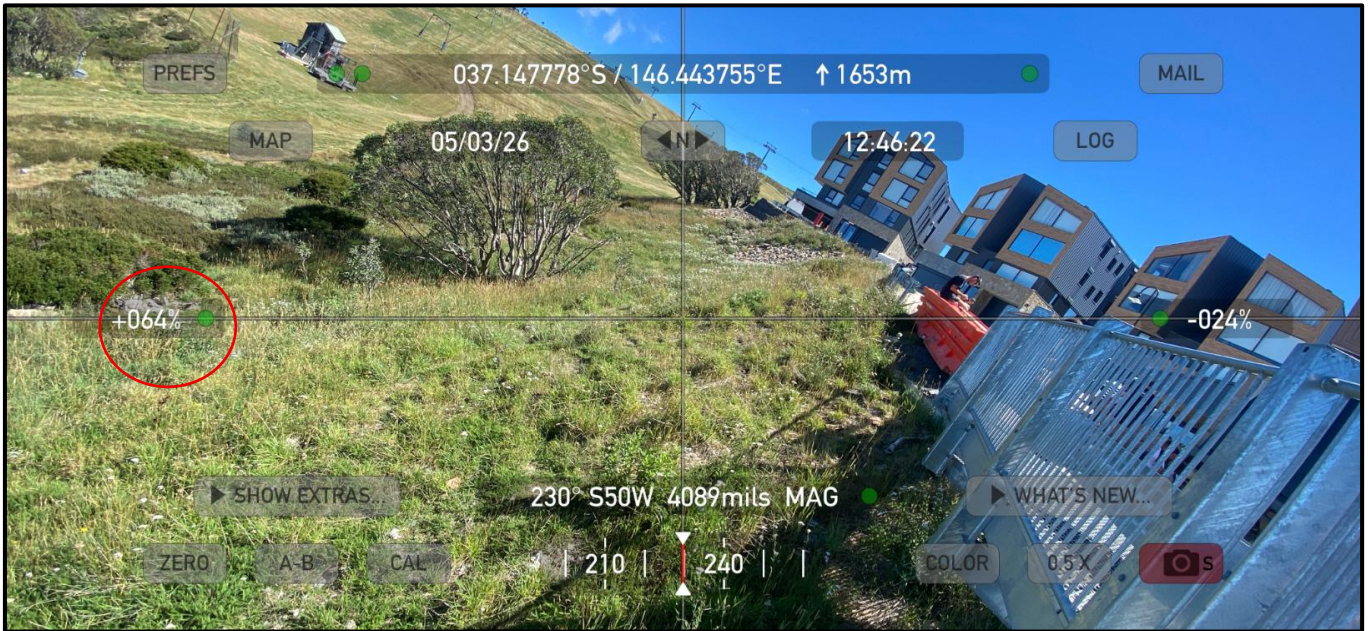
During our recent site investigation, it was noted that a large proportion of the site that fronts the low side of the road, has been filled. This filling appears to be associated with the lower fill embankment to facilitate the construction of Whitehorse Village Road. As can be seen from the photographs below, the depth of filling across the front of this site is likely to be in the order of 4.0 to 5.0 m deep.

Photo 1 view of typical degree of slope on road fill embankment (taken on angle to match the slope).

To help reduce the impact of the proposed works on the large road embankment across the front of the subject site it is recommended that the proposed works be sited further down the embankment which will reduce the height of the site required to facilitate the proposed works. Strong consideration should also be given to raising the proposed finished levels of works which will also reduce the depth the site cut. Ideally, the site cut should be kept as close as practical to a maximum overall height of 1.0 m.

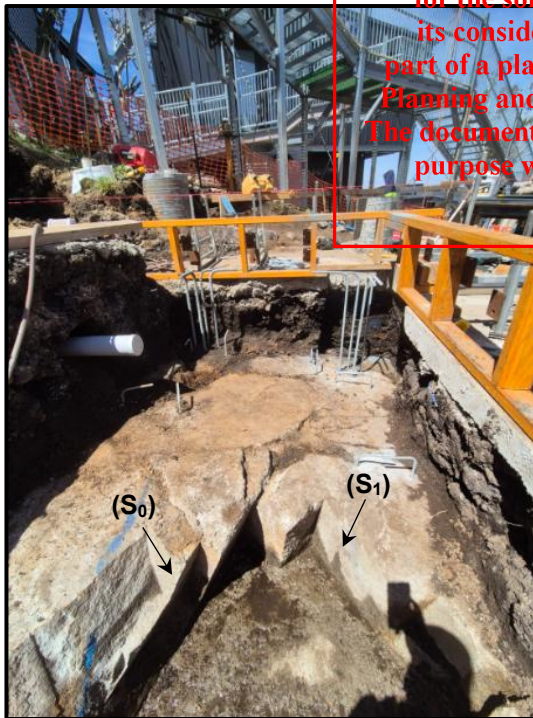
During our recent site investigation, two separate fracture planes were observed within the granodiorite bedrock. The primary fracture plane (S<sub>0</sub>) dips at 65° towards 040° (approx) and the secondary fracture plane (S<sub>1</sub>) dips at 70° towards 310°(approx). Refer to the photographs below.

Photo 2 (previously taken by contractor) of insitu, slightly weathered granodiorite bedrock exposed in the footing excavations for that building. Note the two main fracture planes.

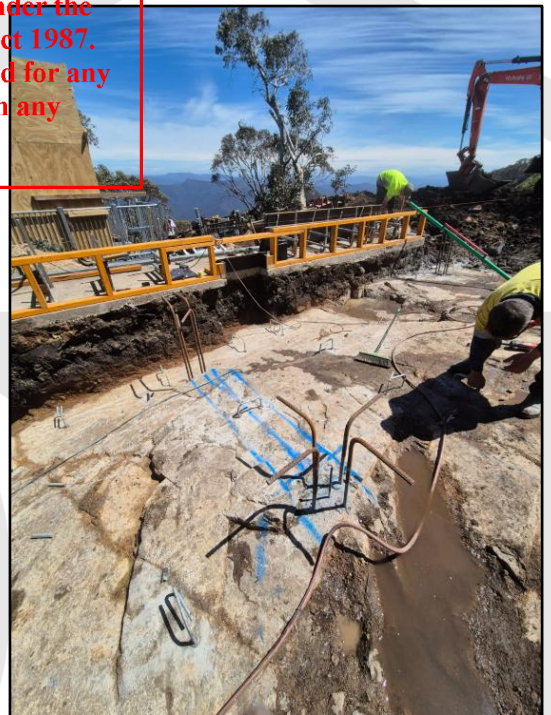
Photo 3 (previously taken by contractor) of insitu, slightly weathered granodiorite bedrock exposed in the footing excavations for that building.

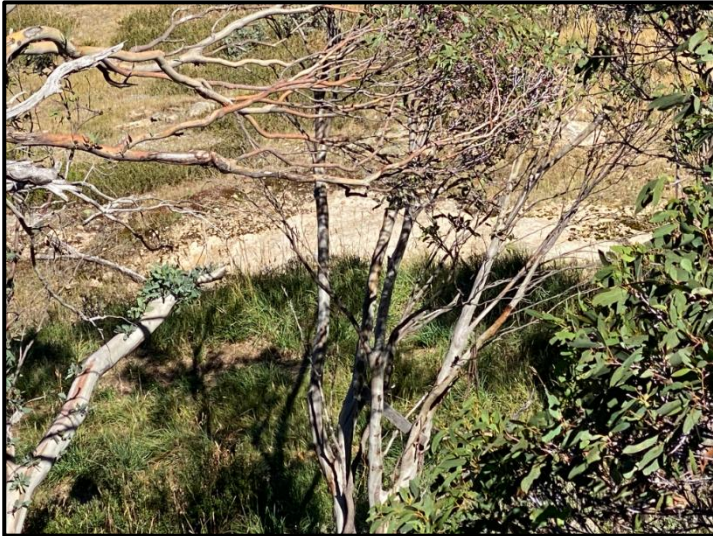
Photo 4 outcrop of insitu, slightly weathered granodiorite bedrock downslope from the subject site.

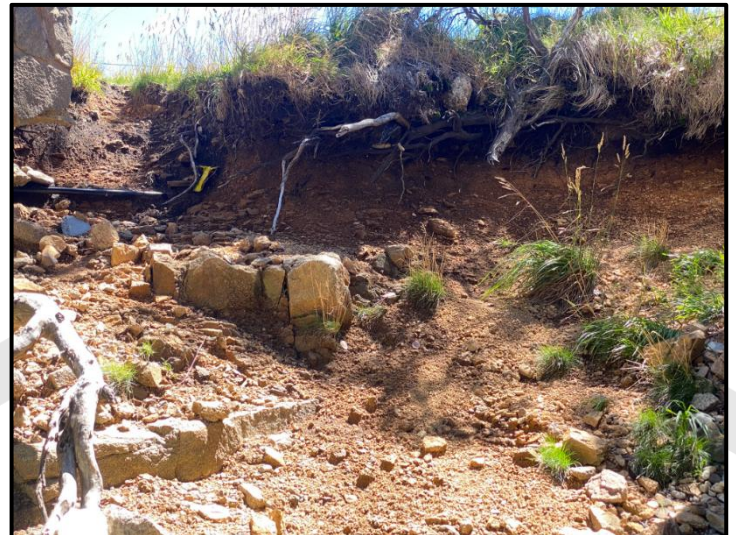
Photo 5 view of typical insitu soil/rock profile exposed in a site cut above Whitehorse Village Road.

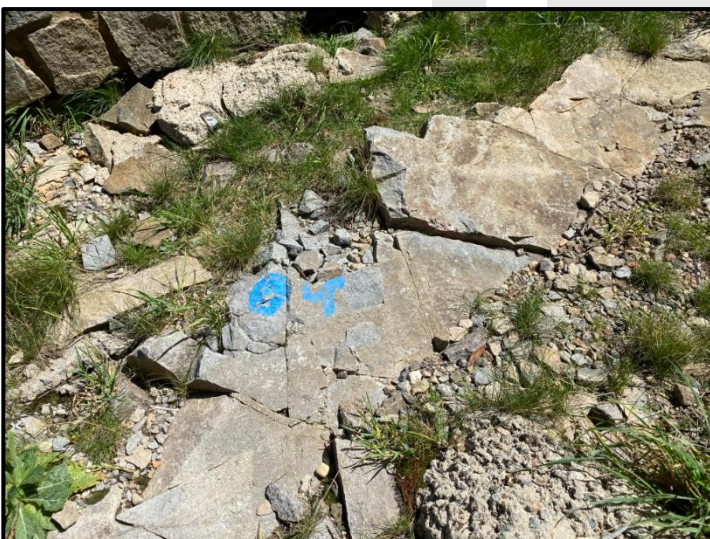
Photo 6 outcrop of insitu, slightly weathered granodiorite bedrock upslope from the subject site.
