ARBORICULTURAL REPORT

Construction Impact assessment

PREPARED FOR: Caroline Chisholm Catholic College

Subject Site: Sacred Heart & St Johns Campus
204 Churchill Avenue, Braybrook, VIC 3019
27th July 2023

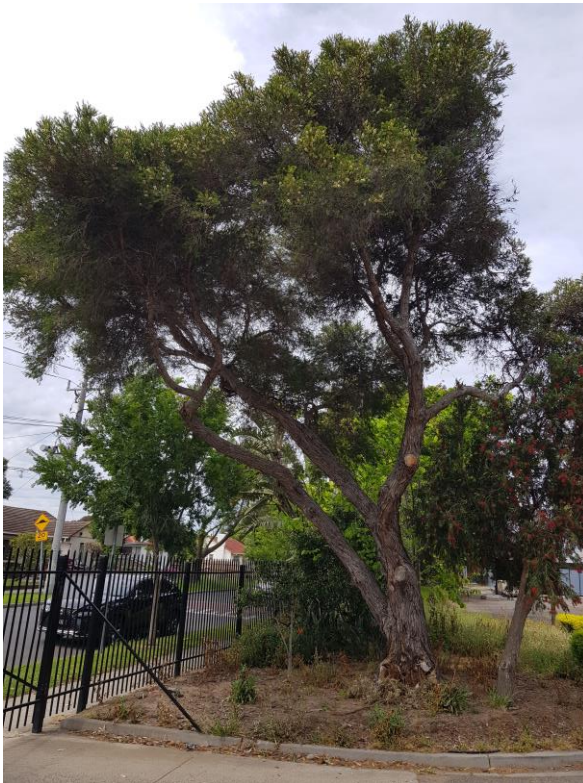
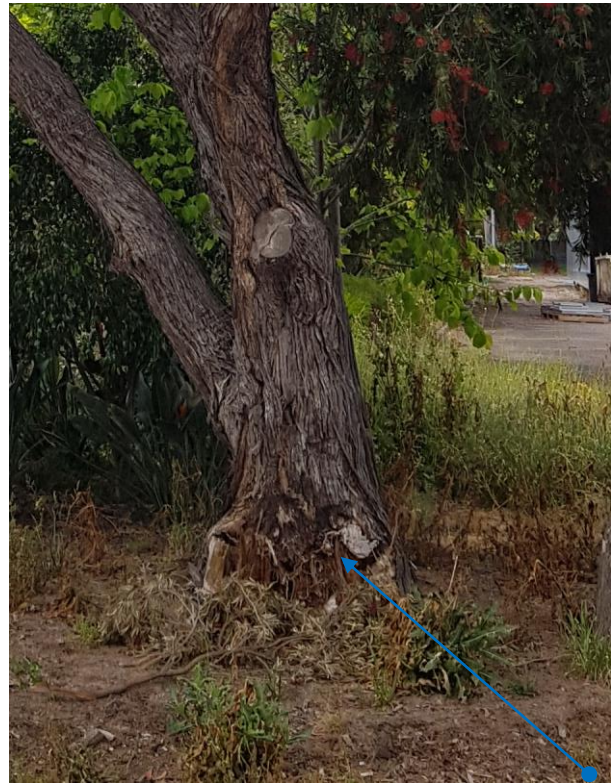
Tree 30. *Melaleuca armillaris*

This tree has been exposed to partial tree failure from a bifurcation at its base, tree not expected to remain standing due to a compromised structural integrity, tree removal is recommended.

Tree 30. Melaleuca armillaris

Arborist Comment: Tree has been exposed to partial tree failure from a bifurcation at its base. The remaining living section is not expected to remain standing due to a compromised structural integrity.

Tree has been exposed to partial tree failure from a bifurcation at its base. The remaining living section is not expected to remain standing due to a compromised structural integrity.

It is recommended that Tree 30 be removed due to a compromised structural integrity.

Recommendation: Recommend tree removal

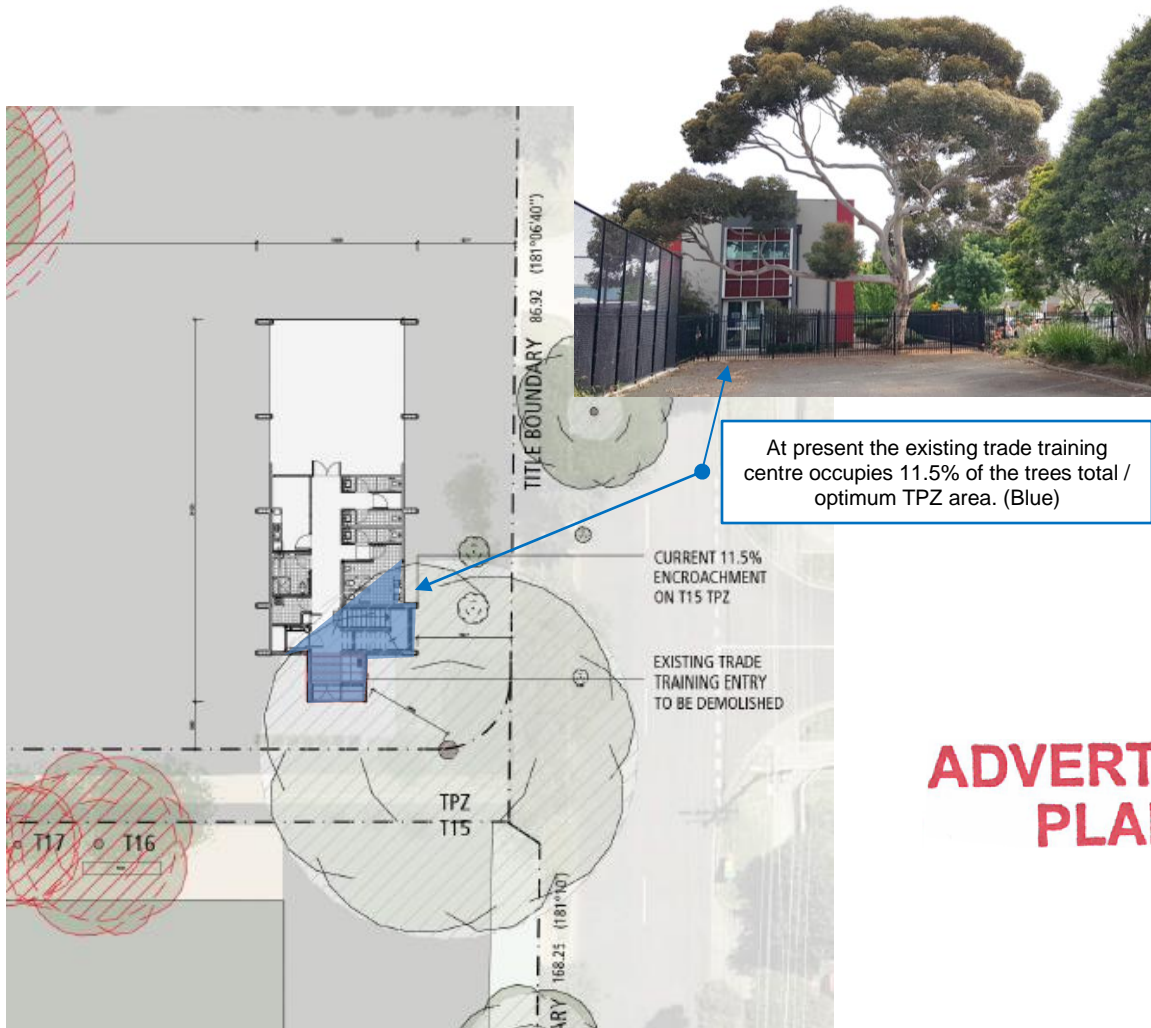
5.3 Existing site conditions and existing hard structures within the TPZ area of Tree 15 (63)

At present the existing trade training centre occupies 11.5% of the trees optimum TPZ area with additional encroachments from hard surface pavements i.e. pathways and carparks.

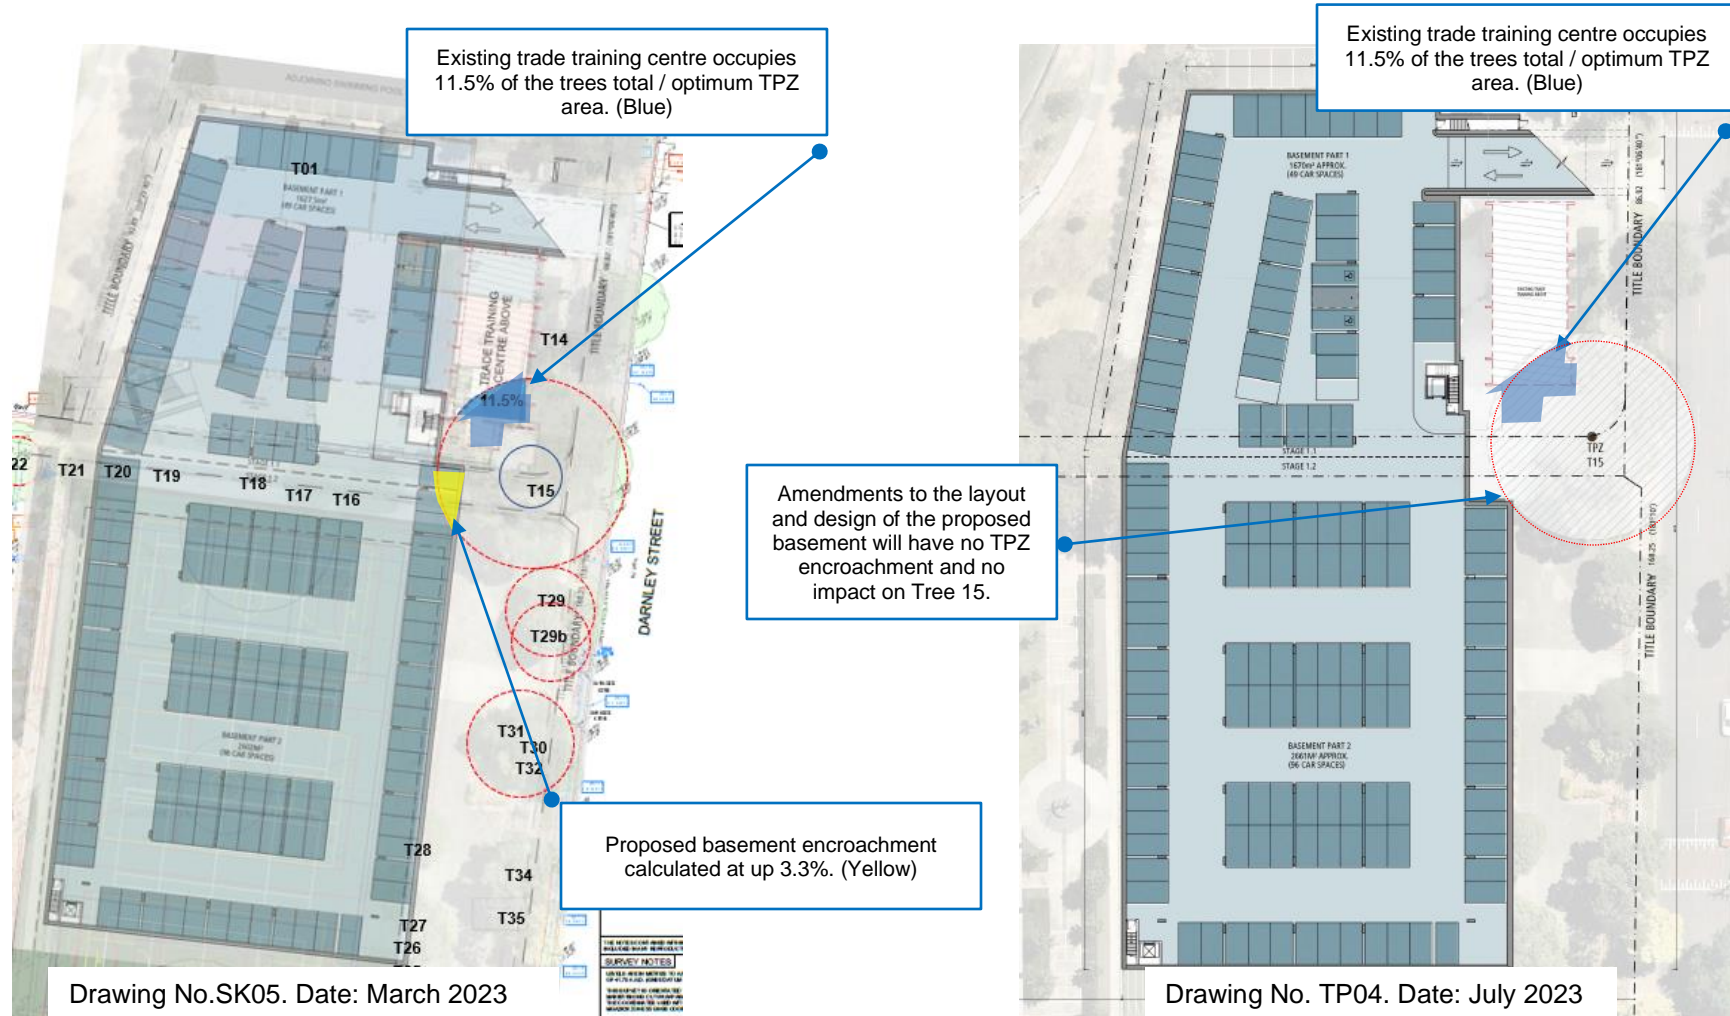
5.4 Impact from proposed basement – Tree 15 (63) July 2023

The amended layout and design of the proposed basement now remains outside of the TPZ area of Tree 15 where it has no encroachment.

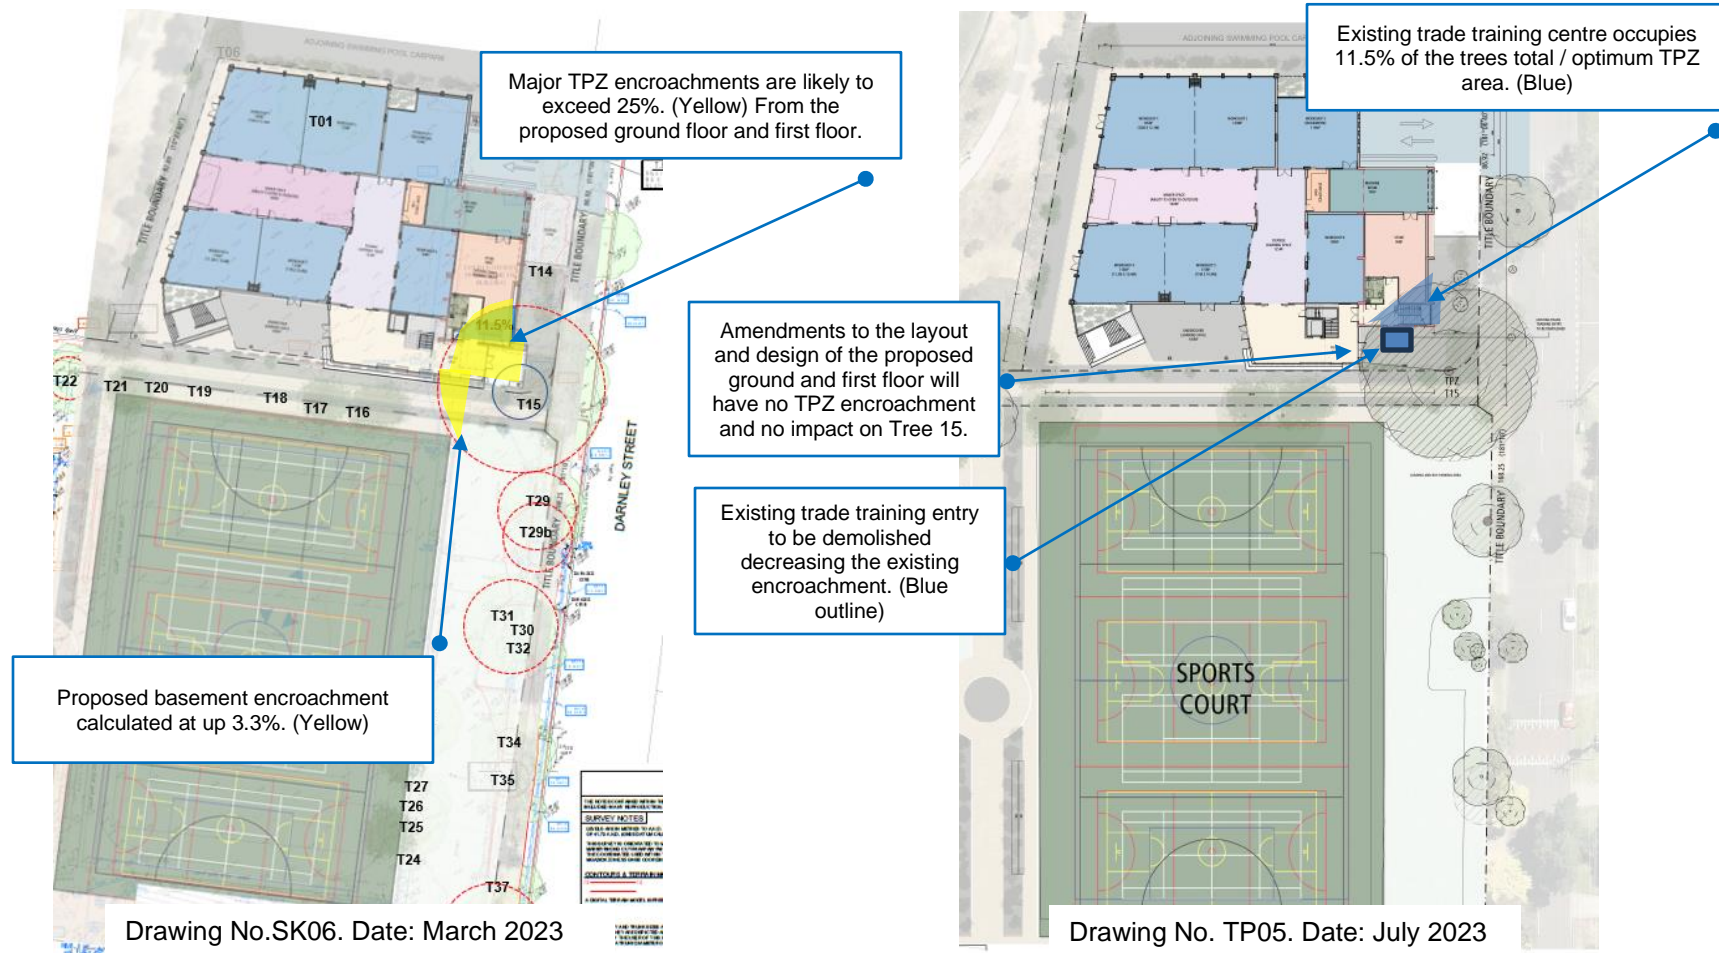
5.5 Proposed ground floor and first floor encroachments Tree 15 (63), July 2023

The amended layout and design of the proposed ground and first floor now remains outside of the TPZ area of Tree 15 where it has no encroachment.

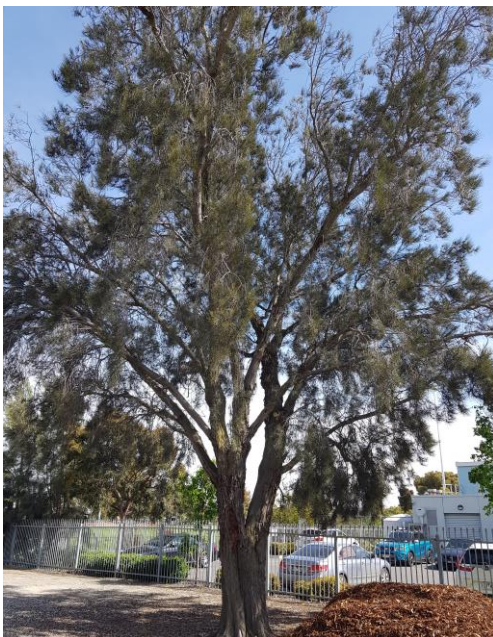
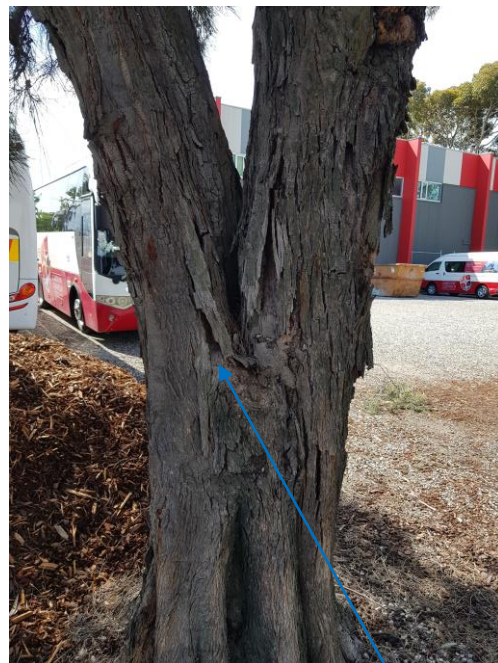
Tree 1. *Casuarina stricta* (*Allocasuarina verticillata*).

Tree 1. *Casuarina stricta* (*Allocasuarina verticillata*)

Arborist Comment: Tree contains multiple bifurcations and defective faults within main trunk and canopy with evidence to suggest from wound wood development that there is partial separation within the bark inclusion within the bifurcation of the main trunk. Signs of borer activity is also evident throughout its main trunk.

It is also expected that this tree has been exposed to construction impacts and soil compaction. This tree is expected to fail due to structural issues and may impact on vehicles within the carpark where it is located and / or impact on the parking area and general public using the swimming pool.

Tree contains multiple bifurcations and defective faults within main trunk and canopy with evidence to suggest from wound wood development that there is partial separation within the bark inclusion within the bifurcation of the main trunk. Signs of borer activity is also evident throughout its main trunk.

Recommendations: Recommend tree removal.

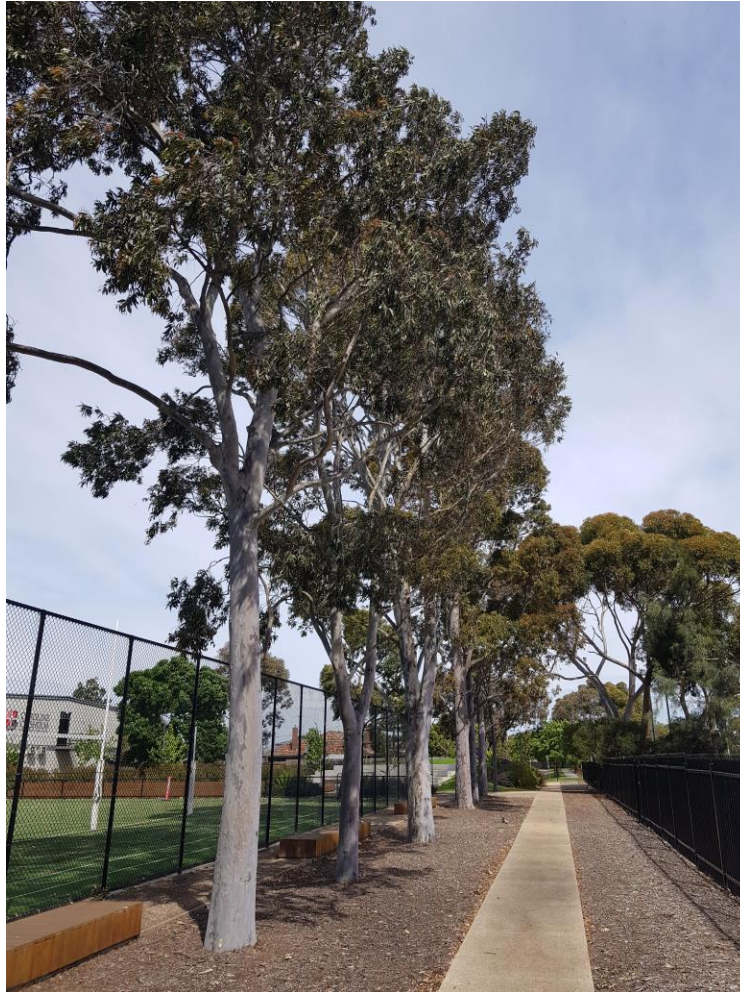
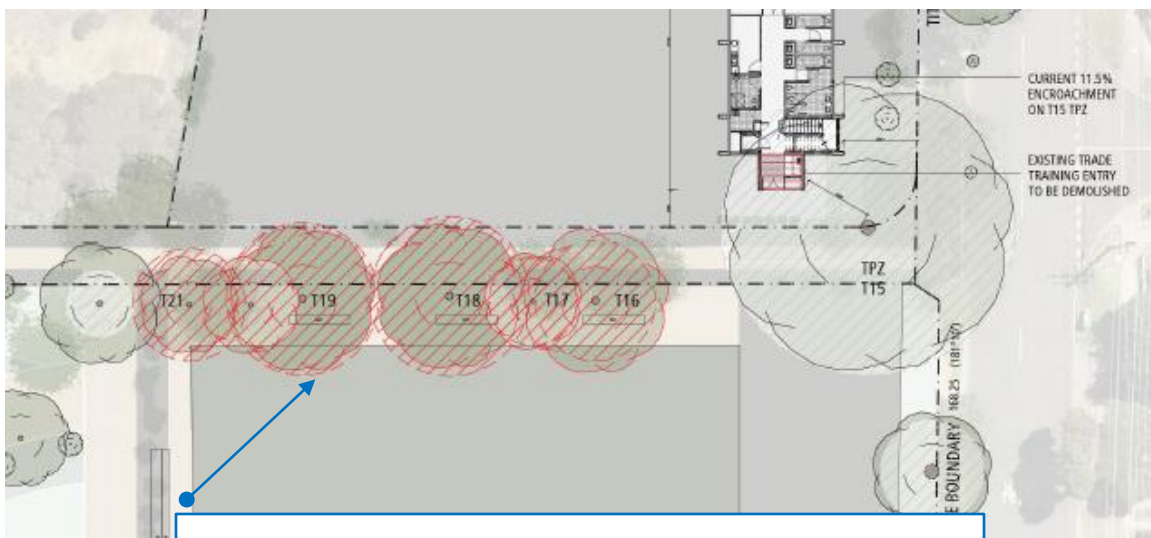
5.8 Trees 16, 17, 18, 19, 20 and 21. These trees are within the area of the proposed basement, these trees have been categorized as medium retention.

Trees 16, 17, 18, 19, 20 and 21. These trees are within the area of the proposed basement and will require removal to support the planning proposal.

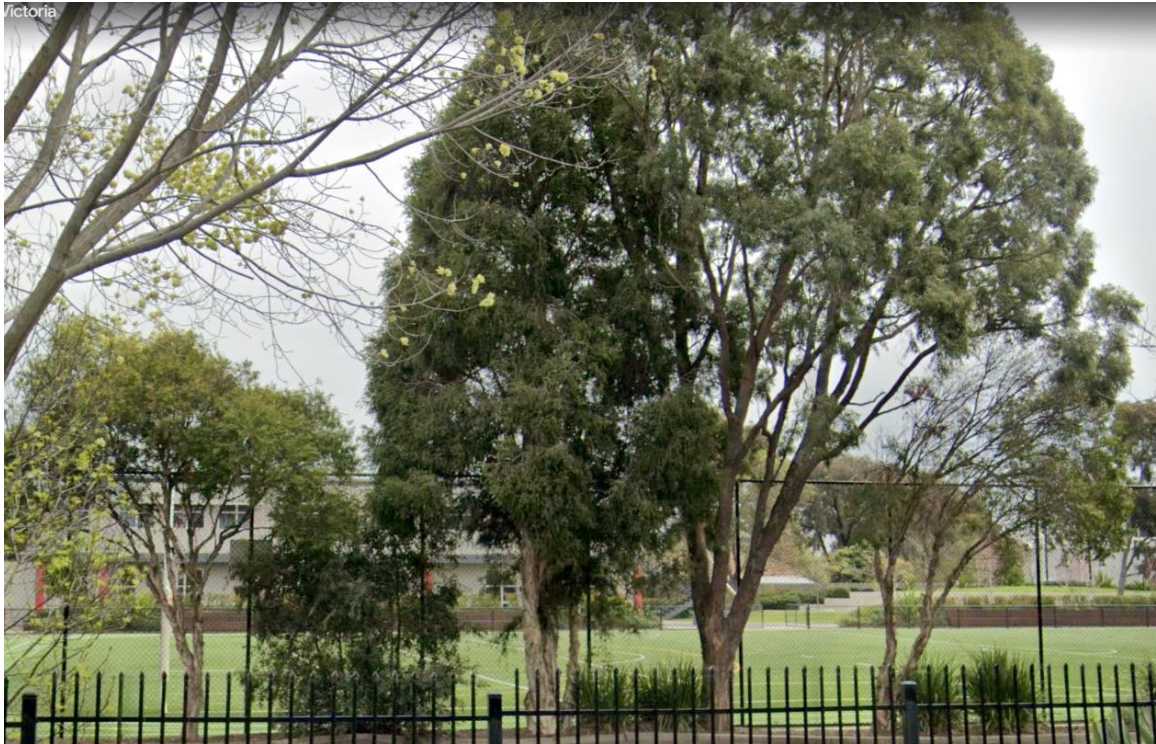
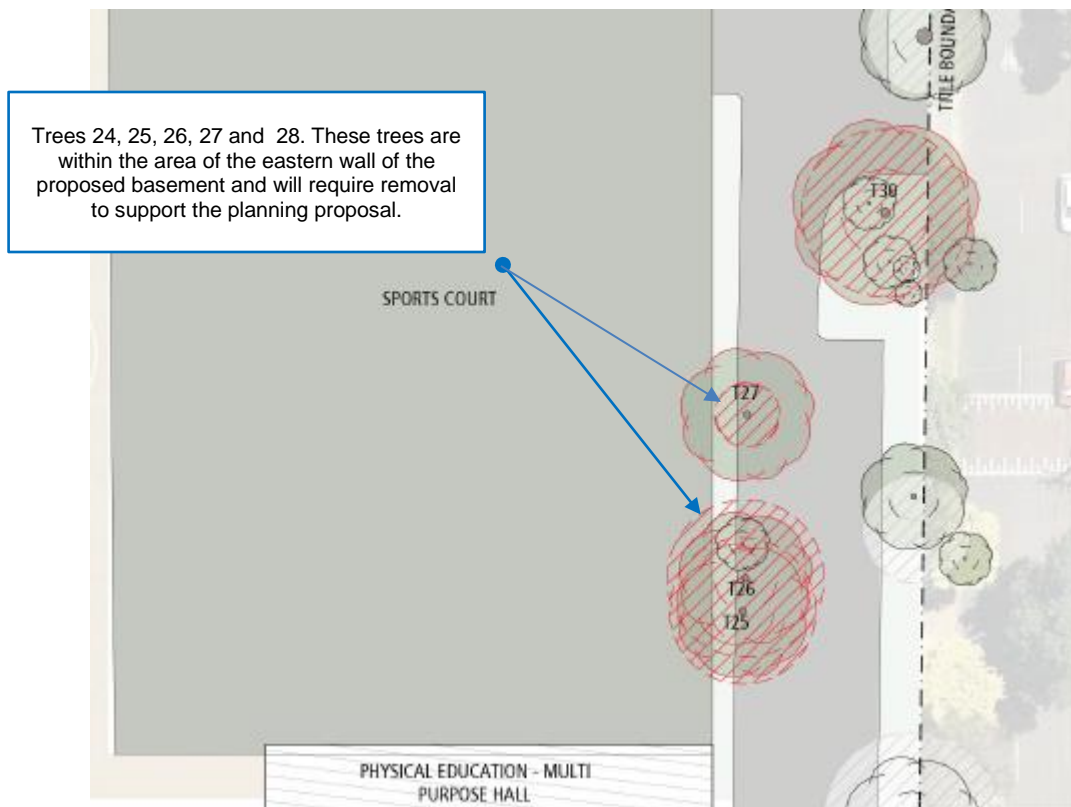
5.9 Trees 24, 25, 26, 27 and 28. These trees are within the area of the proposed basement, these trees / shrubs have been categorized as low retention.
