Proposed Zipline

Geotechnical Landslide Risk Assessment

Buller Ski Lifts

23 March 2026

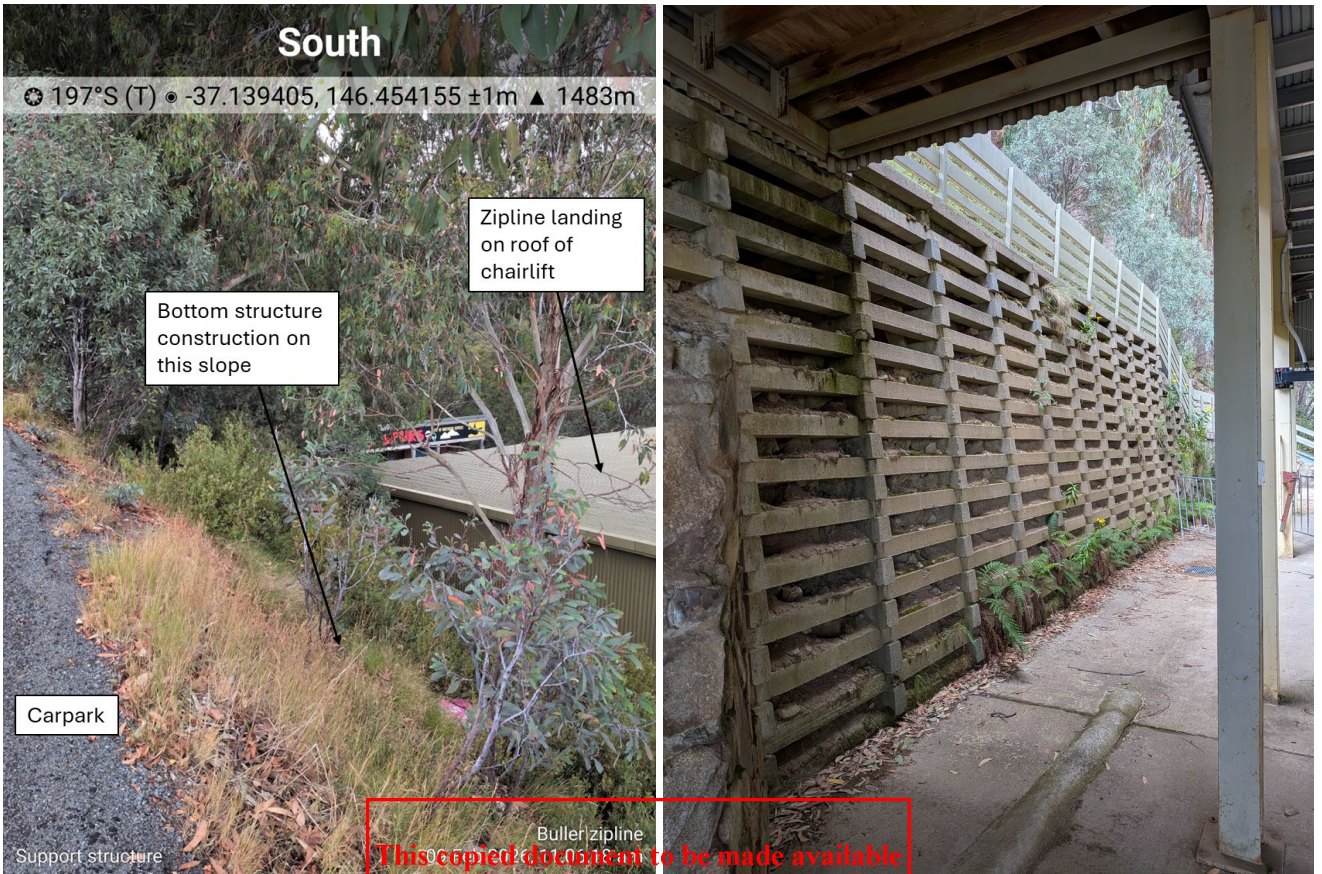
wall (Figure 4), behind which the un-engineered fill looks to be composed of granodiorite boulders and weathered soils, likely sourced from the local cut/excavation works. No obvious evidence of instability or failure was observed of the crib wall, which appears to be in apparent good condition.

Figure 4 Left – location of zipline bottom structure. Right – crib wall at base of slope.

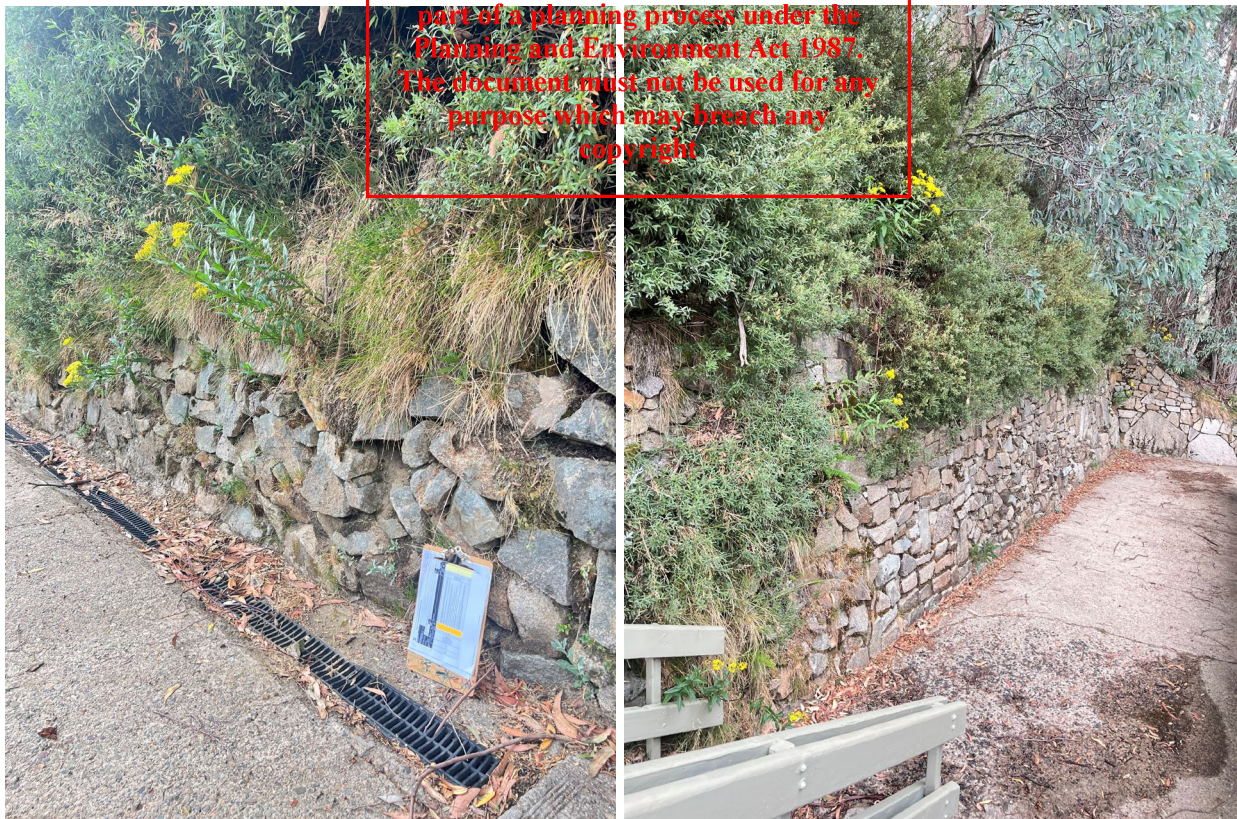
A footpath cuts through the mid-slope allowing foot traffic between the carpark and chairlift. A 1.0-1.5 m tall dry wall is located at the edge of the footpath. The material behind the dry wall is uncertain, expected to be extremely weathered soils of granodiorite with some possible overlying fill material (Figure 5). Based on site observations and previous investigation descriptions, the slope material is expected to be granodiorite core stones in a sandy matrix. Visual assessment of the dry wall suggests some blocks have been dislodged in places, and there is some minor localised bulging. The dry wall condition is variable, appearing to be composed of loosely packed blocks upslope, and downslope being supported by grout between the blocks and drainage holes. Given the dry wall is approximately ~40 years old, it appears in apparent good condition.

Figure 5 Dry wall downslope of proposed zipline landing structure. Minor blocks dislodged, some sections grouted with drainage pipes.

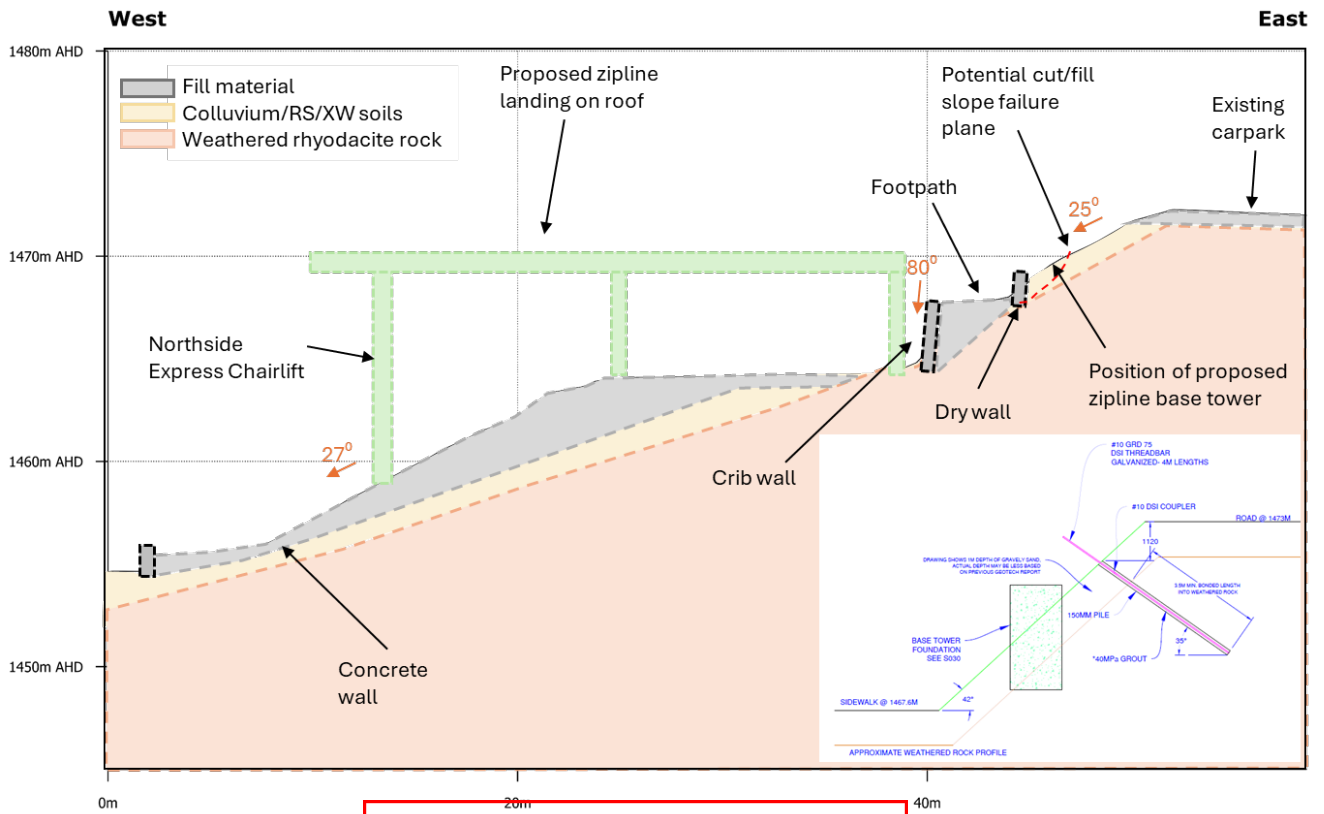
Figure 7 East-West cross section through location of proposed bottom zipline structure, showing indicative existing structures and estimated sub-surface materials.

Based on our assessment, a single conceivable hazard has been identified at the proposed landing structure. The hazard is summarised in Table 3, and illustrated in Figure 7, and has been considered as part of the landslide risk assessment.

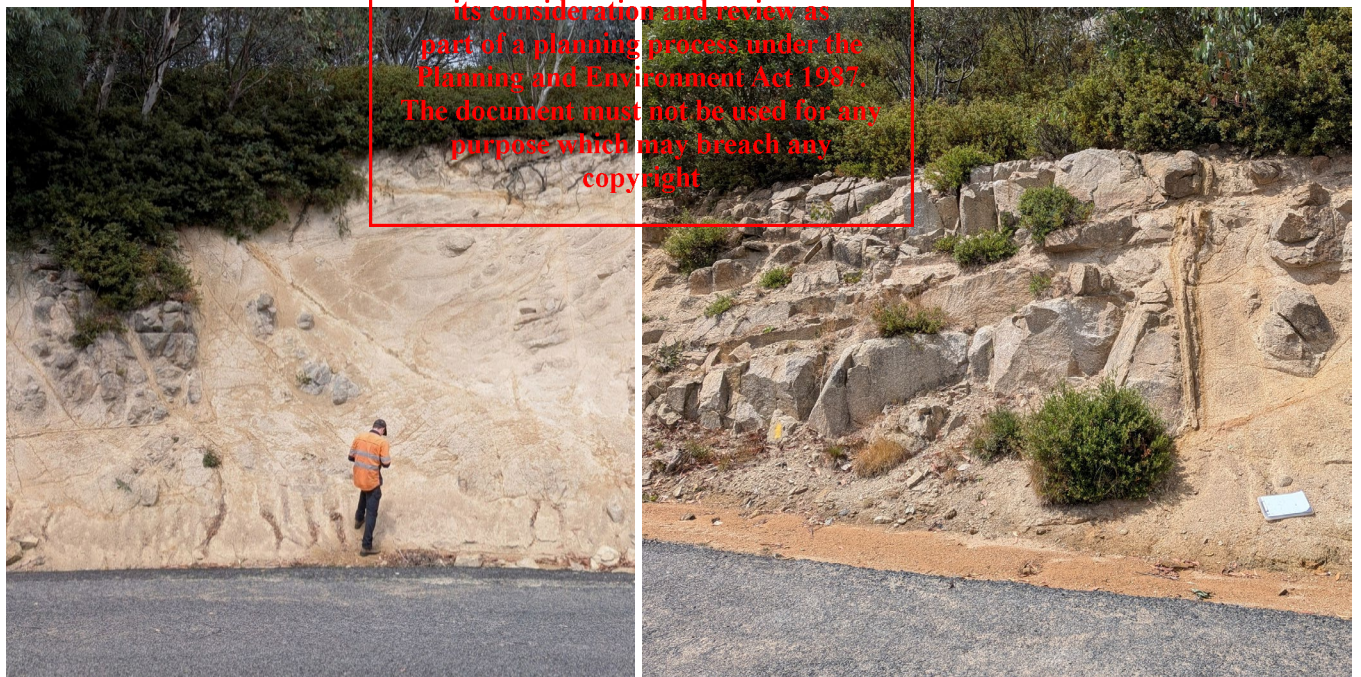
The subsurface conditions at the proposed bottom zipline structure is expected to be extremely weathered soils of granodiorite, with some possible un-engineered fill associated with cut and fill activities of the carpark and chairlift. This material is likely to be composed of weathered granodiorite corestones within a sandy matrix. Fill material is likely composed of similar material, locally sourced. Underlying this is expected to be granodiorite. The weathered profile of the granodiorite was observed at a cutting upslope in the carpark to be highly variable. Figure 8 illustrates the highly variable profile, where extremely weathered soils were observed to a depth of 8-10m, immediately adjacent to an outcrop with highly weathered granodiorite rock at surface. Shearing and deposition of quartz and iron in defects was observed.

Figure 8 Variable weathering profile of the granodiorite observed at Horse Hill Carpark. Left – extremely weathered soil profile to ~10m. Right – variable profile of Highly weathered to extremely weathered soil profile.
