Arboricultural Assessment and Report

3 Nortons Lane, Wantirna South

27 November 2025

Tree Logic Ref. 013990

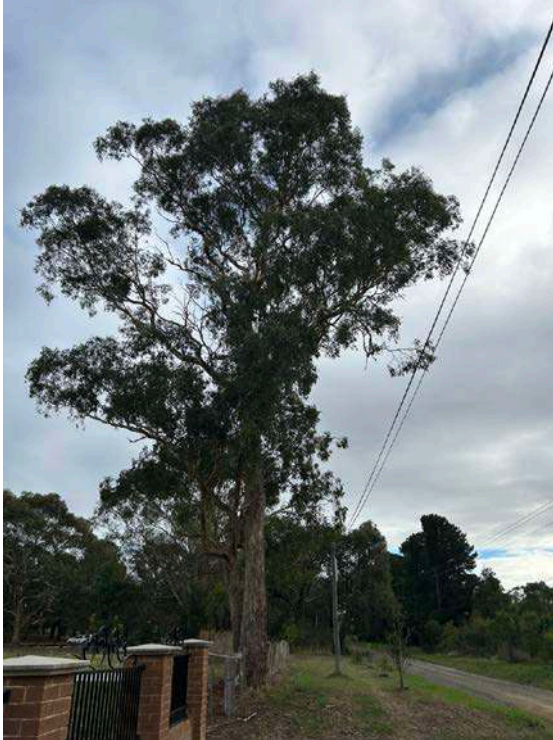
Tree ID: 2. *Pinus radiata* (Monterey Pine), Maturing Exotic conifer.
DBH: 102cm. Arb. Rating: Mod.A. Past branch failure. Crown in conflict.. TPZ (rad. m): 12.2. SRZ (rad. m): 3.4.

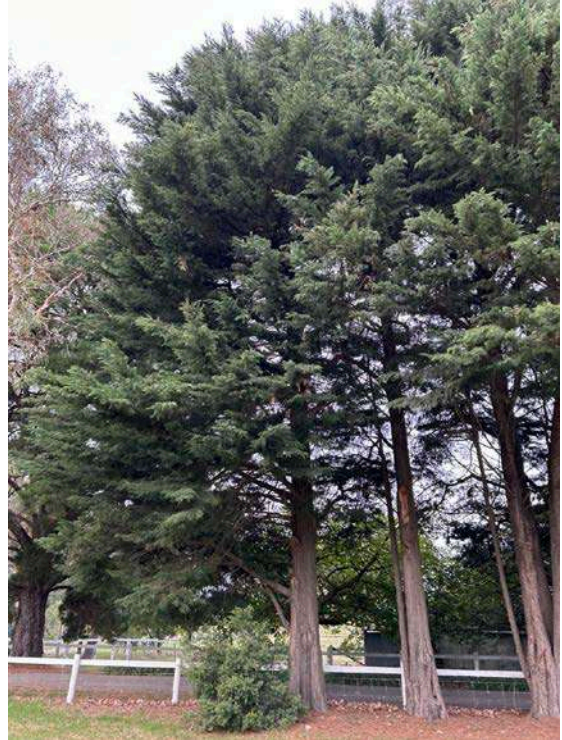
Tree ID: 12. *Cupressus macrocarpa* (Monterey Cypress), Maturing Exotic conifer.
DBH: 55,13cm. Arb. Rating: Mod.C. Past branch failure, past limb failure, suppressed.. TPZ (rad. m): 6.8. SRZ (rad. m): 2.8.

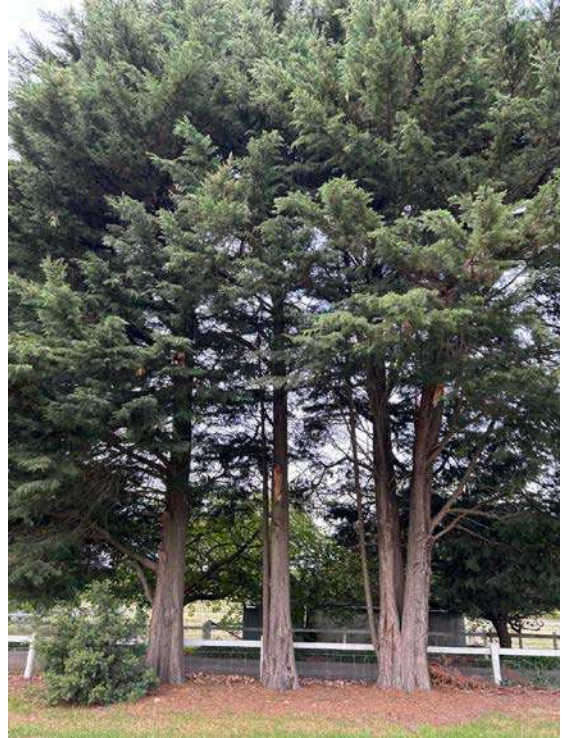
Tree ID: 13. *Cupressus macrocarpa* (Monterey Cypress), Maturing Exotic conifer.
DBH: 79,56cm. Arb. Rating: Mod.C. Acute forks, past branch failure, past limb failure, crown bias-w.. TPZ (rad. m): 11.6. SRZ (rad. m): 3.4.

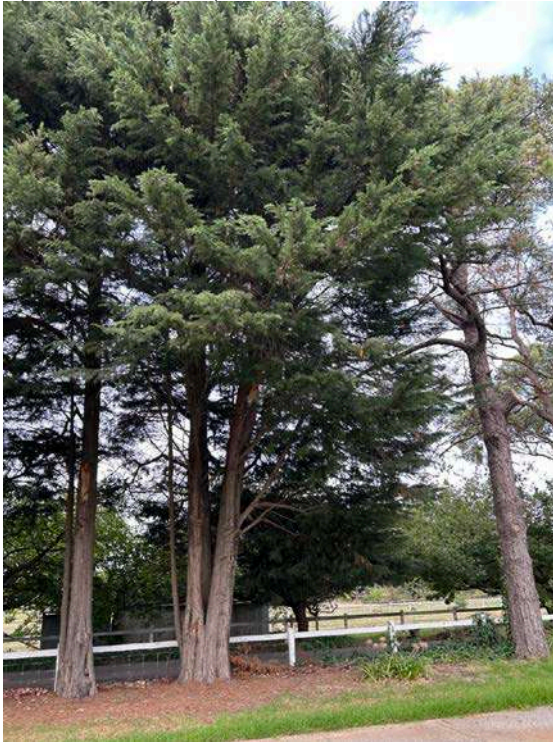
Tree ID: 14. *Pinus radiata* (Monterey Pine), Maturing Exotic conifer.
DBH: 69cm. Arb. Rating: Mod.C. Past branch failure, past limb failure, reduced foliage density, suppressed.. TPZ (rad. m): 8.3. SRZ (rad. m): 2.9.

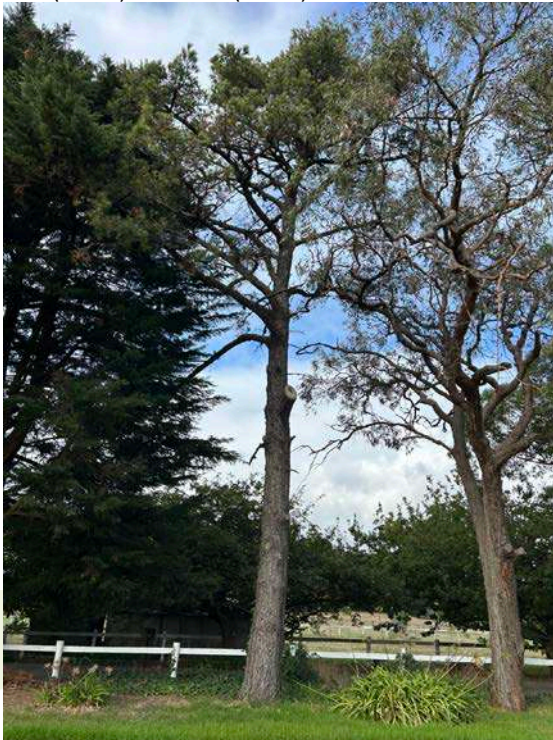
Tree ID: 15. *Eucalyptus cephalocarpa* (Mealy Stringybark), Maturing Victorian native.
DBH: 55,50cm. Arb. Rating: Mod.C. Co-dominant stems, included bark, past branch failure, reduced foliage density.. TPZ (rad. m): 8.9. SRZ (rad. m): 3.2.

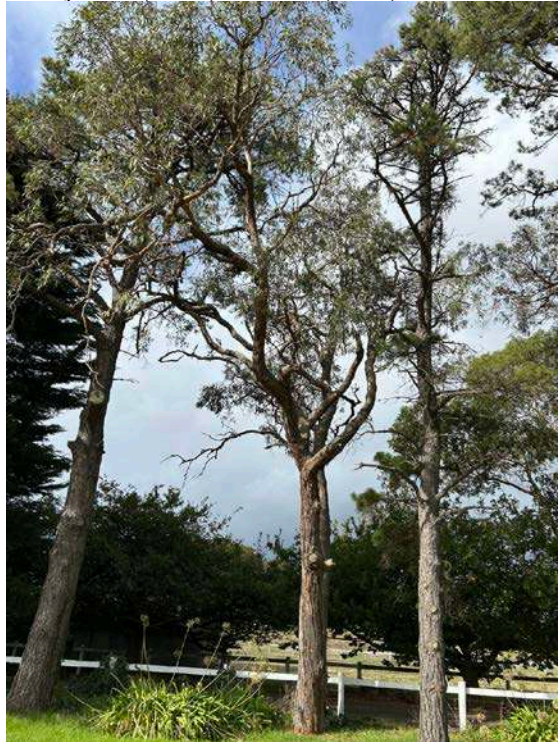
Tree ID: 16. *Pinus radiata* (Monterey Pine), Maturing Exotic conifer.
DBH: 47cm. Arb. Rating: Low. Past branch failure, tip dieback.. TPZ (rad. m): 5.6. SRZ (rad. m): 2.6.

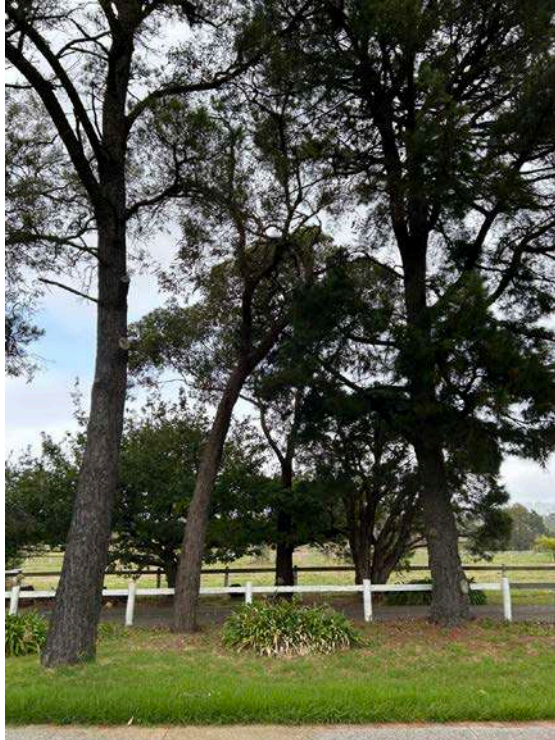
Tree ID: 18. *Eucalyptus cephalocarpa* (Mealy Stringybark), Early-mature Victorian native.
DBH: 50cm. Arb. Rating: Mod.C. Past branch failure, suppressed, crown bias-e.. TPZ (rad. m): 6. SRZ (rad. m): 2.7.

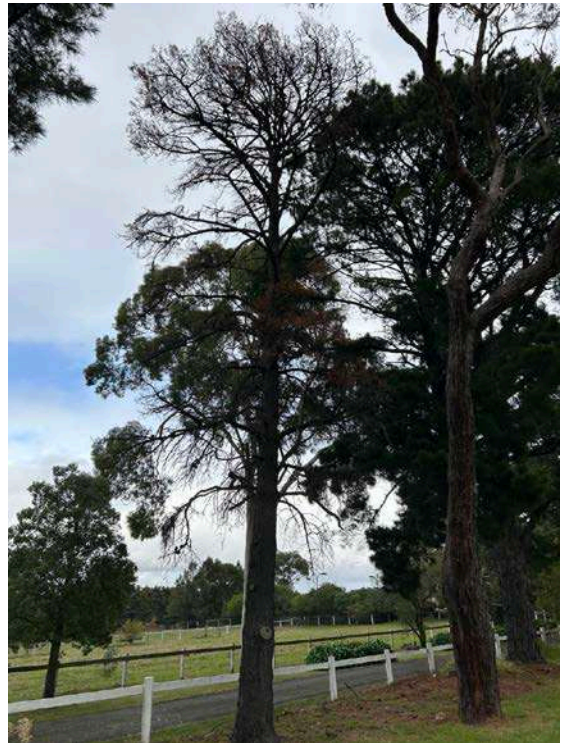
Tree ID: 21. *Pinus radiata* (Monterey Pine), Maturing Exotic conifer.
DBH: 73cm. Arb. Rating: Mod.C. Deadwood >50mm, over-extended limbs developing, suppressed, crown bias- n.. TPZ (rad. m): 8.8. SRZ (rad. m): 2.9.

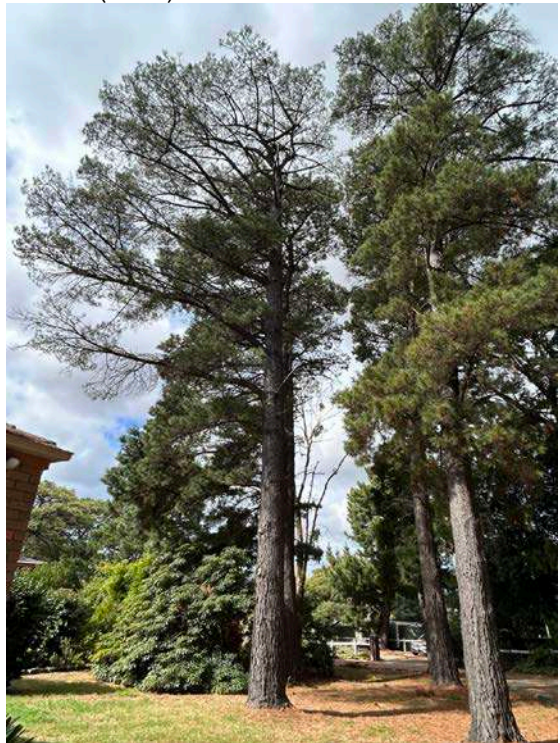
Tree ID: 33. *Pinus radiata* (Monterey Pine), Maturing Exotic conifer.
DBH: 59cm. Arb. Rating: Mod.C. Deadwood >50mm, hangers.. TPZ (rad. m): 7.1. SRZ (rad. m): 2.8.

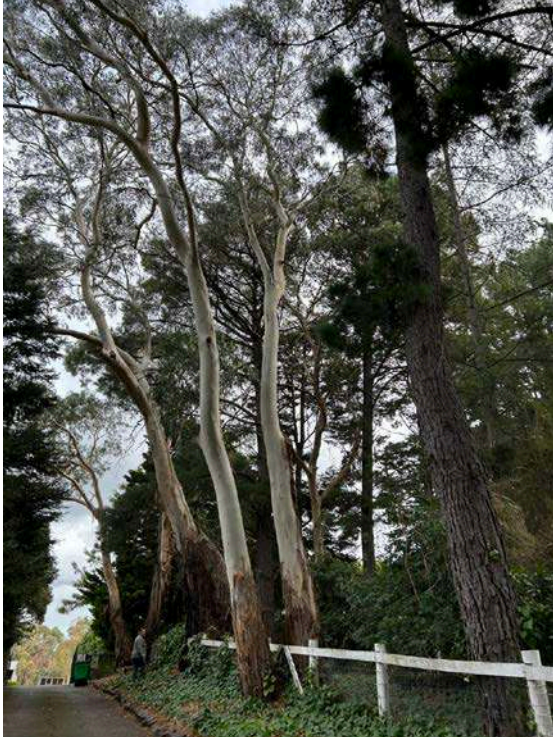
Tree ID: 38. *Eucalyptus viminalis* (Manna Gum),
 Maturing Victorian native.
 DBH: 130cm. Arb. Rating: Mod.C. Basal decay, basal
 wounds, deadwood >50mm, over-extended limbs
 developing. To sth. TPZ (rad. m): 15. SRZ (rad. m): 3.9.

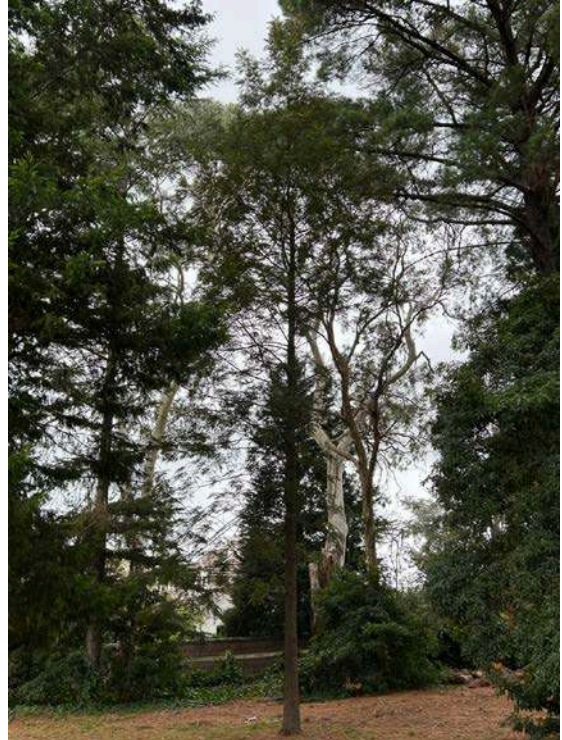
Tree ID: 41. *Pittosporum undulatum* (Sweet Pittosporum), Early-mature Victorian native. DBH: 17cm. Arb. Rating: Low. Basal decay, basal wounds, epicormic shoots, Environmental Weed. TPZ (rad. m): 2. SRZ (rad. m): 1.8.

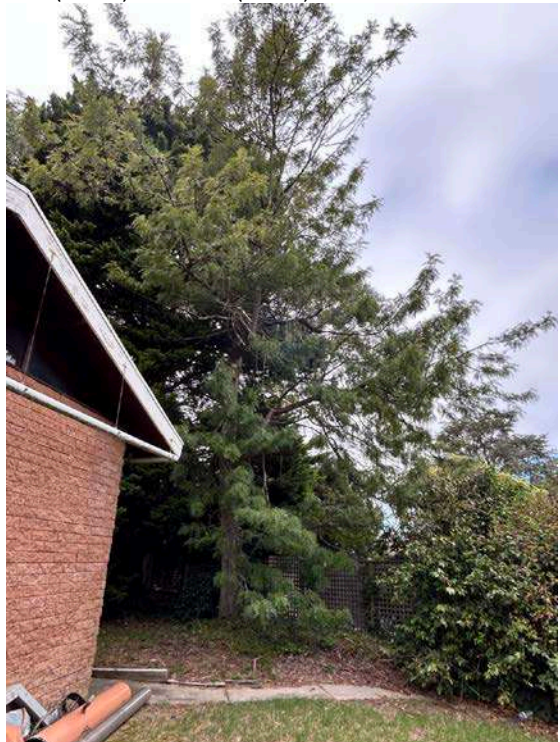
Tree ID: 48. *Grevillea robusta* (Silky Oak), Early-mature
Australian native.
DBH: 41cm. Arb. Rating: Low. Deadwood, exposed
roots, mower damage to surface roots. Possibly
previously lopped. TPZ (rad. m): 4.9. SRZ (rad. m): 2.4.

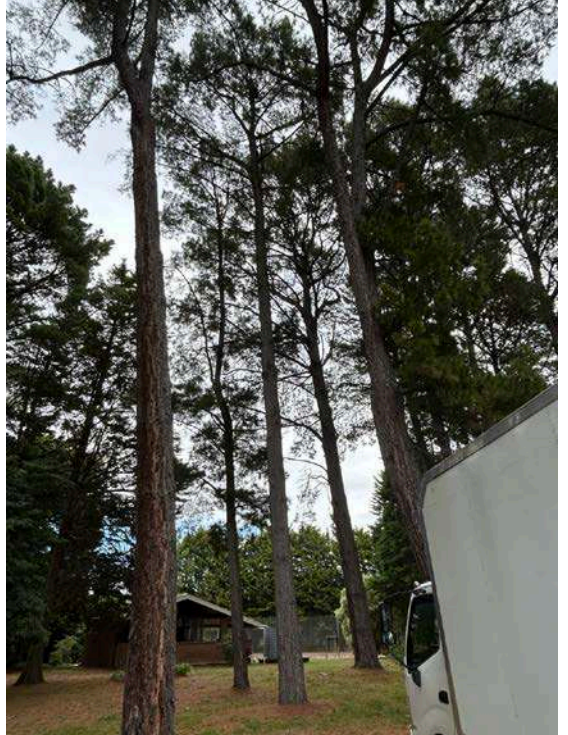
Tree ID: 53. *Pinus radiata* (Monterey Pine), Maturing Exotic conifer.
DBH: 74cm. Arb. Rating: Mod.C. Acute forks, co-dominant stems, included bark. Cabled- last inspection unknown. TPZ (rad. m): 8.9. SRZ (rad. m): 3.

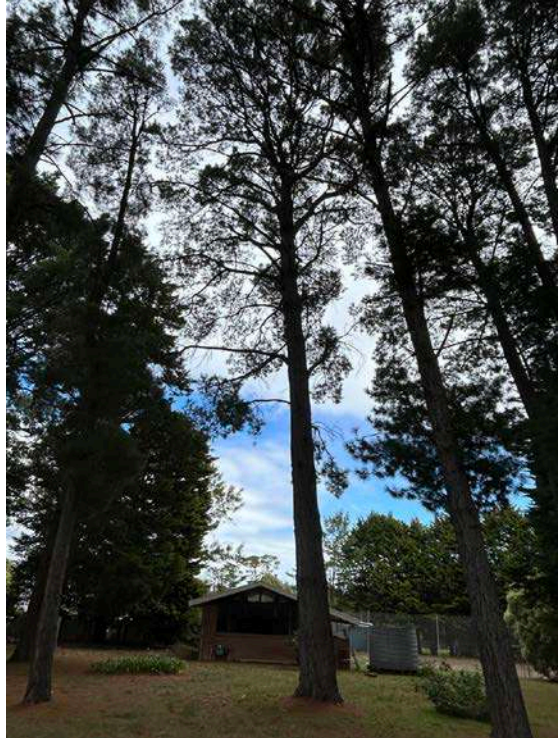
Tree ID: 56. *Pinus radiata* (Monterey Pine), Maturing Exotic conifer.
DBH: 58cm. Arb. Rating: Mod.C. Deadwood >50mm, partly suppressed - crown bias. Minor trunk lean to southeast. TPZ (rad. m): 7. SRZ (rad. m): 2.7.

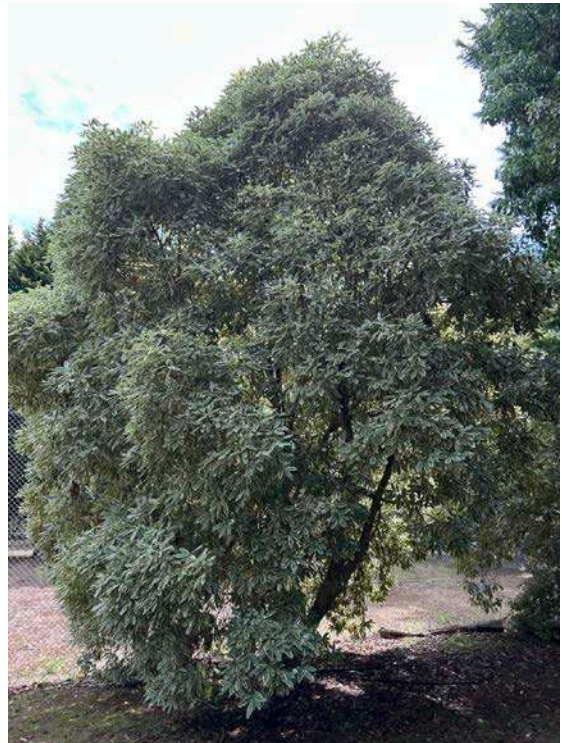
Tree ID: 65. *Pittosporum eugenioides* 'Variegatum' (Variegated Tarata), Early-mature Exotic evergreen. DBH: 12cm. Arb. Rating: Low. Basal decay, basal wounds, borers, deadwood >50mm.. TPZ (rad. m): 2. SRZ (rad. m): 1.6.

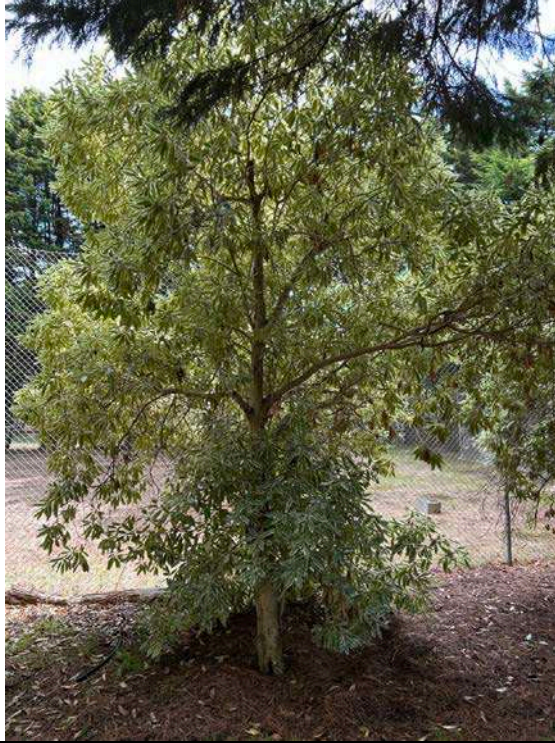
Tree ID: 66. *Pittosporum eugenioides* 'Variegatum' (Variegated Tarata), Early-mature Exotic evergreen. DBH: 9,8,6cm. Arb. Rating: Low. Borers, decay, epicormic shoots, limb wounds.. TPZ (rad. m): 2. SRZ (rad. m): 1.7.

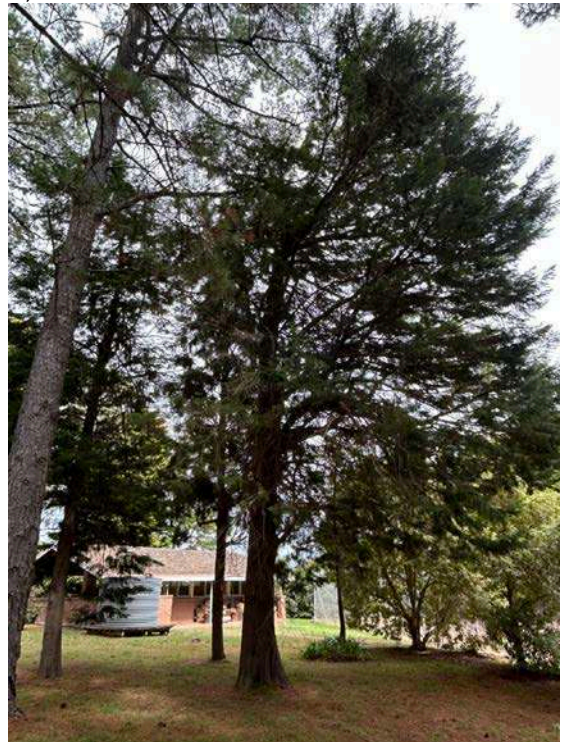
Tree ID: 68. *Pinus radiata* (Monterey Pine), Maturing Exotic conifer. DBH: 62cm. Arb. Rating: Mod.C. Co-dominant stems, deadwood >50mm, girdling root.. TPZ (rad. m): 7.4. SRZ (rad. m): 2.8.

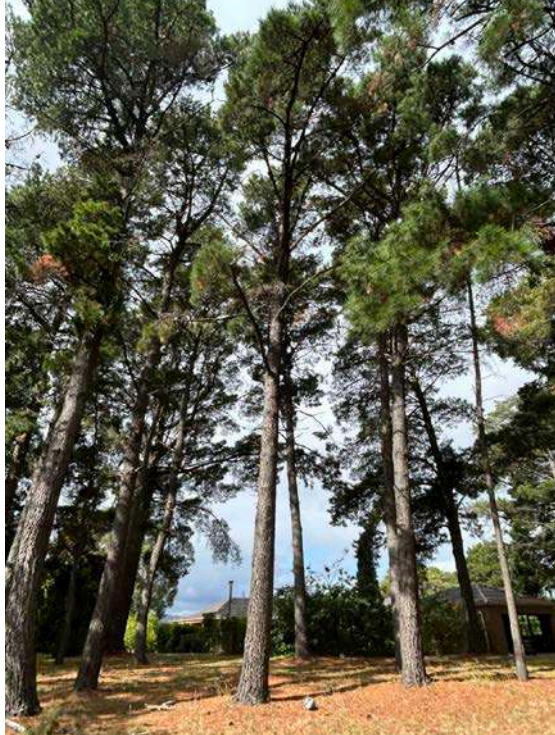
Tree ID: 78. *Pinus radiata* (Monterey Pine), Maturing Exotic conifer.
DBH: 69cm. Arb. Rating: Mod.C. Deadwood >50mm, leaning trunk, mower damage to surface roots.. TPZ (rad. m): 8.3. SRZ (rad. m): 3.

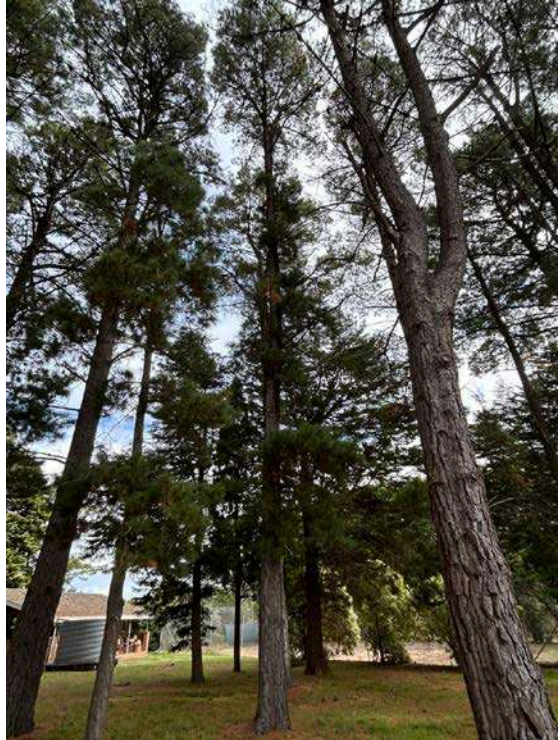
Tree ID: 81. *Pinus radiata* (Monterey Pine), Maturing Exotic conifer.
DBH: 69cm. Arb. Rating: Low. Co-dominant stems, deadwood >50mm, included bark, mower damage to surface roots.. TPZ (rad. m): 8.3. SRZ (rad. m): 2.9.

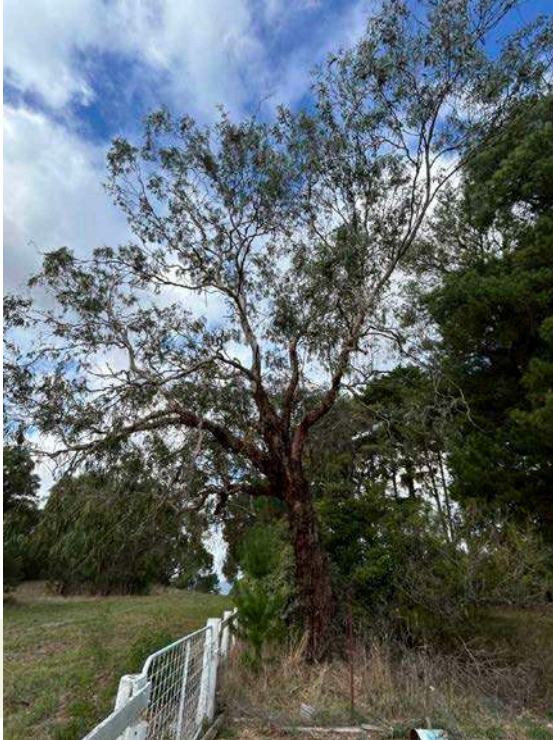
Tree ID: 91. *Eucalyptus cephalocarpa* (Mealy Stringybark), Maturing Australian native.
DBH: 55,48cm. Arb. Rating: Low. Bracket fungi, co-dominant stems, trunk wounds. Sp ?.. TPZ (rad. m): 8.8. SRZ (rad. m): 3.1.

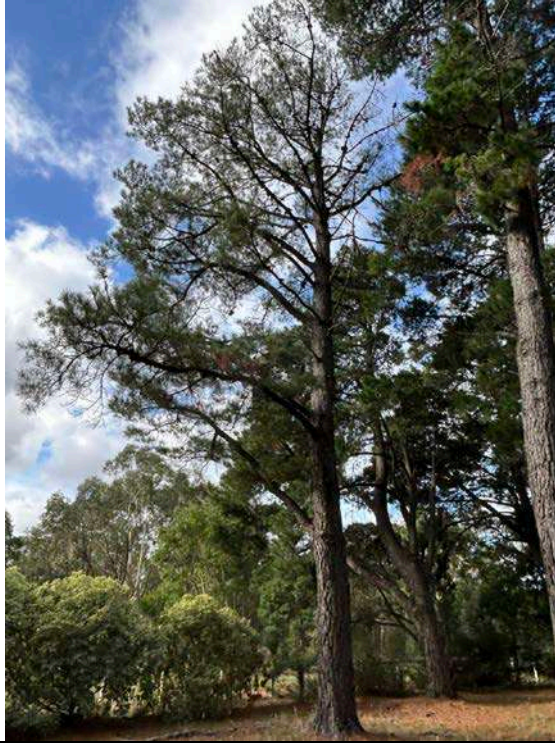
Tree ID: 94. *Pinus radiata* (Monterey Pine), Maturing Exotic conifer.
DBH: 63cm. Arb. Rating: Low. Deadwood >50mm, exposed roots, girdling root, mower damage to surface roots. Kinked trunk.. TPZ (rad. m): 7.6. SRZ (rad. m): 2.9.

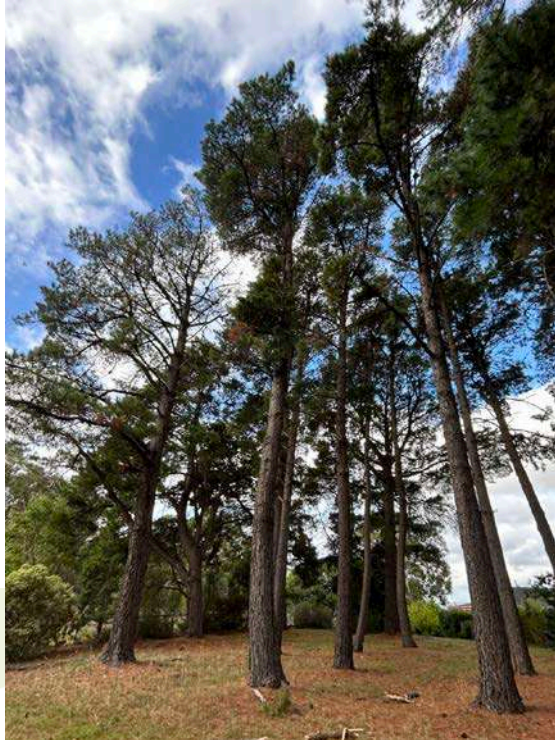
Tree ID: 95. *Pinus radiata* (Monterey Pine), Maturing Exotic conifer.
DBH: 74cm. Arb. Rating: Mod.C. Exposed roots, over-extended limbs developing, suppressed, crown bias- n.. TPZ (rad. m): 8.9. SRZ (rad. m): 3.1.

- Trees 95, 108, and 109 will have their TPZs encroached by landscaping works to facilitate new planting. Landscaping design and construction should be sensitive to the site conditions and avoid soil level changes near retained trees. Changes in moisture levels, loss of tree roots and soil level changes can have detrimental effects on trees. It is recommended that with reference to the above trees, the proposed landscaping is to be tree sensitive, with garden beds or planter boxes / structures to be placed directly on ground or secured with individual footings instead of topping up existing soil level.
- It is also recommended that mulching and underplanting be part of the overall landscaping design to enhance the condition of root zones around retained trees.

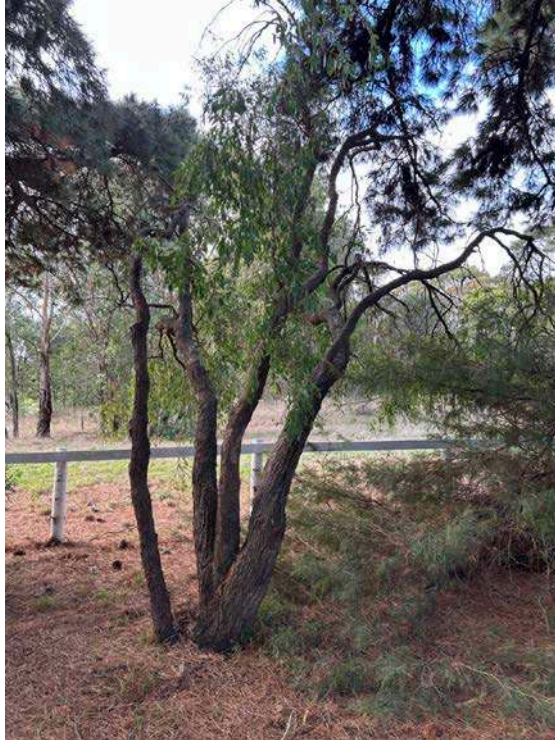
Tree ID: 106. *Acacia elata* (Cedar Wattle), Maturing Australian native.
DBH: 38,28cm. Arb. Rating: Low. Borers, co-dominant stems, past branch failure, past limb failure.
Delaminating bark, trunk exudation. TPZ (rad. m): 5.7. SRZ (rad. m): 2.9.
