Amended Tree Impact Assessment

Site: 675 Victoria St, Abbotsford 3067

Date of Inspection: 21 April 2022 & October 2024

Report prepared by: Joe Kellett (Adv. Cert. Arb. & Dip. App. Sc. (Arb.))

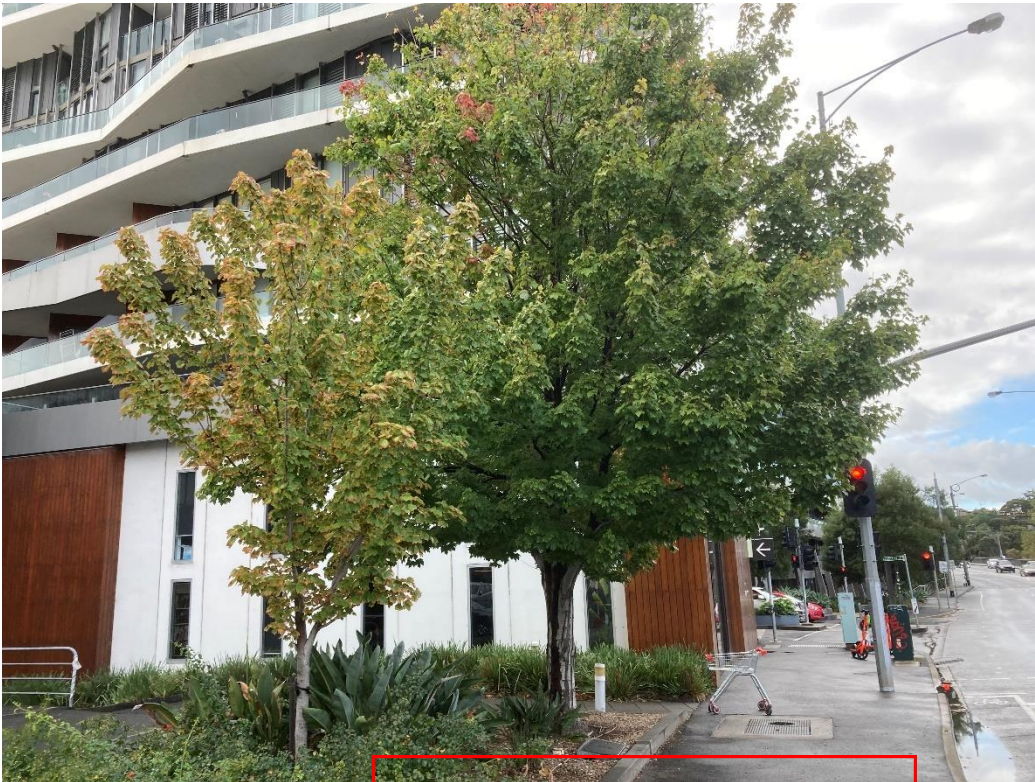
Photo A shows

Trees 1 and 2 a pair of *Acer rubrum* CV (Hybrid or Red Maple) as seen from the west; Tree 2 is the smaller tree on the left of shot; both are to be removed and replaced.

Trees 1 and 2 are *Acer rubrum* CV (Hybrid of Red Maple), these exotic trees are growing on the southern boundary of this property. Tree 1 is larger and has a history of failures, with a number of acute branch attachments with included bark that could fail in the near future. Tree 2 is drought stressed, with its restricted size and all leaves have burnt leaf margins. These poor specimens should be removed to allow for the rejuvenation of this neglected area of this landscape.

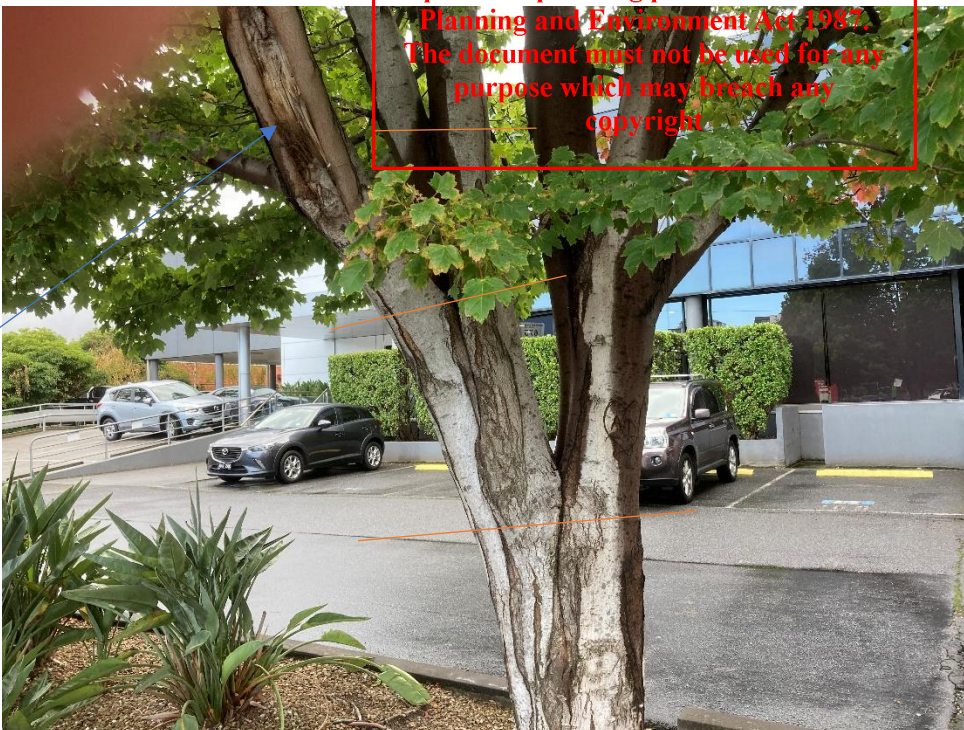
Photo B shows a close up of Tree 1 as seen from the north east; illustrating the acute branch attachments (red lines) and previous points of branch failures due to poor attachment (blue arrow).

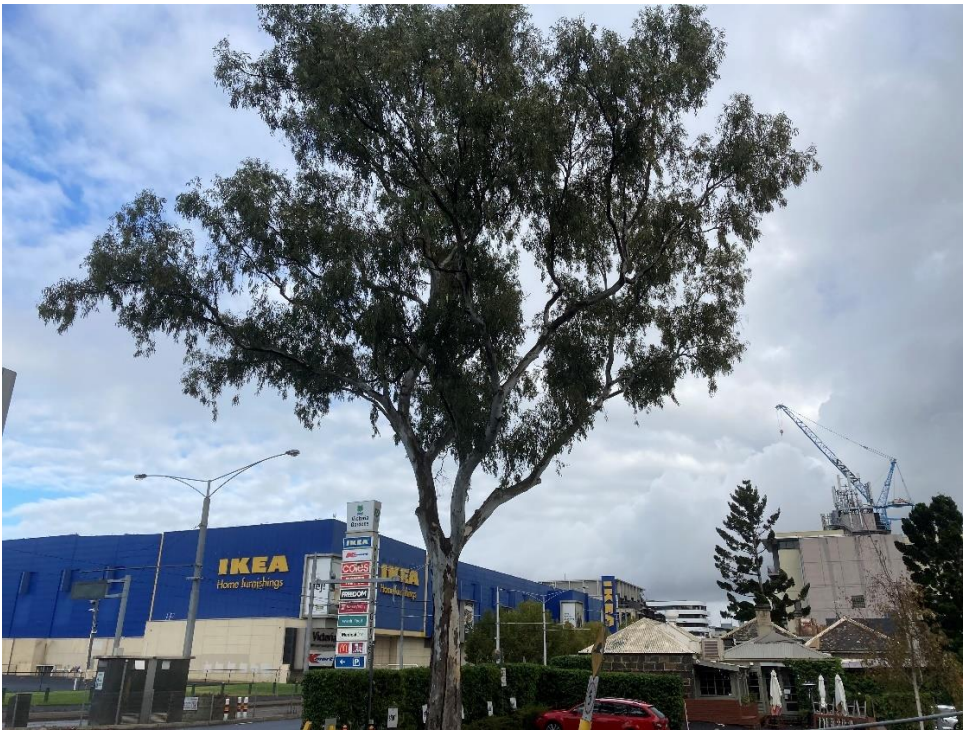
Tree 3 is a *Eucalyptus camaldulensis* (River Red Gum), this tree is situated immediately on the western boundary of this property, mostly in the neighbouring property. It therefore must be protected from any adverse impact. The area opposite this tree inside this property is covered in asphalt, leading to the ramp down to the carpark. This is to be removed and infrastructure relocated further from this tree. The area immediately around the base of this tree will become an open mulched garden bed. There can be no trenching or major excavation within 5.8 metres from the trunk of this tree, without a 'none destructive root inspection' being carried out prior. It would be possible to make available for the sole purpose of enabling its consideration and review as an arborist plan and the approval of the Planning and Environment Act 1987. The document must not be used for any purpose which may breach any copyright

Photo C shows Tree 3 a *Eucalyptus camaldulensis* (River red Gum) as seen from the north east. Illustrating its size in the landscape and even canopy of leaves, it is positioned on the western boundary of this property. This indigenous tree is to be retained and protected

construction within the TPZ of this tree. This must be done under the close supervision of the 'project arborist' and the approval of the local authority. This would all be predicated in there being no adverse impact or damage to this tree.

Temporary fencing will also be required around Tree 3. The current plans have been amended to allow this tree more space in which it can continue to thrive and grow towards its potential. The additional space will become an open mulched garden bed, with under plantings of shrubs, ground cover and grasses. This will allow more space for water to percolate into the soil profile, improve soil conditions and improve the health potential of this indigenous tree in the long-term.

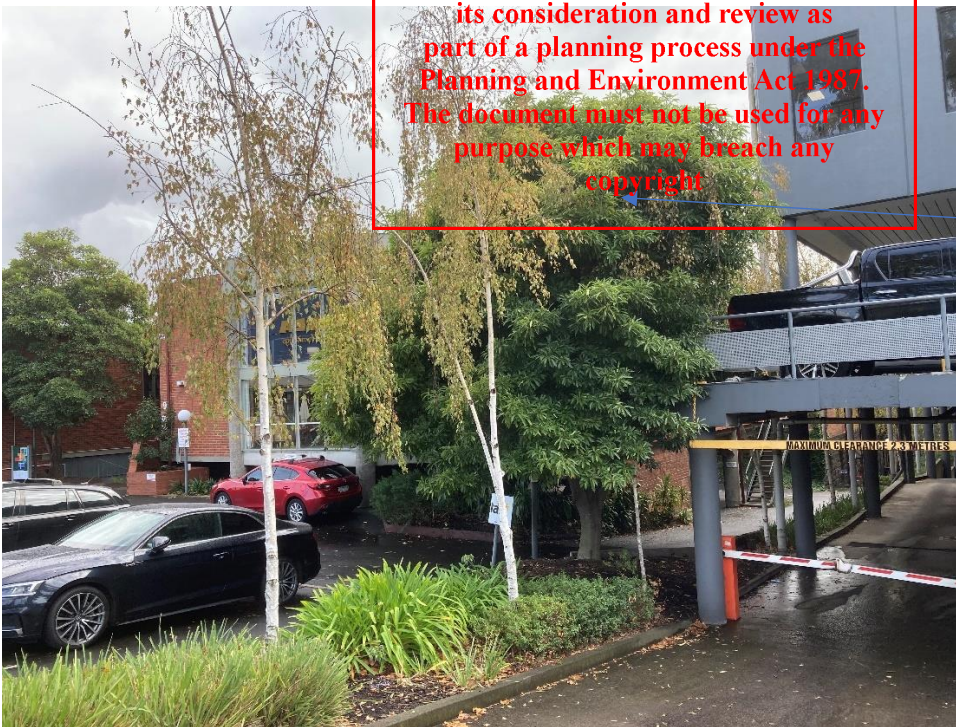
Photo D shows Trees 4 and 5 a pair of *Betula pendula* 'Dalecarlica' (Cut leaf Silver Birch) as seen from the south east; coming in their autumn colour; they are to be removed. Immediately behind them is Tree 6 a *Pittosporum undulatum* (Sweet pittosporum) as indicted by the blue arrow.

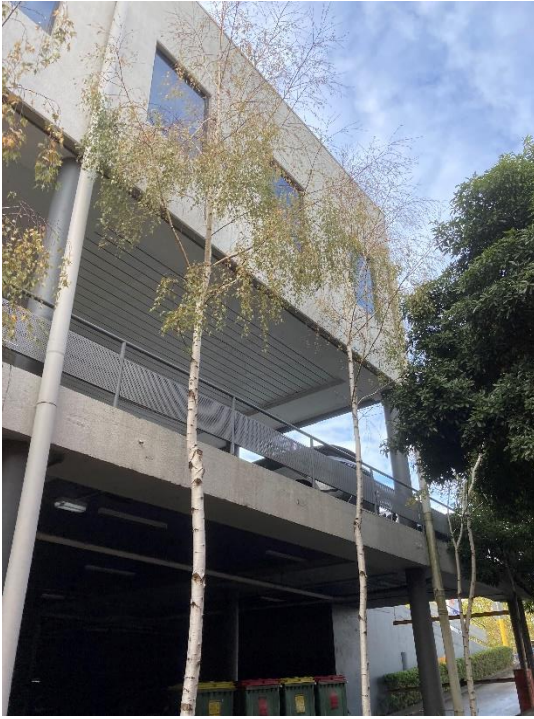
Trees 4, 5, 7-16 are all *Betula pendula* 'Dalecarlica' (Cut leaf Silver Birch), these exotic trees are all growing on this western boundary. They are growing in a narrow garden bed, that has a substantial concrete 'plinth' or retaining wall at the boundary of this property. This type of exotic tree is recognised as being short-lived in our urban landscape. They rarely exceed 40 years of age, due to their sensitivity to dry soils and over pruning. They have areas of their upper canopies

already dying back. This is due to their poor growing conditions, suppressed between the 2 multi-story buildings and the short ULE that is typical for this species of tree. These trees are inside the proposed building envelope and would have to be removed to allow this proposal to proceed as it has been presented here. These trees should not be seen as an impediment to the approval of a good design.

Photo E shows Trees 8 and 9 a pair of *Betula pendula* 'Dalecarlica' as seen from the north west in the neighbouring property. Illustrating their position up against the existing building in a narrow garden bed.

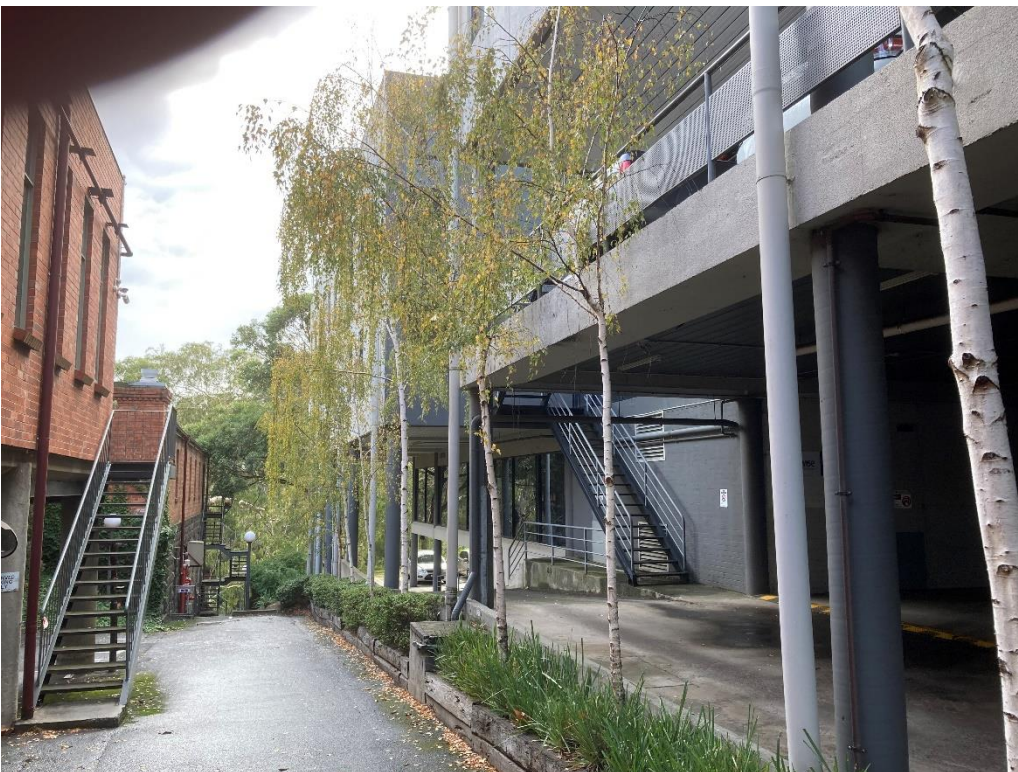
Photo F shows Trees 10–16 a line of *Betula pendula* 'Dalecarlica' as seen from the south west in the neighbouring property. It also shows the narrow garden bed they are positioned in, up against the existing building. All are marked for removal; they provide no amenity in this position.

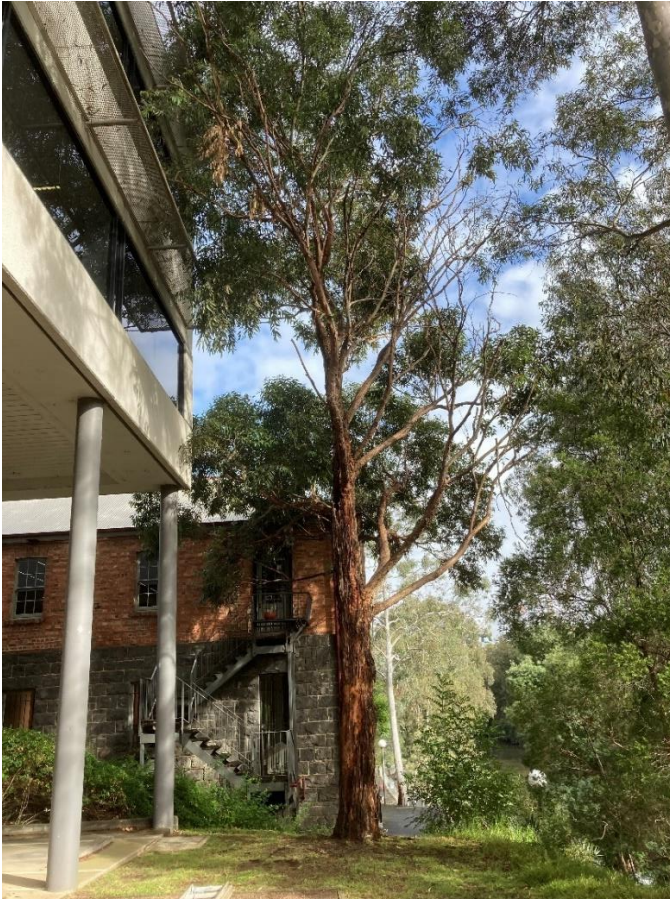
Tree 17 is a *Eucalyptus botryoides* (Bangalay), this native tree is growing up against the rear of the existing building and impacting it, see Appendix 4. The north side of its canopy is dying off, with significant dead wood present in this area. This might be partially the result of the roots of this tree are exposed to the elements, with a loss of soil cover. This tree has longicorn beetle (wood boring insect larvae) attacking its trunk and scaffold branches, with kino bleeding from numerous areas. This tree cannot be recovered from this poor condition and will continue to decline in health regardless of actions taken. This type of tree is known for shedding branches as it ages, in particular as fungal decay established in scaffold branches. It has therefore been marked for removal and replacement with a healthy tree; it would not be missed from this position.

Photo G shows Tree 17 a *Eucalyptus botryoides* (Bangalay) as seen from the east, growing on the north boundary of this property. This tree is impacting the existing building and its north side is mostly dead; it has therefore been marked for removal.

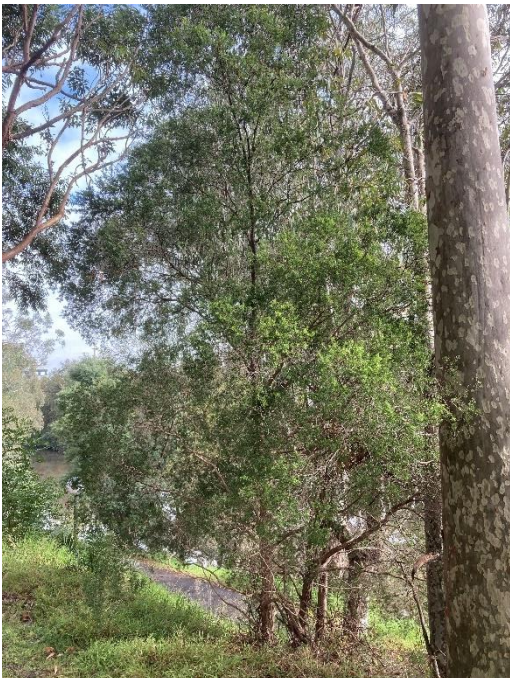
Tree 18 is a *Melaleuca styphelioides* (Prickly Paperbark) this tree is suppressed by nearby trees and will never reach its potential. This type of tree has foliage that causes irritation to people and pets and is a poor selection close to areas used by them. This unattractive tree has been marked for retention in the short-term; once the rejuvenated landscape has become established this tree could be removed to allow more attractive tree more room to grow towards their mature

Photo H shows Tree 18 a *Melaleuca styphelioides* (Prickly Paperbark) growing on the north boundary; this suppressed tree has been marked for retention. The trunk of Tree 19 marks the right-hand side of shot.

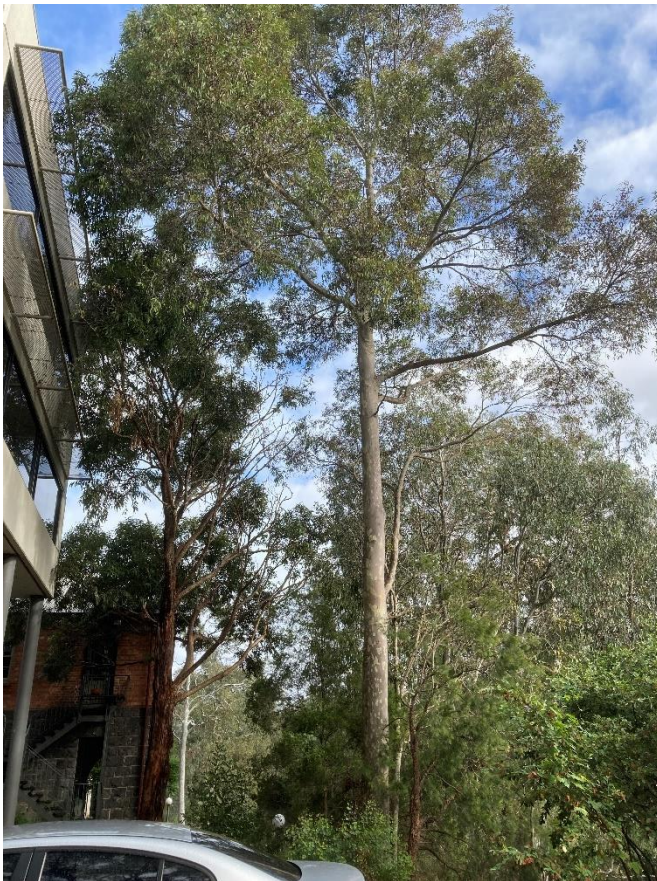
Tree 19 is a *Corymbia maculata* (Spotted Gum), this native tree is growing immediately to the north of the boundary of this property, opposite a compacted gravel parking area and on top of the embankment leading down to river. There can be no trenching or major excavation into the existing spoil within 5.4 metres of the trunk of this tree, without a 'none destructive root inspection' being carried out prior. It would be possible to carry out pier and beam construction within the TPZ of this tree. This must be done under the close supervision of the project arborist and the approval of the local authority. This would all be predicated in there being no adverse impact or damage to this tree.

Photo I shows Tree 19 a *Corymbia maculata* (Spotted Gum) as seen from the east; illustrating its position just on the north boundary of this property. It requires necessary clearance and protection form any adverse impact, including temporary protective fencing.

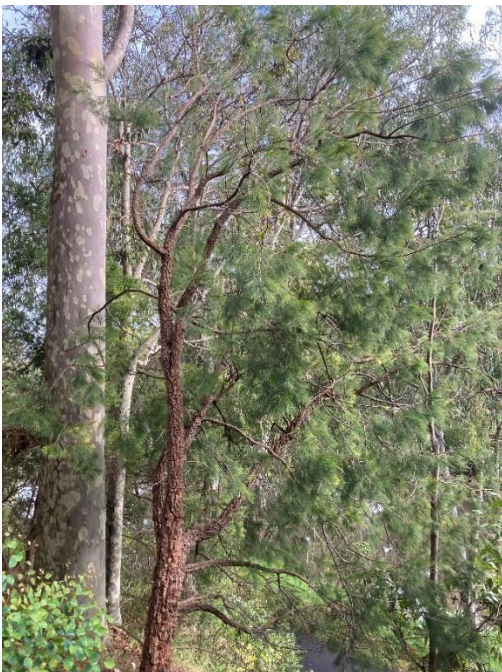
proportions. Tree 20 is a *Allocasuarina torulosa* (Forest She-oak), this small native tree is growing under the canopy of Tree 19. This tree is native to NSW, though not to Victoria. It is growing on the east boundary of this property. This small tree has been planted and will never reach its potential due to larger trees growing nearby. It will benefit from the proposed rejuvenation of the existing landscaping; improvements in soil condition will help this tree to better enhance the immediate area.

Photo J shows Tree 20 an *Allocasuarina torulosa* (Forest She-oak) as seen from the east; it is positioned just on the north boundary of this property and will be retained.

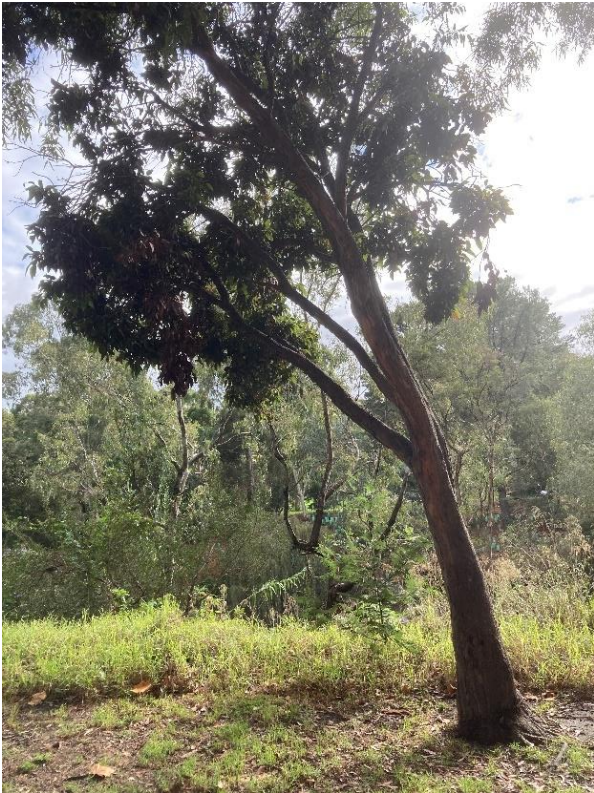
Tree 21 is a *Corymbia ficifolia* (Red Flowered Gum), this tree is suppressed by nearby larger trees. It is weight biased to the west, creating a tree of poor form and poor structure, see Appendix 4. Pruning to manage its weight biased canopy would adversely impact the health of this tree and further reduce its ULE. This small tree would not be missed from this confined position if removed and replaced as part of the rejuvenation of this neglected landscape. Its removal would allow for more planting of healthy trees, that would better enhance the immediate landscape now and the wider landscape in the long-term as they grow towards their mature proportions.

Photo K shows Tree 21 a *Corymbia ficifolia* (Red Flowered Gum) as seen from the south east; illustrating its weight bias to the west or left of shot, a suppressed native has been marked for removal and replacement.

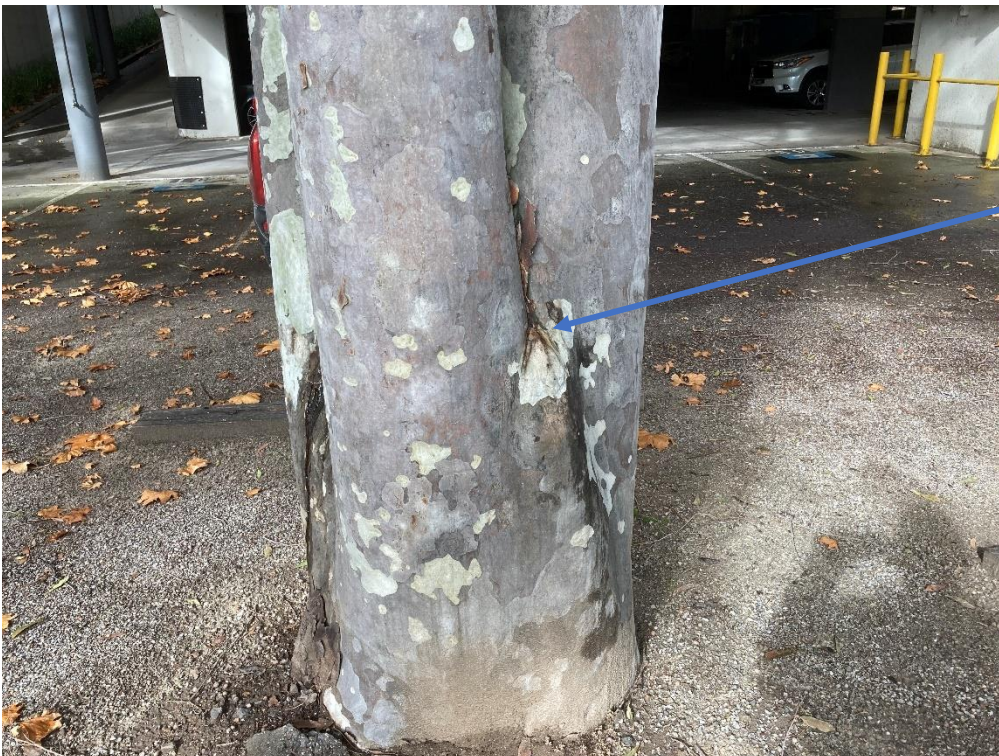
Tree 22 is a *Corymbia maculata* (Spotted Gum), this native tree is bifurcated close to its base with three acutely attached trunks, with included bark and kino bleeding at the largest of these points, see Appendix 4. This is an underlying structural fault that would result in stem failure if no major pruning is undertaken. If major pruning is undertaken, it will reduce this potential for a stem failure to occur; it cannot eliminate this potential. In particular as this tree continues to grow taller, the wind loading on such poorly attached stems would exceed strength at this point and result in a stem failure. This tree is inappropriate in this

Photo L shows the base of Tree 22 a *Corymbia maculata* (Spotted Gum) as seen from the north. It illustrates the bifurcations at this point and the included bark, blue arrow. This structural fault could result in stem failure in the future; it has been marked for removal and replacement.

position in the long-term and has therefore been marked for removal and replacement with a more suitable and structurally sound tree. A tree that will enhance this landscape now and the wider landscape in the long-term.

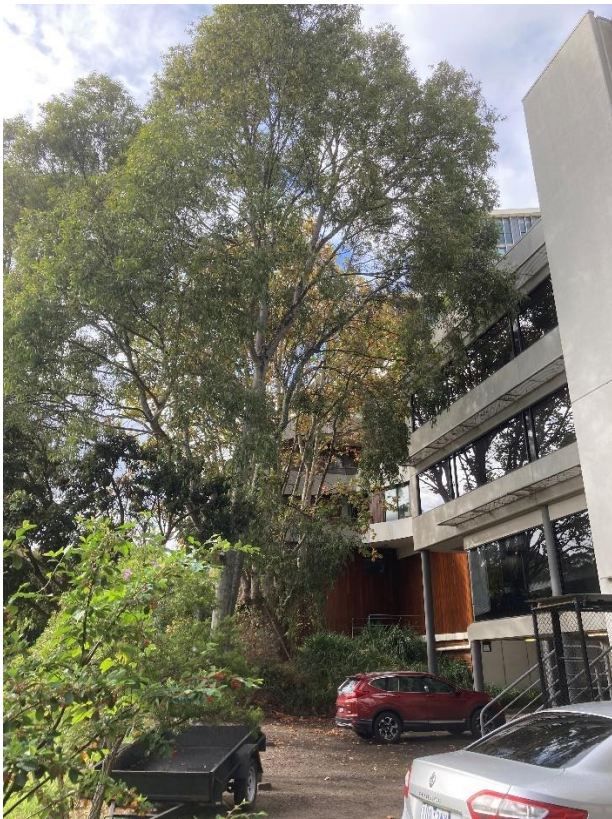
Photo M shows Tree 21 a *Corymbia maculata*, illustrating its entire canopy as seen from the west; illustrating its weight bias to the south and the existing building. It has been marked for removal and replacement due to underlying structural fault at its base.

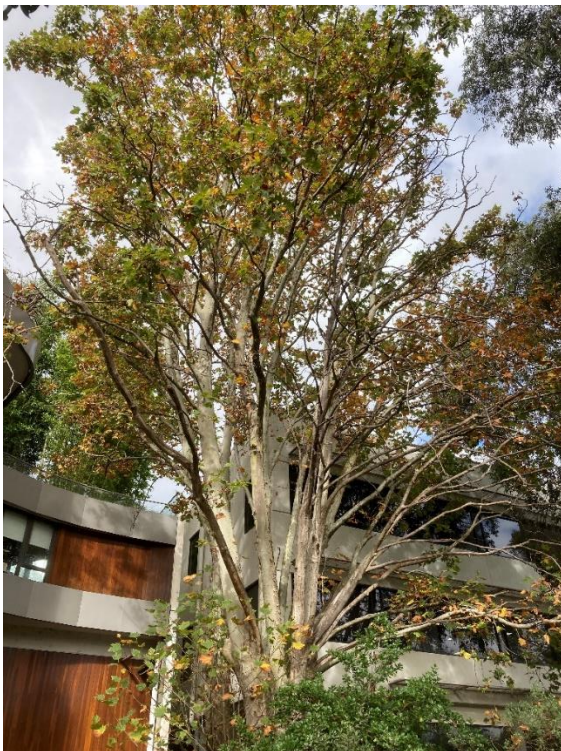
Trees 24 is a *Platanus x acerifolia* (London Plane tree), this exotic is positioned 2.4 metres to the east of the existing property envelope, up a raised short embankment. This tree was previously 'pollarded' in the past, this ceased approximately 30 years ago. It has now regrown a canopy of large woody branches, attached to decayed areas of the trunk of this tree; see Appendix 4. The attachment of these scaffold branches is suspect. If this tree is not pruned appropriately it will continue to decline in health and structure. 23% if its canopy,

concentrated on its northern side is dead or dying, see Appendix 4. This appears to be the beginning of this tree entering a spiral of decline, from which it cannot be revived. This tree will require close monitoring and care, if it is to be retained as a tree that might provide any amenity to this area. There can be no trenching or major excavation into the existing spoil within 7.6 metres of the trunk of this tree. A 'none-destructive root inspection' has been carried out and shown it is possible to install pier and beam construction. It would be possible to carry out pier and beam construction within the TPZ of this tree. This must be done under the close supervision of the 'project arborist' and the approval of the local authority.

Photo N shows Tree 24 a *Platanus x acerifolia* (London Plane) as seen from west; illustrating this side of its canopy dying back a strong sign of its poor health and neglect; growing in neighbouring property.

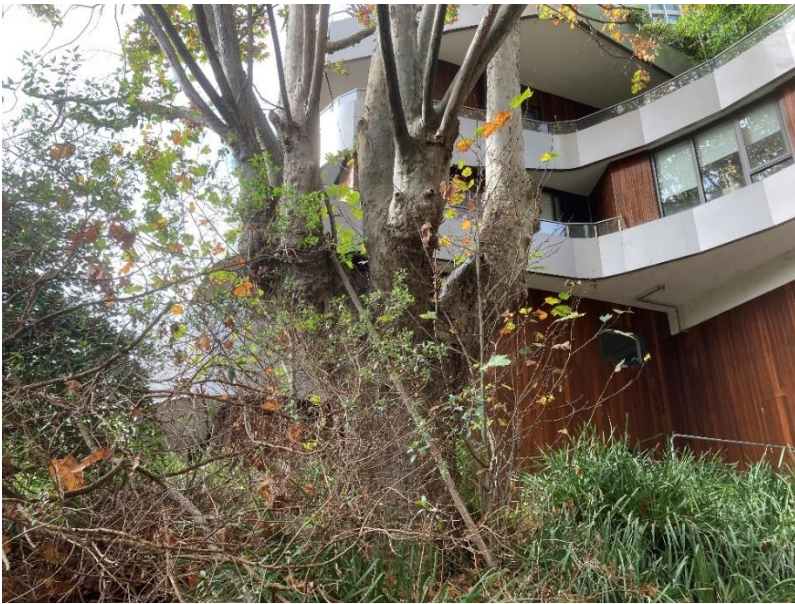
Photo O shows Tree 24 a *Platanus x acerifolia*, illustrating its scaffold branches attached to the point where this tree was previously pollarded. There is fungal decay present in the trunk of this tree, a result of its advanced age. It requires sufficient clearance to fully protect it from any adverse impact, as it is growing close to the eastern boundary of this property.

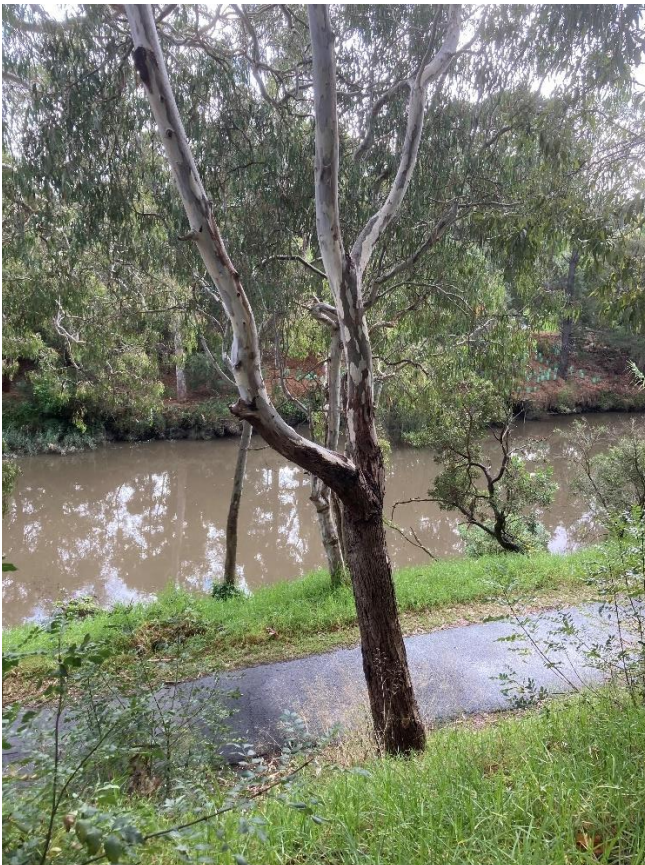
Tree 25 is a *Eucalyptus camaldulensis* (River Red Gum), this indigenous tree is positioned down the embankment by 5 metres from the north boundary of this property. It is well clear of this property and the proposed building envelope. It therefore would not be impacted by this building proposal in any manner. The major landscape plan has a public stair access, this will pass close to the TPZ of this tree. It must be isolated from the proposed works with the installation of temporary protective fencing. All proposed works close to the TPZ of this or other native trees growing in the public domain must be closely supervised by the 'project arborist'. To ensure the greatest care is taken to isolate these trees from any possible impact, including inadvertent impacts, soil contamination or compaction. The use of 'pier and beam construction' techniques would minimise any possible impact to trees, under the close supervision of the project arborist.

Photo P shows Tree 25 a *Eucalyptus camaldulensis* (River Red Gum) as seen from the south; it is growing 5 metres outside the northern boundary of this property. It requires protection from inadvertent impact to ensure its ongoing health and structure; this could include 'pier and beam' construction of proposed stairs inside its TPZ, under the close supervision of a project arborist.
