Arboricultural Report

Holy Spirit Catholic Primary
School, 83 Minerva Road
Manifold Heights

9/12/2023

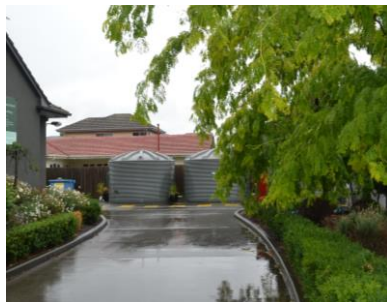
FIGURE 1, UPLIFT OVER DRIVEWAY

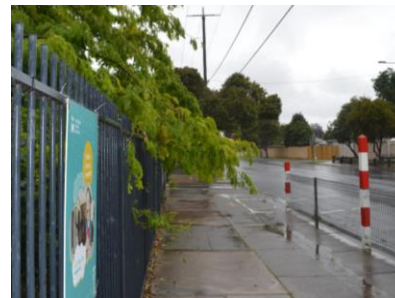
FIGURE 1, UPLIFT OVER FOOTPATH

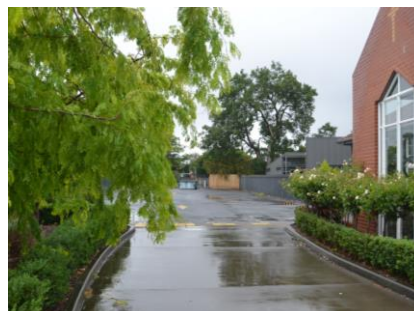
FIGURE 1, UPLIFT OVER DRIVEWAY

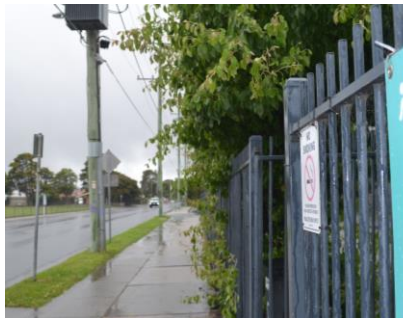
FIGURE 1, FOLIAGE OVER FOOTPATH

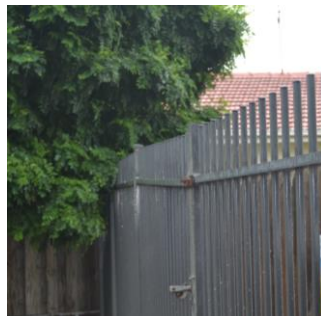
FIGURE 1, CLEAR OF FENCE

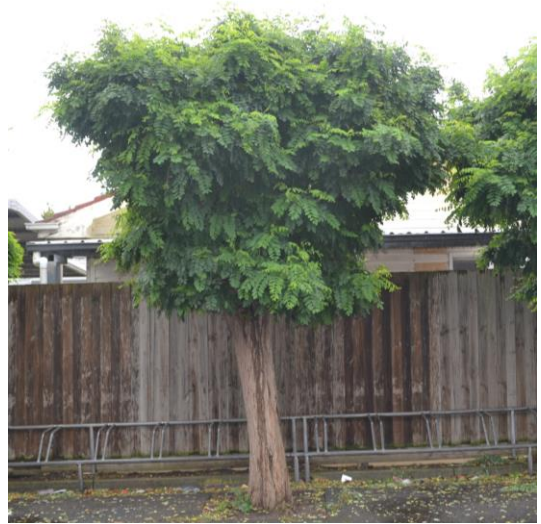
8.5 Tree 9 *Robinia pseudoacacia umbracaulifera*

Semi-mature tree located along fence line of school and houses north side of school. Tree is of good health and fair structure with no works required at time of inspection.

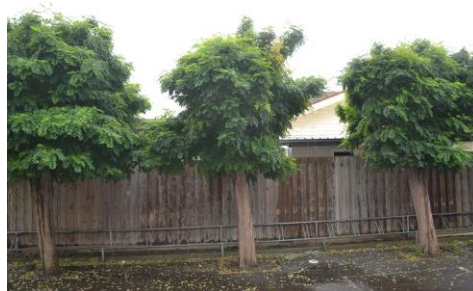
8.6 Tree 10 *Robinia pseudoacacia umbracaulifera*

Semi-mature tree located along fence line of school and houses north side of school. Tree is of good health and fair structure with no works required at time of inspection.

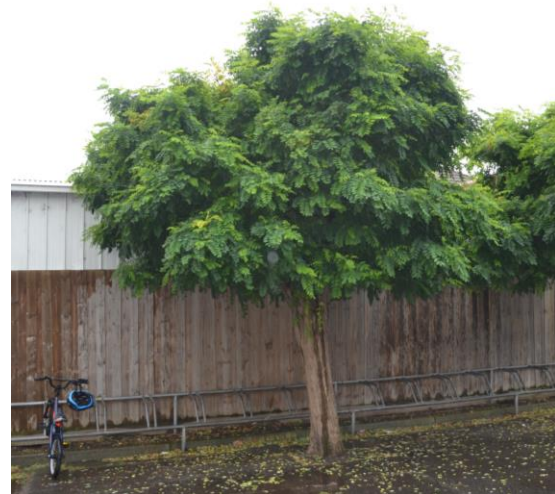
Semi-mature tree located along fence line of school and houses north side of school. Tree is of good health and fair structure with no works required at time of inspection.

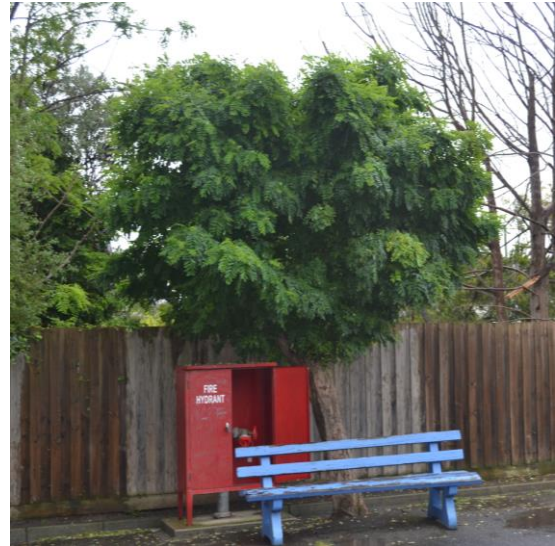
Semi-mature tree located along fence line of school and houses north side of school. Tree is of good health and fair structure with no works required at time of inspection.

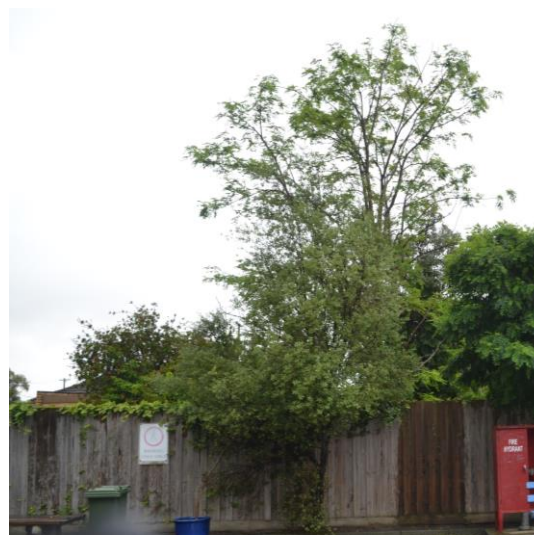
8.9 Tree 13 *Pittosporum tenuifloium*

Semi-mature tree located along fence line of school and houses north side of school. Tree is of good health and fair structure with no works required at time of inspection.

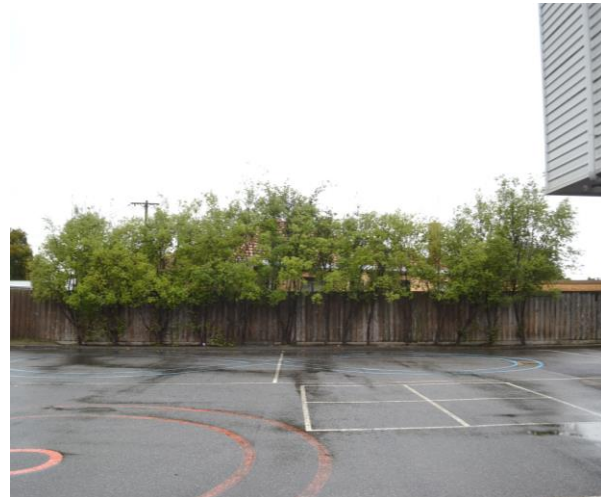
8.10 Tree 14-27 *Pittosporum tenuifloium*

Semi-mature trees located along fence line of school and houses north side of school. Trees are in good health and fair structure with no works required at time of inspection.

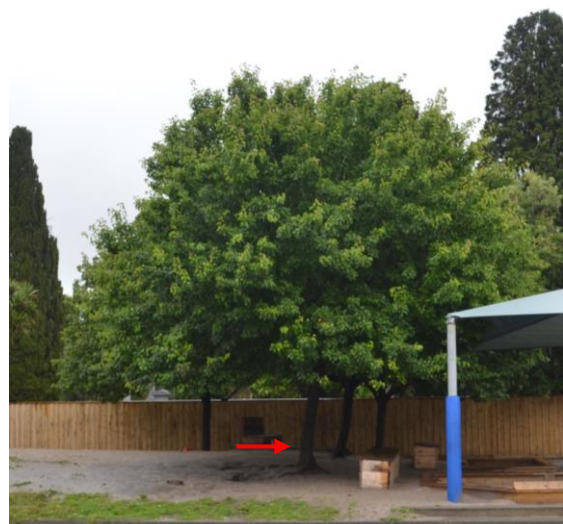
FIGURE 1, LOW FOLIAGE

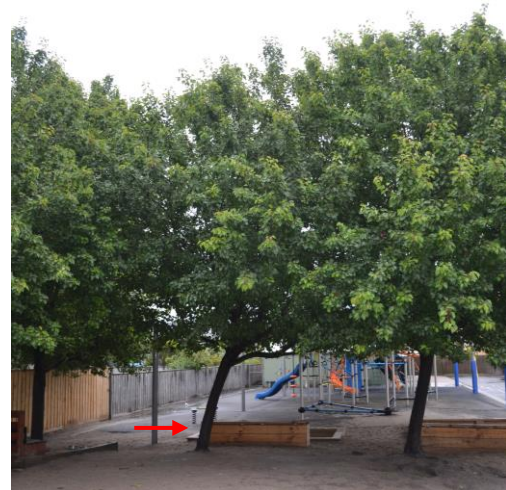
FIGURE 1, LOW FOLIAGE

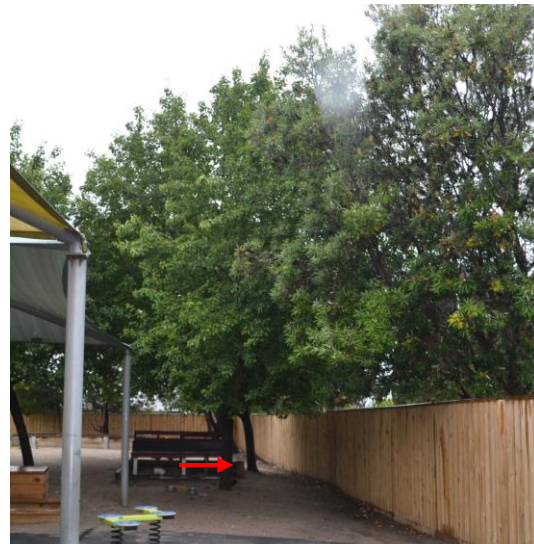
FIGURE 1, LOW FOLIAGE

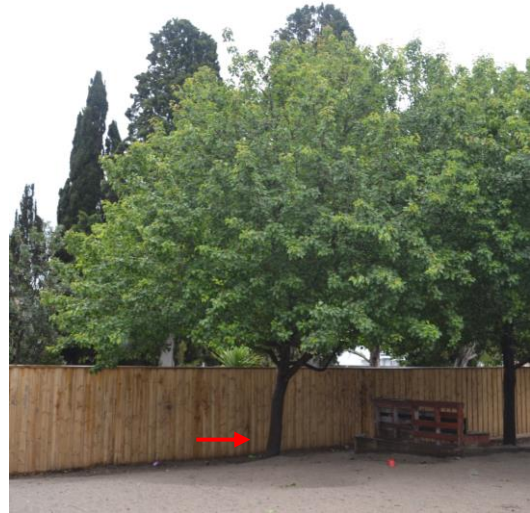
FIGURE 1, LOW FOLIAGE

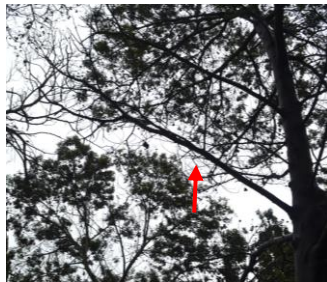
FIGURE 1, DEADWOOD

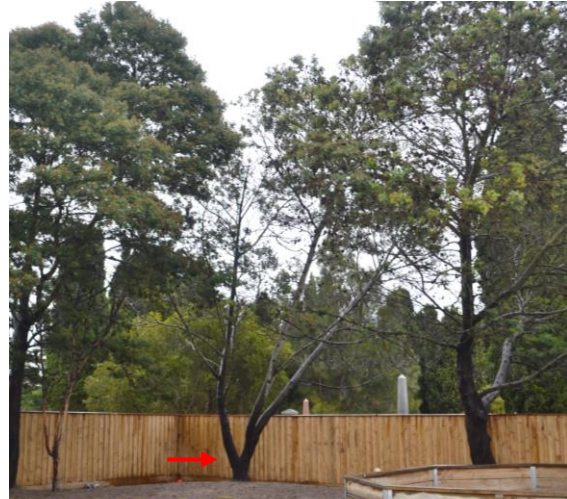
FIGURE 1, DEADWOOD

Semi-mature tree alongside fence line of school and cemetery. Deadwood throughout tree (refer figure 1 & 2). Decay pocket at base of trunk (refer figure 3). Tree is of good health & fair structure at time of inspection.

- Remove deadwood greater than 25mm – **Urgent**.
- Reinspect decay every 12 months – **Annual**.

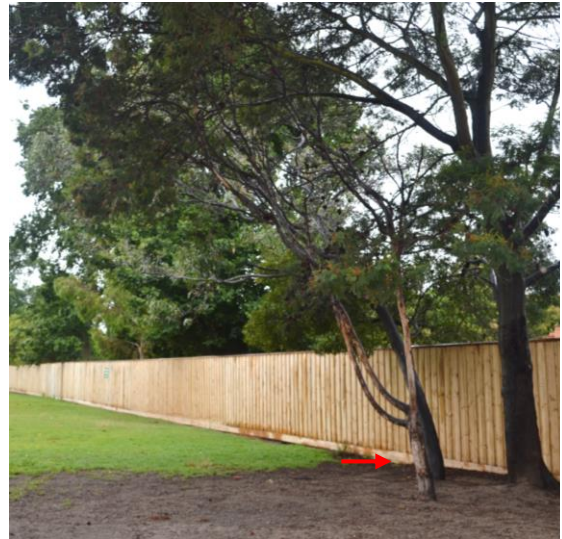
8.17 Tree 34 *Acacia mearnsii*

Semi-mature tree alongside fence line of school and cemetery. Tree is of good health & fair structure with no works required at time of inspection.

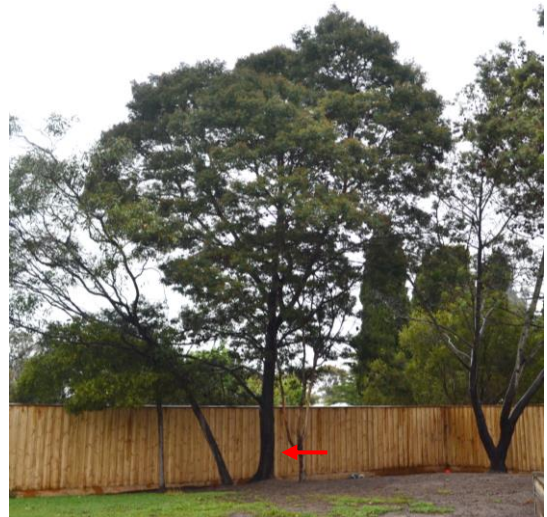
8.18 Tree 35 *Acacia mearnsii*

Mature tree alongside fence line of school and cemetery. Tree is of good health & fair structure with no works required at time of inspection.

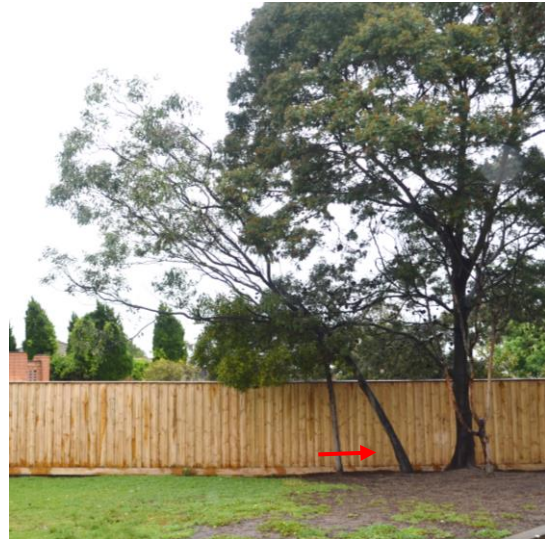
8.19 Tree 36 *Acacia mearnsii*

Semi-mature tree alongside fence line of school and cemetery. Tree is of good health & fair structure with no works required at time of inspection.

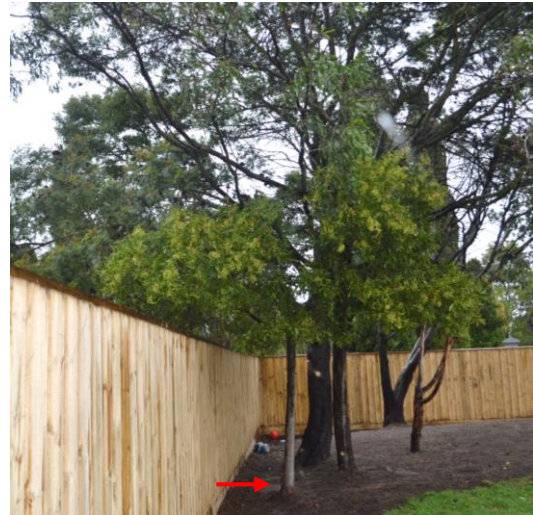
8.20 Tree 37 *Acacia melanoxylon*

Semi-mature tree on Marshalltown Rd behind basketball courts. Tree is of good health & fair structure with no works required at time of inspection.

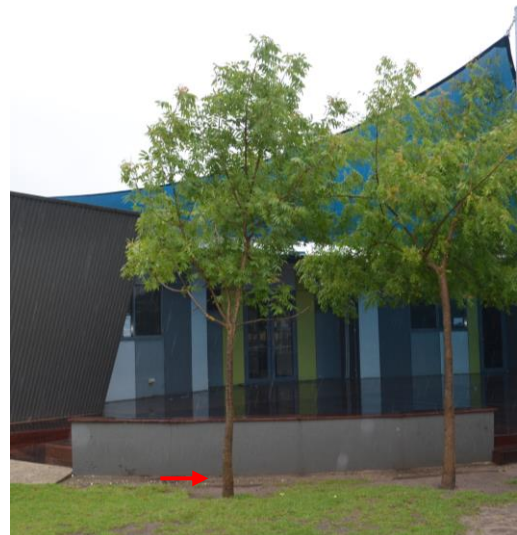
8.21 Tree 38 *Robinia pseudoacacia frisia*

Semi-mature tree between buildings at decking area. Tree is of good health & structure with no works required at time of inspection.

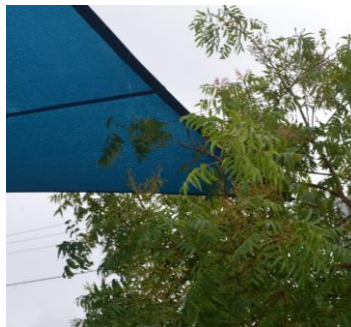
FIGURE 1, FOLIAGE ON SHADE SAIL

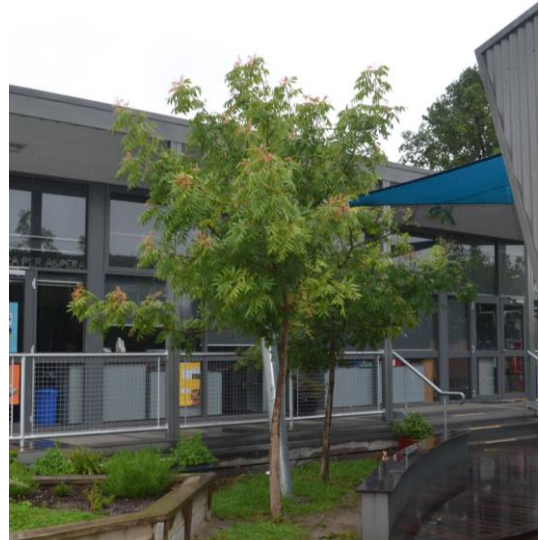
8.24 Tree 41 *Robinia pseudoacacia frisia*

Semi-mature tree between buildings at decking area. Tree is of good health & structure with no works required at time of inspection.
