Selected Mature Tree Health and Condition Assessment

Prepared for: Melbourne Montessori School - Brighton East Campus

Site Address: 741 Hawthorn Rd Brighton East

Date Prepared: April 2024

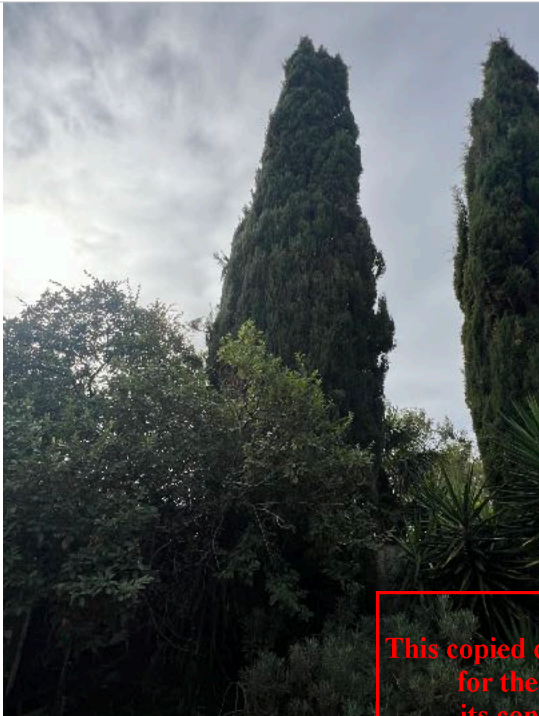
T1: *Cupressus sempervirens*

Tree Number:	Species Name: Botanical	Species Name: Common	Height (m)	Width (m)	DBH (cm)	TPZ (m)	DAB (cm)	SRZ (m)	Age:	SULE:	Structure:	Health:	Condition:	Tree Observations: April 2024	Suggested Works:	Works Priority:
1	<i>Cupressus sempervirens</i>	Pencil Pine	12	2	N.R.	N.R.	N.R.	N.R.	Mature	5 - 20 years	Fair	Fair	Poor	Creeper growing through the tree	No works	No works
2	<i>Cupressus sempervirens</i>	Pencil Pine	12	2	N.R.	N.R.	N.R.	N.R.	Mature	5 - 20 years	Fair	Fair	Poor	Creeper growing through the tree	No works	No works
3	<i>Cupressus sempervirens</i>	Pencil Pine	12	2	N.R.	N.R.	N.R.	N.R.	Mature	5 - 20 years	Fair	Fair	Poor	Creeper growing through the tree	No works	No works
4	<i>Acer negundo</i>	Boxelder Maple	13	12	N.R.	N.R.	N.R.	N.R.	Mature	Under 5 years	Poor	Fair	Poor	Deadwood present in canopy Root system is unbalanced - structural roots growing from east to west and are growing above spoil surface. However when inspecting the root flair, there is very limited root system growing from north to south Evidence of decay in old pruning cuts Tree has been lopped in the past Hanging branches in canopy	Remove to base Grind stump	High

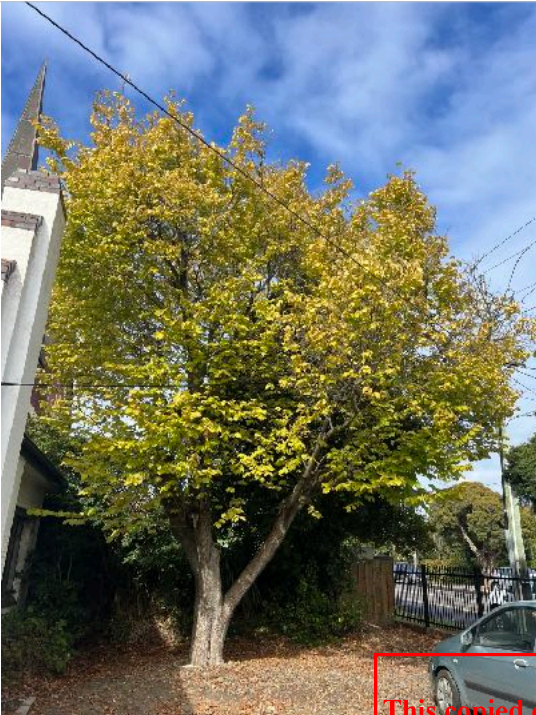
T5: *Ulmus glabra*

5	<i>Ulmus glabra</i>	Golden Elm	13	11	N.R.	N.R.	N.R.	N.R.	Mature	5 - 20 years	Fair	Poor	Fair	Large infestation of Elm Leaf Beetle in canopy History of poor pruning - tree has been lopped in the past Ground around base is compacted and soil level has increased around base resulting in reduction of water to root system Powerlines running through canopy	Elm Leaf Beetle treatment - trunk injections Remove deadwood greater than 30mm in diameter	Medium
6	<i>Syzygium smithii</i>	Lilly Pilly	14	11	N.R.	N.R.	N.R.	N.R.	Over - mature	Under 5 years	Poor	Poor	Poor	Tree appears to have been cut down to base previously, and has regrown as a multi stemmed tree resulting in poor structure and increased risk of failure Tree is close to HV powerlines in the street Tree is pushing over fence	Remove to base Grind stump	High
7	<i>Melaleuca armillaris</i>	Bracelet Honey Myrtle	8	5	26	3.1	36	2.2	Mature	5 - 20 years	Fair	Fair	Fair	Deadwood preset in canopy History of poor pruning Low branches - potential hazard to students Canopy is touching adjacent building Root system is lifting the artificial grass - if client feels the root system is causing a trip hazard, the tree will not survive the removal of the structural root and the tree will need to be removed	Uplift canopy to minimum 2.2m Prune back away from building Continue to monitor root system's interference with artificial grass	High

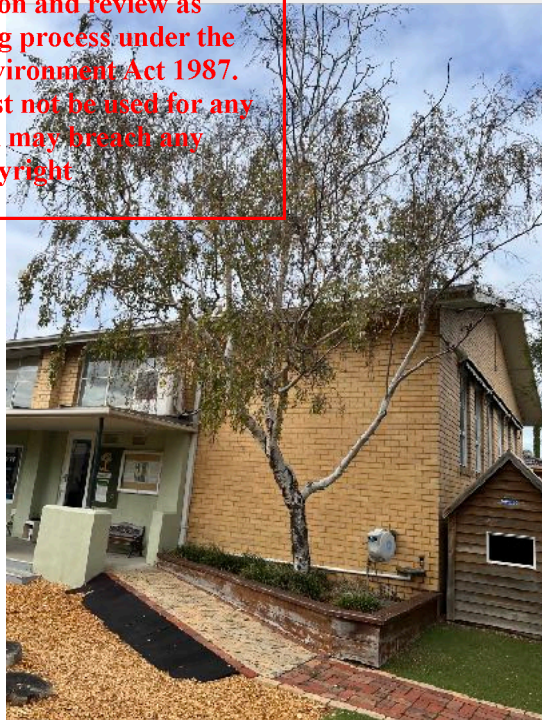
T8: *Betula pendula*

8	<i>Betula pendula</i>	Silver Birch	7	6	22	2.6	27	1.9	Mature	5 - 20 years	Poor	Fair	Poor	Top of canopy is in decline Tree is on a lean History of branch failures Branches close to adjacent building and has been in strong winds	Prune back away from building Remove deadwood greater than 30mm in diameter	High
9	<i>Hakea</i>	Hakea	6	5	33	4.0	41	2.3	Mature	5 - 20 years	Poor	Fair	Fair	Multi stemmed - DBH recorded is combined DBH of multi stems Included bark present at main union Included bark present at several smaller unions in canopy Dense canopy Rubbing branches in canopy	Remove deadwood greater than 30mm in diameter Uplift canopy to minimum 2.2m Prune back away from building	Medium
10	<i>Pyrus ussuriensis</i>	Manchurian Pear	6	2	N.R.	N.R.	N.R.	N.R.	Young	Under 5 years	Poor	Good	Fair	Poor union - included bark present	Prune away from building	Low
11	<i>Pyrus ussuriensis</i>	Manchurian Pear	5	2	N.R.	N.R.	N.R.	N.R.	Young	Under 5 years	Poor	Good	Fair	Appears to have poor branch attachments	Prune away from building	Low

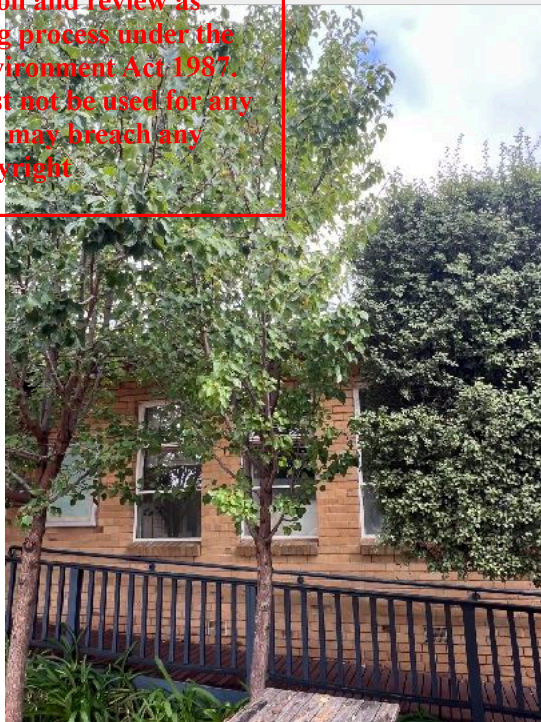
T12: *Pyrus ussuriensis*

12	<i>Pyrus ussuriensis</i>	Manchurian Pear	5	2	N.R.	N.R.	N.R.	N.R.	Young	Under 5 years	Poor	Good	Fair	Appears to have poor branch attachments	Prune away from building	Low
13	<i>Jacaranda mimosifolia</i>	Jacaranda	10	7	23	2.8	31.8	2.0	Semi - mature	5 - 20 years	Fair	Fair	Fair	Damage on south side of trunk Low branches - potential hazard to students	Uplift canopy to minimum 2.2m	High
14	<i>Acacia</i>	Wattle	7	7	26	3.1	N.R.	N.R.	Mature	5 - 20 years	Poor	Good	Fair	Included bark present at main union Tree on a lean Dense canopy Deadwood present in canopy	Prune branches back from overhanging playground Reduce end weight of branches growing to the north west Remove deadwood greater than 30mm in diameter	Medium
15	<i>Grevillea robusta</i>	Silky Oak	7	5	11	2.0	N.R.	N.R.	Young	Over 50 years	Good	Good	Good	Good health and condition	No works	No works
16	<i>Pyrus ussuriensis</i>	Manchurian Pear	6	5	N.R.	N.R.	N.R.	N.R.	Mature	5 - 20 years	Fair	Good	Good	Good health and condition Small unions with included bark	No works	No works

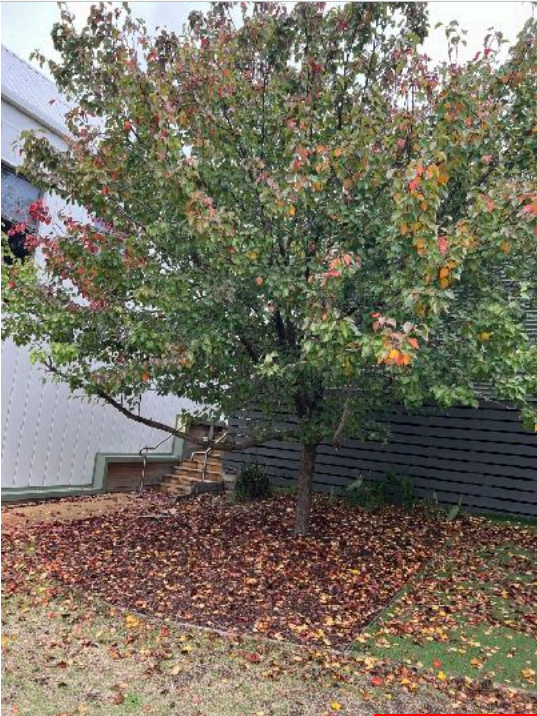
T17: *Pyrus ussuriensis*

17	<i>Pyrus ussuriensis</i>	Manchurian Pear	6	6	22	2.6	22	1.8	Mature	5 - 20 years	Poor	Good	Fair	Rubbing branches in canopy Included bark present at several unions Branches close to adjacent building Low branches - potential hazard to students	Uplift canopy to minimum 2.2m	High
18	<i>Ficus</i>	Fig	5	37	N.R.	N.R.	N.R.	N.R.	N.R.	N.R.	N.R.	N.R.	N.R.	Hedge of Ficus trees	No works	No works
19	<i>Ulmus parvifolia</i>	Chinese Elm	13	16	49	5.9	60.5	2.7	Mature	5 - 20 years	Fair	Good	Poor	History of poor pruning evident Branches touching adjacent building Appears that neighbours have lopped the tree back to fence line recently Exposed roots to the north	Remove to base Grind stump	High
20	<i>Populus nigra</i>	Poplar	NR	NR	NR	NR	NR	NR	NR	NR	NR	NR	NR	Tree is located in the neighbours property and is in the north east corner of the school Previously pruned hard, resulting in epidermic shoots From a ground based visual inspection with assistance of a drone, tree appears to be in good health and the structure appears be to good	Continue to monitor annually	Monitor
