AUDIT FINDINGS AND RECOMMENDATIONS

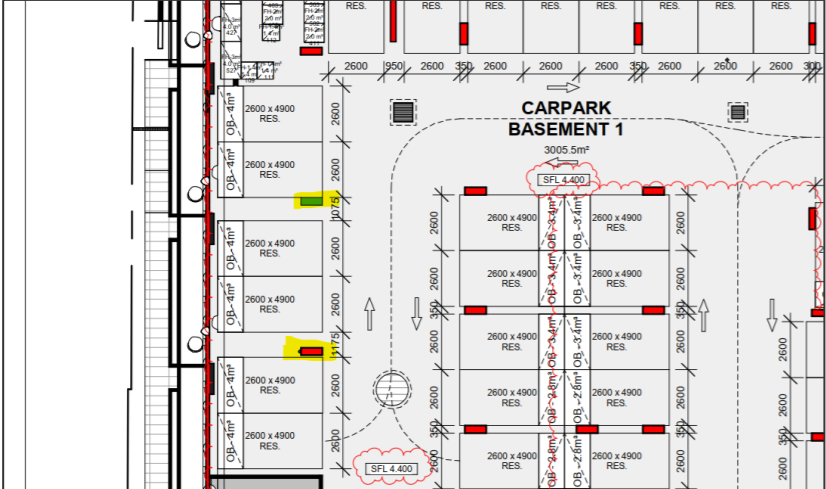
Audit Findings	Recommendations (P) Primary (ST) Step Towards (S) Supporting (N) Non Safe-System	Level of Risk	Safe System Energy	Designer/Project Manager Response
Lower Gound Level, Basement Level 01and Basement Level 02				
<p>1. The location of some columns with respect to car parking spaces (throughout the basement levels) as shown on the architectural plans do not accord with the car parking clearance envelope requirement of AS/NZ 2890.1:2004 or Clause 52.06 of the Planning Scheme. While not a significant safety concern, this could make the spaces more difficult access, and could affect car door opening.</p> <p>Examples of non-conforming column locations are shown below. Please note that this does not show all non-conforming columns.</p>

<p>Review the design of the car park and column locations, having regard to Figure 5.2 of AS/NZS 2890.1:2004 and/or Diagram 1 of Clause 52.06 as appropriate. (N)</p>	<p>Note</p>	<p>Not Applicable</p>	<p>Accepted. Column locations to be modified where possible, subject to structural constraints.</p>

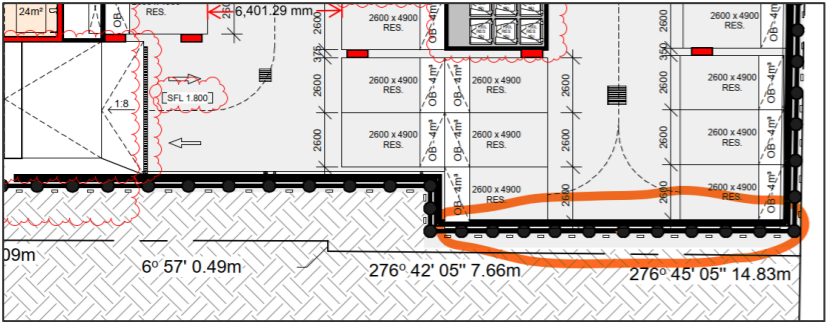
<p>2. Some of the dead-end aisles are not provided with appropriate aisle extensions to meet the requirement of AS/NZ 2890.1:2004. While this is not a significant safety concern, this could cause multiple correctional manoeuvres for a vehicle to access the car parking spaces provided at the end of the aisle.</p> <p>Examples of non-conforming aisle location are shown below. Please note that this does not show all non-conforming aisles.</p>

<p>It is noted that the swept paths provided for lower ground level show vehicles conflicting with the piles at the end of the dead end aisle. No swept path assessment has been provided for basement 2, which is where the dead end aisle extension looks to be shortest.</p>	<p>Review the design of the car park and aisle extensions, having regard to Figure 2.3 of AS/NZS 2890.1:2004 (N)</p>	<p>Note</p>	<p>Not Applicable</p>	<p>Agreed. It is recommended that these spaces are allocated for small cars, or removed.</p>

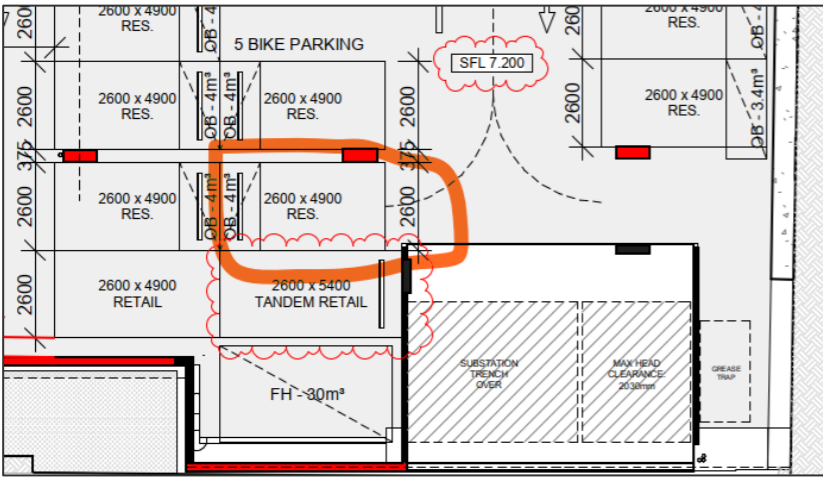
Audit Findings	Recommendations (P) Primary (ST) Step Towards (S) Supporting (N) Non Safe-System	Level of Risk	Safe System Energy	Designer/Project Manager Response
Lower Gound Level				
<p>3. Car parking space located at the south east corner of the lower ground level has a structure impeding into its accessway. This would make the space more difficult to access.</p> <p>Please refer to the PDF extract attached below.</p>

<p>Review the design of the car park and accessway, having regard to the design requirements of Clause 52.06 of the Planning Scheme. (N)</p>	Note	Not Applicable	<p>Agreed. It has been recommended that the space is converted to a tandem space with the space to the west, or removed.</p>
<p>4. The pedestrian sight triangle on the eastern side of the access driveway does not meet the planning scheme requirement. It is acknowledged that the Planning Scheme requirement is for the prescribed area to be 'at least 50% clear of obstructions.'</p>

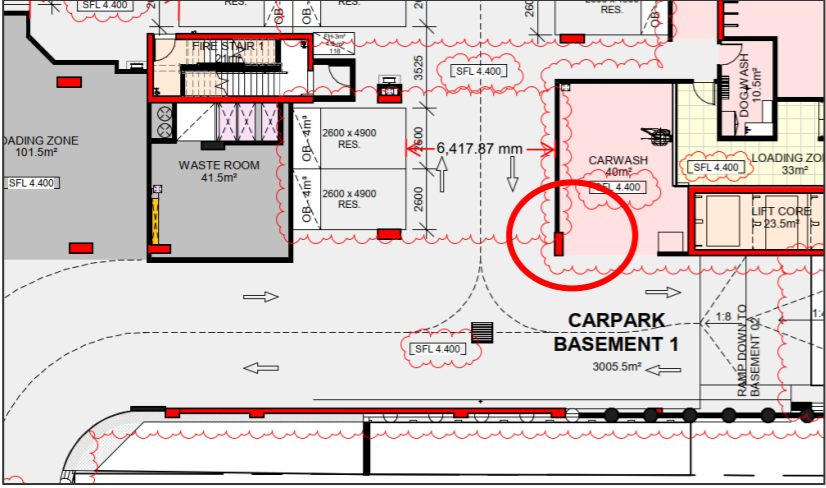
Audit Findings	Recommendations (P) Primary (ST) Step Towards (S) Supporting (N) Non Safe-System	Level of Risk	Safe System Energy	Designer/Project Manager Response
<p>5. Sight lines of the vehicles approaching from the accessway to turn right is obstructed by the walls. This is shown in the extract below.</p> <p>Additionally it is suggested that the intersection of these two aisles could benefit from line marking to define priorities.</p>

<p>Consider making the wall permeable. This will allow for vehicle turning right from the accessway to get to the exit ramp to have a clear sightlines to the ramp. (P)</p> <p>Alternatively, consider providing wall mounted convex mirror to mitigate the sight line issue. (S)</p> <p>Consider providing line marking to define priorities at this location. (S)</p>	<p>Rare Minor Low</p>	<p>Within Tolerable</p>	<p>Accepted. Plans updated to include a convex mirror to improve sightlines.</p>

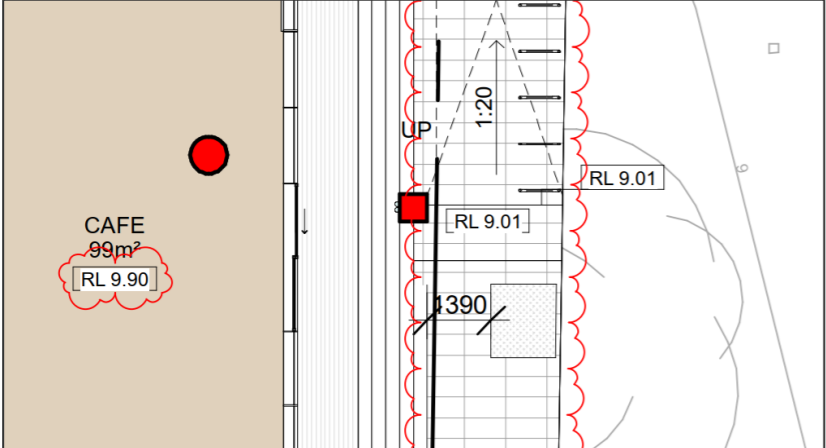
Upper Ground Level				
<p>6. The bicycle parking rails proposed on the Boundary Road footpath are located close to the kerb line, particularly the rails towards the southern end of the site frontage. Bicycle rails typically measure about 1.0 m in length, while the Australian Standard for bicycle parking (AS 2890.3) requires an allowance of 1.8 m for the length of a bike. This means that a bicycle parked on one of these rails will extend beyond the front and back of the rail. With the rail being close to the kerb line, the bike could protrude towards and perhaps into the kerbside parking provision. Similarly the bike could extend back towards the columns that are proposed at the back of the footpath, creating a pinch point which could be difficult to negotiate for users with wheelchairs or prams.</p>

<p>Review the bicycle parking along the Normanby Road frontage to ensure an appropriate bicycle parking envelope is provided. This should ideally provide a minimum 300 mm clearance between the envelope and the adjacent parking provisions, and a minimum 1.2 m (but preferably 1.5 m) offset from the columns to the west of the spaces. The spaces could be rotated to a 60 degree or 45 degree angle if that helps to achieve appropriate clearances.</p>	<p>Rare Minor Low</p>	<p>Within Tolerable</p>	<p>Accepted. Plans updated to provide bicycle hoops at 45 degree angle, minimising any intrusion into the footpath from parked bicycles.</p>
