ITEM	DETAIL
Arbor Survey Reference:	R6435_2 173 Burke Rd & 28 Hope St GLEN IRIS
Client Reference:	23076 (Cera Stribley)
Site / Data Collected:	01/12/2020, 23/06/2021 (NDRI), 21/07/2023 & 07/12/2023
Report Prepared:	28/07/2023
Reviewed:	28/08/2023
Status:	Final
Version / Revision No:	2
Revision Date:	11/12/2023
Issued Date:	14/12/2023
Issue format:	Portable Document Format (*.pdf) – Uncontrolled when Printed

# 1. SUMMARY

The Development Impact Assessment has been undertaken to determine the impact to trees or vegetation on or adjoining 173 Burke Road and 28 Hope Street, Glen Iris from the proposed construction of a mixed-use development and apartment complex. The report provides an overview of the site characteristics and relevant regulatory controls, the arboricultural condition of the trees and determines the Protection Value of the trees and vegetation on the project site and adjoining lands where the tree protection zones may be impacted. The primary purpose of this assessment is to identify the impact from the proposed construction and to outline impact mitigation and tree protection measures for trees of high or moderate protection value. The survey has identified a total of

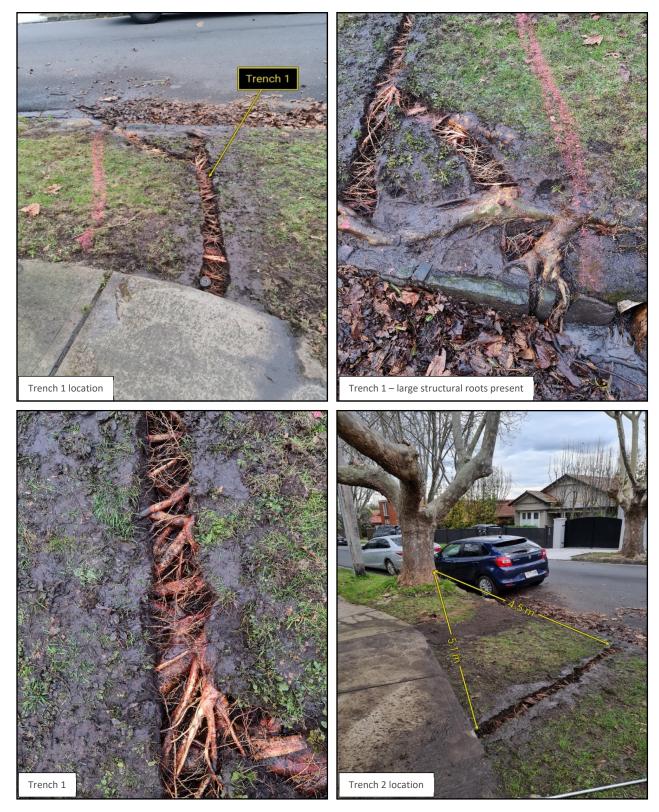
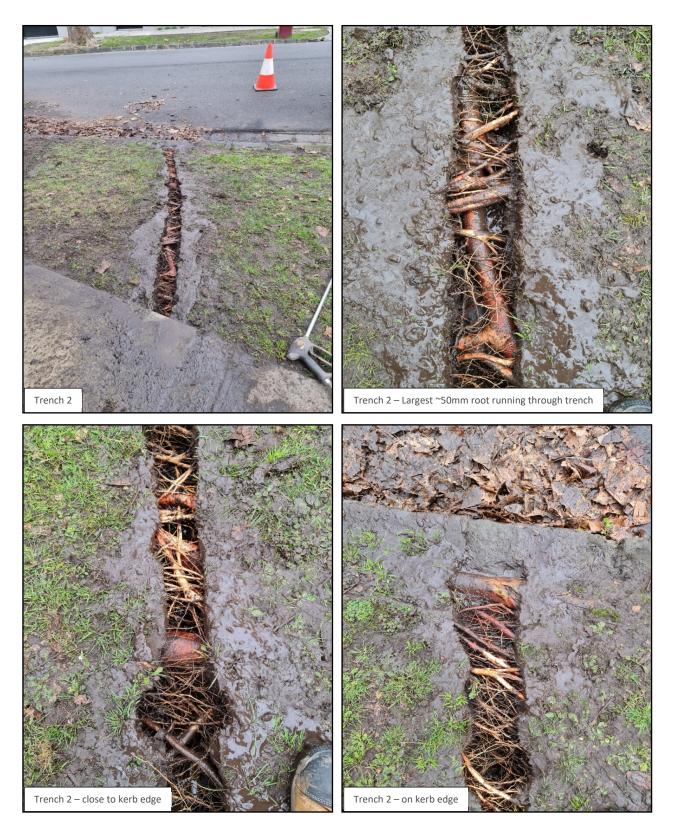
# **Photographic Records:**

A second trench was excavated at a distance of 4.5 metres from the outside edge of the trunk of the tree to the kerb and channel. The results of this excavation revealed that the root mass reduced considerably in size and number with the largest roots observed being <50mm in size (Refer Photographic Records). Although there were still a number of smaller surface roots, it is considered feasible that these roots could be pruned with no long-term impact on tree health.

Based on the large number of structural roots in Trench 1 at a distance of 1.8 - 2.0 metres from the tree, it is not recommended that a new crossover is constructed in this location. However, at a distance of 4.5 - 5.0 metres (Trench 2), the roots are considerably smaller in size ~<50mm diameter was the largest root observed and there were only ~3 roots of this size that would be severed from any new crossover.

Based on the findings it is considered feasible to construct a new crossover at a minimum distance of 4.5 metres from the tree (subject to Council Arborist approval). However, specialised construction requirements would need to be undertaken to ensure that the roots are pruned correctly during crossover construction.

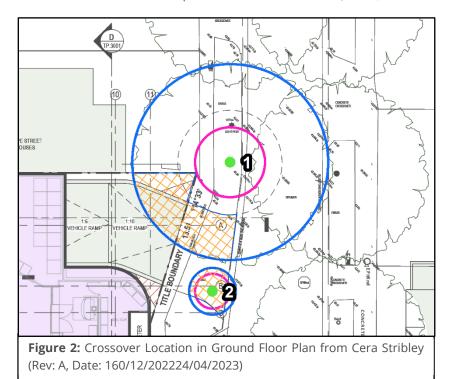
• Tree 1: The crossover on Hope Street within the TPZ of Tree 1 is to be modified as specified in the NDRI results (i.e. 4.5m from the tree) and as previously shown in the provided plans(Refer to Figure A). is to Relocate Hope Street Crossover as stated in NDRI and as shown in previous Ground Floor Plan (Rev: A, Date: 10/10/2022).

- Tree 1: The Hope Street Apartment Bin Room and Bike Parking is to be at/above grade. There should be no continuous strip footing as part of the construction works of any walls/fencing. All fencing / walls should be on piers with edge beams above existing grade.
- Trees 13\* & 16\*: The Hope Street Apartment Terraces and Car Parking is to be at/above grade. There should be no continuous strip footing as part of the construction works. All fencing / retaining walls should be on piers with edge beams above existing grade.
