Macquarie Corporate Holdings Pty Ltd

1120 Thompsons Road Cranbourne West

Arboricultural Construction Impact Assessment

Tuesday, 3 August 2021

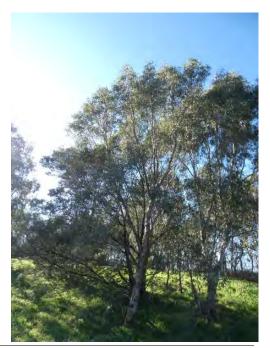
SRZ (m):	1.5	Works priority:	N/A
TPZ (m):	2.0	Construction Proximity:	0.2
mTPZ (m)	= TPZ

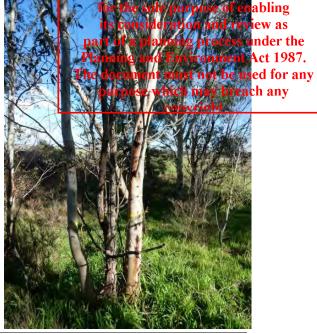
Genus / species: Eucalyptus camaldulensis				
Evergreen		River Red G	Bum	
Height (m):	7		Structure	Fair
Width (m):	1		Health:	Fair
DBH (cm):	12	Measured	Maturity:	Immature
Origin:	Melbourne		ULE (years)	15 - 30
Retained?:	Removed		Form:	Fair
Retention Value:		Low		
Removal / retention reason:			N/A.	
Amenity value:		Low		
Works Required: N/A.

SRZ (m):	1.5	Works priority:	N/A	
TPZ (m):	2.0	Construction Proximity:		0.1
mTPZ (m)	= TPZ

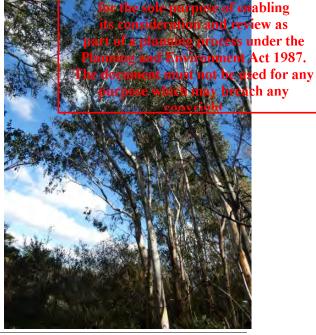
Genus / speci	es: Ac	acia para	doxa	
Evergreen		angaroo W		
Height (m):	2	inguloc I	Structure	Fair
Width (m):	3		Health:	Poor
DBH (cm):	9 E	stimated	Maturity:	Immature
Origin:	Melbou	urne	ULE (years)	1 - 5
Retained?:	Removed		Form:	Poor
Retention Value:			Very low	
Removal / retention reason: N/A.				
Amenity value:			Very low	
Works Required: N/A.				
Home Roqui	ou : 10//

SRZ (m):	1.5	Works priority:	N/A	
TPZ (m):	2.0	Construction Proximity:		0.1
mTPZ (m)	= TPZ

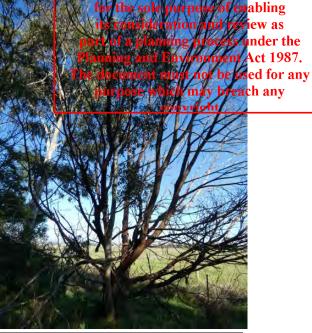
Genus / species: E		Eucalyptus	Eucalyptus camaldulensis		
Evergreen		River Red G	Gum		
Height (m):	19		Structure	Fair	
Width (m):	8		Health:	Good	
DBH (cm):	35	Measured	Maturity:	Mature	
Origin:	Mell	bourne	ULE (years)	> 60	
Retained?:	Ren	noved	Form:	Good	
Retention Value:			High		
Removal / retention reason:			N/A.		
Amenity value:			Moderate		
Works Required: N/A.					
-

SRZ (m):	2.2	Works priority:	N/A	
TPZ (m):	4.2	Construction Proximity:		0.1
mTPZ (m)	= TPZ

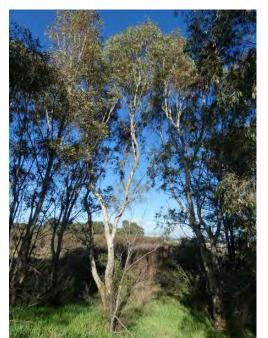
Genus / species:		Eucalyptus camaldulensis			
Evergreen		River Red G	I Gum		
Height (m):	10		Structure	Fair	
Width (m):	4		Health:	Good	
DBH (cm):	25	Measured	Maturity:	Immature	
Origin:	Mell	bourne	ULE (years)	> 60	
Retained?:	etained?: Removed		Form:	Fair	
Retention Value:			High		
Removal / retention reason:			N/A.		
Amenity value:			Moderate		
Works Required: N/A.

SRZ (m):	1.8	Works priority:	N/A	
TPZ (m):	3.0	Construction Proximity:		0.7
mTPZ (m)	= TPZ
