Greenwood Consulting P/L

William Ross Architects Pty Ltd

Sacred Heart Girls College Warrigal Road Hughesdale

Arboricultural Construction Impact Assessment

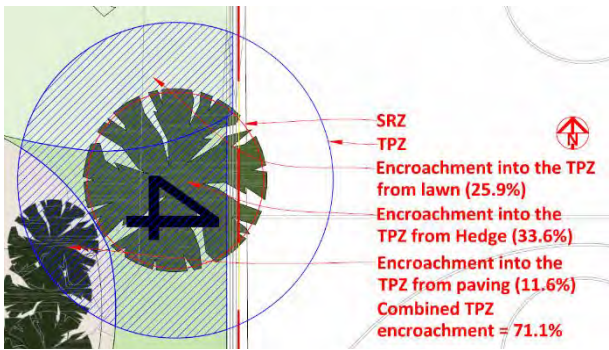
Figure 4 Tree 4 - SRZ and TPZ encroachments.

Landscaping works and a fence are proposed within the SRZ and TPZ of Tree 4. A section of lawn, paving and a hedge planting are shown in the SRZ and TPZ of Tree 4.

A fence, lawn and hedge planting are shown within the SRZ of Tree 4 (Figure 4). Provide that there are no soil disturbances in the SRZ of this tree, then it is unlikely that the establishment of the lawn will impact on the structure of Tree 4. If topsoil is required for the establishment of the lawn, then the depth of the topsoil should not exceed 100 millimetres.

The hedge planting within the SRZ is likely to have minimal impact on the Structure of Tree 4. Any vegetation planted within the SRZ of Tree 4 should be hand dug. If roots with a diameter of 30 millimetres or greater are exposed, then these roots should be preserved, and the vegetation should be planted in holes where there are no roots with a diameter of 30 millimetres or greater.

Tree 9 to the west of Tree 4 is to be removed. The stump of Tree 9 should be ground out rather than pulled out to prevent damage to the roots of Tree 4.

3. The stump of Tree 9 should be ground out rather than pulled out to prevent damage to the roots of Tree 4.
4. If topsoil is required for the establishment of the lawn, then the depth of the topsoil should not exceed 100 millimetres.

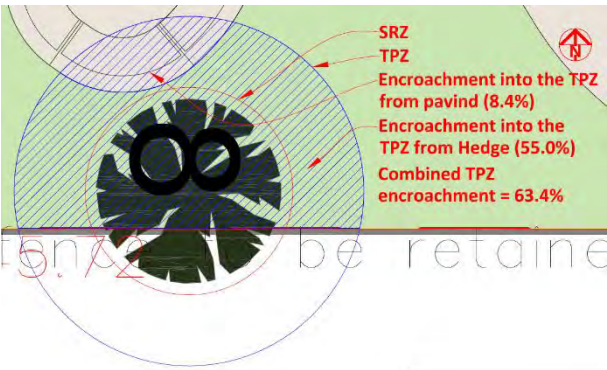
Figure 5 Tree 8 - SRZ and TPZ encroachments.

A section of concrete tile paving and a garden bed are to be demolished in the SRZ and TPZ of Tree 8. Provided that the demolition of the garden bed and concrete tile paving is undertaken with care, then it is unlikely that Tree 8 will be impacted by the proposed demolition works. All soil disturbance should be avoided in the SRZ and TPZ of this tree. The concrete pavers within the SRZ of Tree 8 should be removed by hand.

The hedge planting will occupy the entirety of those parts of the SRZ of Tree 8 that are located within the subject site (Figure 5). The hedge planting within the SRZ is likely to have minimal impact on the Structure of Tree 5. Any vegetation planted within the SRZ of Tree 5 should be hand dug. If roots with a diameter of 30 millimetres or greater are exposed during excavation, then these roots should be preserved, and the vegetation should be planted in holes where there are no roots with a diameter of 30 millimetres or greater.

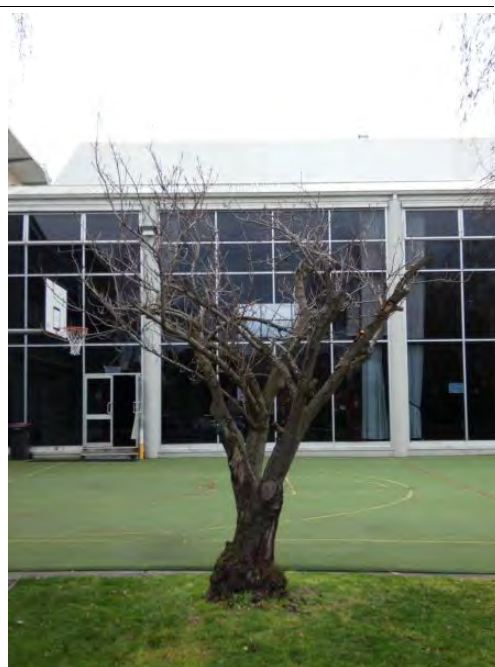
Tree ID: **2**

Height (m):	4	Structure	Poor
Width (m):	3	Health:	Good
DBH (cm):	28 Measured	Maturity:	Over mature
Origin:	Exotic	ULE (years)	1 - 5
Retained?:	Removed	Form:	Poor
Retention Value:	Remove.		
Removal / retention reason:	Structure ULE.		
Amenity value:	Low		
Works Required:	N/A.

SRZ (m):	1.9	Works priority:	Low
TPZ (m):	3.4	Construction Proximity:	0.1
mTPZ (m) = TPZ

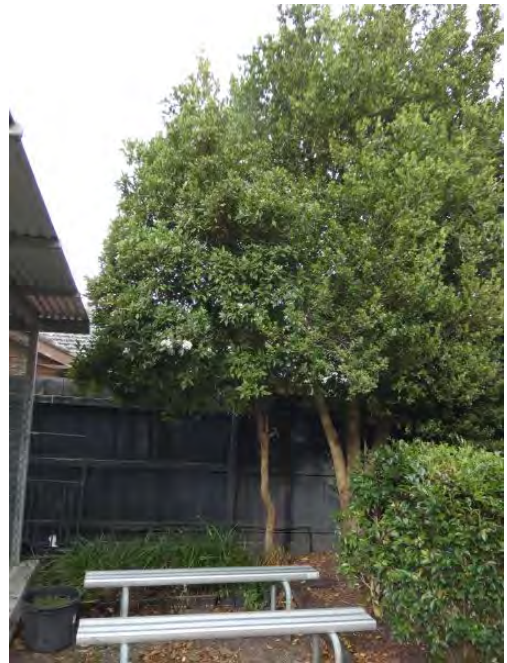
Tree ID: 8

Height (m): 6		Structure	Fair
Width (m): 5		Health:	Good
DBH (cm): 27	Measured	Maturity:	Mature
Origin:	Australian	ULE (years)	15 - 30
Retained?:	Retained	Form:	Good
Retention Value:	Low		
Removal / retention reason:	N/A.		
Amenity value:	Low		
Works Required:	N/A.

SRZ (m): 1.9	Works priority:	N/A
TPZ (m): 3.2	Construction Proximity:	0.8
mTPZ (m) = TPZ

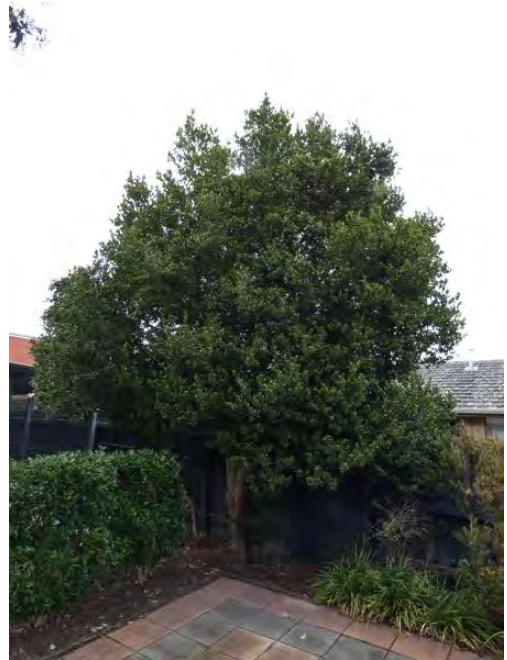
Tree ID: 9

Height (m): 8		Structure	Fair
Width (m): 7		Health:	Good
DBH (cm): 32	Measured	Maturity:	Mature
Origin:	Exotic	ULE (years)	15 - 30
Retained?:	Removed	Form:	Good
Retention Value:	Low		
Removal / retention reason:	N/A.		
Amenity value:	Low		
Works Required:	N/A.

SRZ (m): 2.1	Works priority:	N/A
TPZ (m): 3.8	Construction Proximity:	0.1
mTPZ (m) = TPZ
