Greater Gippsland Tree & Garden Care

Arboricultural Assessment

Site address: Chairo Christian School Pakenham campus
585 Bald Hills Rd
Nar Nar Goon 3812

Date of assessment: 9th April 2024

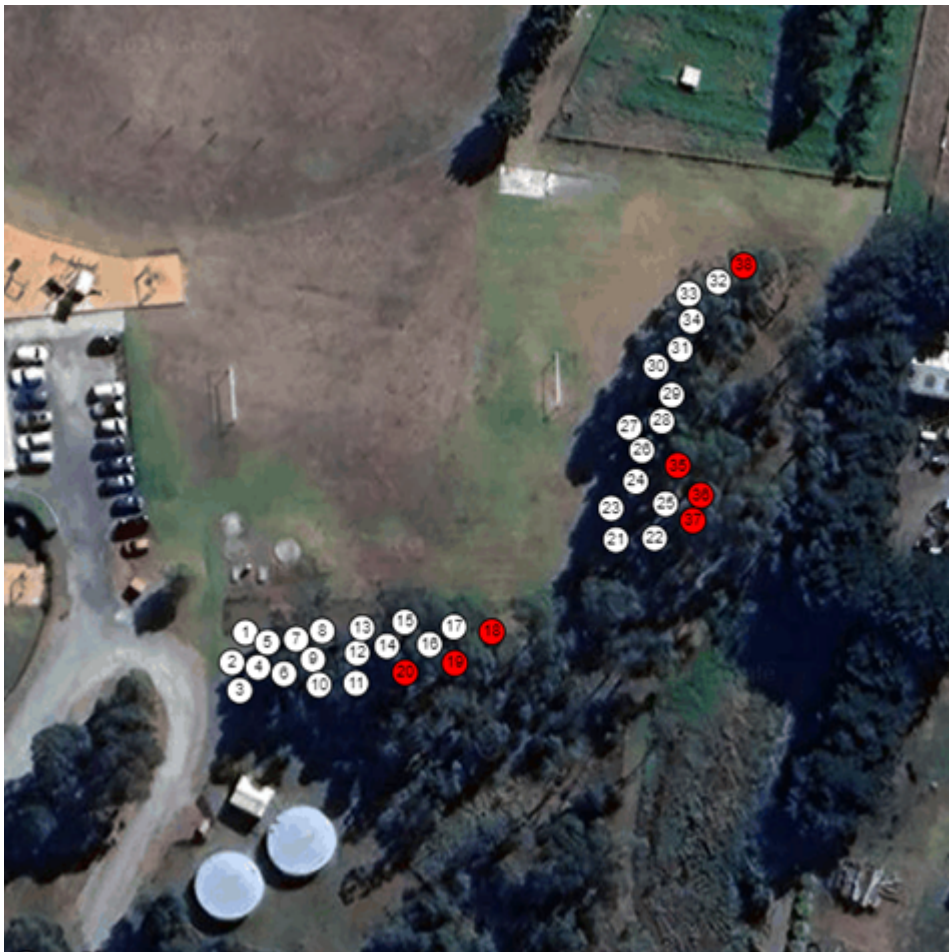
Site map

Refer architectural drawing TP03 B “Vegetation Impact Plan”

White dots denote trees to be removed.
Red dots denote trees to be retained.
