# Greater Gippsland Tree & Garden Care

## Arboricultural Assessment

Site address: Chairo Christian School Pakenham campus  
585 Bald Hills Rd  
Nar Nar Goon 3812

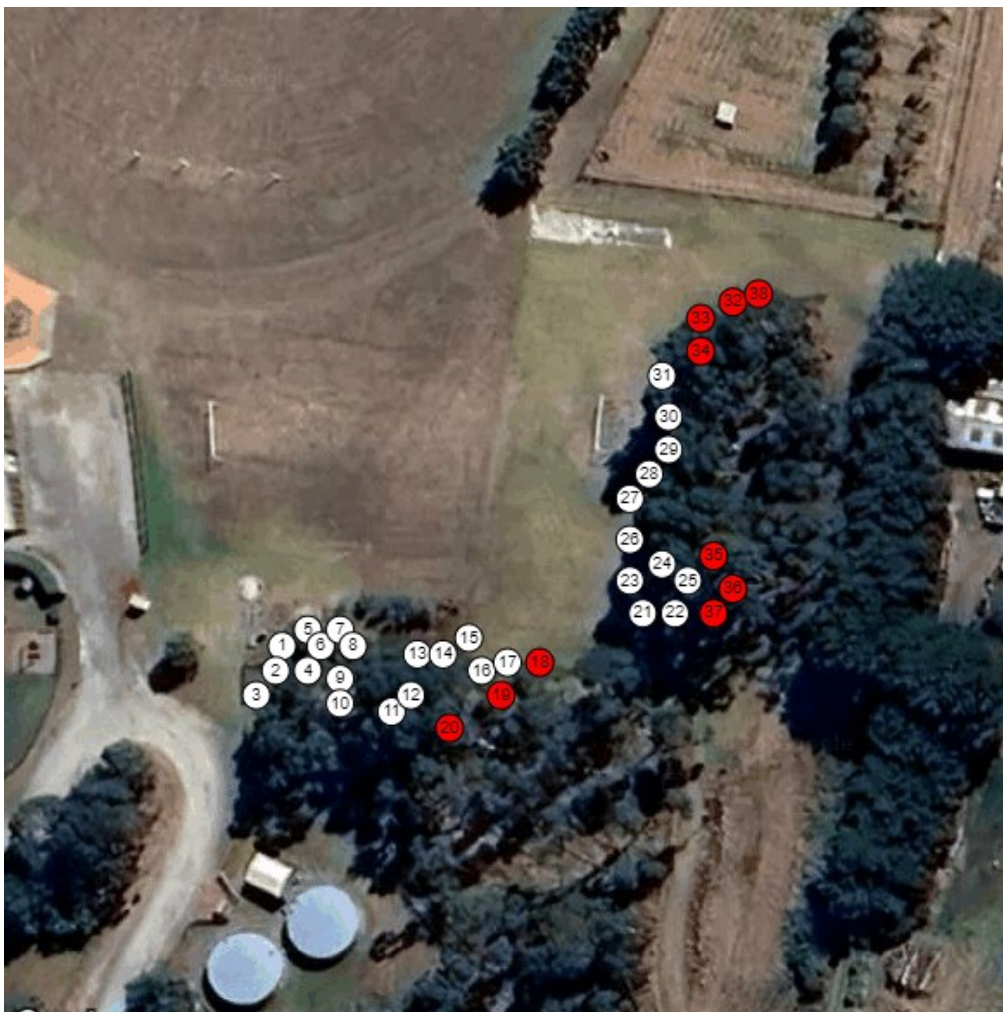
Refer Architectural plan TP03 “VEGETATION IMPACT PLAN” dated 18-4-24 by Van Damme DESIGN

White dots denote trees to be removed.  
Red dots denote trees to be retained.

There are a number of trees that are marked for removal due to their proximity to the proposed car park and the proposed building. These are trees # 1, 2, 3, 4, 5, 6, 7, 8, 9, 10, 11, 12, 13, 14, 15, 16, 17, 21, 22, 23, 24, 25, 26, 27, 28, 29 & 30. The trees in the direct vicinity of the development which are to be retained are trees # 18, 19, 20, 31, 32, 33, 34, 35, 36, 37 & 38. All of the trees to be removed are either where the building is proposed to be built or where the car park is proposed to be built.

- Trees # 1, 2, 3, 4, 5, 6, 7, 8, 9, 10, 11, 12, 13, 14, 15, 16, 17, 21, 22, 23, 24, 25, 26, 27, 28, 29 & 30 should be removed and appropriated replanting done as per council specifications
- Tree# 18, 19, 20, 31, 32, 33, 34, 35, 36, 37 & 38 should be retained and appropriate tree protection zones should be set up during the construction process.
- Any incursion into the tree protection zone needs to be supervised by a suitably qualified arborist. Where roots need to be severed they should be cut with a saw/ secateurs not ripped out with a machine.
- Significant monetary penalties should be applied to any breaches to tree protection zones
