ARBORICULTURAL REPORT

10-12 LOFTS AVENUE, KEW

14 August 2024

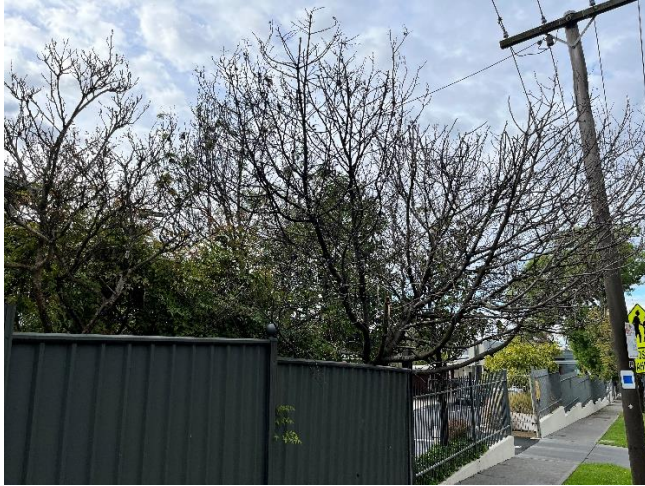
Image 1: Tree 1

5.3 Tree 1 is a dead exotic self-germinated weed proposed to be removed.

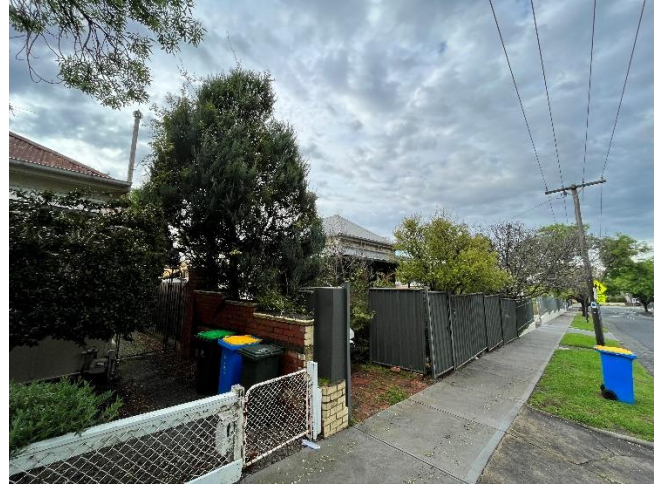
Image 2: Trees 2, 3, 4 (right to left)

5.4 The works proposed to the front of the site are restricted to the construction of a driveway which extends between the two dwellings through to the rear of the site. This will require the removal of Tree 3, a pair of Arizona Cypress. These trees are below the size that requires a permit for their removal under Boroondara's Tree Protection Local Law.

5.5 Tree 4 a Camellia has no new TPZ encroachments the proposed path is in the location of existing pedestrian paths and driveways within te site.

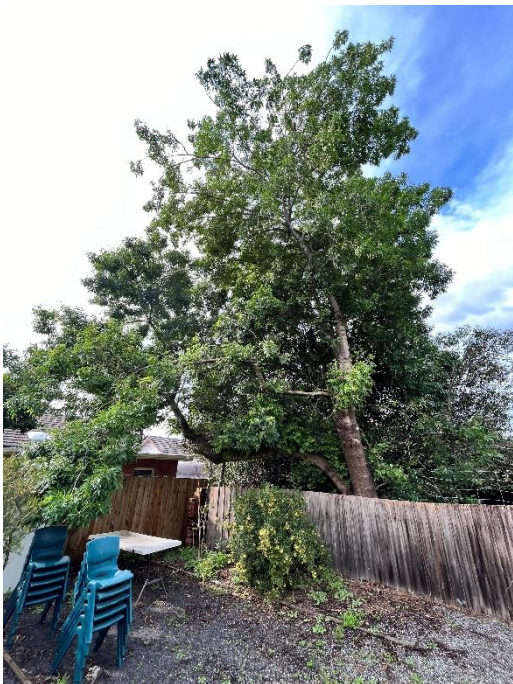
Image 3: Tree 5

5.6 Tree 5 a Desert Ash of poor structure and subsequently Low Arboricultural Value is proposed to be removed.

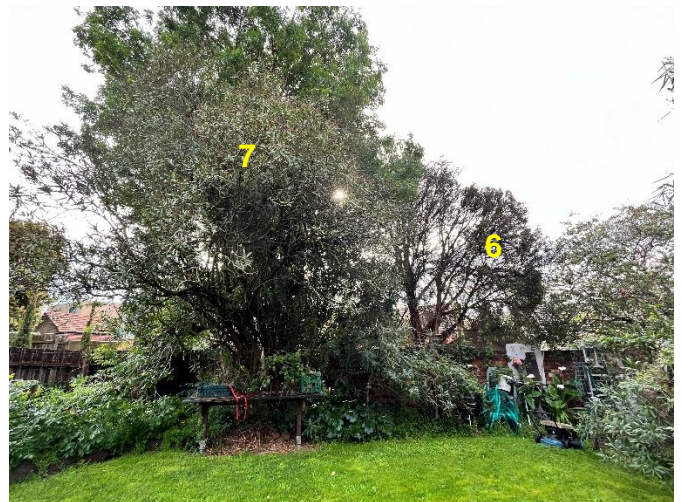
Image 4: Trees 6 and 7

5.7 Tree 7 is proposed to be retained.

5.8 There is no encroachment into the TPZ of Tree 7, Oleander.

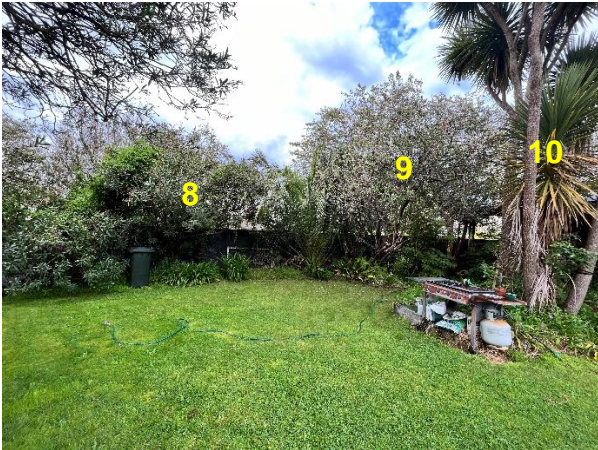
Image 5: Trees 8, 9 10

5.9 Trees 8, Oleander, 9, Cotoneaster and 10, Cabbage Tree are all proposed to be removed. These are all of low arboricultural value and not worthy of retention. Trees 8 and 9 will require a permit for their removal under Boroondara's Tree Protection Local Law.

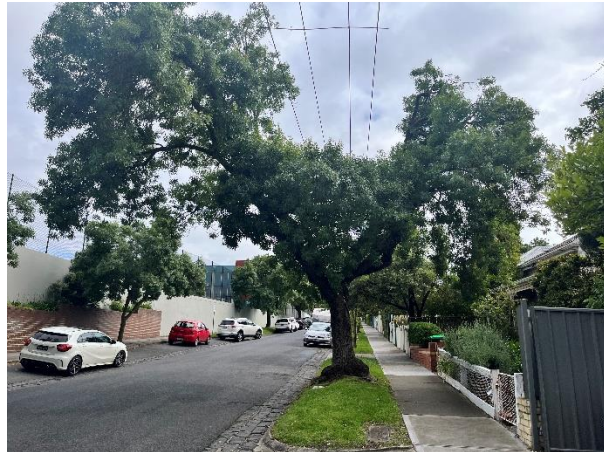
Image 6: Tree 11

- 5.10 It is proposed to widen the existing crossover adjacent to Tree 11 a Desert Ash by approximately 1000mm and subsequently it will encroach to within approximately 3.4m from the tree. This is only an additional 2.4% encroachment to the 1.8% of the existing crossover.

- 5.11 A Telstra pit that is currently located within the TPZ of Tree 11 is proposed to be relocated to accommodate the extended crossover. Plans do not indicate where this will be relocated to, but it is recommended it be relocated outside the TPZ of this tree.
- 5.12 There are no proposed encroachments into the TPZ of Tree 6, a neighbouring Bottlebrush.
- 5.13 If any boundary fences are to be replaced, it is recommended that any section of the new fences that pass through the TPZ of trees to be retained be of light-weight construction with post holes hand dug and relocated if necessary to avoid major roots. It is also recommended that all landscape areas within the TPZ of trees to be retained be maintained at existing grades.

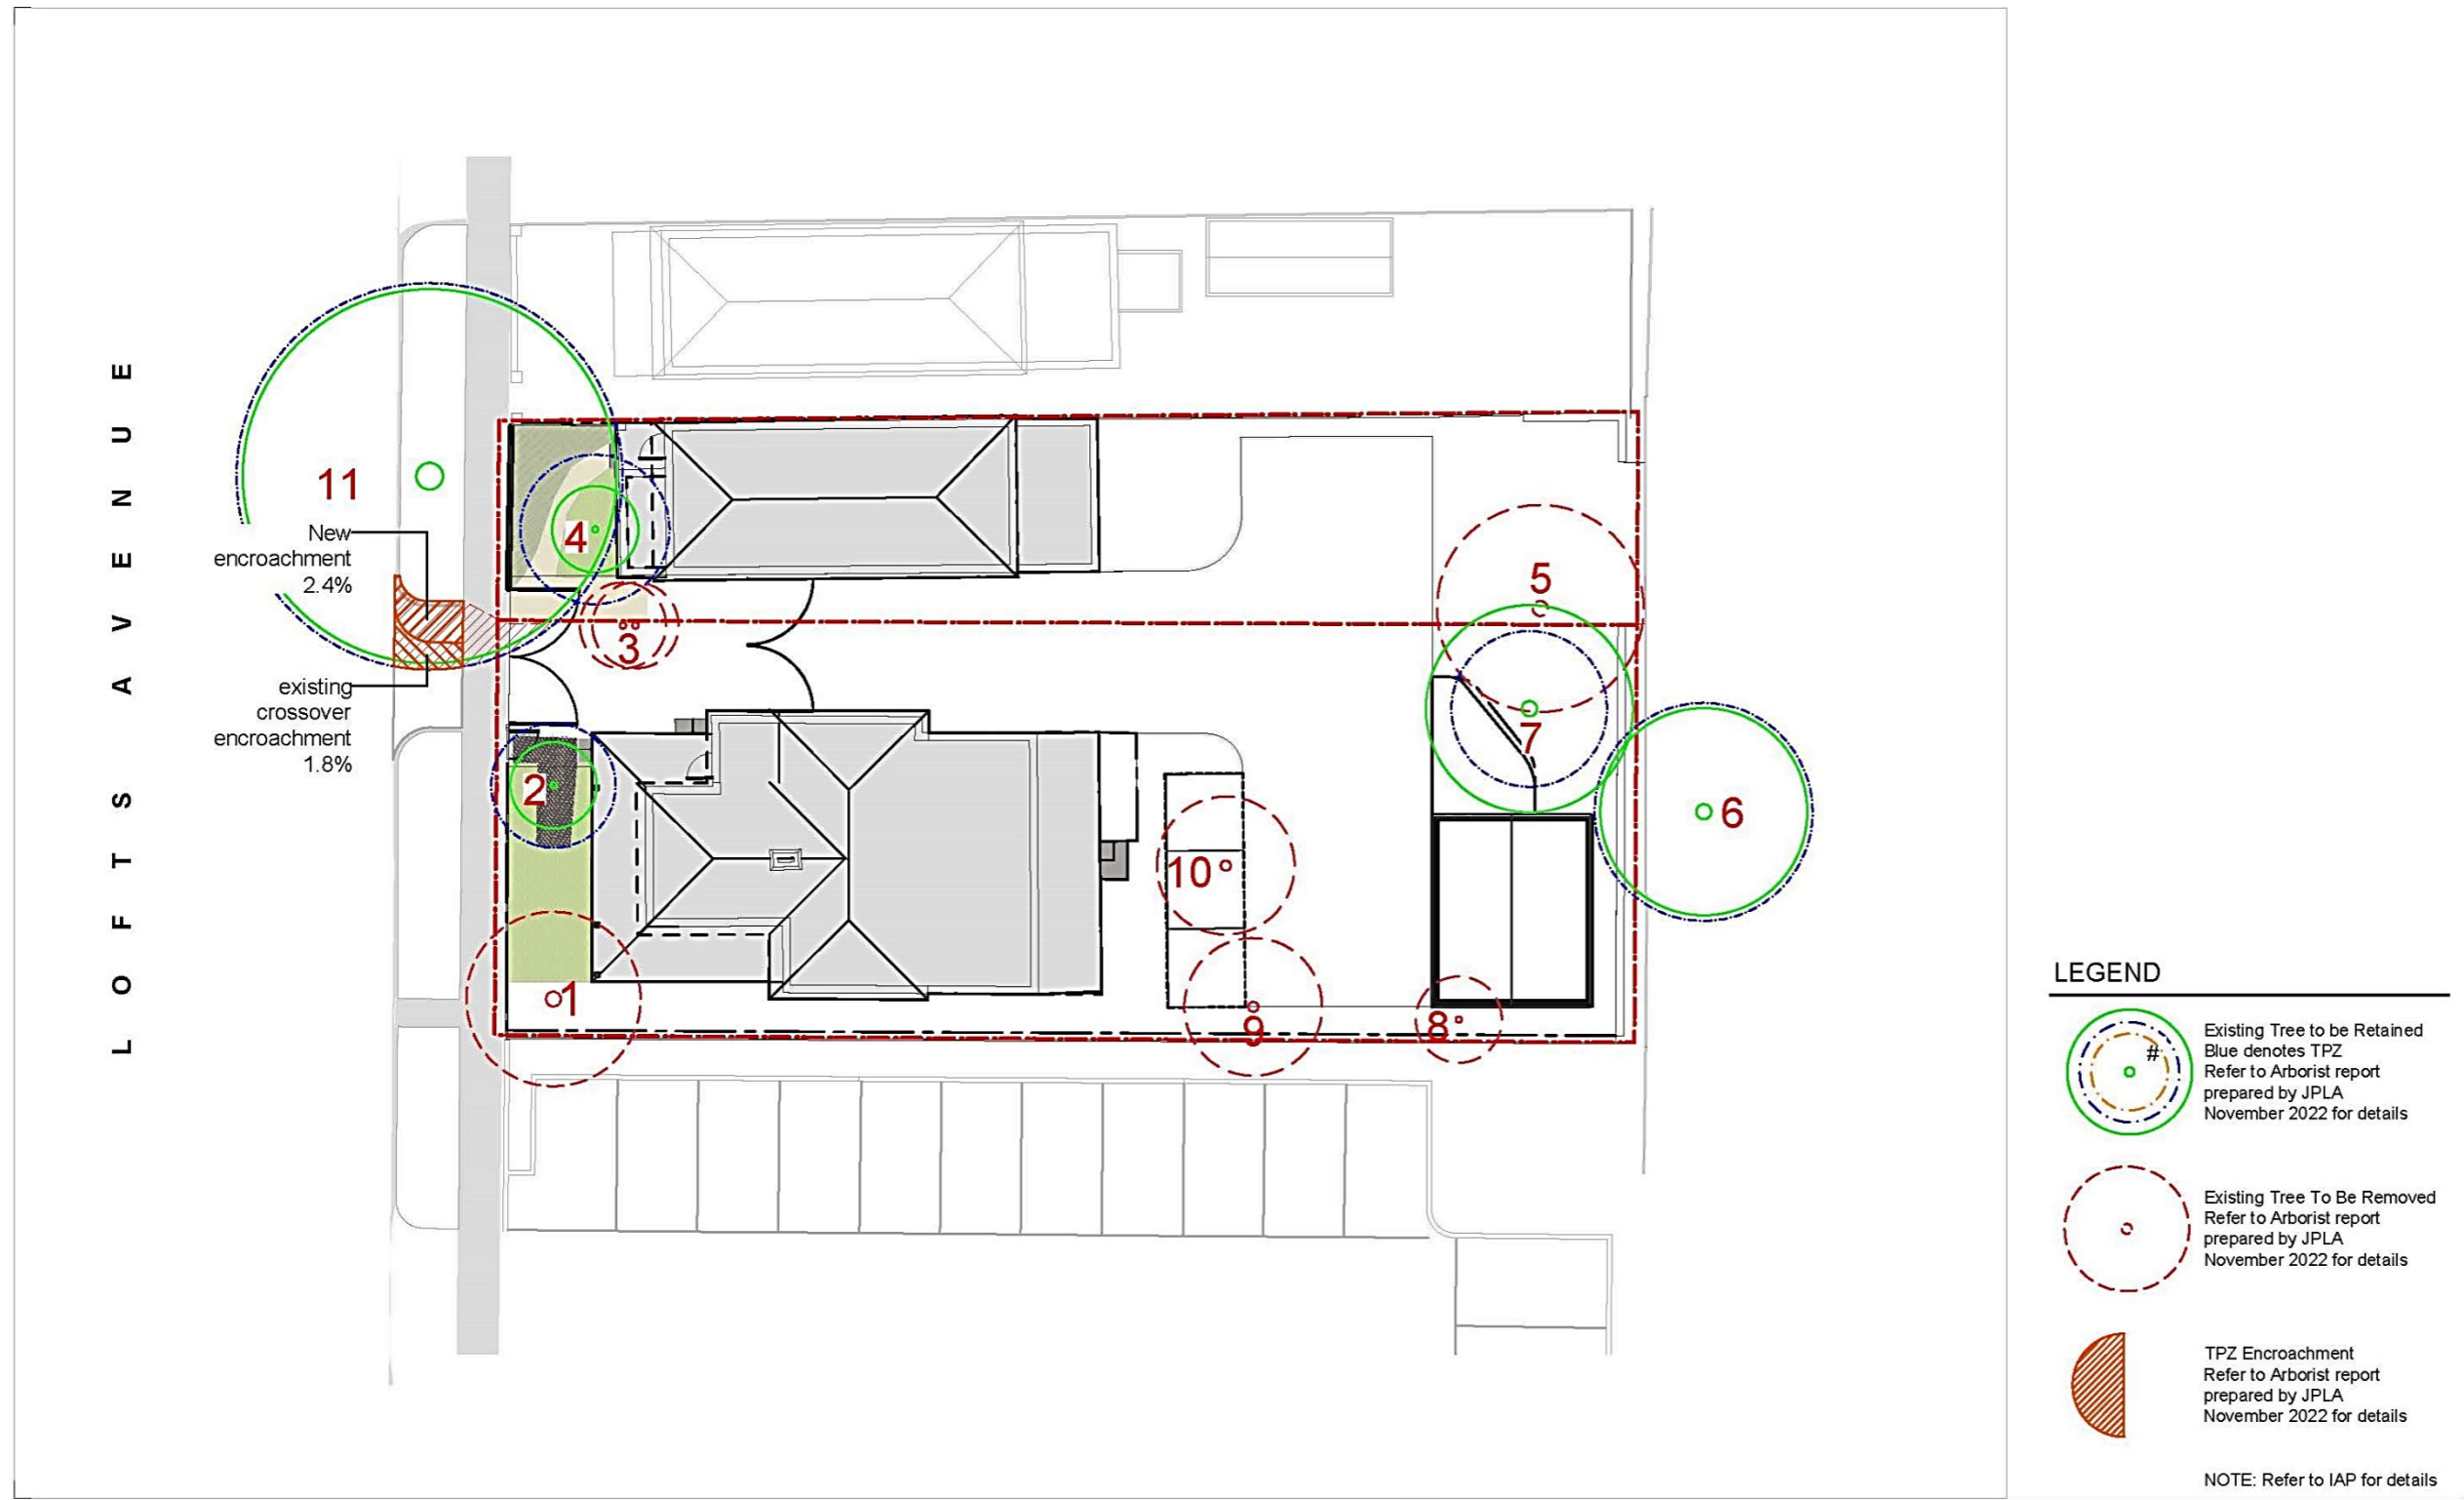
DRAWING
 Impact Assessment Plan for Town Planning

11
New
encroachment
2.4%

existing
crossover
encroachment
1.8%
