# Arboricultural Impact Assessment

Aquinas College  
46 Great Ryrie St, Ringwood

Prepared for:  
Kosloff Architects

Submitted  
22/04/2025

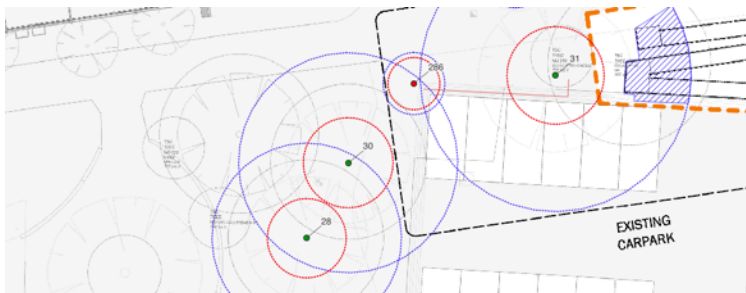
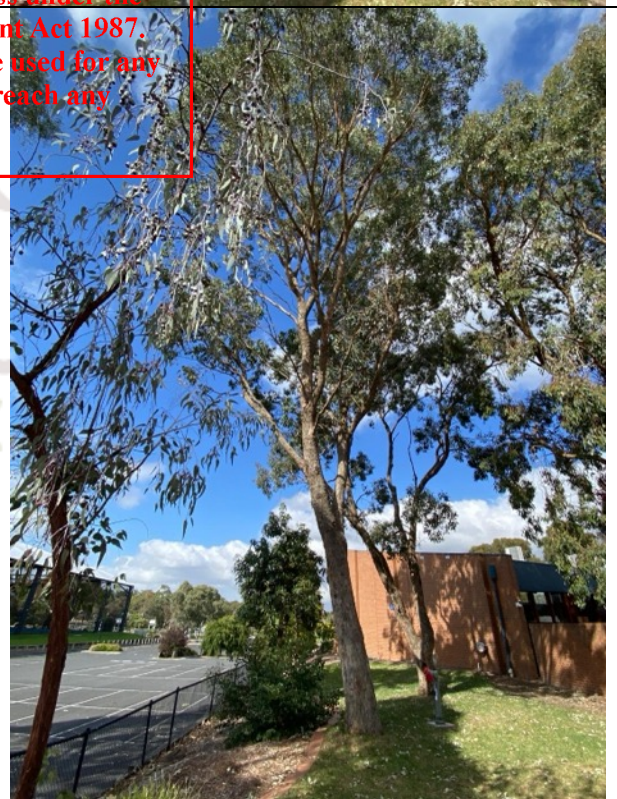
**Observations:** Included codominant stems. Previous failures.

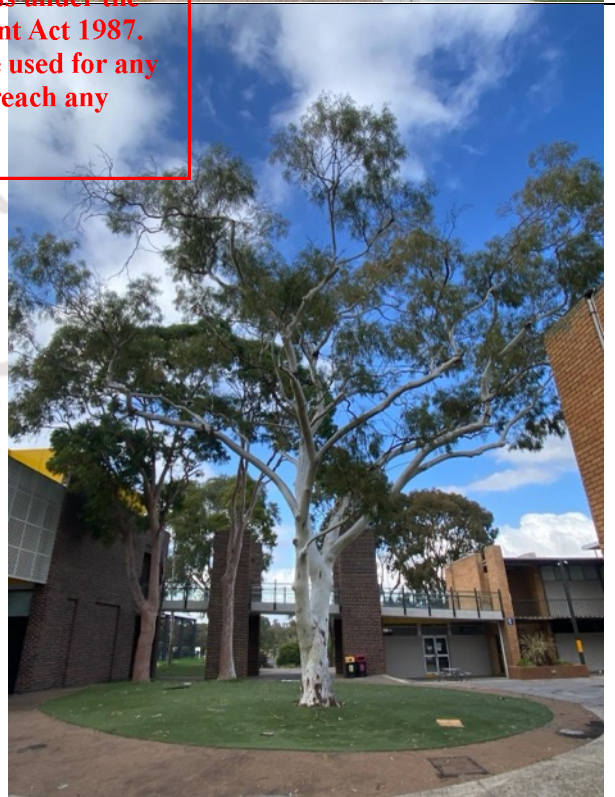
**Observations:** Cable brace installed. Bird damage. In decline. Dieback. Cable under tension. Tension wounds. Small cavity in tension side of western lateral.

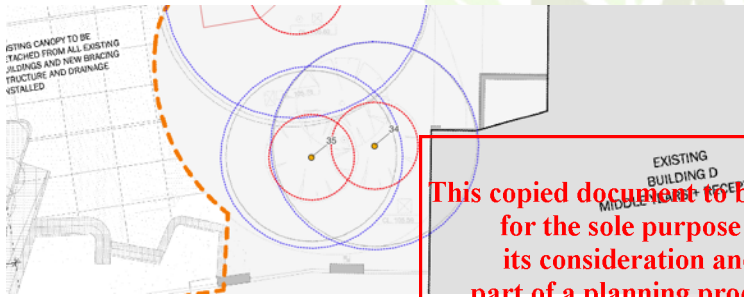
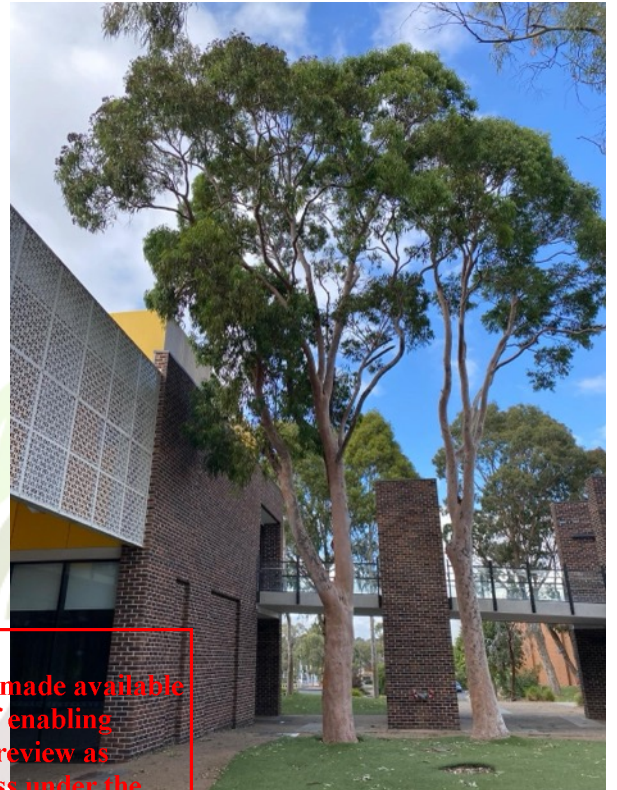
**Tree Id:** 35

**Observations:** Bird damage. Over-pruned. Poor stem taper.

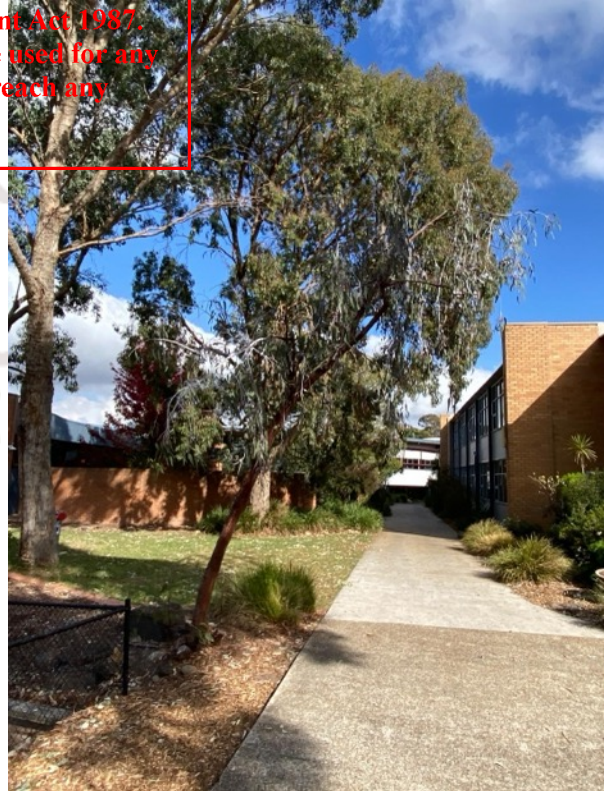
**Tree Id:** 296

**Observations:** Root plate failure.

**Encroachment:** 100%

**Retention Status:** Remove

- Trees 238, 296, 297, and 382 are within the proposed construction envelope. As these trees have low retention value, removal is recommended prior to the proposed development.

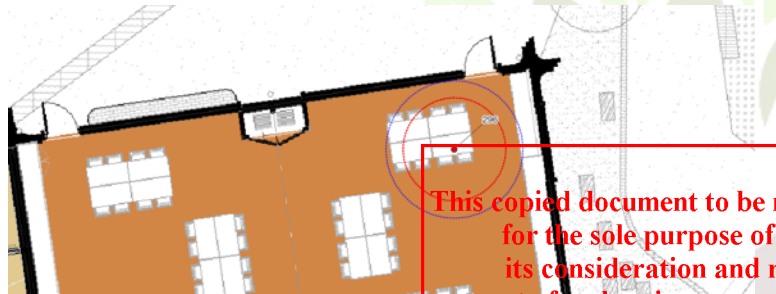
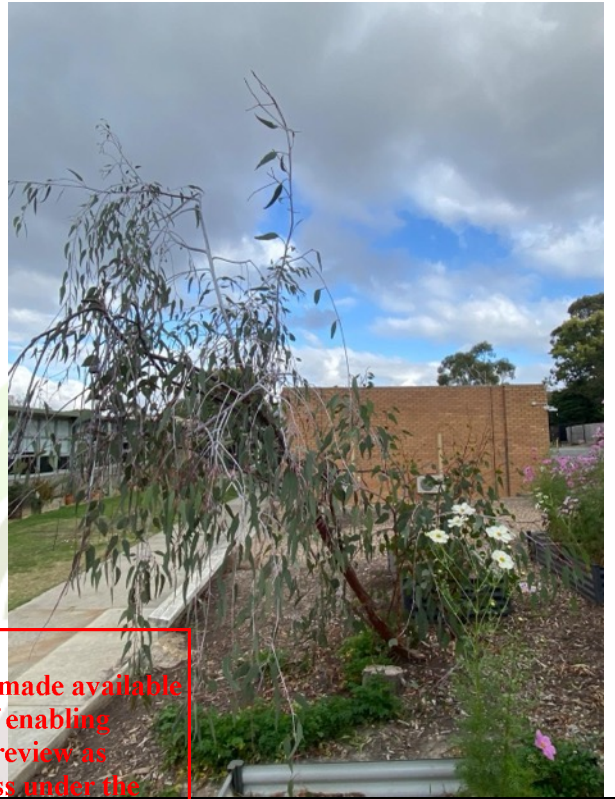
**Tree Id:** 297

**Encroachment:** 100%

**Retention Status:** Remove

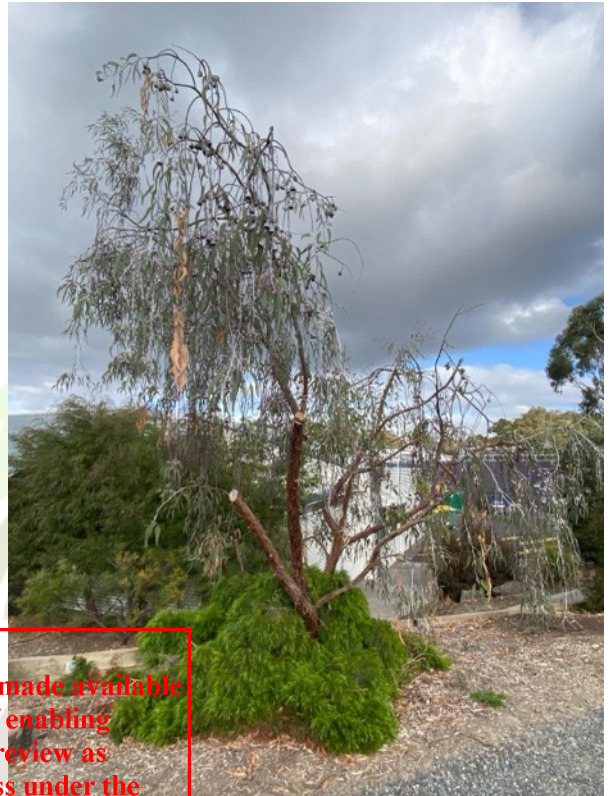
**Tree Id:** 354

**Observations:** Encroaching structure. Root plate failure.

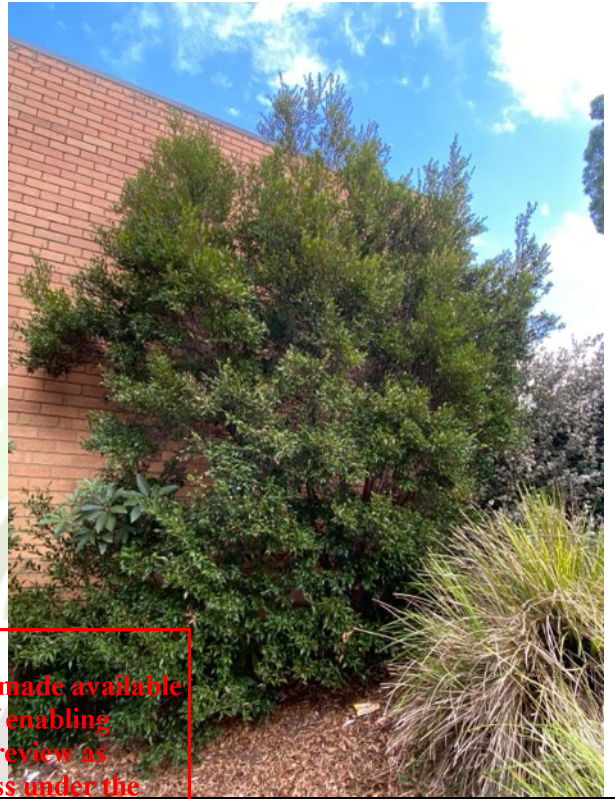
**Tree Id:** 384

**Observations:** Poor location.

**Encroachment:** Major **Retention Status:** Remove

- The TPZ of trees 298, 383, and 384 will be encroached by >10% by the proposed Year 9 Learning Building and Outdoor Learning Centre landscaping. The retention value of these trees is low and it is recommended the trees be removed prior to construction.
