**Preliminary Tree Assessment & Tree Management Plan - TMP.**

**Saint Bernards College: No.41 Rosehill Rd - Essendon**

*"Proposed Year 12 Senior Centre Building Development"*

## Tree Assessment & Management Plan: 41 Rosehill Rd. Essendon

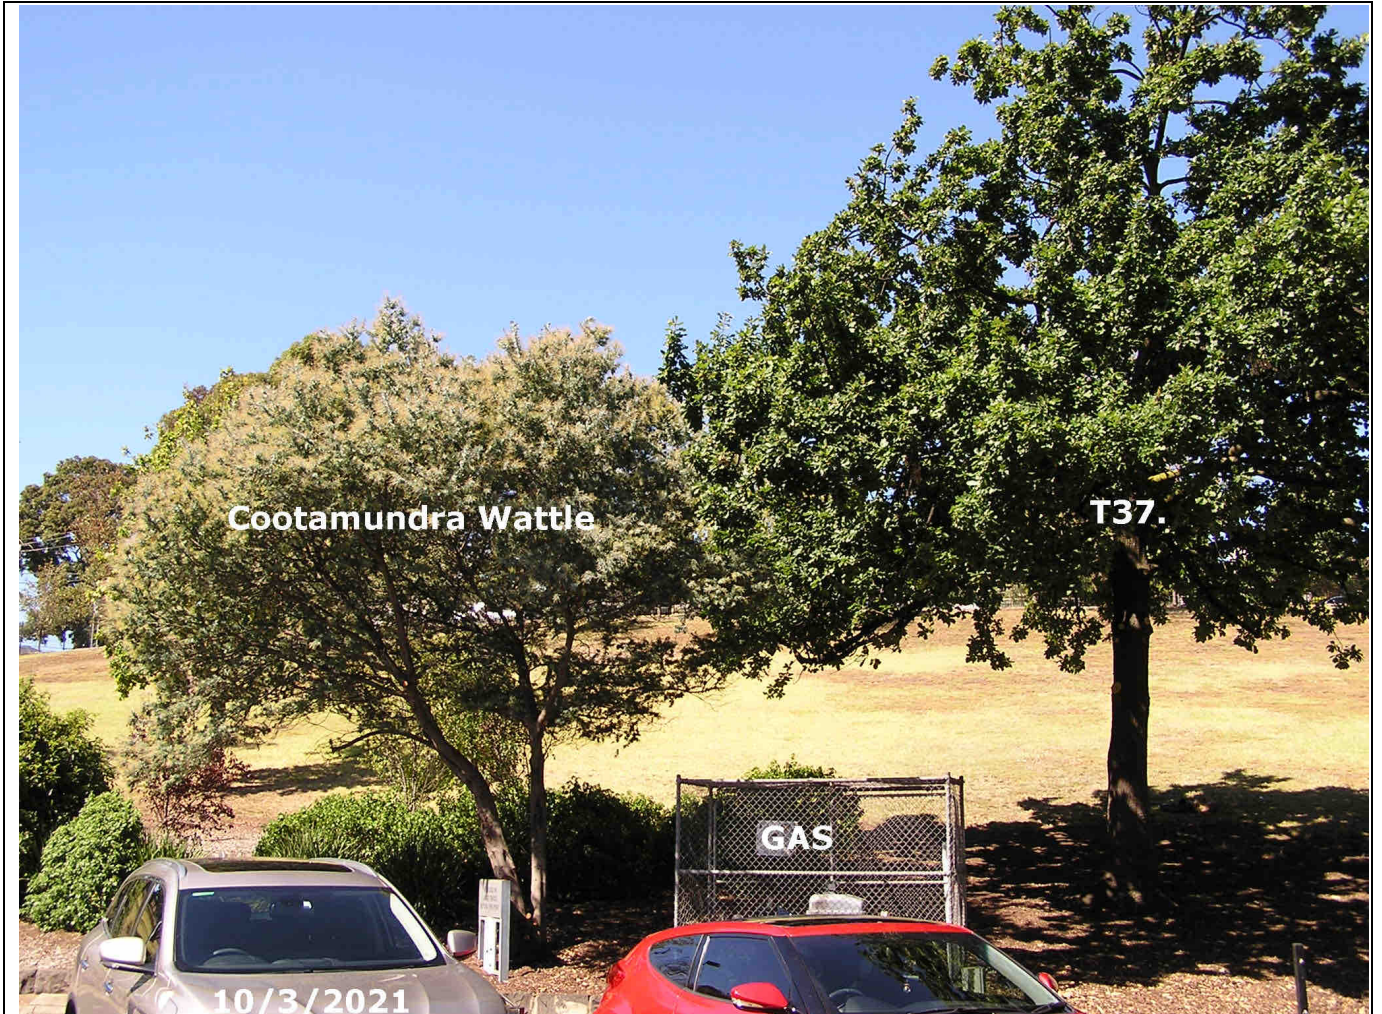
**Photo Samples: T37 Oak tree to be protected – note existing high-pressure gas manifold.**

T37: Retain. All Others to be removed. General Position of Proposed New Building Outside Canopy.

**RETAIN:** T37: Algerian Oak. Protect with squared-off & fixed temporary fencing as described in SK04 Dwg.

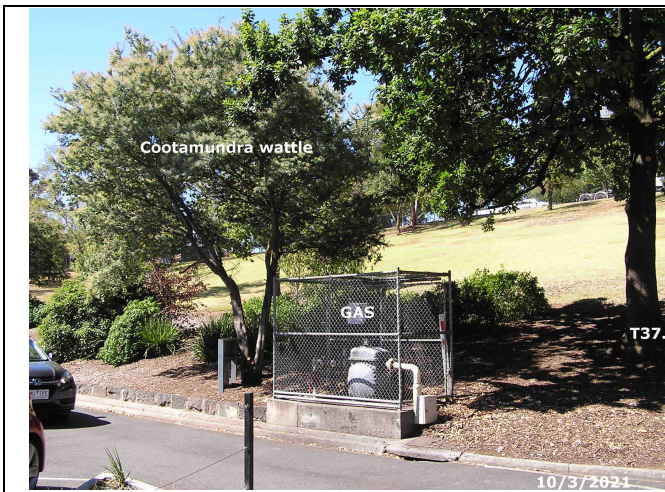
T37 & Restrictions.

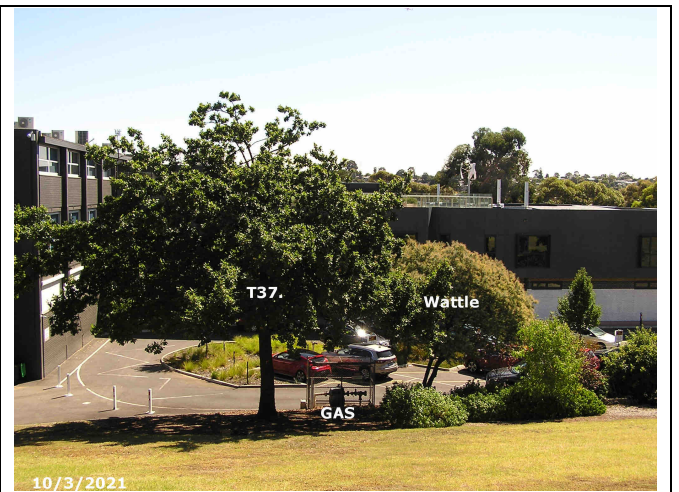
T37: General Description.

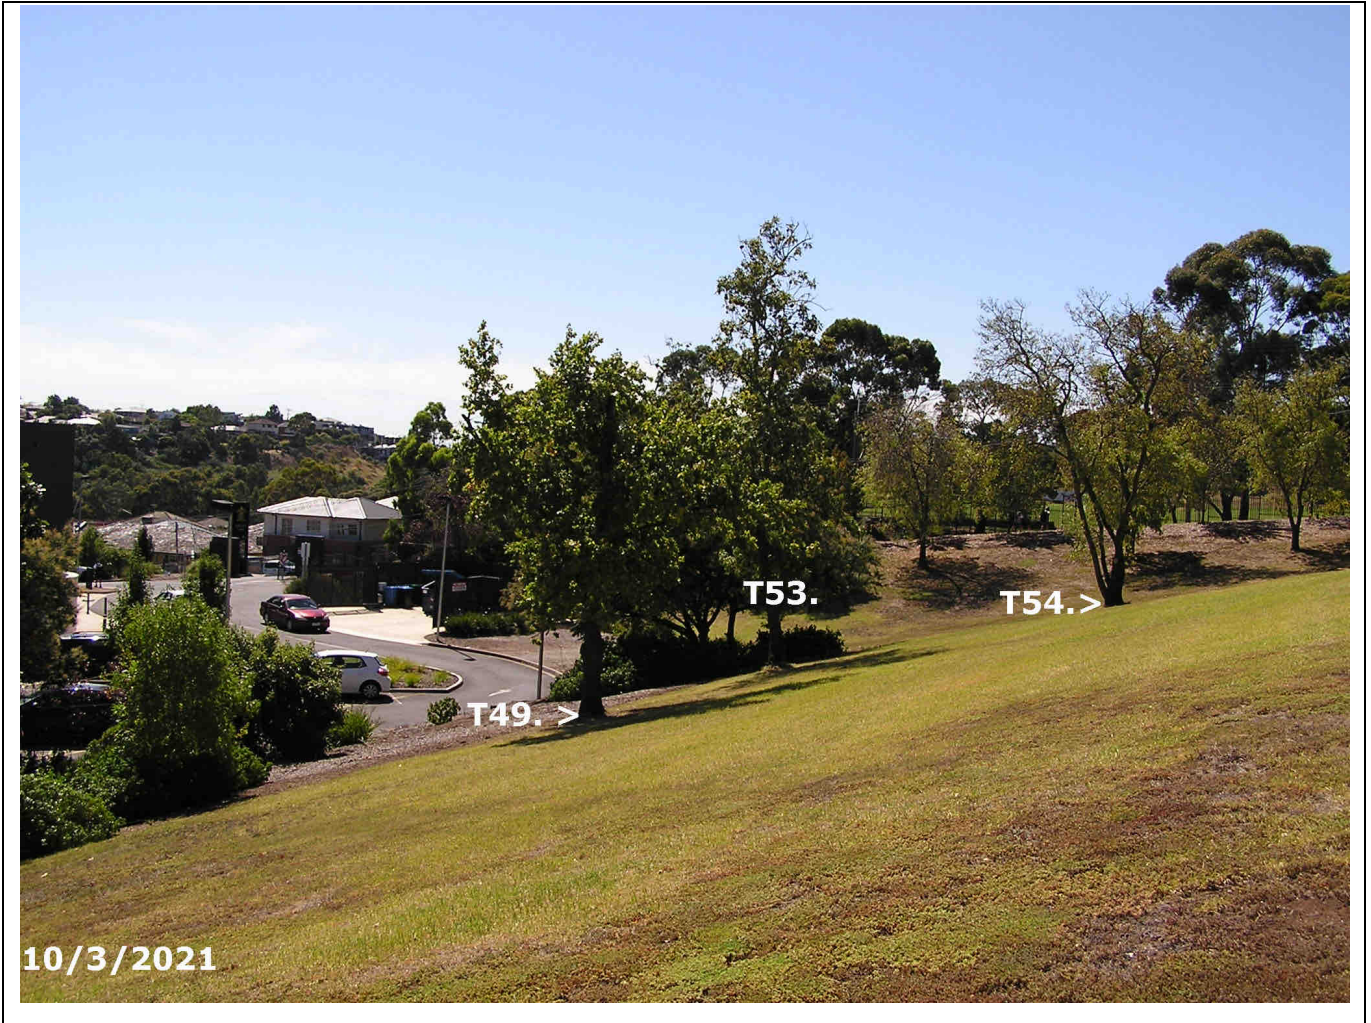
T49, T53 & T54: Remove. General Position of Proposed New Year 12 Senior Centre Building.

- Remove x3 Trees T49. T53. T54. They are decrepit Ageing and Not-viable. Past their SULEs.

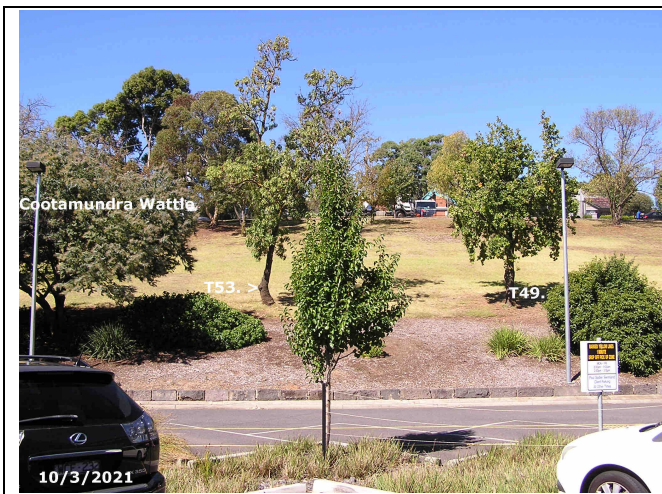
<b>T53</b>	<b>Desert Ash:</b> <i>Fraxinus oxycarpa</i>	Mature Plus	9.5	7	350	Poor-Fair SULE Short Cat: 3a-d.	Small Suppressed. Poor Form. Asymmetry. Weed Tree. Recently Pruned. No Merit. *Remove.
<b>T54</b>	<b>Desert Ash:</b> <i>Fraxinus oxycarpa</i>	Senescent	8.5	9	185. 245. 250. 150. CAV = 420mm	Poor SULE V. Short Cat: 3a-d Cat: 4aefg.	Multi-stemmed. X4 Stems. Some Rotten & Hollow. Asymmetry. Gross dead-wood. Weed Tree. Recently Pruned. No Merit. *Remove.

T49 & T53.

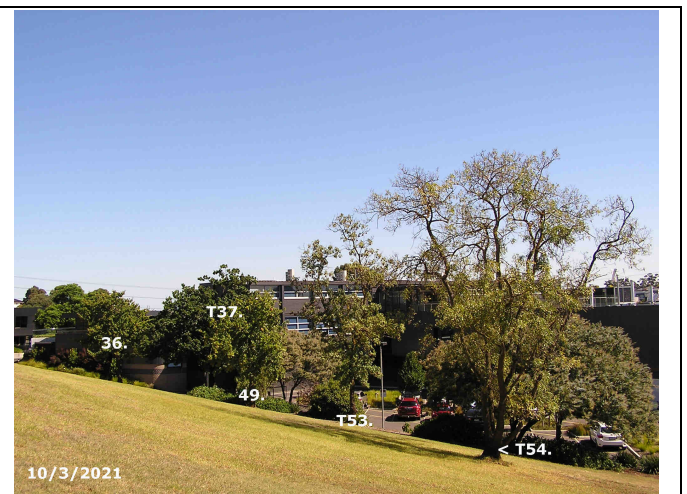
T54 & Others.
