## Tree Care Consulting

**Tree/s Location:** Goroke-Harrow Road, Charam, VIC 3318

**Inspection date:** 18 September 2023

**Prepared by:** Jimmy Ross, Consulting Arborist

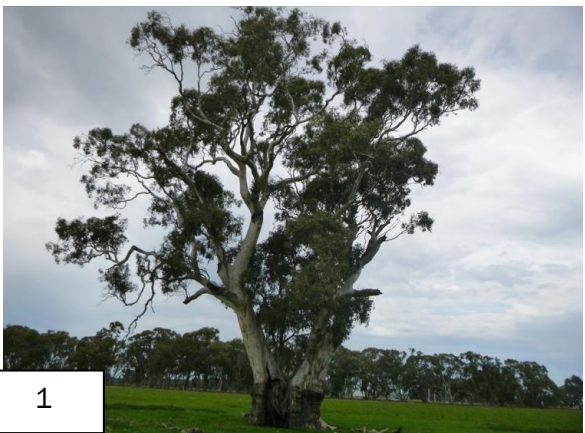
Tree No.	Identification	Origin	Permit required for removal	Age	ULE	Health	Structure	Hazard	Height (m)	Width (m)	Retention Value	Recommended for retention	DBH (cm) * =multi-stem	TPZ (m)	SRZ (m)
1	<i>Eucalyptus camaldulensis</i> (River Red Gum)	Indigenous, Naturally Regenerated	Yes	M	L	F	P	H	30	30	H	Yes	320	15.0	5.4
2	<i>Eucalyptus camaldulensis</i> (River Red Gum)	Indigenous, Naturally Regenerated	Yes	M	L	F	P	H	21	15	H	Yes	130	15.0	3.7
3	<i>Eucalyptus camaldulensis</i> (River Red Gum)	Indigenous, Naturally Regenerated	Yes	M	L	F	G	H	22	24	H	Yes	125	15.0	3.6

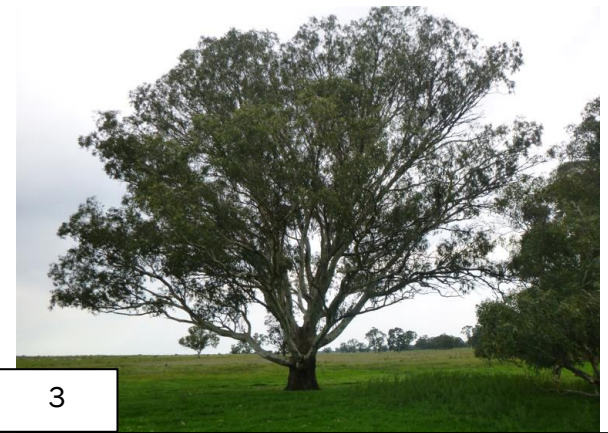
<p>3</p>
<p><b>Observations</b> Cambial dieback on trunk. Co-dominant leaders, significant decaying wood beneath union. Severe structural damage to trunk. Wound at base of trunk. Significant decay within cavity. Decay in large limb. Epicormic growth throughout canopy. History of limb failures. Severe structural damage to branches. Significant deadwood in canopy greater than 25mm. Stub/s inhibiting wound closure.</p>	<p><b>Observations</b> History of limb failures. Failed limb on ground. Failed limb suspended in canopy. Wound at base of trunk. Significant decay within cavity. Epicormic growth throughout canopy. Minor deadwood greater than 25mm.</p>	<p><b>Observations</b> Epicormic growth throughout canopy. Minor deadwood greater than 25mm.</p>

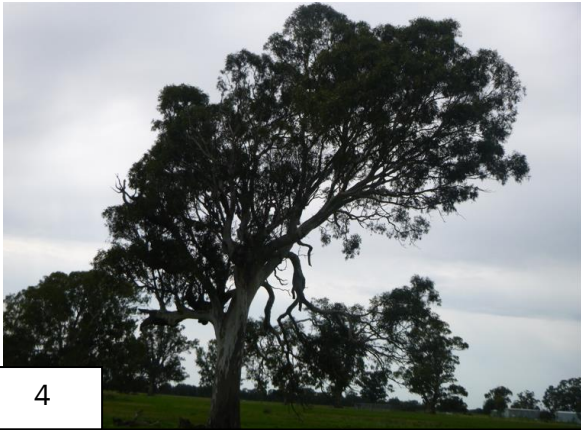
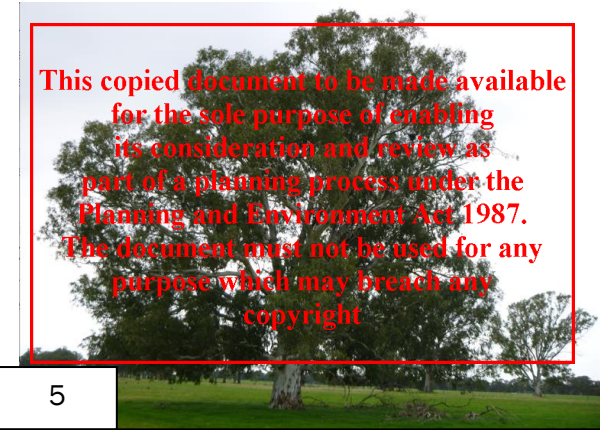
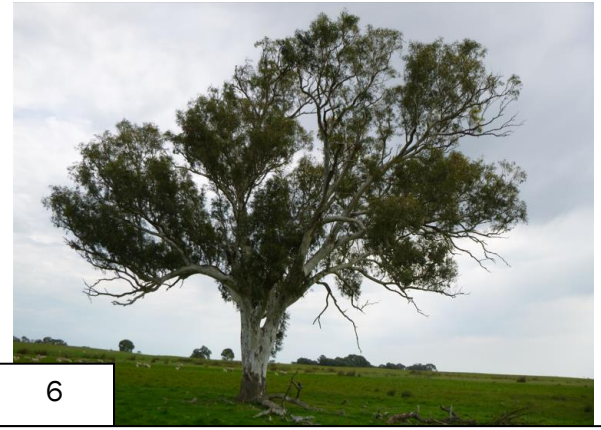
Tree No.	Identification	Origin	Permit required for removal	Age	ULE	Health	Structure	Hazard	Height (m)	Width (m)	Retention Value	Recommended for retention	DBH (cm) * = multi-stem	TPZ (m)	SRZ (m)
4	<i>Eucalyptus camaldulensis</i> (River Red Gum)	Indigenous, Naturally Regenerated	Yes	M	L	F	G	H	26	22	H	Yes	132	15.0	3.7
5	<i>Eucalyptus camaldulensis</i> (River Red Gum)	Indigenous, Naturally Regenerated	Yes	M	L	F	P	H	24	24	H	Yes	151	15.0	3.9
6	<i>Eucalyptus camaldulensis</i> (River Red Gum)	Indigenous, Naturally Regenerated	Yes	M	L	F	P	H	20	22	H	Yes	111	13.3	3.5

<p><b>Observations</b> History of limb failures. Failed limb on ground. Epicormic growth throughout canopy. Large and small natural hollows present on branch/es. Minor deadwood greater than 25mm. Some cambial dieback/damage on branch/es. Severe structural damage to branches.</p>	<p><b>Observations</b> History of limb failures. Failed limb on ground. Epicormic growth throughout canopy. Large and small natural hollows present on branch/es. Minor deadwood greater than 25mm. Some cambial dieback/damage on branch/es. Severe structural damage to branches.</p>	<p><b>Observations</b> History of limb failures. Failed limb on ground. Epicormic growth throughout canopy. Large and small natural hollows present on branch/es. Minor deadwood greater than 25mm. Some cambial dieback/damage on branch/es. Severe structural damage to branches.</p>

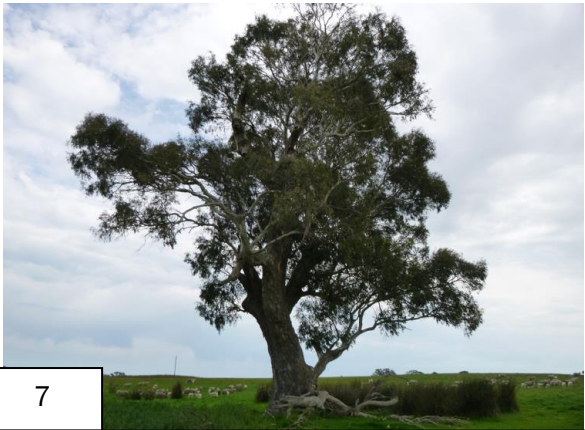
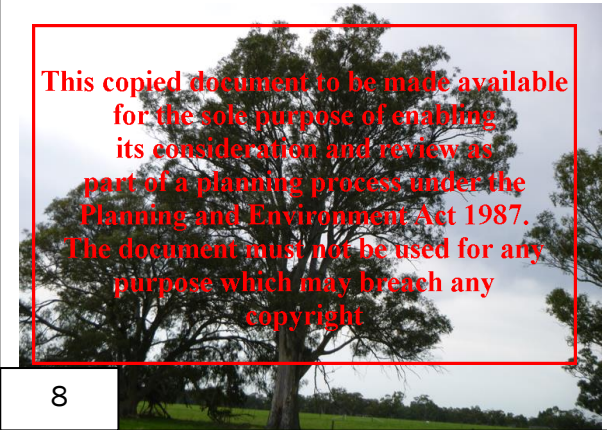
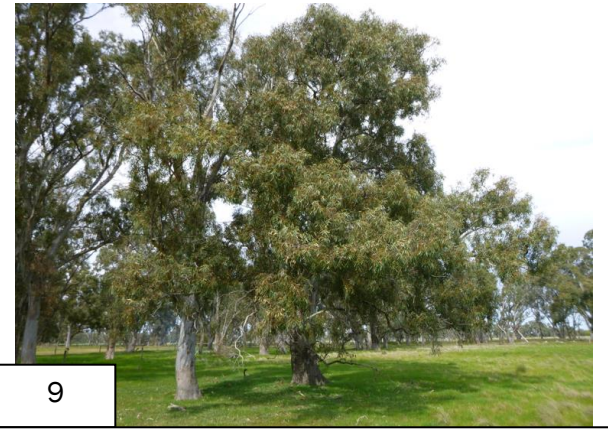
Tree No.	Identification	Origin	Permit required for removal	Age	ULE	Health	Structure	Hazard	Height (m)	Width (m)	Retention Value	Recommended for retention	DBH (cm) * = multi-stem	TPZ (m)	SRZ (m)
7	<i>Eucalyptus camaldulensis</i> (River Red Gum)	Indigenous, Naturally Regenerated	Yes	M	L	F	P	H	23	15	H	Yes	223	15.0	4.6
8	<i>Eucalyptus camaldulensis</i> (River Red Gum)	Indigenous, Naturally Regenerated	Yes	M	L	F	P	H	28	22	H	Yes	162	15.0	4.1
9	<i>Eucalyptus camaldulensis</i> (River Red Gum)	Indigenous, Naturally Regenerated	Yes	M	L	F	G	H	13	15	H	Yes	101	12.1	3.3

<p><b>Observations</b> Cambial dieback/damage on trunk. History of limb failures. Epicormic growth throughout canopy. Failed limb on ground. Large natural hollow present in trunk. Significant decay within cavity. Large and small natural hollows present on branch/es. Minor deadwood greater than 25mm. Severe structural damage to branches. Some cambial dieback/damage on branch/es.</p>	<p><b>Observations</b> History of limb failures. Failed limb on ground. Failed limb suspended in canopy. Epicormic growth throughout canopy. Some cambial dieback/damage on branch/es. Large and small natural hollows present on branch/es. Minor deadwood greater than 25mm. Severe structural damage to branches.</p>	<p><b>Observations</b> Severe structural damage to branches. Some cambial dieback/damage on branch/es. Some epicormic growth within canopy. Minor deadwood greater than 25mm.</p>

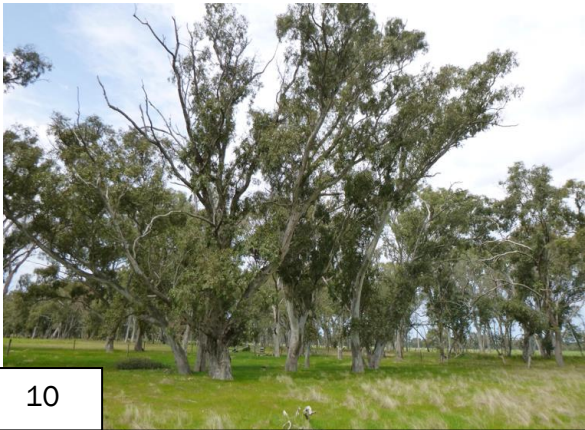
Tree No.	Identification	Origin	Permit required for removal	Age	ULE	Health	Structure	Hazard	Height (m)	Width (m)	Retention Value	Recommended for retention	DBH (cm) * = multi-stem	TPZ (m)	SRZ (m)
10	<i>Eucalyptus camaldulensis</i> (River Red Gum)	Indigenous, Naturally Regenerated	Yes	M	L	F	P	H	24	20	H	Yes	112	13.4	3.5
11	<i>Eucalyptus camaldulensis</i> (River Red Gum)	Indigenous, Naturally Regenerated	Yes	M	L	F	P	H	27	20	H	Yes	90	10.8	3.2
12	<i>Allocasuarina verticillata</i> (Drooping Sheoak)	Indigenous, Naturally Regenerated	Yes	M	L	G	P	L	17	6	M	Yes	40	4.8	2.3

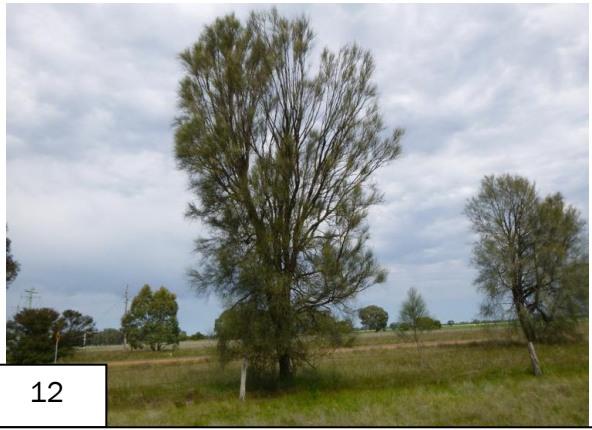
12

<p><b>Observations</b> Wound at base of trunk. Significant decay within cavity. Cambial dieback/damage on trunk. Severe structural damage to branches. Significant deadwood greater than 25mm. Some cambial dieback/damage on branch/es. Some epicormic growth within canopy.</p>		<p><b>Observations</b> History of limb failures. Failed limb on ground. Small natural hollow present in trunk. Severe structural damage to branches. Significant deadwood greater than 25mm. Some cambial dieback/damage on branch/es. Some epicormic growth within canopy.</p>		<p><b>Observations</b> Codominant leaders with included bark union. Significant deadwood less than 25mm.</p>

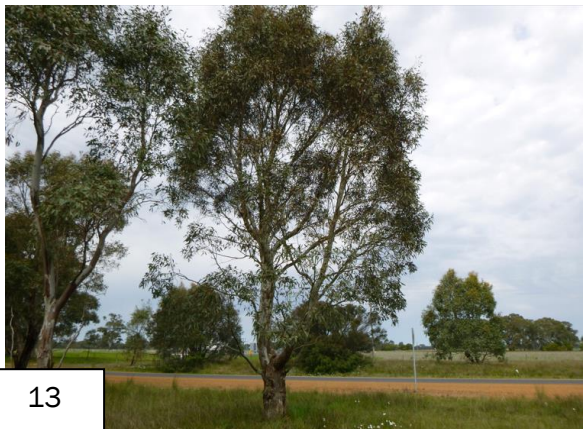
Tree No.	Identification	Origin	Permit required for removal	Age	ULE	Health	Structure	Hazard	Height (m)	Width (m)	Retention Value	Recommended for retention	DBH (cm) * =multi-stem	TPZ (m)	SRZ (m)
13	<i>Eucalyptus camaldulensis</i> (River Red Gum)	Indigenous, Naturally Regenerated	Yes	SM	L	G	G	L	12	6	M	Yes	50	6	2.5

Structurally sound specimen.
