Agricultural Assessment

Proposed Solar Farm - 6 Meridian Road, Yelta

Green Gold Energy

Cadeema

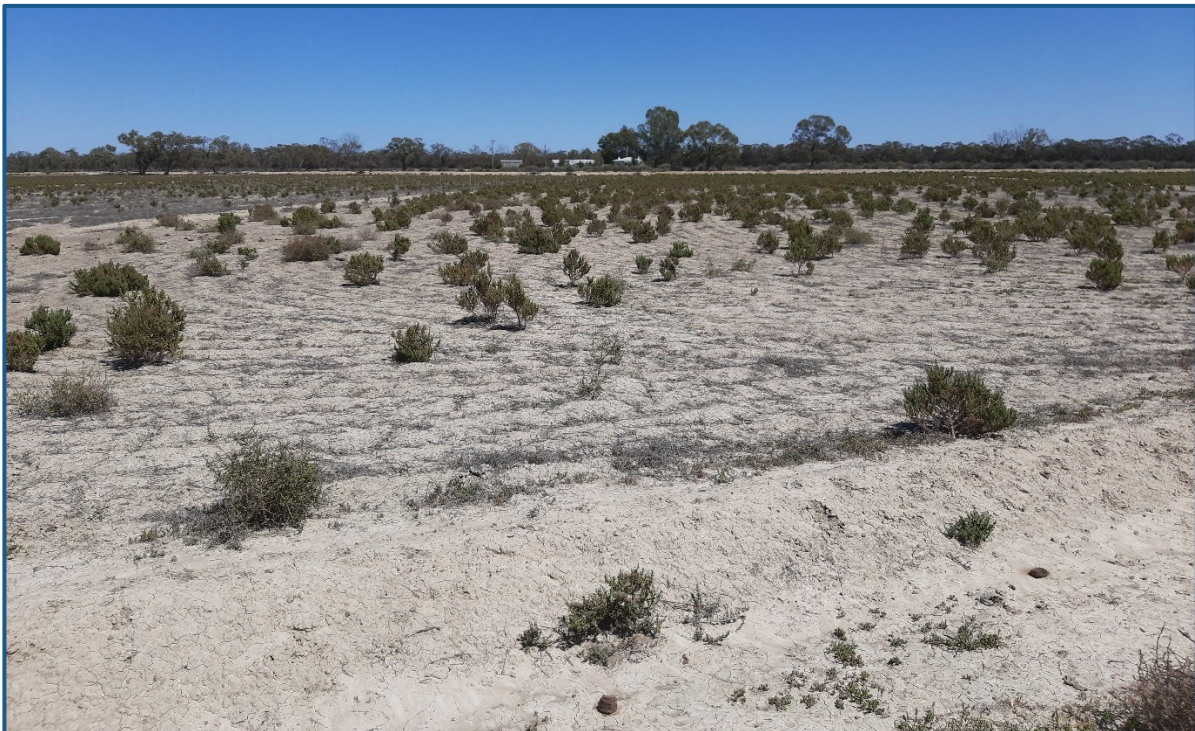
Image 1: *The site consists of flat open land with saltbush and few trees.*

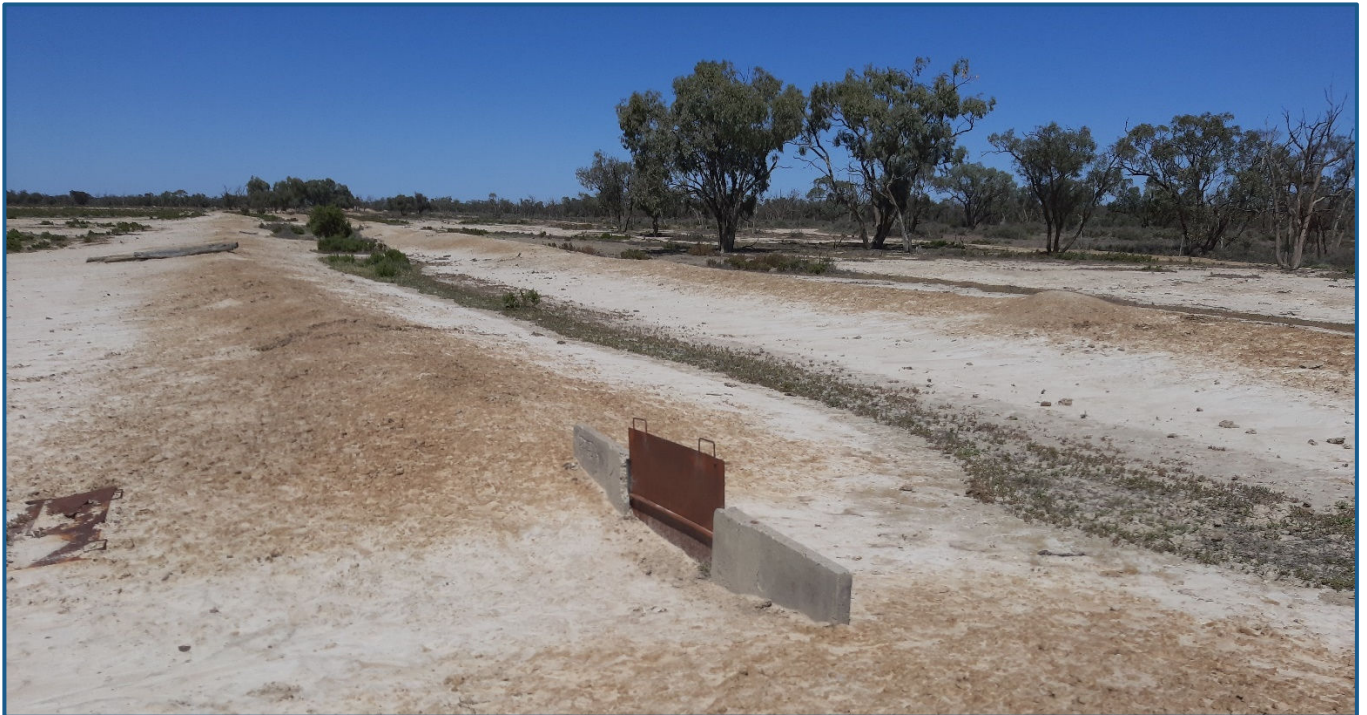
Image 4: An unmaintained and now-defunct earthen irrigation water supply channel and outlet in the southwest of the site.

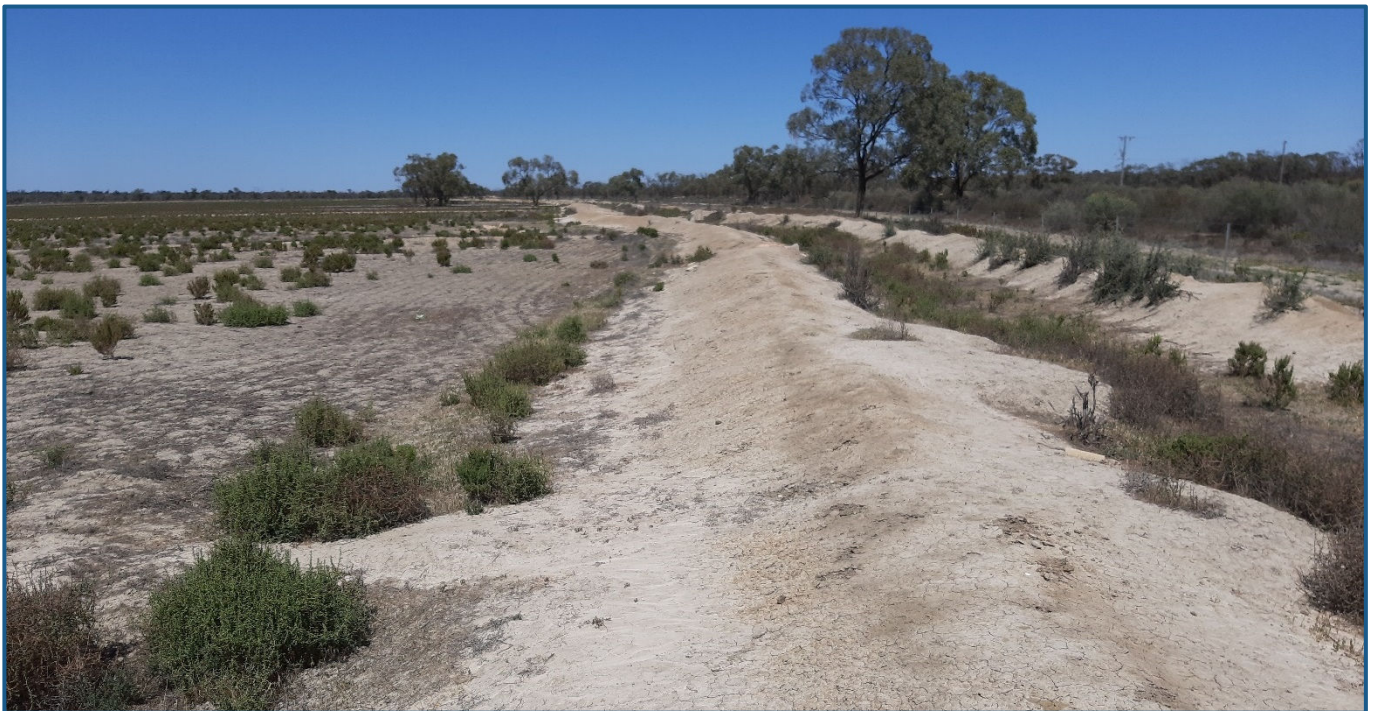
Image 5: An unmaintained and now-defunct earthen irrigation water supply channel is located along the western boundary of the site.

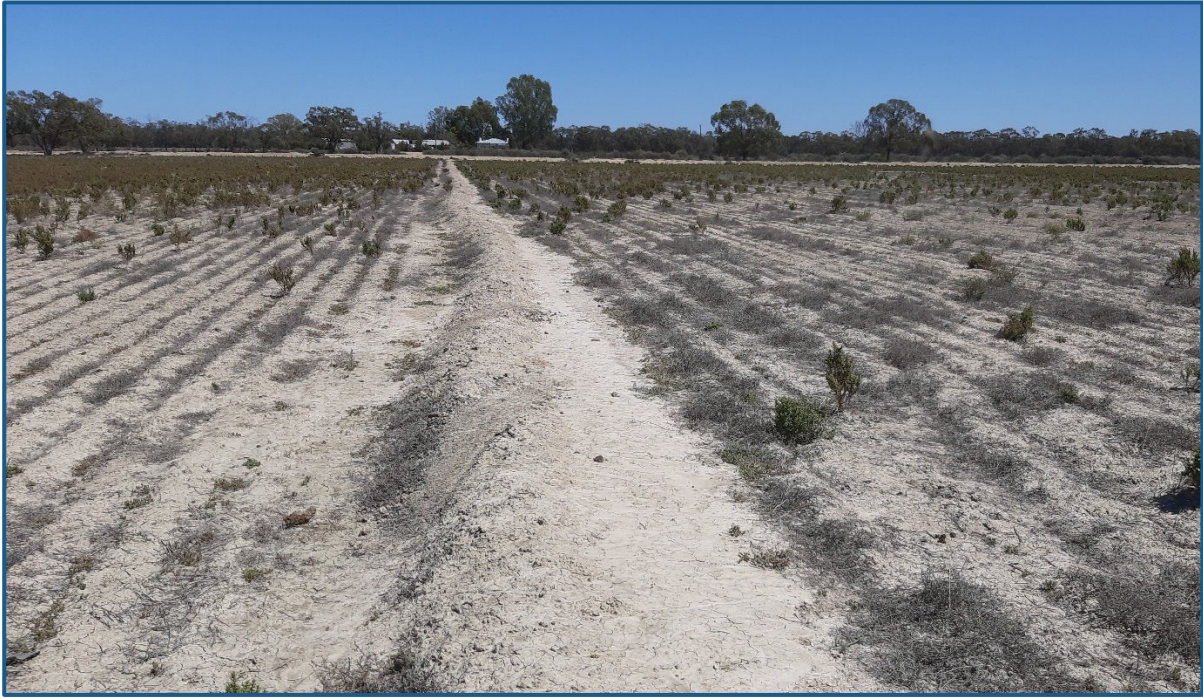
Image 6: A small earthen check bank, which is a remnant of the now-defunct flood (border check) irrigation system, is one of the few remaining remnants of irrigation on the site.

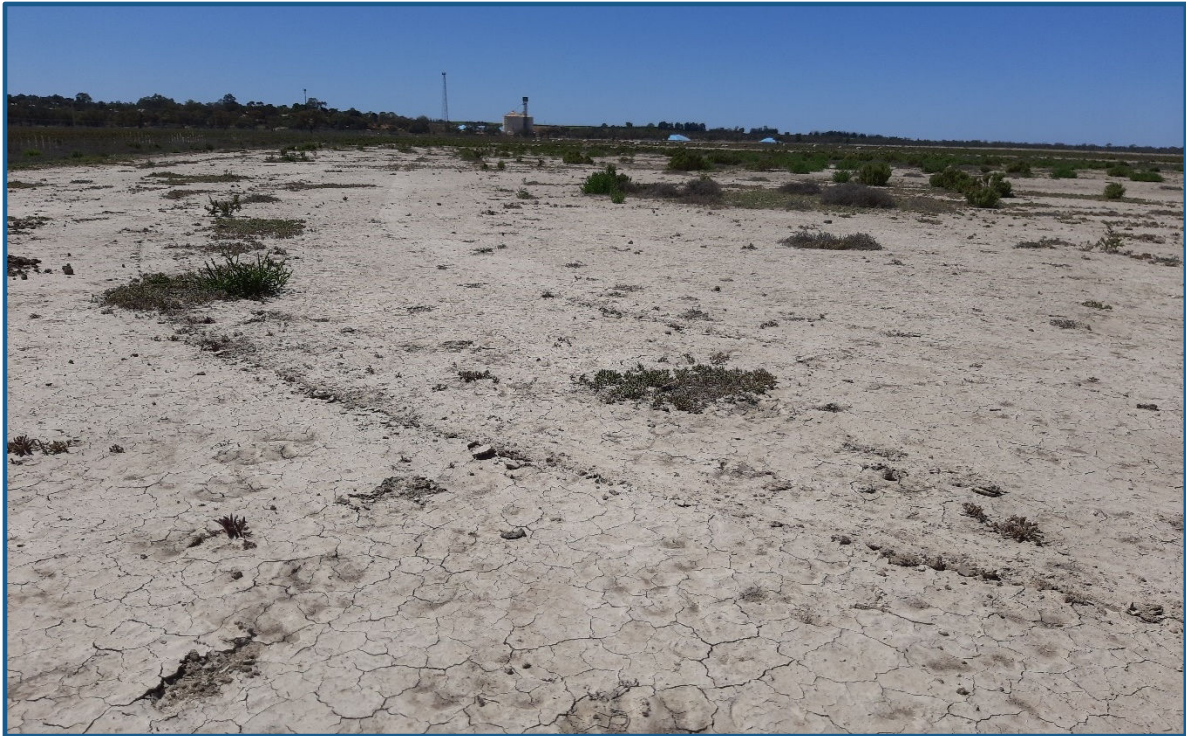
Grey Clay Vertisols – The soil surface is slaked and on drying consists of fine cracking (*Image 7*). The soil profile consists of a shallow (0-6 cm), grey (or light grey), light to medium clay surface soil layer (A Horizon) which grades into a poorly structured, poorly drained, dark grey to dark grey-brown heavy clay subsoil (B Horizon) which extends to depth (50+ cm) (*Images 8 & 9*). Surface soil structure is granular to subangular blocky and subsoil structure is columnar to subangular blocky. Soil structure throughout the soil profile is dense, tough and intractable, and is hard when dry and plastic when wet. Whilst no natural lime (soil carbonates) were identified on the site, it is likely that these occur at depth in sporadic (5-10%) fine powdery and modulated deposits as is typical of Vertisol soils in this landscape. Because of the topographically low-lying nature of this soil type, combined with the flat landscape, limited surface drainage, high water holding capacity and low soil profile permeability, the soils across the site are susceptible to waterlogging, salting and sodicity.

Image 7: The soil surface is slaked and consists of fine cracks when dry; the grain receival/storage facility to the southeast of the property can be discerned in the background of this image.

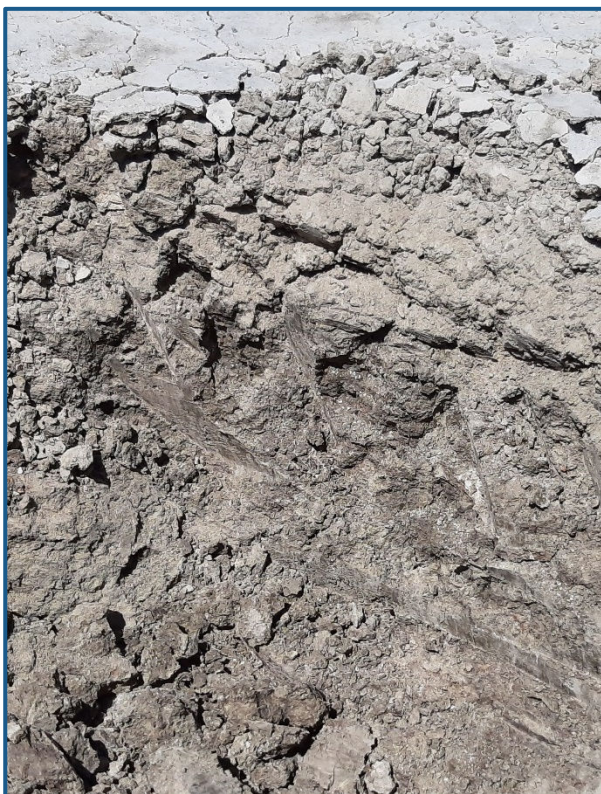
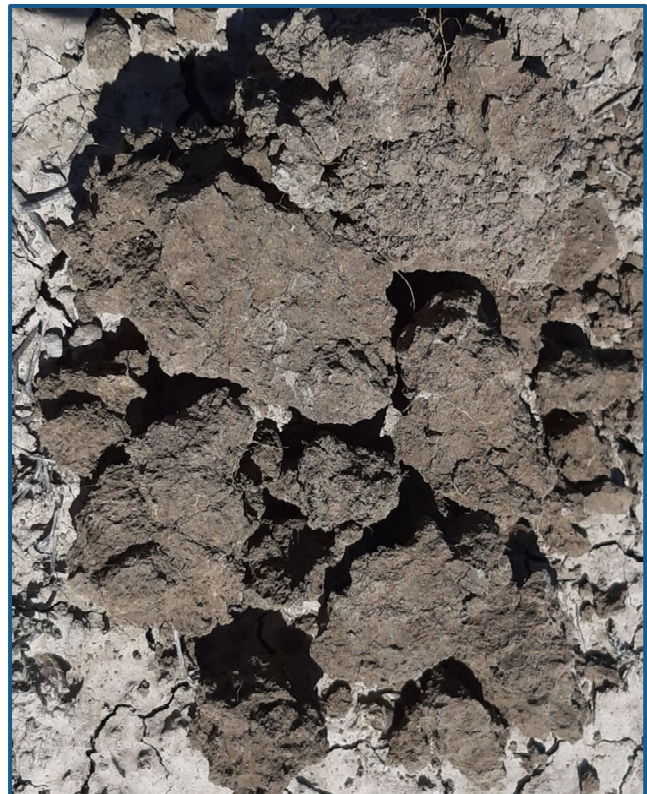
Images 8 & 9: The soils consist of a shallow (0-6 cm), grey (or light grey), light to medium clay surface soil layer (A Horizon) which grades into a poorly structured, poorly drained, dark grey to dark grey-brown heavy clay subsoil (B Horizon) which extends to depth (50+ cm).

Soil Productivity Potential – The soils on the site have a low agricultural productivity potential because of the shallow depth of surface soil, high clay content, tough and intractable soil structure, poor drainage and susceptibility to waterlogging, salting and sodicity. In combination, these features provide unfavourable conditions for root growth and function, and limit the soil volume available for plant root exploitation. The soils are not amendable to tillage due to unfavourable conditions at slightly wet or slightly dry soil moisture contents. Where tillage improves soil structure, poor soil structure rapidly returns. The soils are not suitable for agriculture or horticulture. The soils are not suitable for higher value horticultural fruit or vegetable crops. The soils are also not suitable for lower value, broad acre, row crops, cereal/grain/oilseed crops and perennial or annual pastures. At best, the soils are suitable for low value, low intensity, grazing of native pastures however, little if any native pastures grow in this landscape on this site as plants predominantly consist of weeds, halophytes and saltbush (*Image 10*).

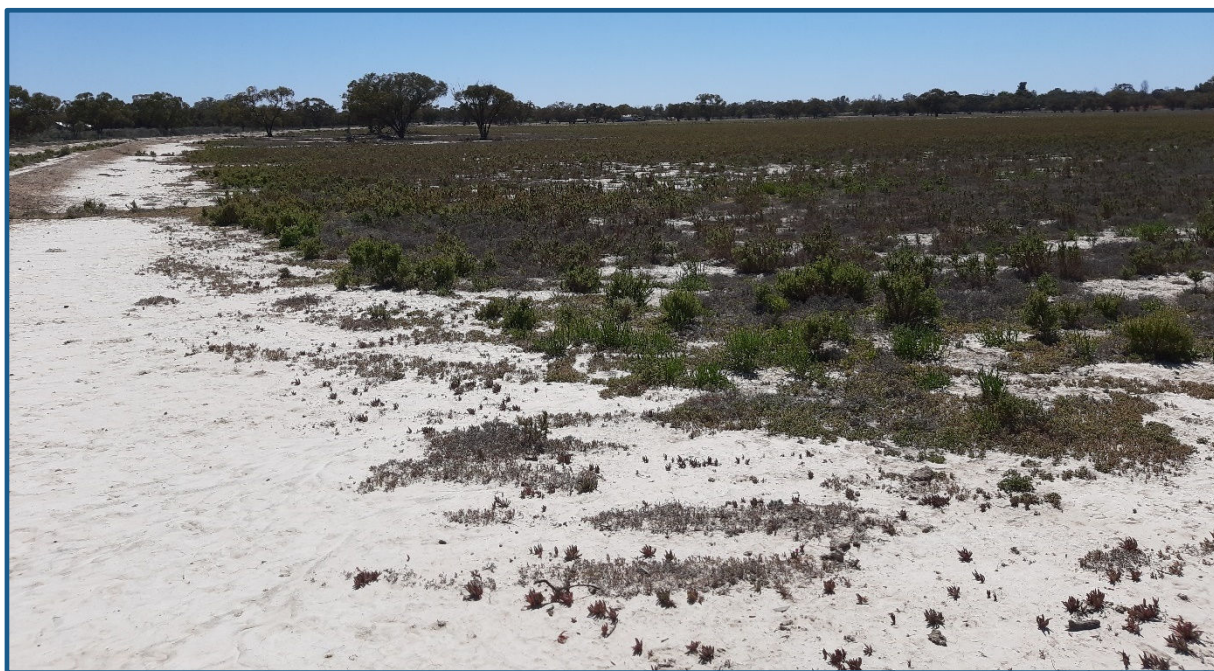
Image 10: Plant growth on the site consists of weeds, halophytes and saltbush.

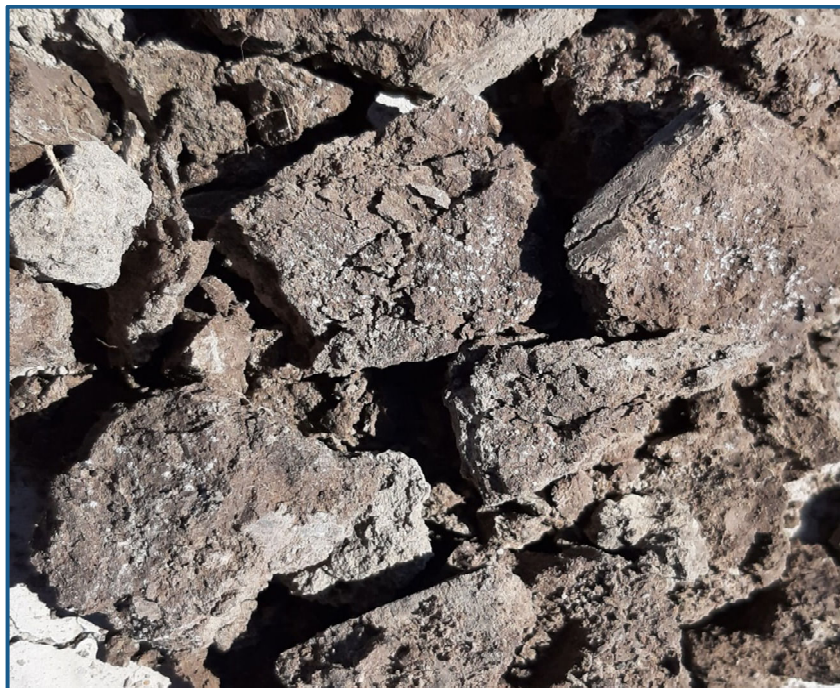
Salinity – The climate, topography, landscape and soil types on this site are conducive to adverse impacts from salinity which are likely to be exacerbated by the adjoining horticultural irrigation areas and the historical removal of remnant vegetation. It is likely that the soils on the site contain elevated salinity levels, particularly sodium chloride (NaCl) levels, as was evidenced by the presence of halophytes and efflorescence (*Image 11*).

Sodicity – Elevated subsoil sodicity can naturally and inherently occur in these soil types in this district. Sodicity on this site is likely to have been exacerbated by land clearing and historical land use practices. The subsoil on this site are likely to be adversely impacted from sodicity as was evinced by sodic soil physical characteristics such as poor structure (*Image 11*). This soil sodicity adversely impacts soil structure which can limit plant root proliferation and soil profile penetration, and also reduces soil profile permeability exacerbating waterlogging. It is likely that soil sodicity and salinity are limiting the agricultural viability of the site. Whilst salinity and sodicity can be improved with practices such as the application of gypsum, significant benefits from gypsum and improvements in salinity and sodicity are not likely due to the poor drainage and permeability of the soils.

Image 11: Poorly structured subsoil peds displaying white efflorescence indicating the presence of salts.

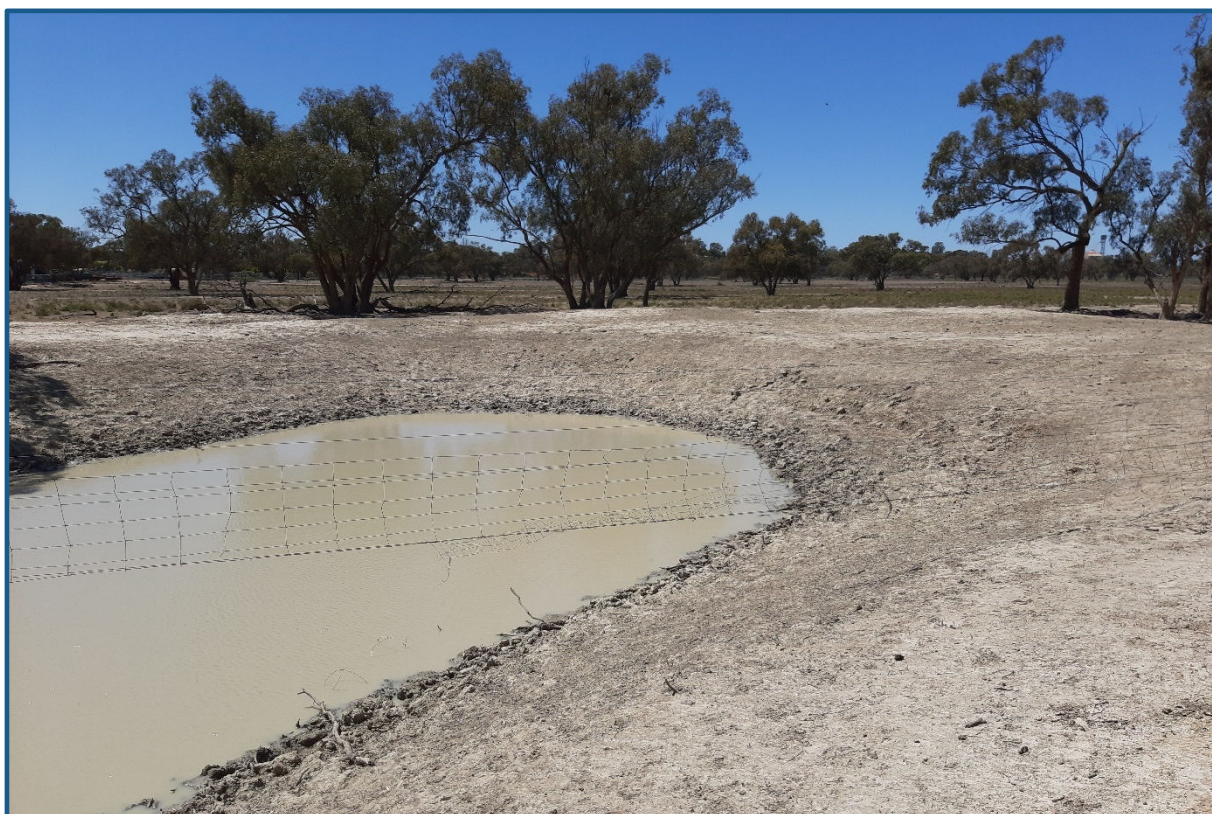
Image 12: A small incised earthen farm dam, located approximately 100 m north of the site, is utilised to supply stock drinking water on the property.

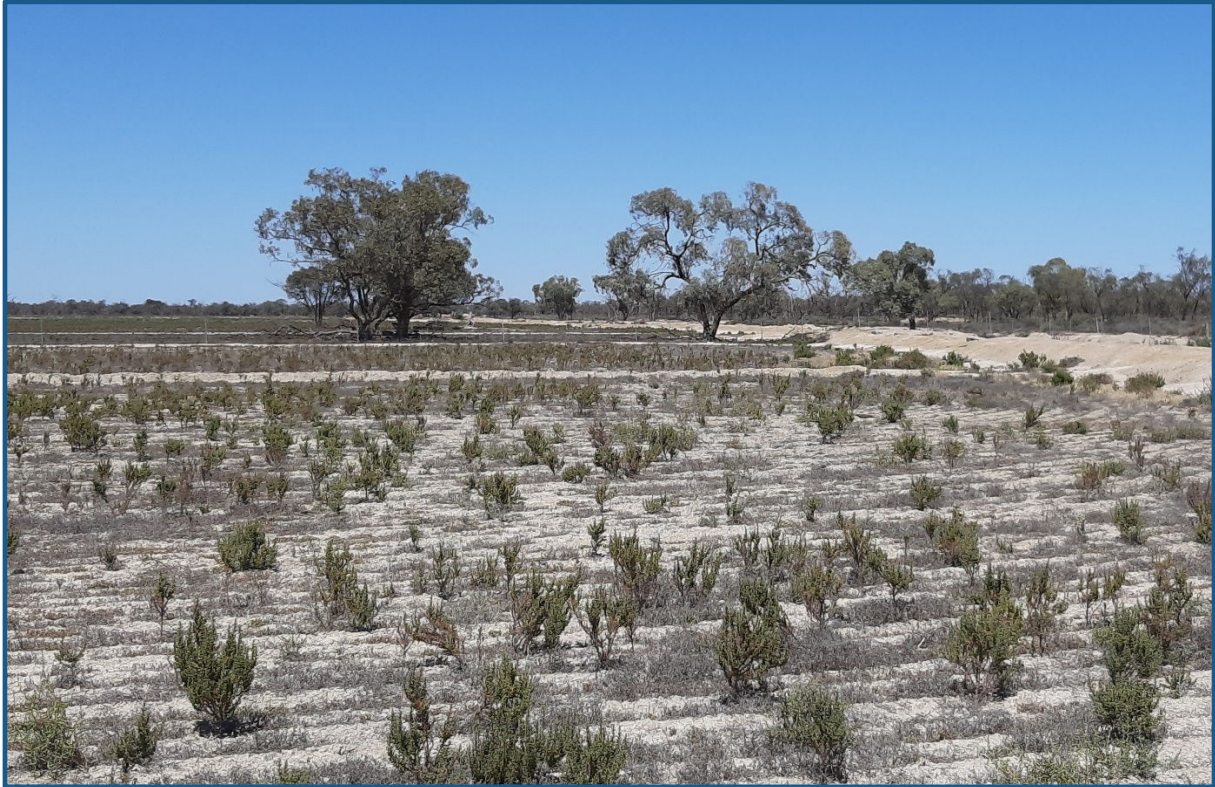
Image 13: Approximately 4 (assumed remnant) Black Box (*Eucalyptus largiflorens*) trees occur in the central western area of the site.

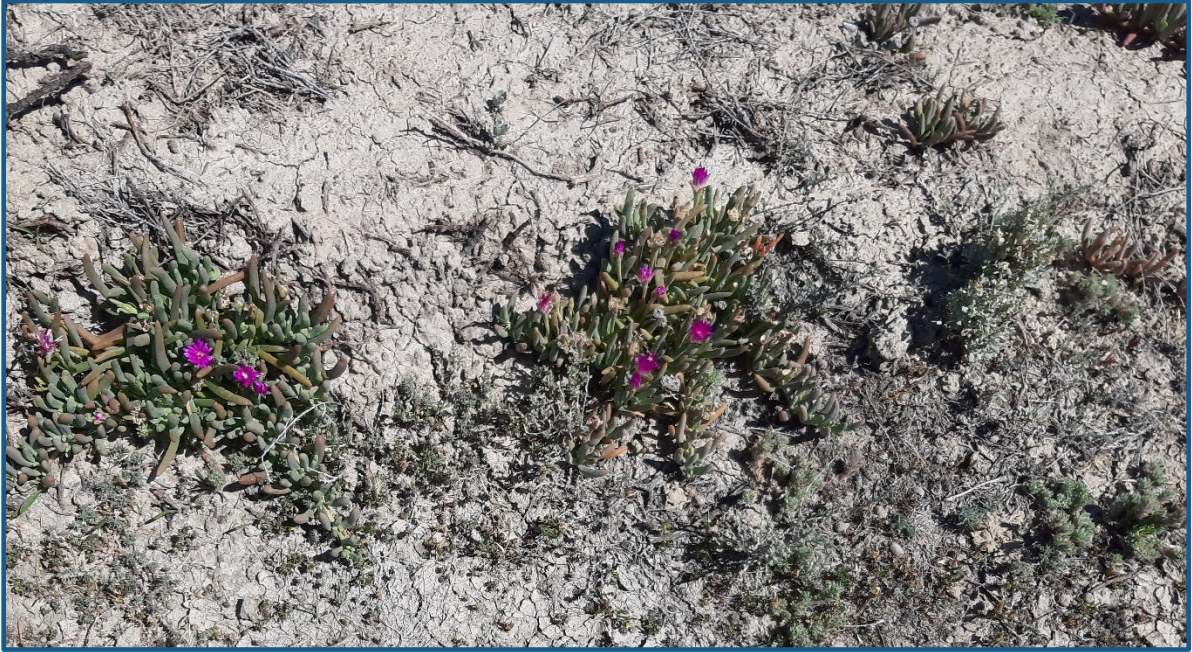
Image 14: Salt indicator plant species such as halophytes occur naturally in this landscape and on the site.

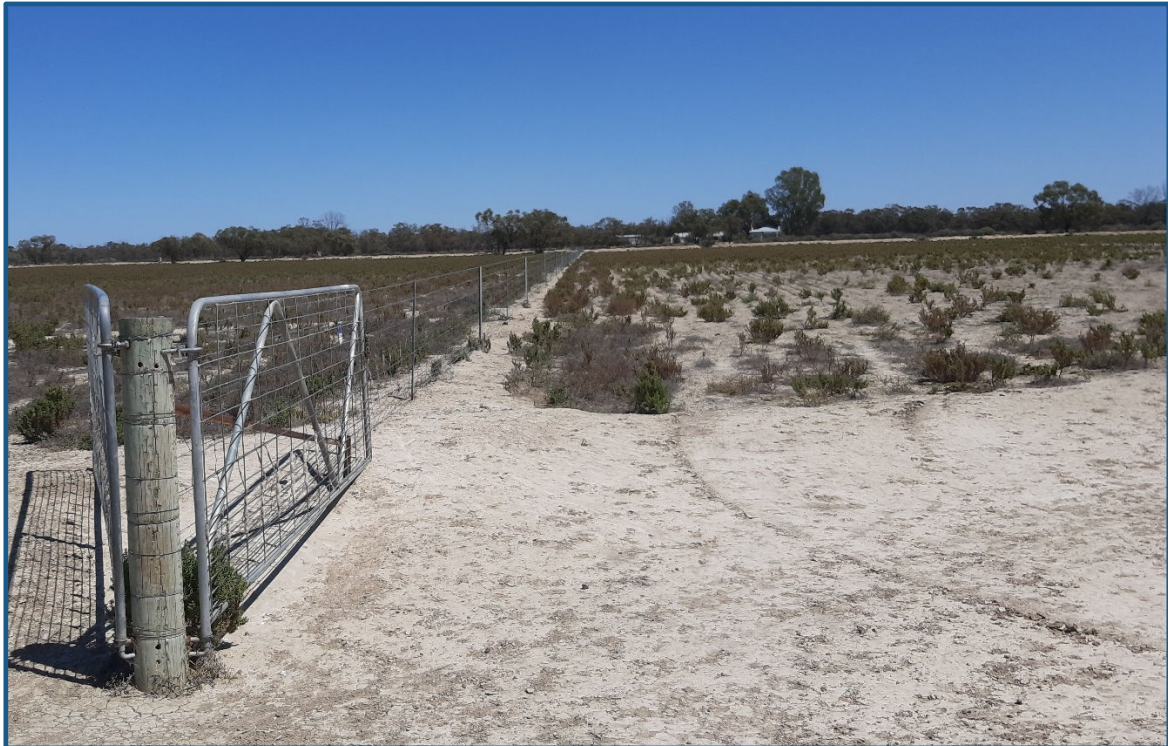
Image 16: The only agricultural infrastructure on the site is farm fencing.

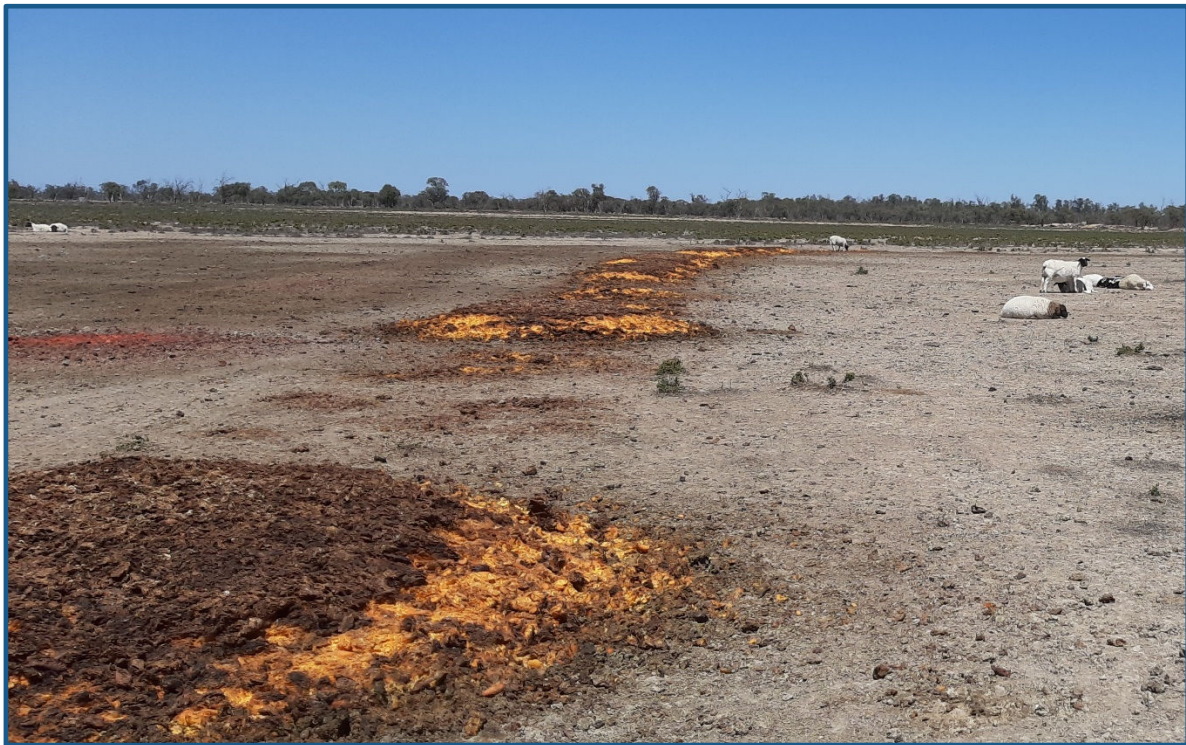
Image 17: The Landholder sources fruit waste from a local juice processor to provide feed for sheep; without this it would not be possible to sustain stock on the site.
