TREE PROTECTION PLAN

DEVELOPMENT WITHIN ST BERNADETTE'S PRIMARY SCHOOL, THE BASIN

FEBRUARY 2021

Prepared by Stephen Fitzgerald
for:
St Bernadette's Primary School, The Basin

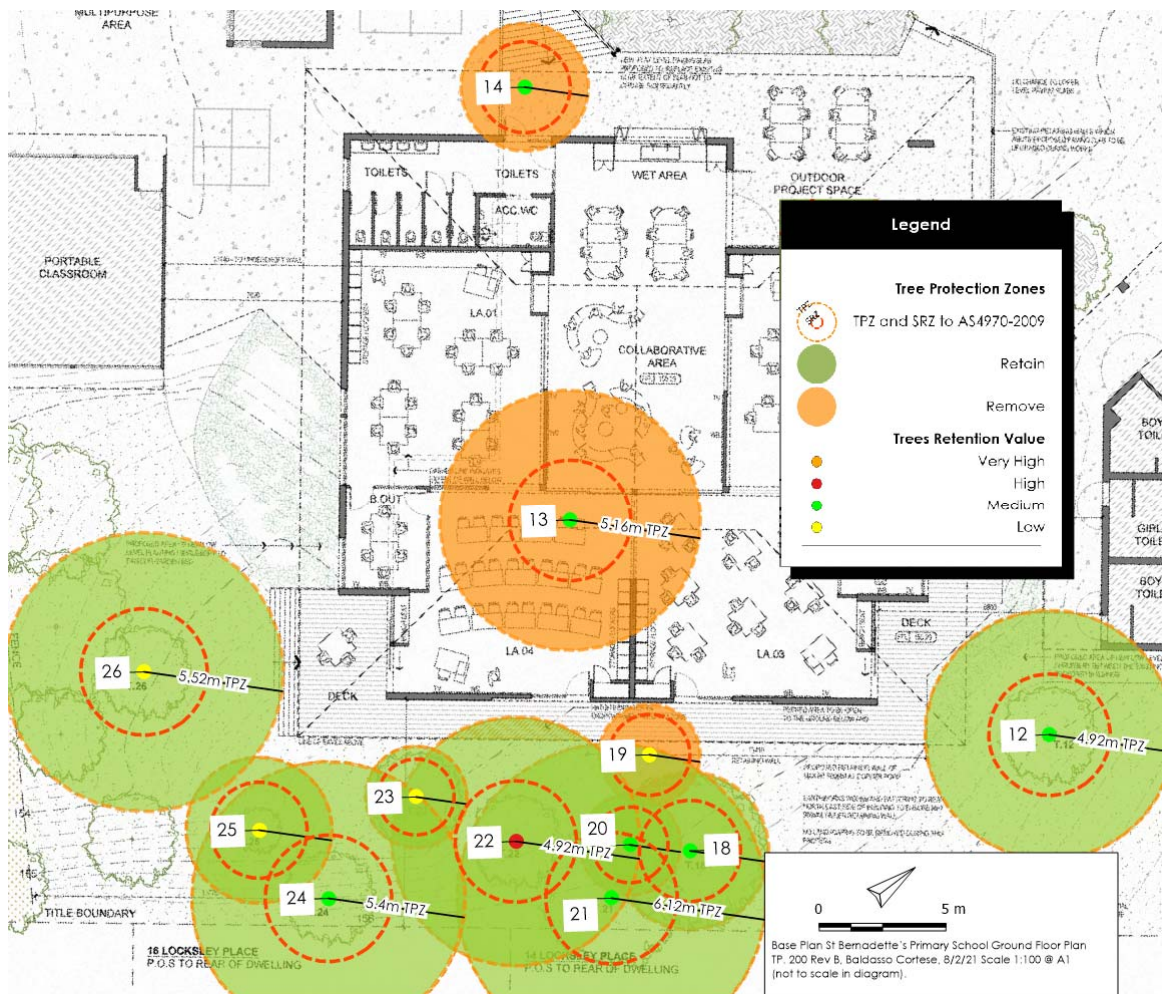
Three planted exotic trees exist around the perimeter of the existing building to be demolished and as such are to be removed. They are: an Evergreen Alder (tree #13 - *Alnus acuminata* subsp. *glabrata*), a Thornless Golden Honey Locust (tree #14 - *Gleditsia triacanthos* 'Sunburst') and a Box Elder (tree #19 - *Acer negundo*, listed as under environmental weed in SLO3). The trees to be removed are less than 20 years old (as can be seen in historical aerial images) and, due to their size and locations not significant to the greater landscape. The landscape amenity afforded by the trees will be easily compensated for by appropriate replacement plantings in locations nearby within the school.

The Evergreen Alder is within the footprint of the proposed building while the Honey Locust and Box Elder will suffer major TPZ and SRZ (structural root zone) encroachments by excavations for footings for the new building (see Figure 1 below). The details and photos of these trees are included in Appendix 1 – Photos and Appendix 2 – *Tree Inspection Records*.

Figure 1 Location of three exotic trees to be removed for construction of new building. TPZs are shaded to indicate tree removal / retention. TPZs to AS4970-2009, red dashed circle are SRZs. Proposed deck presents minor encroachments to trees #26 and #22. Base plan is from St Bernadette's Primary School Ground Floor Plan TP. 200 Rev B, 8/2/21, Baldasso Cortese

A permit should be sought for the removal of trees #13 and #14 under SLO3. Tree #19 is exempt from a permit requirement as it is listed in the Table 1 – *Species exempt from permit* in the SLO3 Schedule.

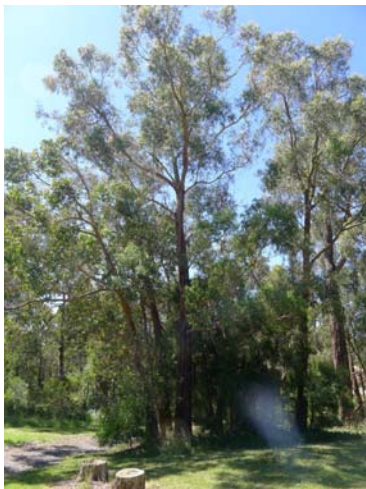
Photo 1 from south: Tree 2 centre and tree 1 left centre

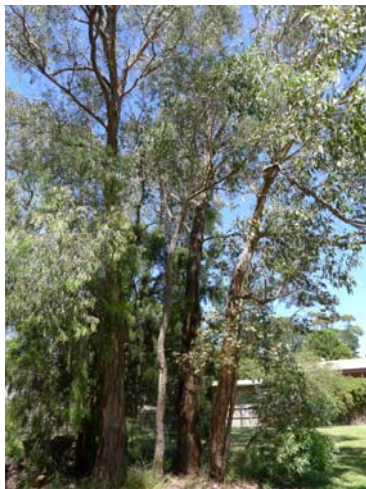
Photo 2 from west: Tree 3 centre

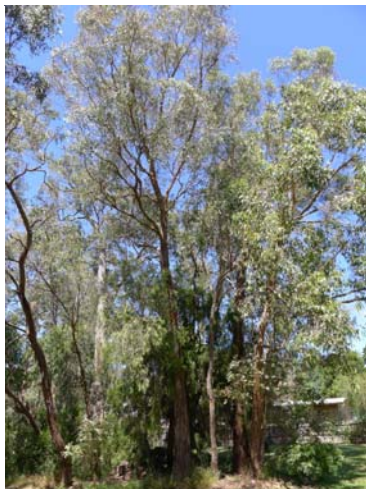
Photo 3 from west: Tree 4 centre

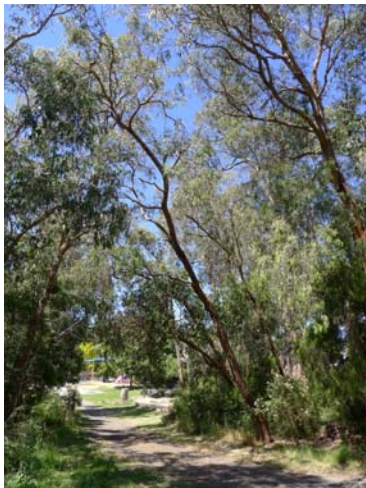
Photo 4 from south-west: Tree 5 centre (leaning over track)

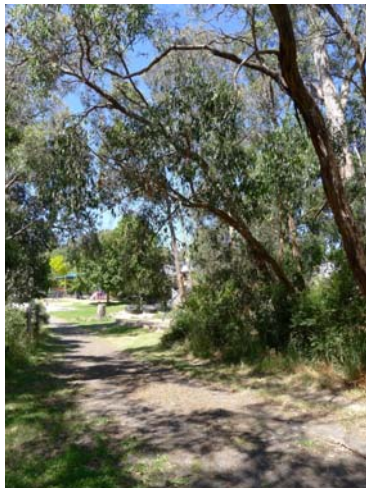
Photo 5 from west: Tree 6 centre leaning over track

1.1m		Fair				0%	<input type="checkbox"/> Encroached?			
6	<i>Eucalyptus obliqua</i> Messmate	Semimature	20cm (1)	10-14m x 5m	Fair	Bifurcation defects of stem	To be protected	Very High	2.4m	1.8m	Vic Native	10-25 years	4m from track edge. TPZ fence at 3.5m from base of stem to avoid impact injury. Height clearance ~4.2m clearance only. If required pruning to be done by arborist See Appendix 1 Photo 5

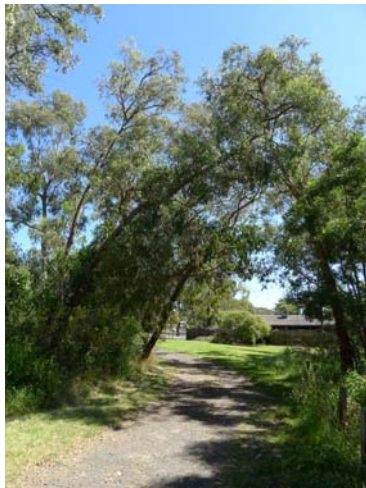
Photo 6 from north-east: Tree 7

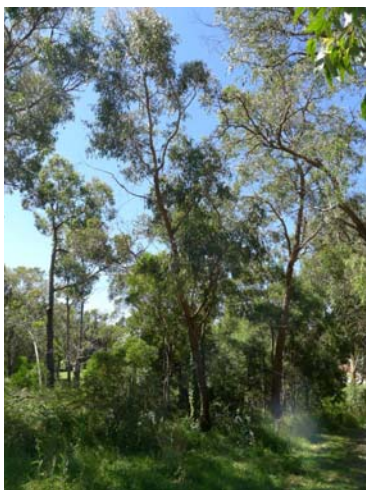
Photo 7 from south-west: Tree 8 centre

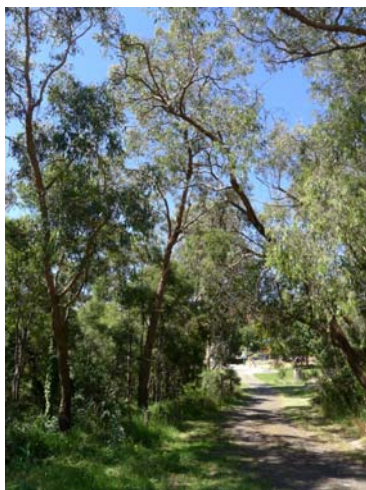
Photo 8 from south-west: Tree 9 centre

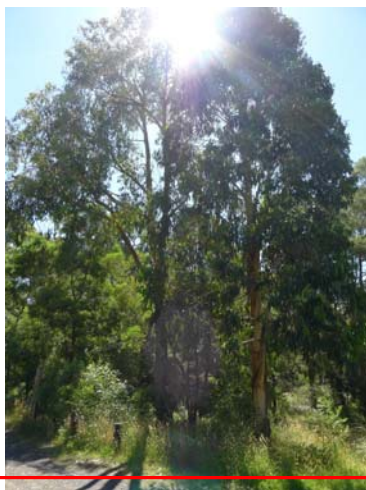
Photo 9 from east: Tree 10 left centre

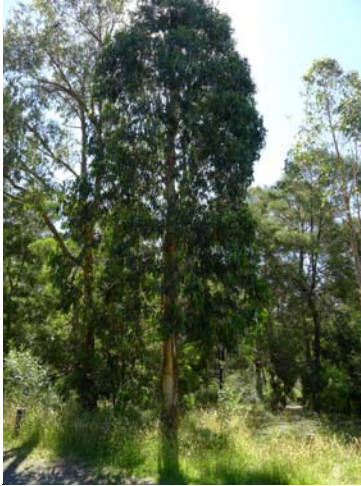
Photo 10 from east: Tree 11 centre

TREE #	SPECIES / COMMON NAME	AGE	DBH ¹	HEIGHT	HEALTH	DEFECTS ²	ACTIONS ³	RETENTION	TPZ ⁴	SRZ ⁵	ORIGIN	LIFE Exp. ⁶	COMMENTS
			Circumf	x Width	STRUCTURE			VALUE	Encroach.	Encroached ²			
11	<i>Eucalyptus globulus</i> Blue Gum	Semimature	42cm (1)	15-19m x 6m	Good	Minor or none noticed	To be protected	High	5.04m	2.4m	Vic Native	50+ years	3.3m from track edge. TPZ fence at 3.3m from base of stem See Appendix 1 Photo 10

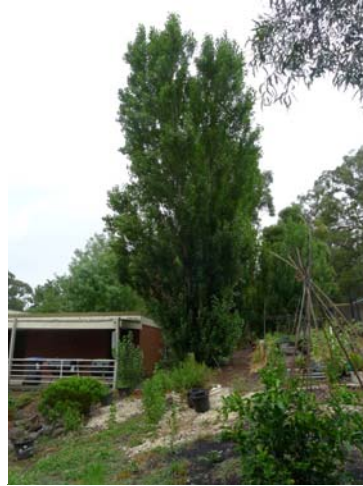
Photo 11 from south-east: Tree 12

1.3m		Good				0%	<input type="checkbox"/> Encroached?			
12	<i>Populus nigra var. italica</i> Lombardy Poplar	Semimature	41cm (4)	15-19m x 6m	Good	Bifurcation defects of stem	To be protected for retention	Medium	4.92m	2.4m	Exotic	25-50 years	See Appendix 1 Photo 11 (Multi-DBH (cm): 17,21,21,23)

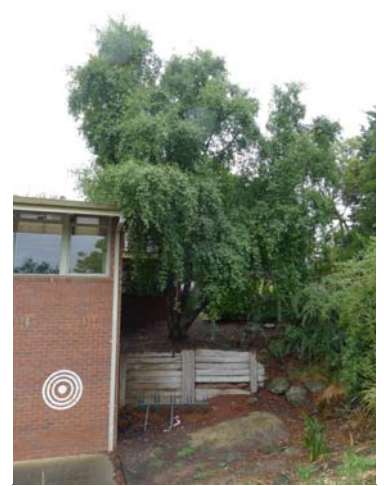
Photo 12 from south-west: Tree 13

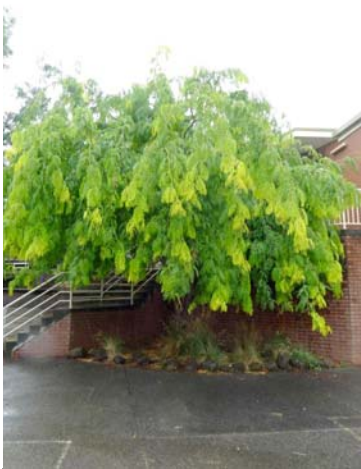
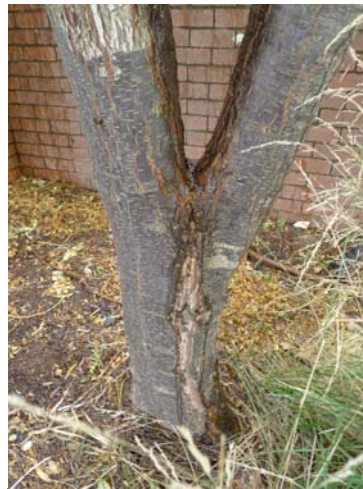
Photo 13 from south-west: Tree 14

Photo 14 from south-west: Tree 14
bifurcation defect of stem

1.4m		Fair				100%	<input checked="" type="checkbox"/> Encroached?			
14	<i>Gleditsia triacanthos</i> Honey Locust	Mature	21cm (2)	8m x 7m	Good	Bifurcation defect of stem	To be removed to allow construction	Medium	2.52m	1.8m	Exotic	25-50 years	100% encroachment due to demolition of building See Appendix 1 Photos 13 & 14 (Multi-DBH (cm): 16,14)

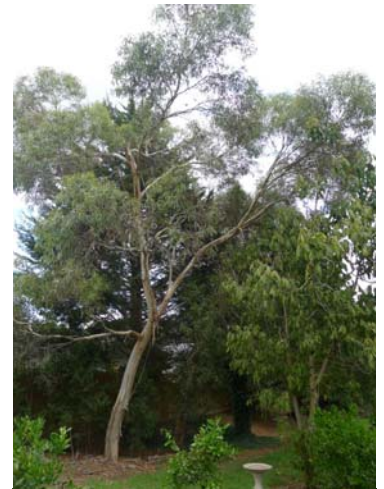
Photo 15 from north: Tree 18

0.7m		Poor				100%	<input checked="" type="checkbox"/> Encroached?			
18	<i>Eucalyptus leucoxylon subsp. megalocarpa</i> Large-fruited South Australian Blue Gum	Mature	26cm (1)	10-14m x 12m	Fair	Broken branch wound top of tree	To be protected for retention	Medium	3.12m	2m	Aus Native	10-25 years	See Appendix 1 Photo 15

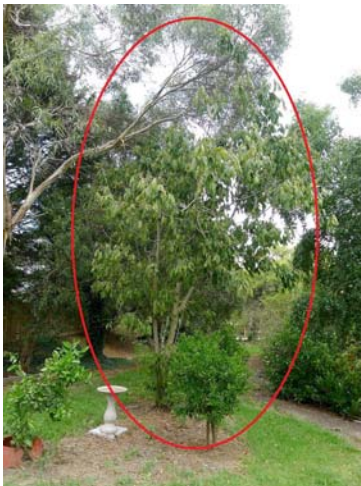
Photo 16 from north: Tree 19

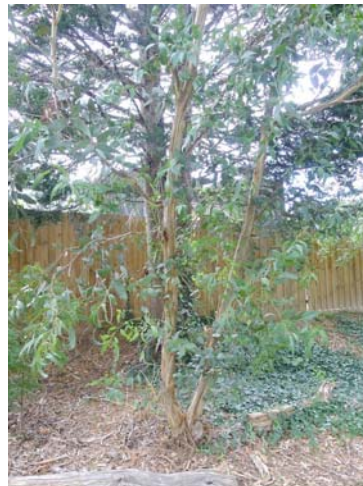
Photo 17 from north-west: Tree 20

0.5m		Fair				70%	<input checked="" type="checkbox"/> Encroached?			
20	<i>Eucalyptus leucoxylon subsp. megalocarpa</i> Large-fruited South Australian Blue Gum	Mature	11cm (2)	6m x 3m	Fair	Broken branch wound top of tree	To be protected for retention	Medium	2m	1.5m	Aus Native	10-25 years	See Appendix 1 Photo 17 (Multi-DBH (cm): 9,7)

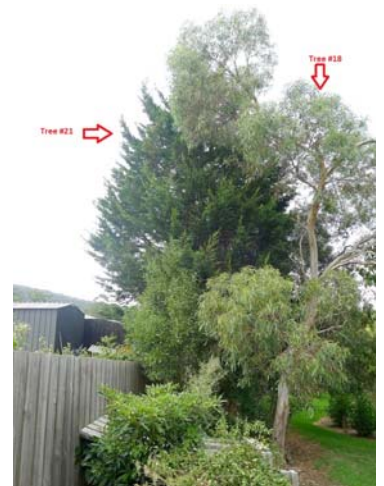
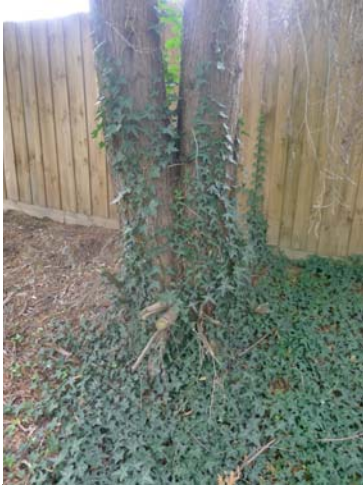
Photo 18 from north-east: Tree 21

Photo 19 from west: Tree 21

0.3m		Fair				0%	<input type="checkbox"/> Encroached?			
21	<i>Cupressus × leylandii</i> Leyland Cypress	Semimature	51cm (2)	10-14m x 8m	Good	Bifurcation defect of stem	To be protected for retention. Tree will need bolt bracing and/or cabling in future to prevent splitting of main stem	Medium	6.12m	2.6m	Exotic	10-25 years	See Appendix 1 Photos 18 & 19 (Multi-DBH (cm): 38,34)

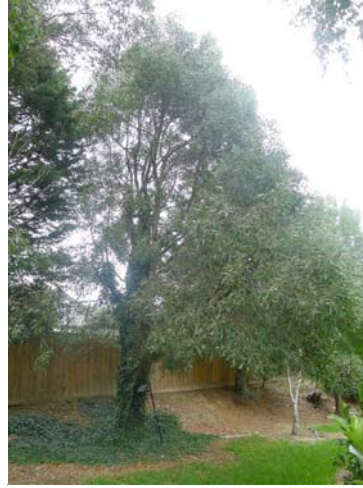
Photo 20 from north-west: Tree 22

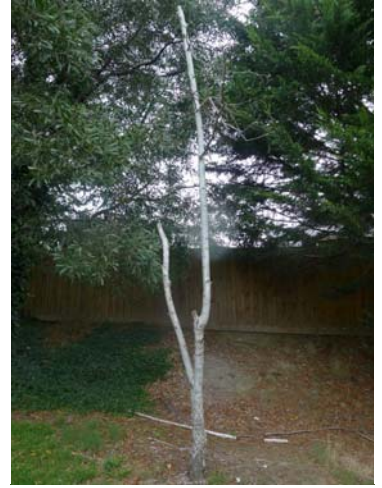
Photo 21: Tree 23

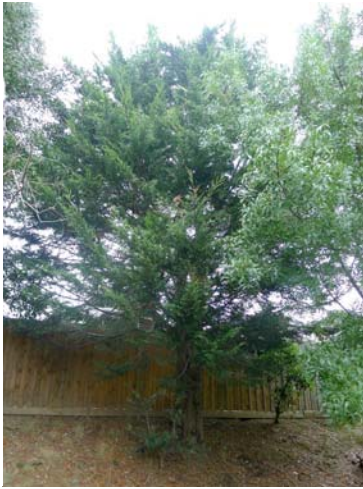
Photo 22 from north-west: Tree 24

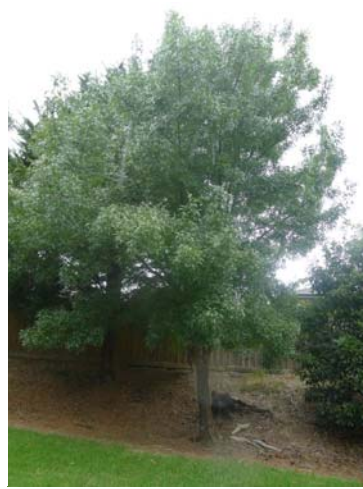
Photo 23 from west: Tree 25

TREE #	SPECIES / COMMON NAME	AGE	DBH ¹	HEIGHT x Width	HEALTH	DEFECTS ²	ACTIONS ³	RETENTION VALUE	TPZ ⁴	SRZ ⁵	ORIGIN	LIFE Exp. ⁶	COMMENTS
			Circumf		STRUCTURE				Encroach.	Encroached ?			
23	<i>Betula pendula</i>	Semimature	8cm (1)	4m x 1m	Dead	General decline of structure (advanced)	Tree Removal	Low	2m	1.5m	Exotic	0 years	TPZ and SRZ do not apply as tree is dead. No permit required to remove this tree Reasons for tree removal: Dead See Appendix 1 Photo 21
	Silver Birch	0.3m	Poor	0%	<input type="checkbox"/> Encroached?								
24	<i>Cupressus × leylandii</i>	Semimature	45cm (2)	10-14m x 8m	Good	Bifurcation defect of stem	To be protected for retention	Medium	5.4m	2.5m	Exotic	10-25 years	See Appendix 1 Photo 22 (Multi-DBH (cm): 31,33)
	Leyland Cypress	1.4m	Poor	0%	<input type="checkbox"/> Encroached?								
25	<i>Fraxinus angustifolia</i>	Semimature	24cm (1)	10-14m x 6m	Good	Minor or none noticed	To be protected for retention	Low	2.88m	1.9m	Exotic	25-50 years	Reason for tree removal: Weed species See Appendix 1 Photo 23

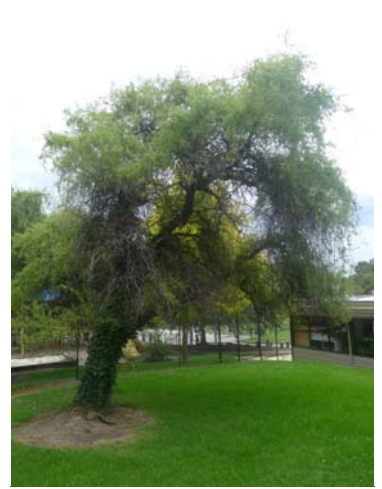
Photo 24 from east: Tree 26
