## ARBORIST REPORT Tree Condition Assessment

Marian College

304 Barkly Street, Ararat VIC

11/11/2022

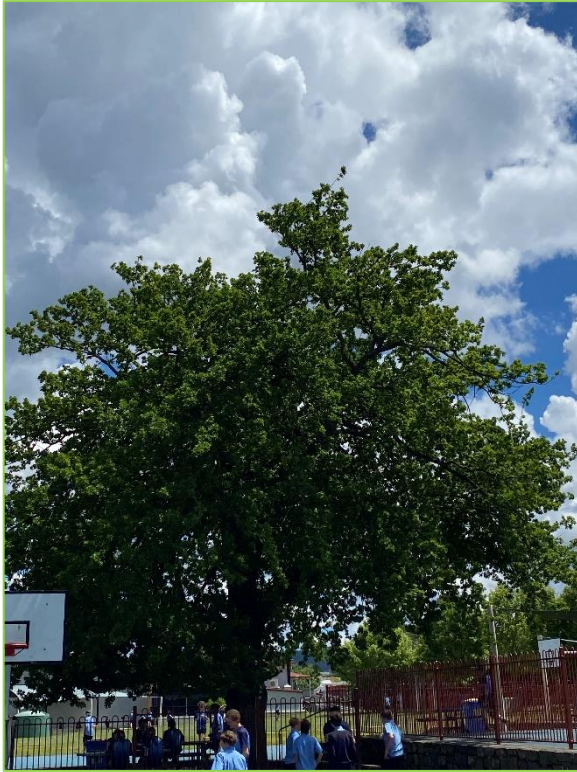
These trees have showed similar health and structure to the last inspection. Tree 1 has better health with a fuller canopy with larger leaves compared to Tree 2. There is also less deadwood in Tree 1.

There is construction occurring in the near future close to Tree 1 that will possibly impact the health of the tree. The extent of impact is unknown without seeing the plans for construction. Tree 1 has a tree protection zone of 10.8m from the centre of the tree, however, it is surrounded on all sides by paved areas. Most of the root mass will be found inside the mulched area as it is a better environment for roots. Any construction would be preferred outside of this area.

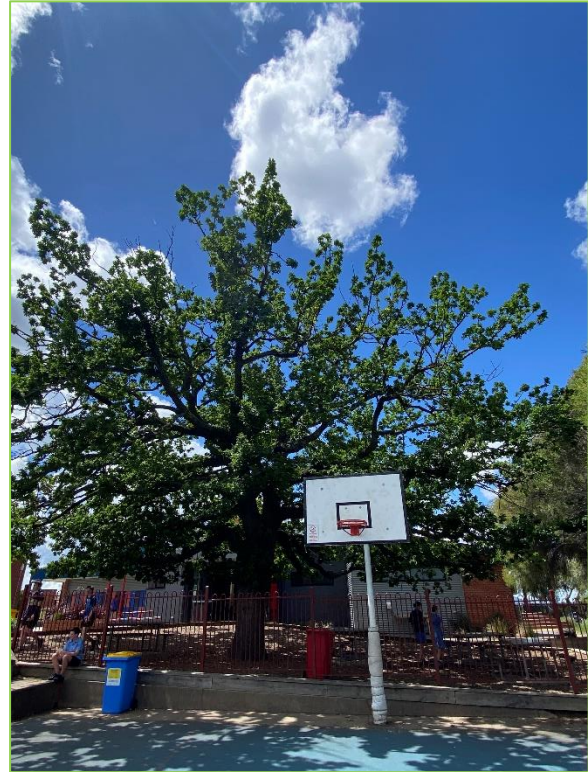
Tree 2 has some larger pieces of deadwood overhanging the tables and areas of high traffic. These should be removed as the pose a threat to health if a person is struck. Deadwood larger than 25mm diameter should be removed. It is unsure if this tree has had any soil treatment. Boosting the soil health with Seasol can promote the health of the tree also.

- Tree 2 – Remove deadwood larger than 25mm diameter throughout canopy.
- Promote soil health by doing a soil drench with Seasol to improve root health and help add organic matter back into the soil.
- Continue to maintain irrigation program during hotter months for both trees. Monitor soil moisture to ensure waterlogging doesn't occur.
- Remove hanging branch and reduce height of 1x London Plane tree (closest to office). Reduce height of damaged stem to below the failure point.
