Arboricultural Assessment

Penola Catholic Collage Glenroy Campus

Art Building Development

9th February 2026

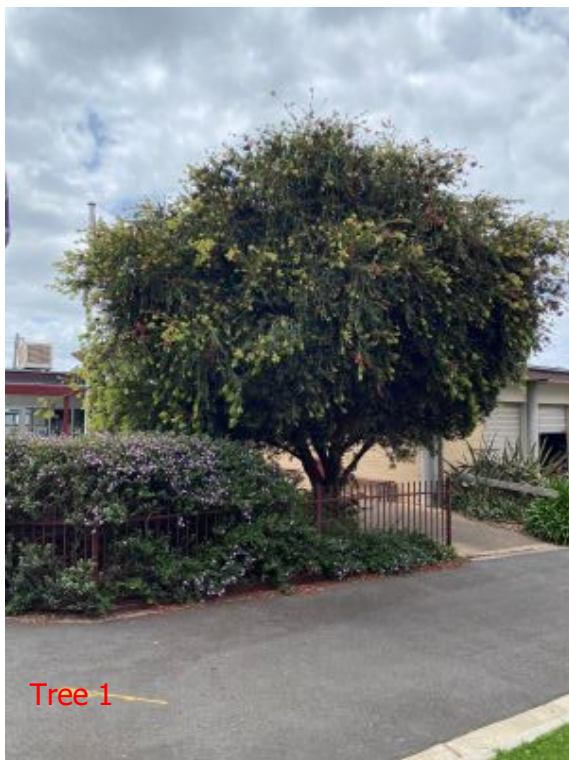
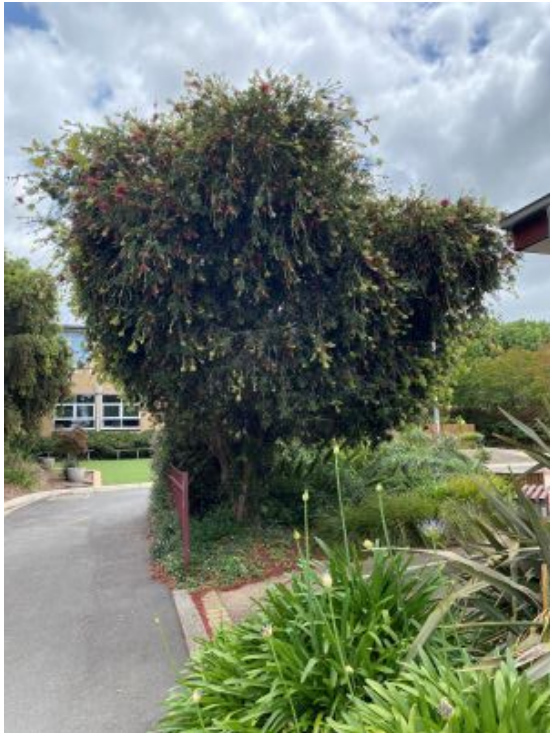
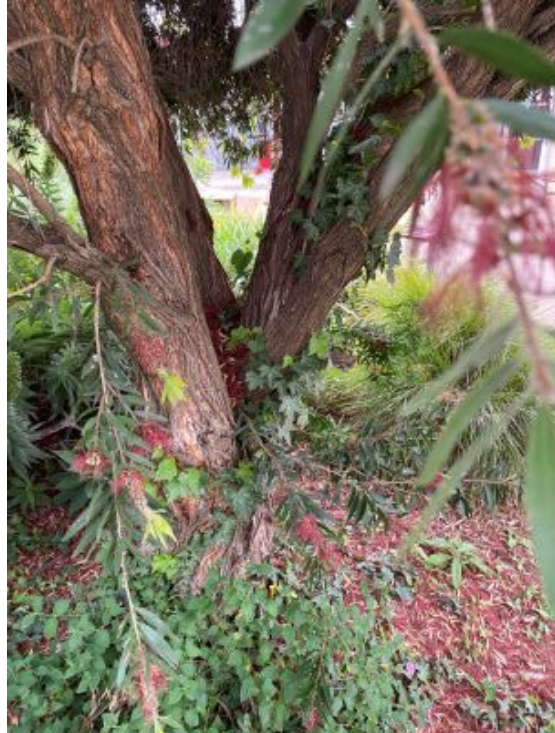
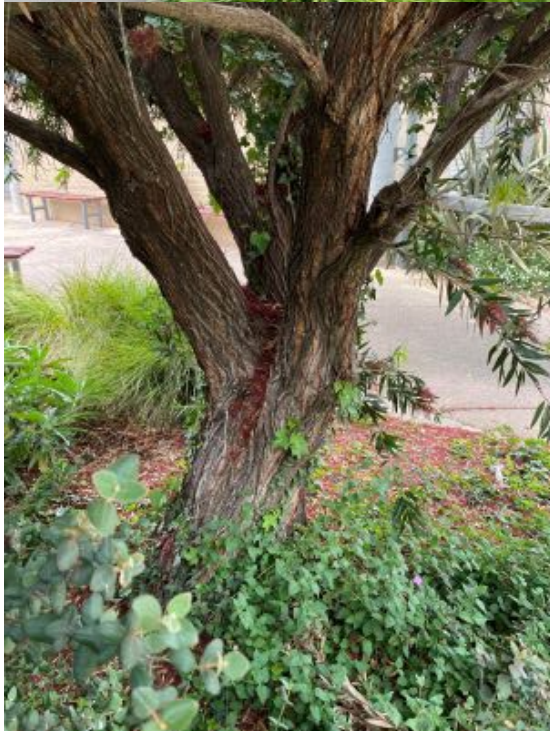
Tree 1:

| Health: | Good |
| Structure: | Fair |
| Comments: | Tree has typical multi trunk base |

It is recommended that the Callistemon tree in the landscape at the Penola Glenroy Campus 35 William Street, Glenroy be retained as a part of the proposed art building development. The proposed construction will have little impact on the tree's root system other than some lifting of hard surfaces in the vicinity of the tree that may contain tree roots underneath. The TPZ is clear of all proposed hard surface construction. That an arborist be on site for the lifting of the hard surfaces around the tree. That the tree to be retained on the site follow the TPZ appendix.

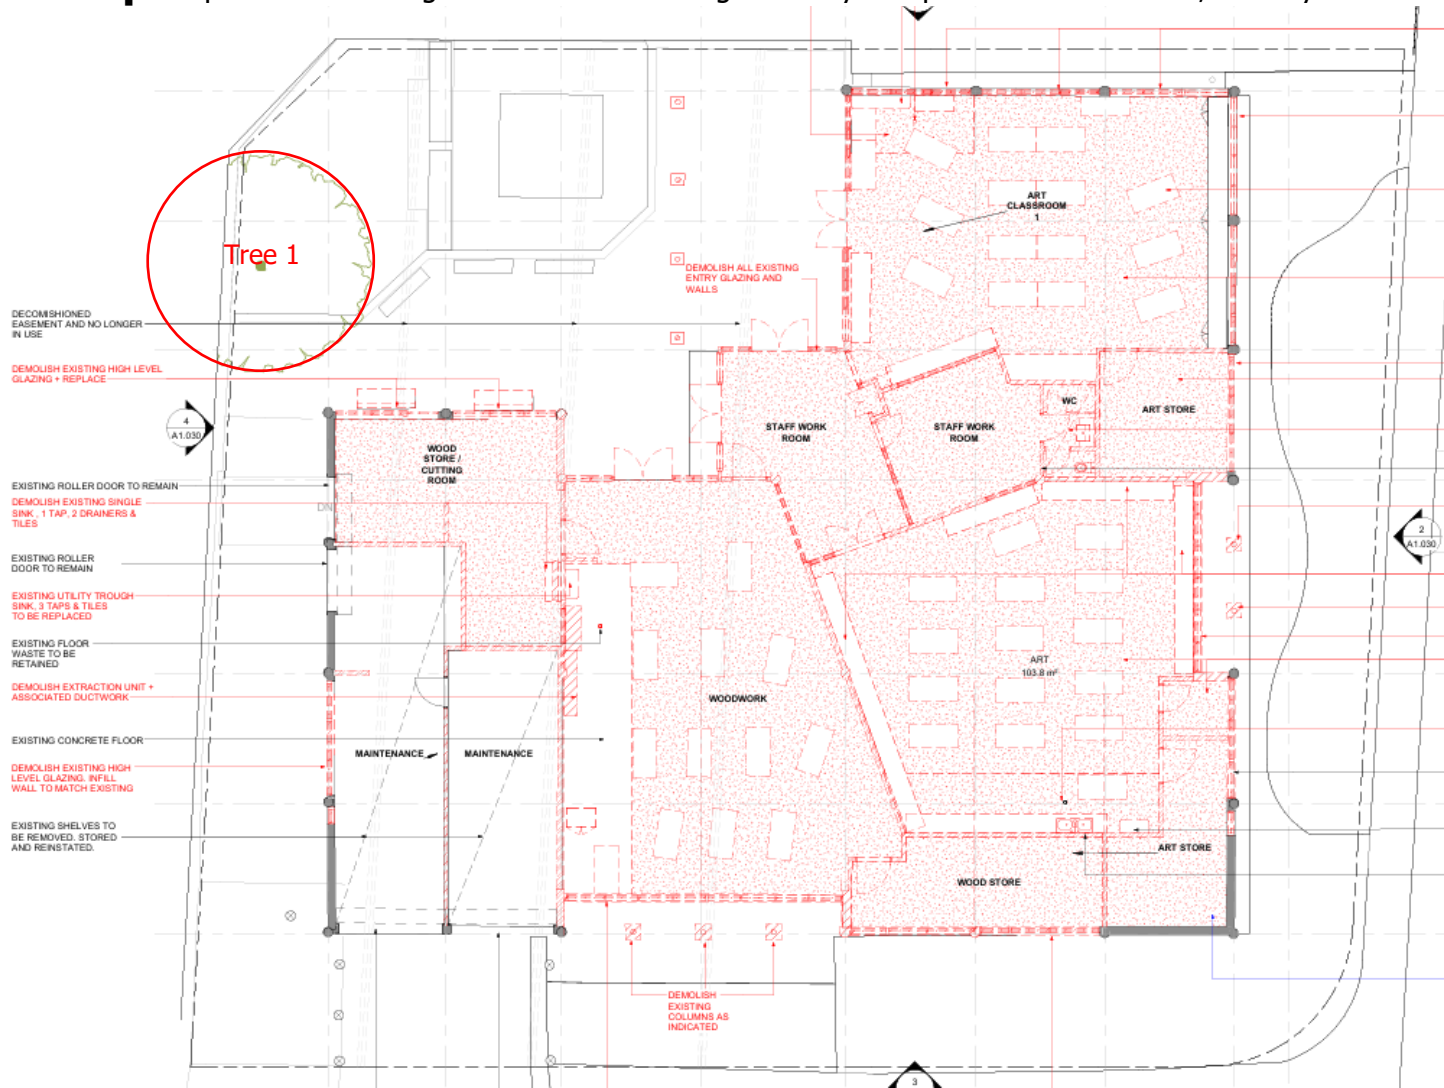
Tree Map Proposed art building Penola Catholic Collage Glenroy Campus 35 William Street, Glenroy.

| Tree Number | Genus | Location | TPZ | Comments |
|---|---|---|---|---|
| 1 | Callistemon | Front Aikenhead building | 2m | TPZ clear of construction |

The proposed arts building for the Penola Glenroy Campus has sufficient space to accommodate the existing tree in the landscape of the new building without interfering with the TPZ.

It would be a requirement for an arborist to be on site as any works are conducted within the tree TPZ to ensure that no tree roots are damaged as a part of the construction of the proposed art building. That the TPZ in the amendments be followed to minimise damage to the trees pre during & post construction. The tree currently does not require any pruning & all proposed works shall not interfere with the tree canopy. If there is a requirement for the tree to be pruned then the on-site arborist must be notified to perform pruning. The placement of temporary fencing around the trees TPZ to ensure no unnecessary entry into the TPZ. That all entry into the TPZ be overseen by the on-site arborist.
