29 June 2022

Arboricultural Impact Assessment Report regarding twenty-two (22) trees located within the vicinity of the proposed STEM Building at Loyola College

We are pleased to provide you with the following Arboricultural Impact Assessment Report for twenty-two (22) trees within the grounds of Loyola College, 32 Grimshaw Street, Watsonia.

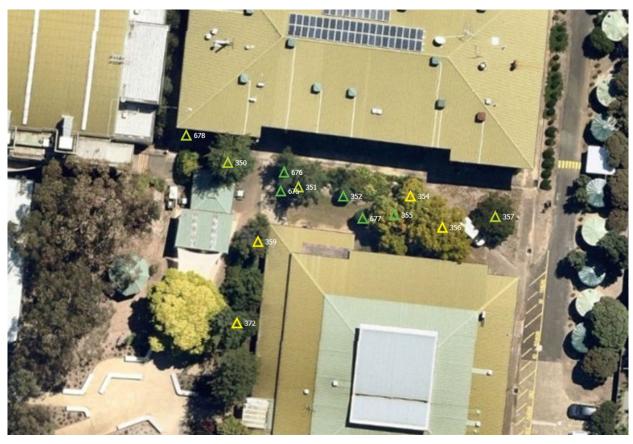
7.1.1 Thirteen (13) trees would require removal (Figure 6) as follows, based on the supplied design proposal. These trees would require removal to allow the proposed development:

Figure 6. Site map showing trees proposed for removal to facilitate the development. (ArborPlan, June 2022).

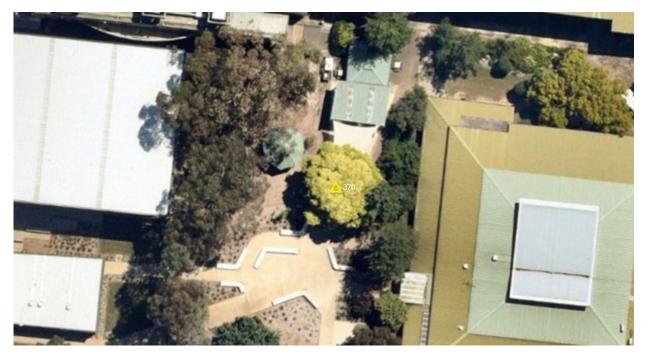
- 7.3.1 Tree 370 (Figure 7) has proposed demolition and minor landscaping upgrades proposed within its northern TPZ.
- 7.3.2 The use of small machinery (situated outside the TPZ on existing hardstand) and additional spotter (to limit the potential for root and/or branch damage) is to be used when working near the tree. To minimise the potential for root compaction/breakage any existing pavers and/or concrete pathways are to be lifted as the machine moves backwards out of the TPZ while sitting on the existing hardstand. The proposed surfacing, when within the TPZ should be installed above the existing grade with minimal excavation undertaken.

Figure 7. Site map showing Tree 370 requiring specific protection measures. (ArborPlan, June 2022).

- 7.3.3 Roots discovered are to be treated with care and minor roots (<40mm in diameter) pruned 'square' with a sharp, sterile handsaw or secateurs. All significant roots (>40mm in diameter) are to be recorded, photographed and reported to the project arborist.

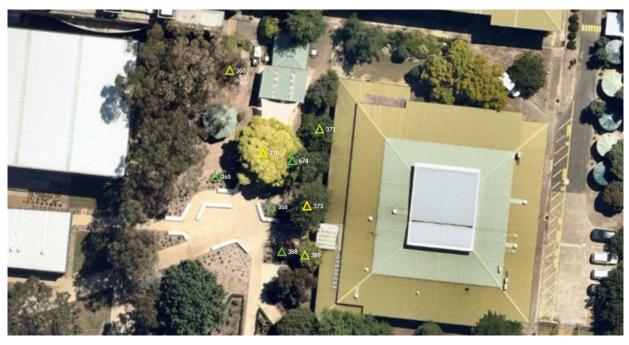
7.4.1 All retained trees (Figure 8) require generic protection measure (7). Refer to Section 7.5–7.8 for further detail.

Figure 8. Site map showing tree requiring generic protection measures. (ArborPlan, June 2022).

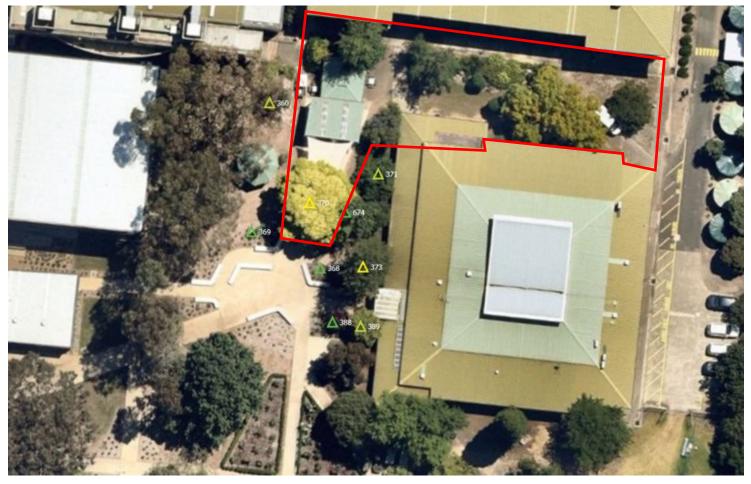
Figure 12. Site map showing retained trees with suggested Tree Protection Fence locations. (ArborPlan, June 2022).
