A19 ARBORIST REPORT
St Kilda

Assessment of trees as part of proposed tramstop upgrades at Park Street, St Kilda

Arboricultural Impact Assessment

14 February 2024

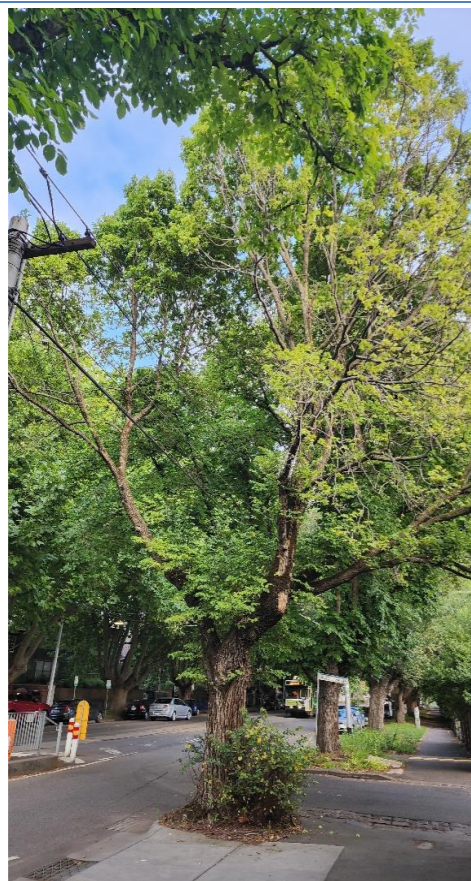
| Tree Number | 1 | 2 |
| Tree dimensions | 15m x 12m | 14m x 9m |
| Health | Fair | Fair |
| Structure | Fair | Fair |
| ULE | 10-20 years | 20+ years |
| Comments | Pruned under power lines, basal damage and decay with suckers | Pruned under power lines, minor decay and dieback |

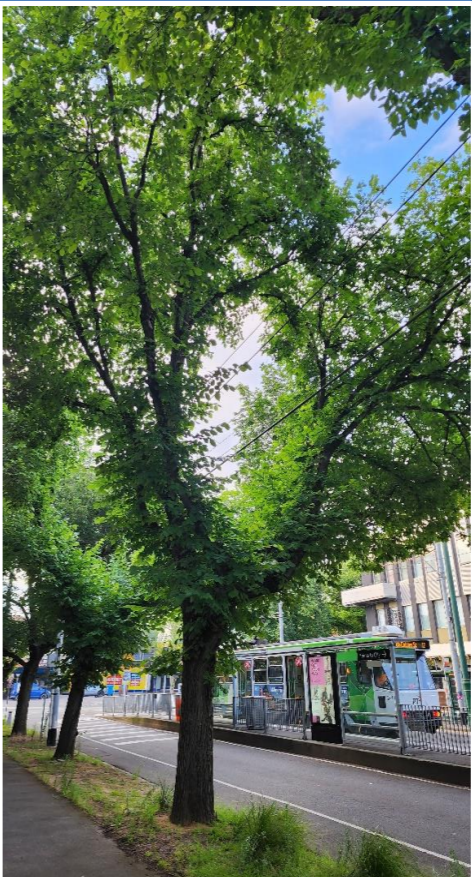
| Tree Number | 3 | 4 |
| Tree dimensions | 13m x 9m | 10m x 9m |
| Health | Good | Good |
| Structure | Fair | Fair |
| Comments | Pruned under power lines, canopy growing towards power lines | Pruned under power lines, canopy growing towards power lines |

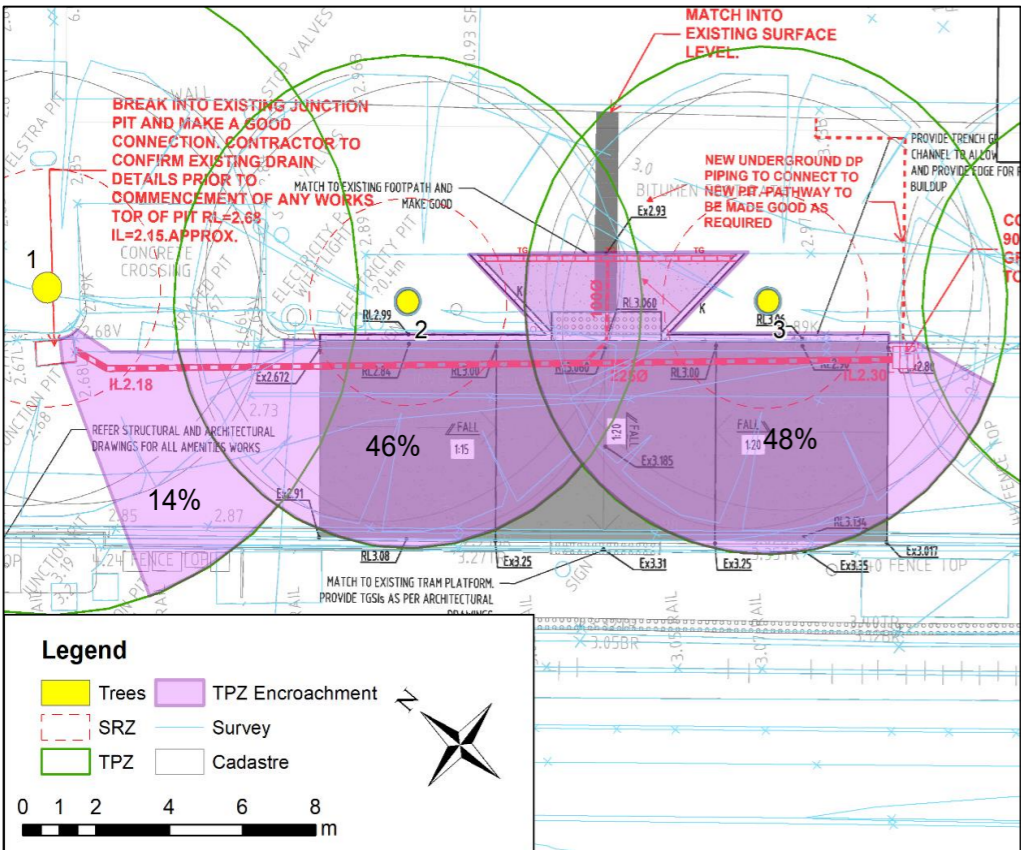
Figure 3: TPZ encroachment from the proposal.

Despite the TPZ encroachment percentages, all trees can be retained as part of the works (Figure 3).

Tree 1 will only have TPZ encroachment within the existing roadway (Figure 3). A drainage pipe is proposed to run down the road and tie into the existing pit that is at the base of the tree.

Empirical evidence suggests that there tends to be very few roots located under roads. The compaction, lack of oxygen and water all make for an inhospitable rooting environment. Excavation for the drainage will result in no impact to the tree.

Drainage will be constructed and run down the road, similar to Tree 1, this will have no impact to the trees (Figure 3).

A project arborist must be on-site for the drainage excavation to ensure there is no potential for damage to unexpected roots.

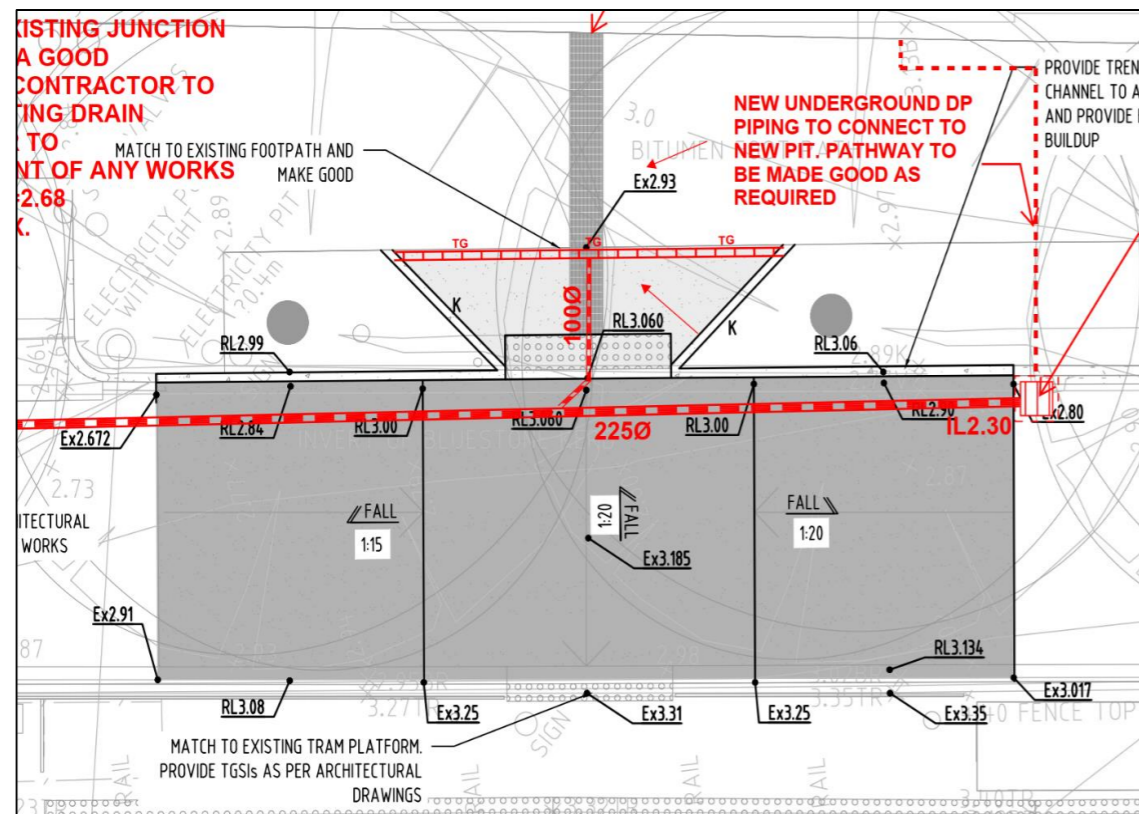
Figure 4: Proposed works on the verge.

The construction of the raised, asphalt crossover will be over existing, impermeable asphalt and have no net change to the soil and rooting conditions beneath (Figure 4). This will have no impact to the trees.

The kerb will require removal and reinstatement, a process that has significant potential to impact trees. In order to minimise any potential risk for tree damage, the following must be adhered to:

1. The existing bluestone kerb is to be removed carefully using an excavator with 'pick' or single tine ripper attachment. In this way the bluestone pitchers can be removed one at a time near the trees and avoid any root damage.
2. Excavation behind the 'back of kerb' is to be avoided as much as possible. Only the minimum amount required for formwork is to be excavated. A kerb machine must not be used.
3. Removal of bluestones and any excavation must be supervised by a project arborist.

The timber edging for the new section of path must be excavated by hand and not deeper than 150mm. There is to be no excavation within the area proposed for asphaltting. All works for the timber edging, asphaltting and installation of drainage within the verge must be supervised by the project arborist.

Any root pruning that is required must be completed by the project arborist and in accordance with AS4373-2007 *Pruning Amenity Trees*. If any roots are uncovered that require pruning which may affect tree health, the works are to stop until there is a satisfactory resolution.
