Hotham Heights Lodges

Preliminary Geotechnical Assessment – Lots 27 and 29, Hotplate Drive, Mount Hotham

Reference: 754-MELGE227984.2 AB

Preliminary Geotechnical Assessment

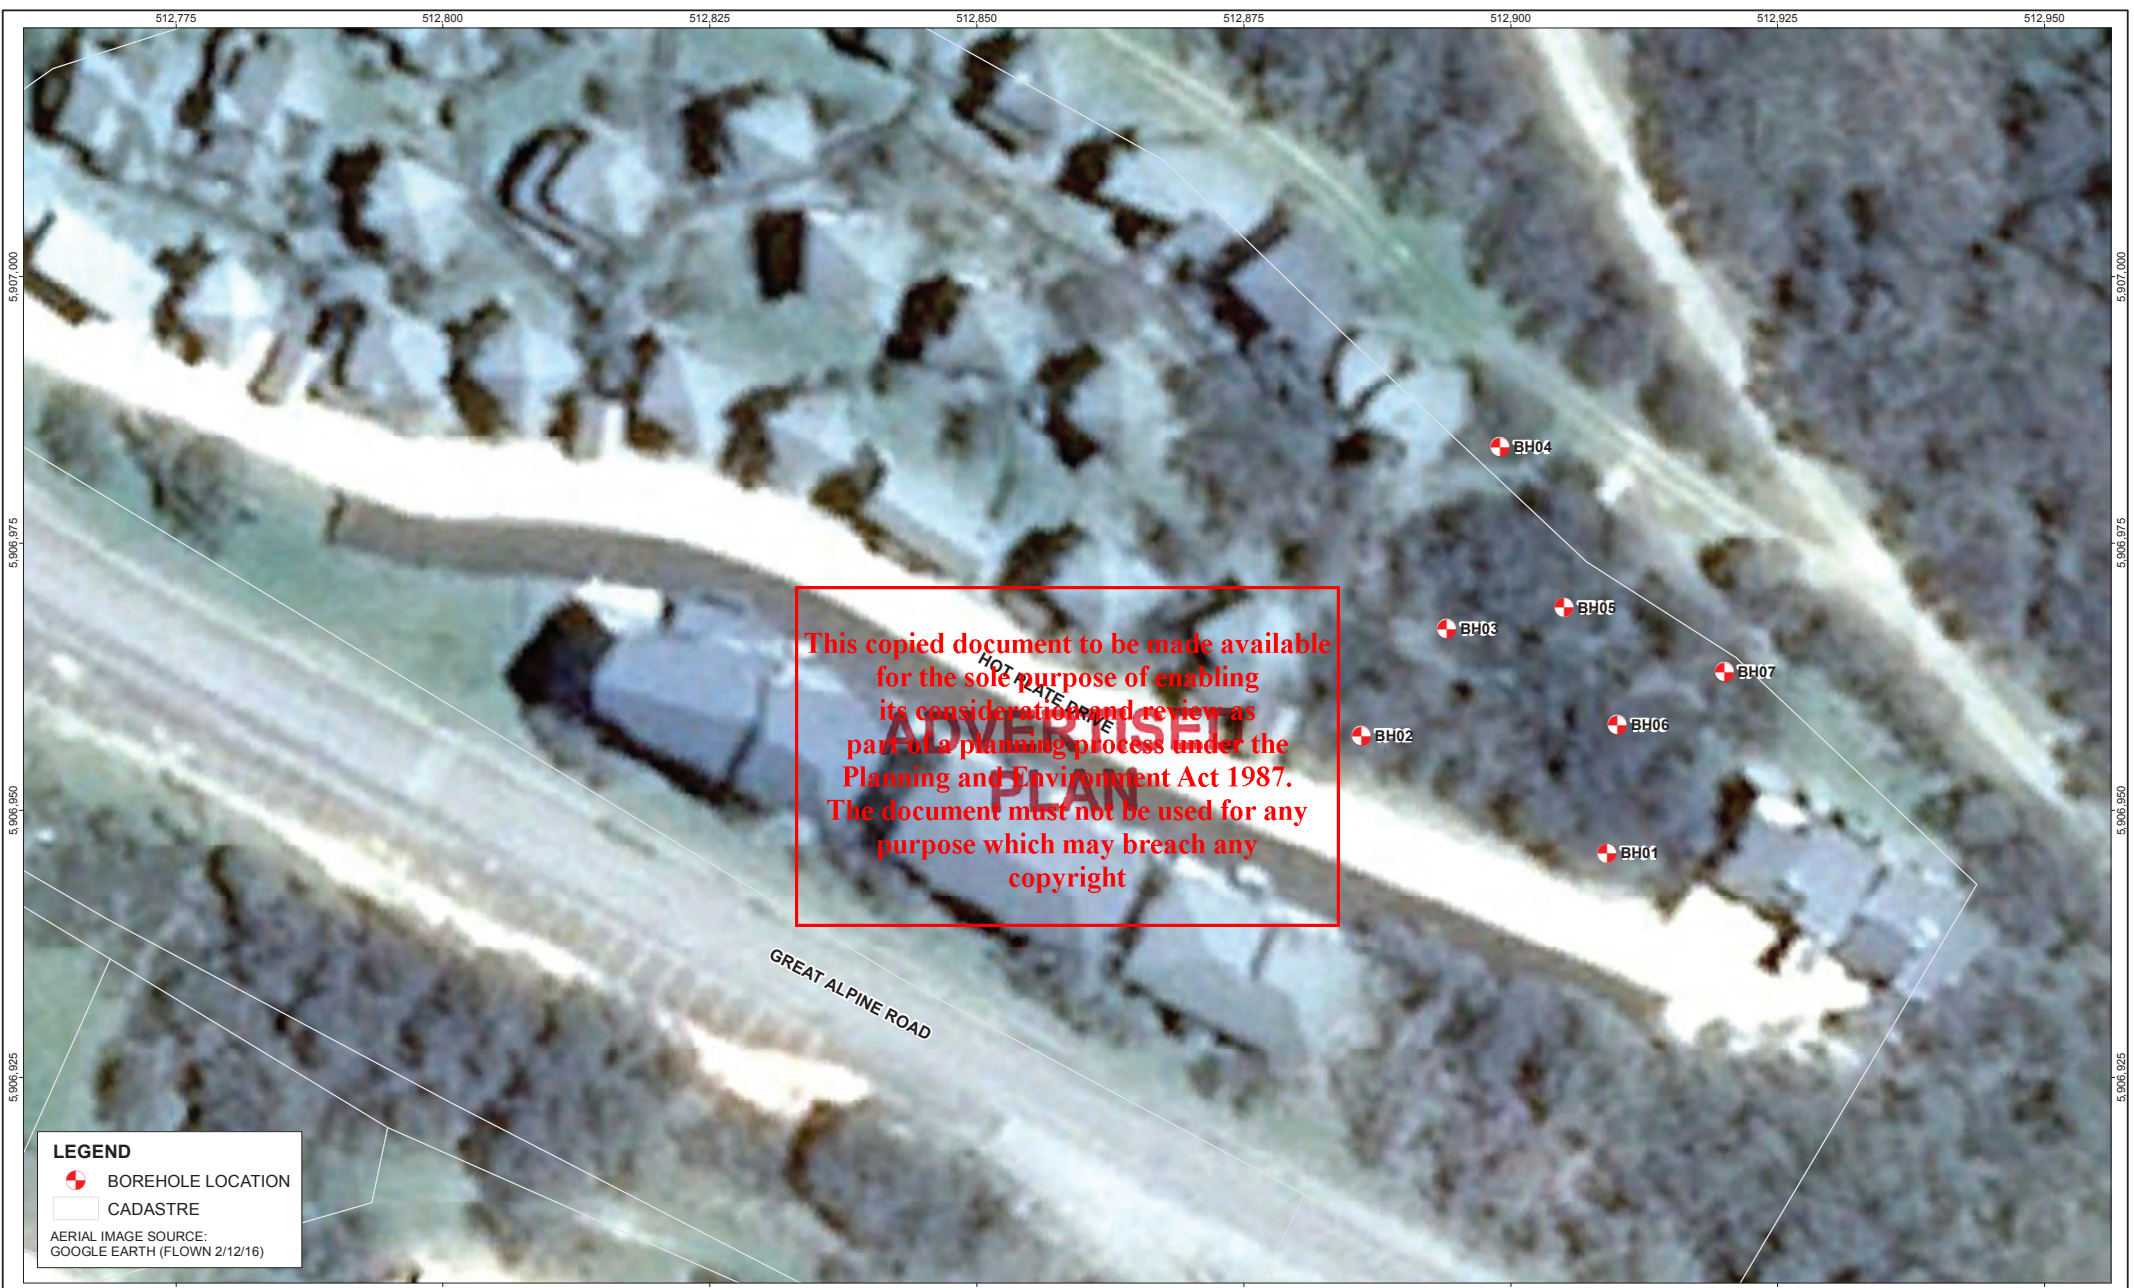
client:	MFGD Developments		
project:	LOTS 22, 24, 26, 27 AND 29 HOTPLATE DRIVE, MOUNT HOTHAM		
title:	BOREHOLE LOCATION PLAN		
project no:	754-MELGE227984AB	figure no:	FIGURE 2
rev:	A

- BOREHOLE LOCATION
- CADASTRE

The natural subsurface conditions encountered in BH01 to BH07 are consistent with the published geology.

Details of the materials encountered in the boreholes and the results of the DCP tests are described in the engineering logs presented in Appendix A. Site specific subsurface conditions are summarised in Table 1.

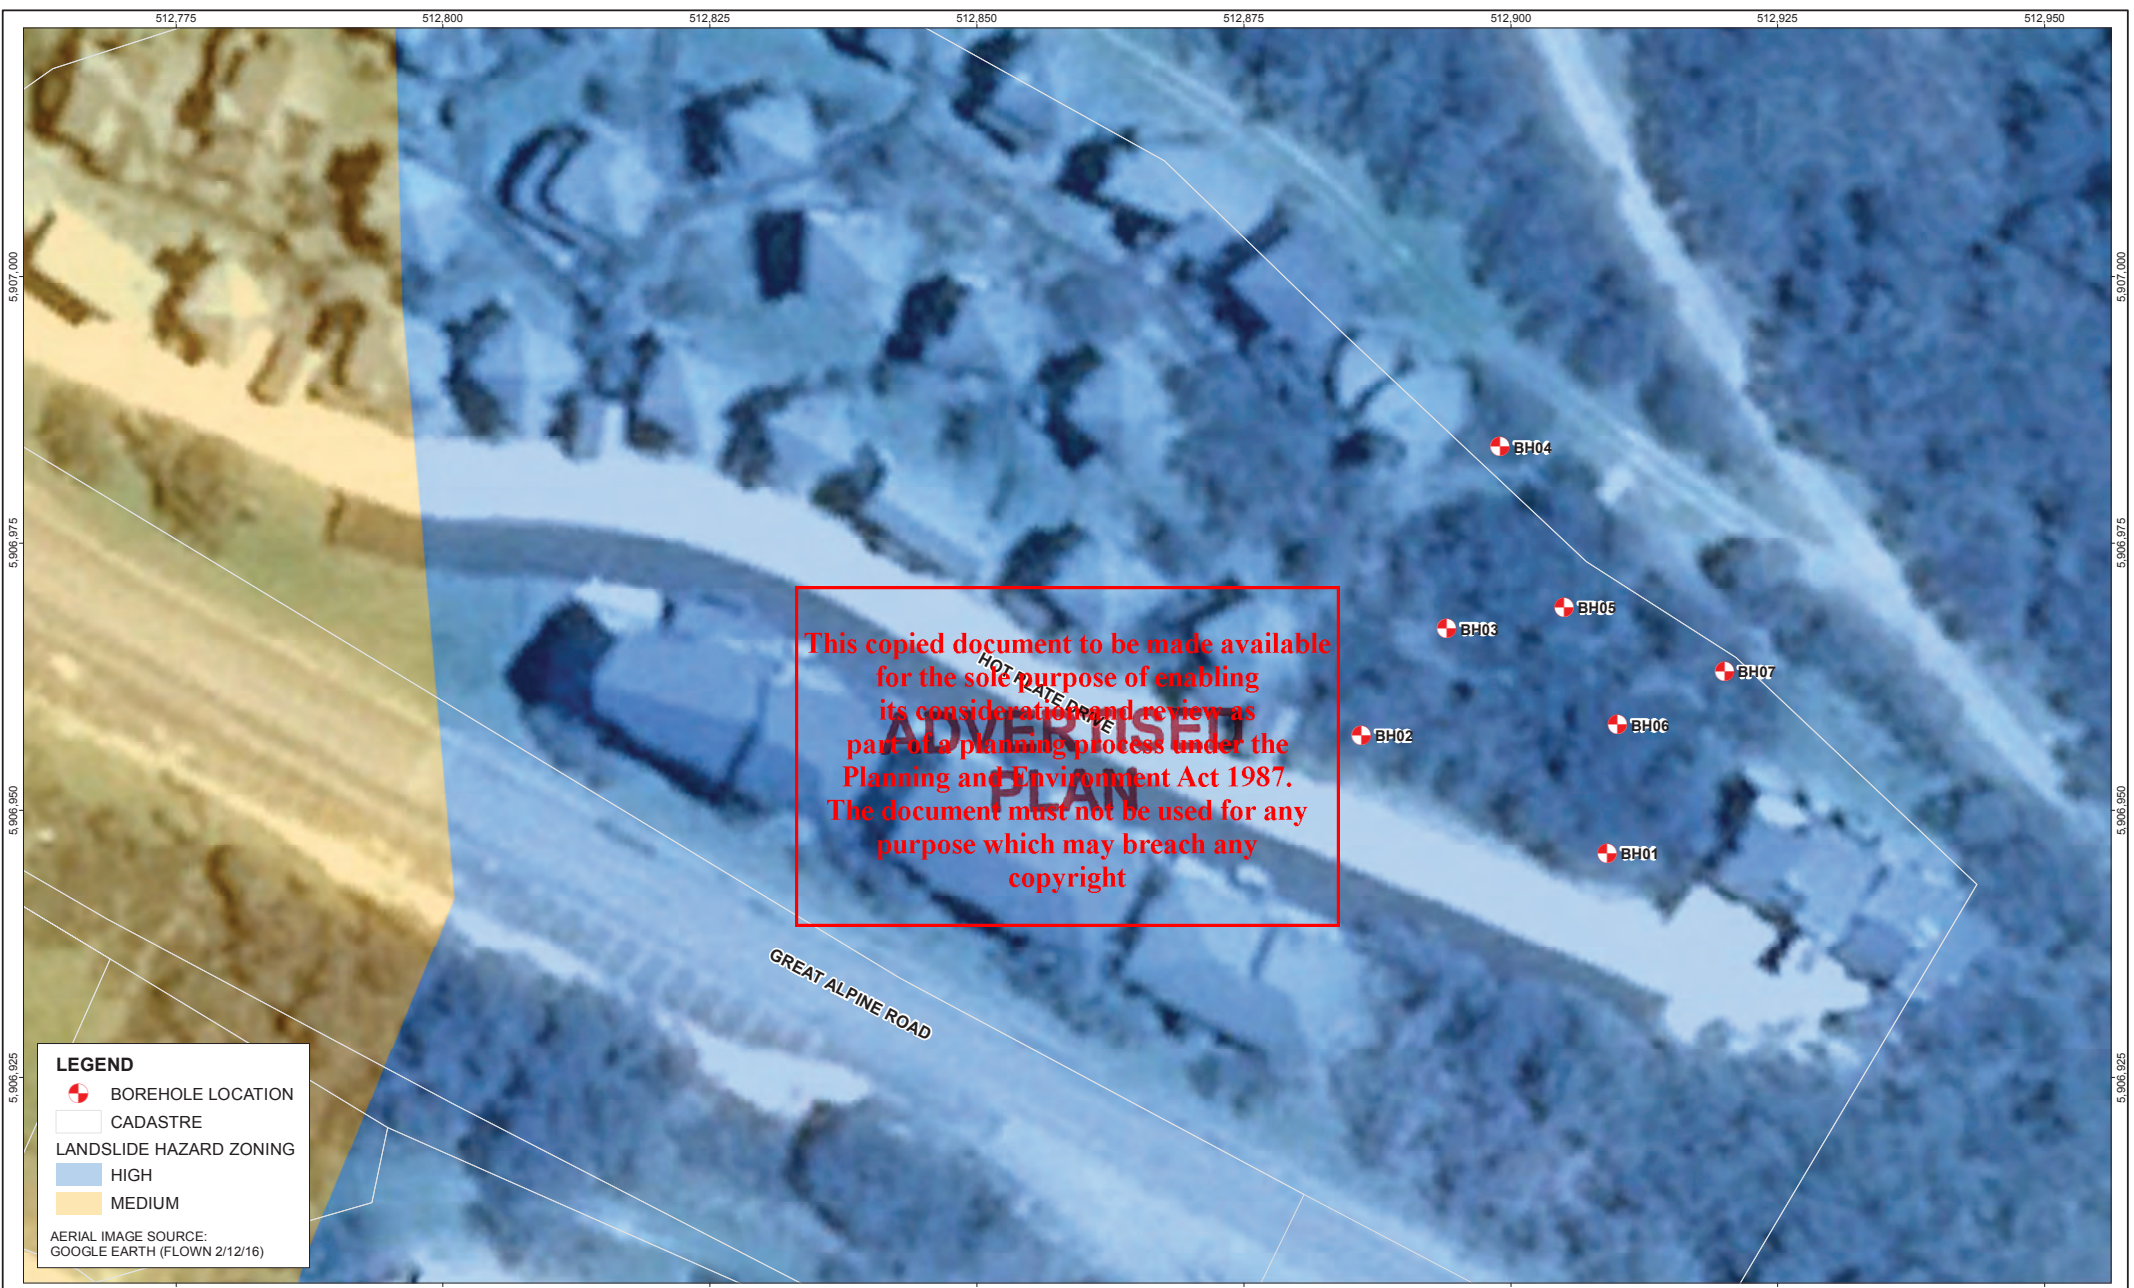
client:	MFGD Developments		
project:	LOTS 22, 24, 26, 27 AND 29 HOTPLATE DRIVE, MOUNT HOTHAM		
title:	LANDSLIDE HAZARD MAP		
project no:	754-MELGE227984AB	figure no:	FIGURE 3
rev:	A

SMEC completed a stability review and hazard assessment of sites in Alpine areas in 1999. The results of the assessment for these sites have been shown as a Landslide Hazard Zoning Map as partially presented in Figure 3. Along Hotplate Drive, the assessed hazard rating for landside ranged as 'high'.

- BOREHOLE LOCATION
- CADASTRE
- LANDSLIDE HAZARD ZONING
- HIGH
- MEDIUM

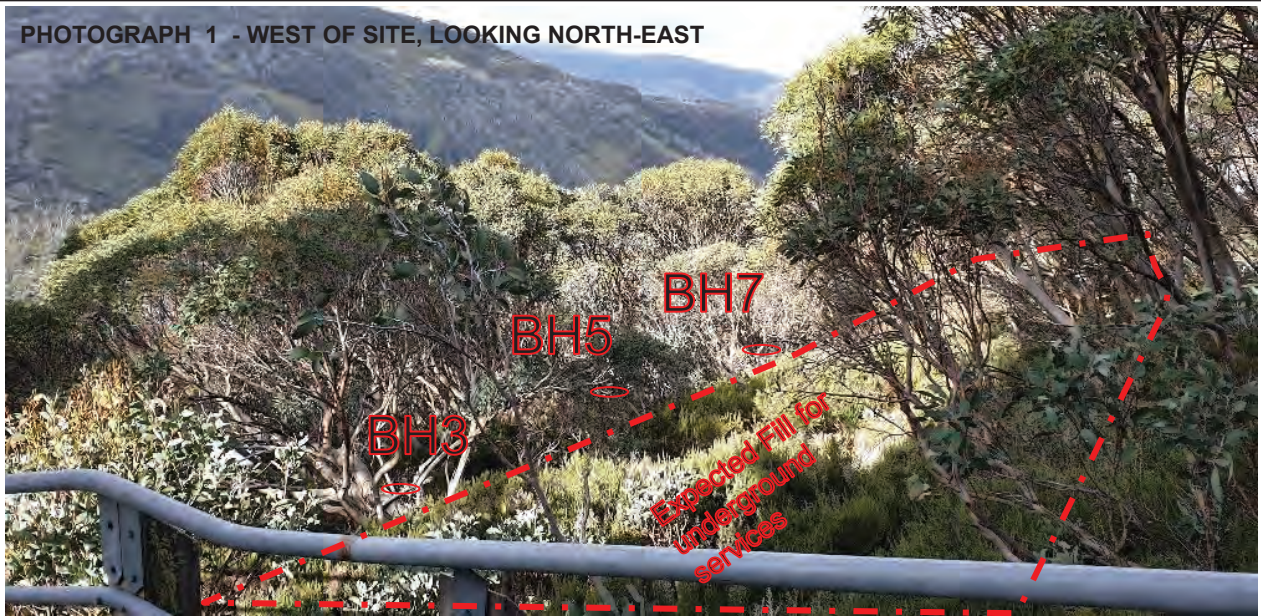
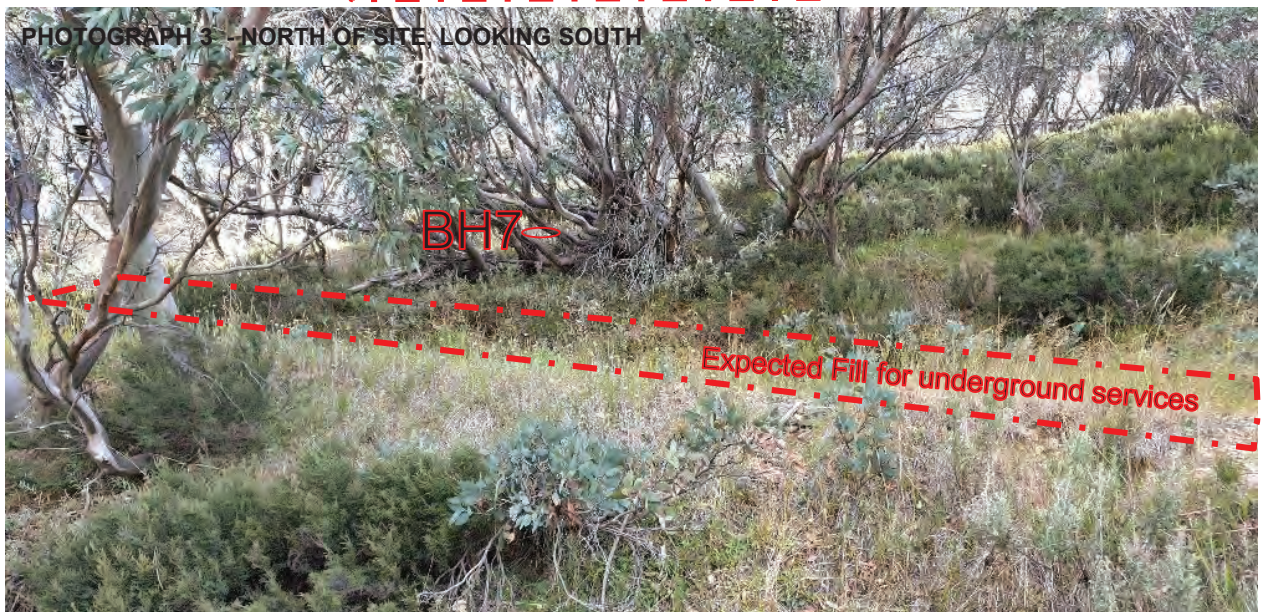
client:	MFGD Developments		
approved	WLN		project:	LOTS 22, 24, 26, 27 AND 29 HOTPLATE DRIVE		
date	22.11.2023		title:	Site Photographs		
scale	NTS		project no:	754-MELGE227984AB	figure no:	FIGURE 04
original size	A4

PHOTOGRAPH 1 - WEST OF SITE, LOOKING NORTH-EAST

PHOTOGRAPH 2 - SOUTH OF SITE, LOOKING NORTH

PHOTOGRAPH 3 - NORTH OF SITE, LOOKING SOUTH

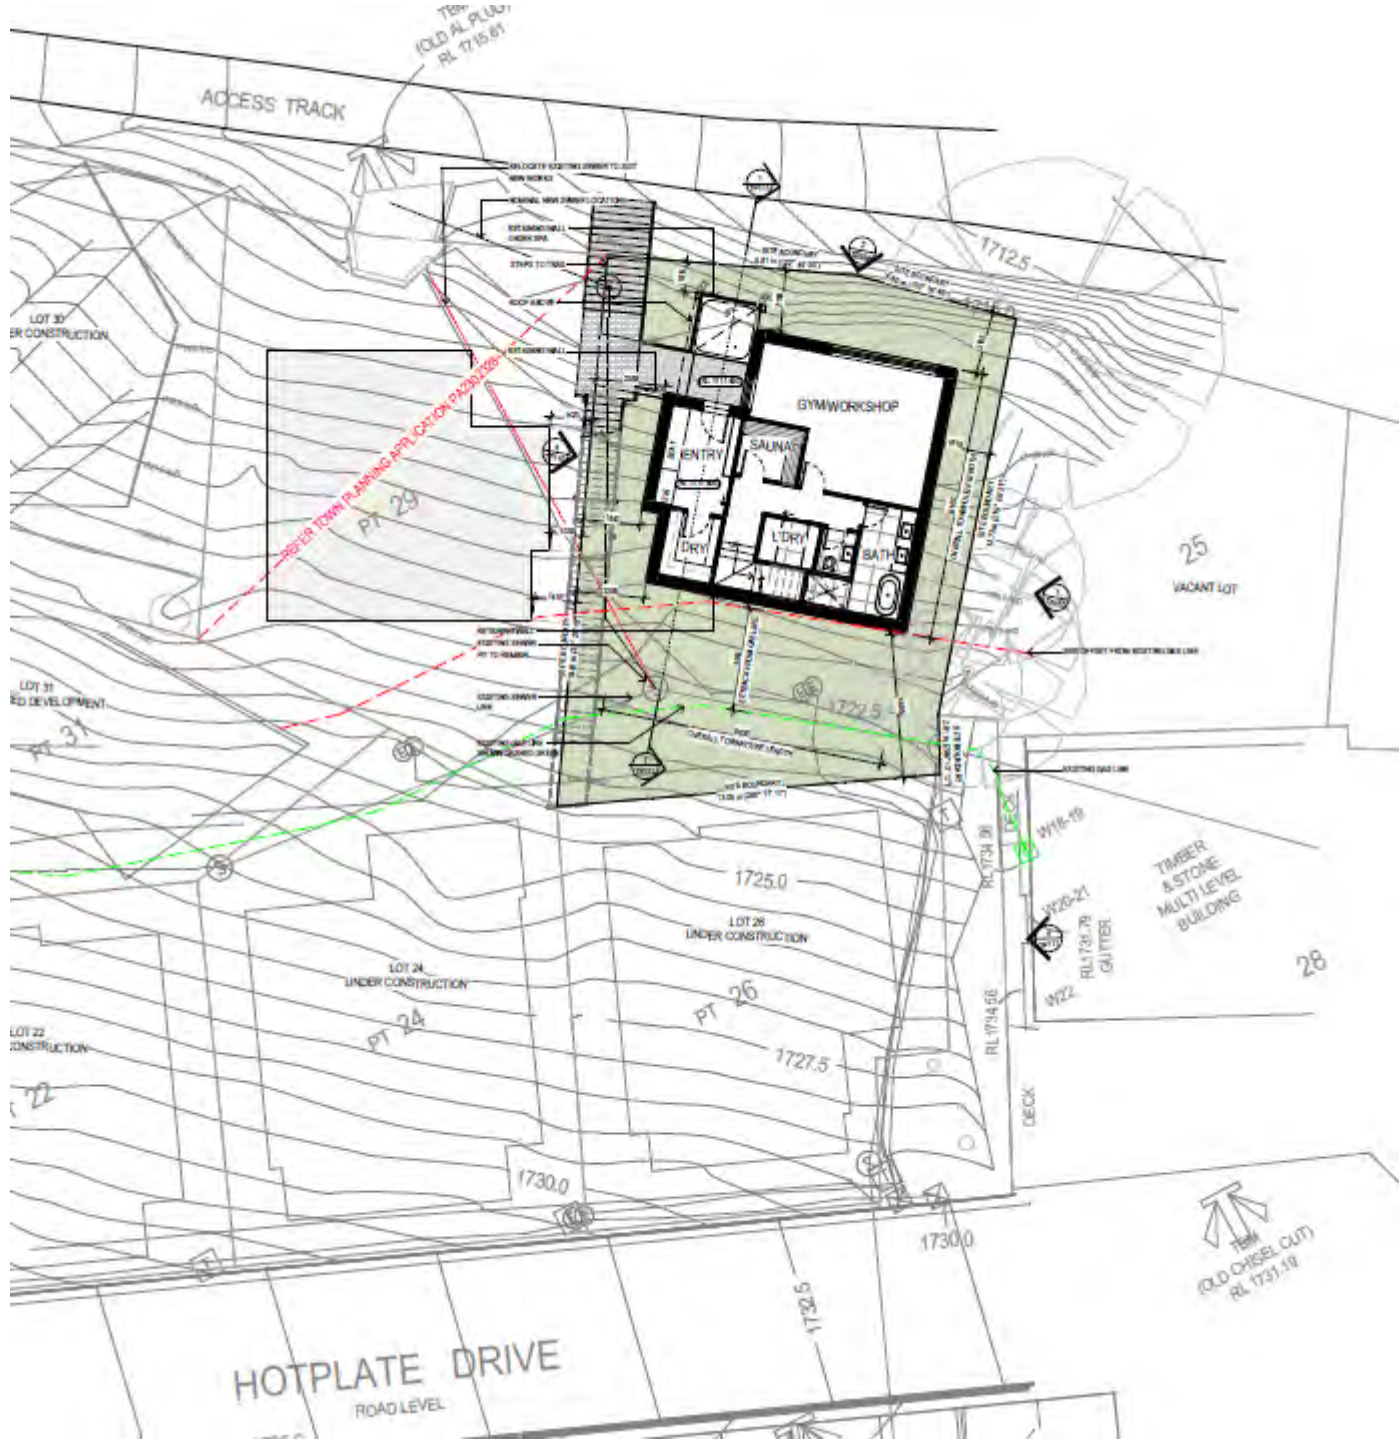
client:	MFGD Developments
project:	LOTS 27 AND 29, HOTPLATE DRIVE, MOUNT HOTHAM
title:	Layout Plan and Section of Development Lot 27
project no:	754-NTLGE227984.2 AB
figure no:	FIGURE 5

LOT 27 SECTION

The proposed building development should be carried out in accordance with sound engineering principles and good hillside practice (refer Appendix C). Geotechnical recommendations for the proposed developments as shown in Figure 5 and Figure 6 are provided in the following sections.

MFGD advised that the proposed excavation levels are approximately +1717.3m AHD and +1718.6m AHD for Lot 27 and Lot 29 respectively. Based on the subsurface conditions encountered within the boreholes and previous assessments nearby, the materials to be excavated would typically comprise layers of topsoil, clay and weathered rock.

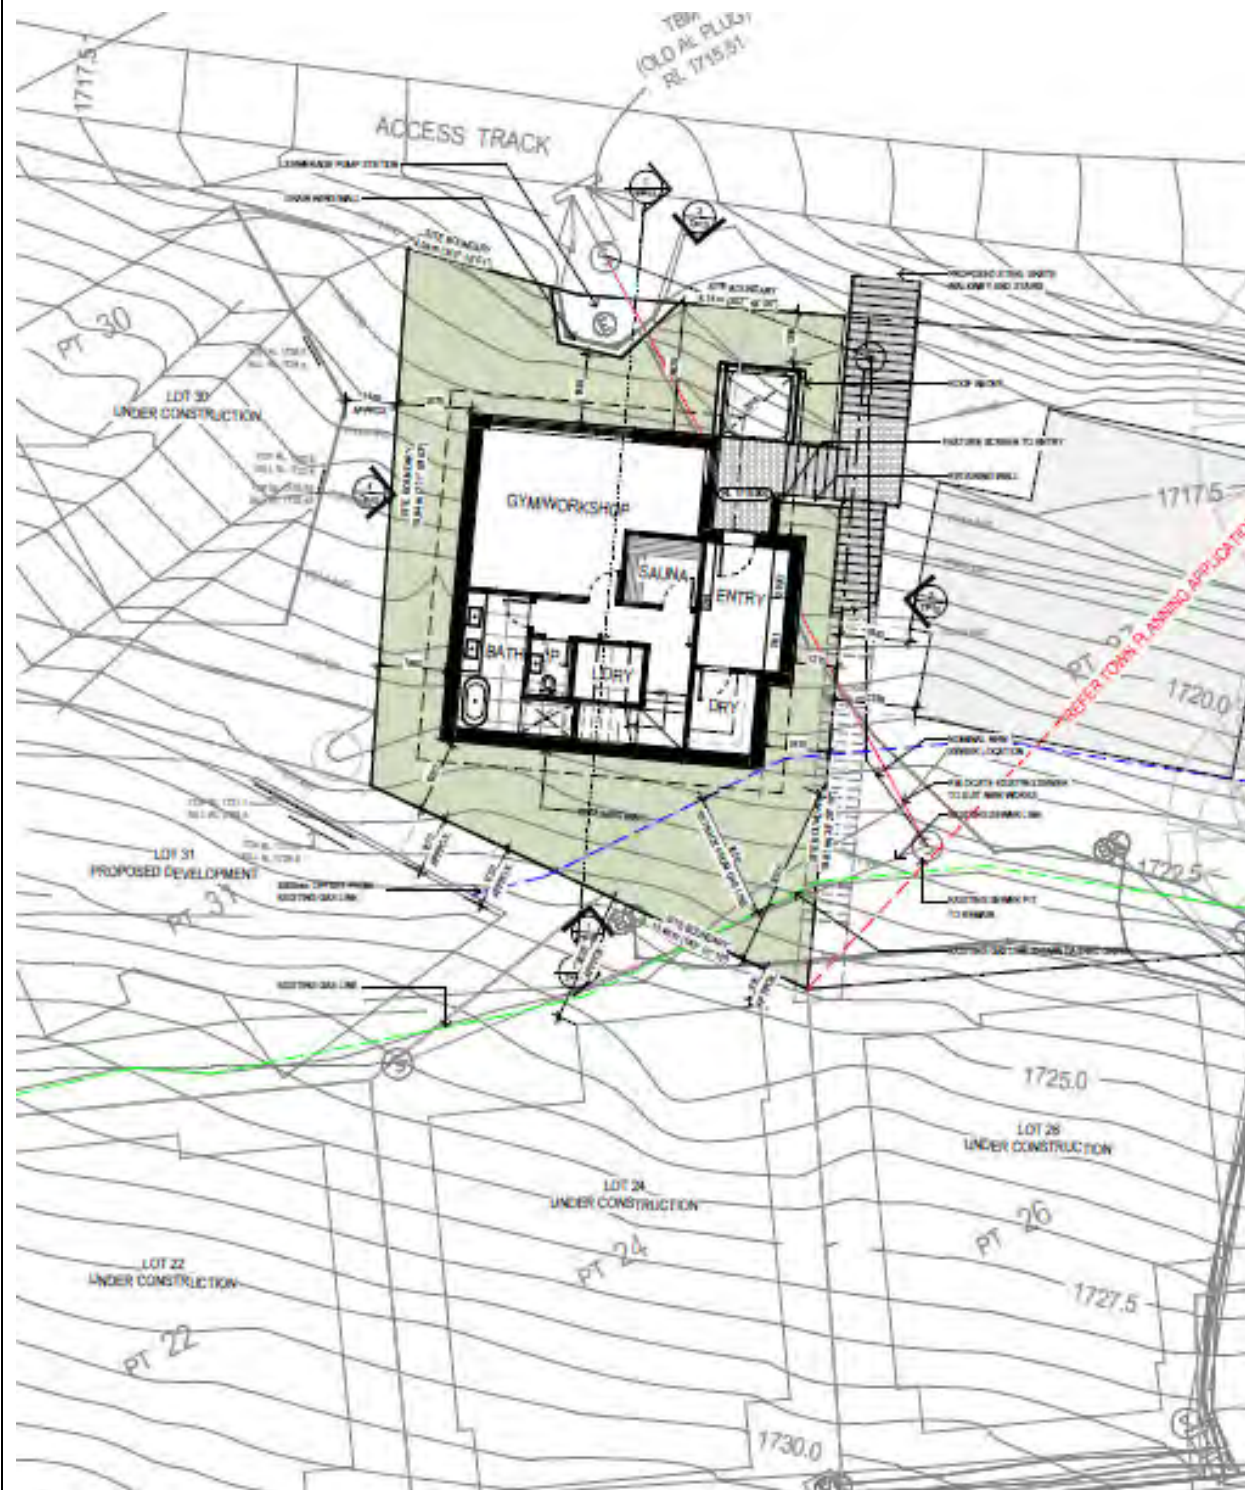
| LOT 29 SECTION

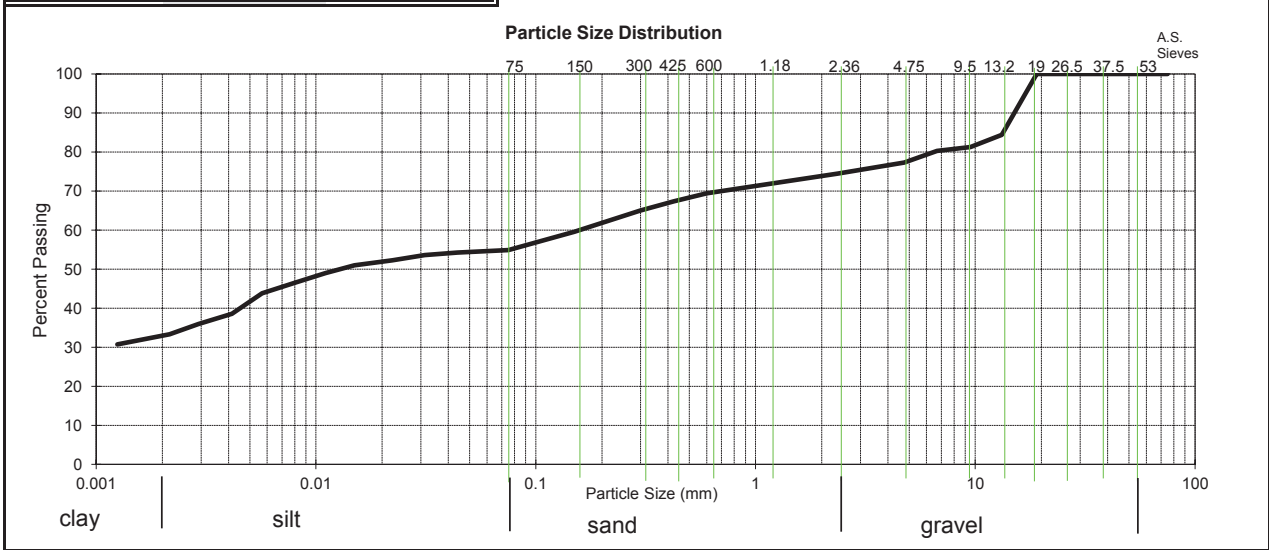
4.75 mm	77		Linear Shrinkage	% AS1289 3.4.1	9	
2.36 mm	74		Moisture Content	% AS1289 2.1.1	41.5	
1.18 mm	72		Sample History:			Oven Dried
600 um	69		Method:			Dry sieved
425 um	67		Cracking / Curling of linear shrinkage:			Cracking
300 um	65		Linear shrinkage mould length:			118
150 um	60		Notes: ND = not determined, NO = not obtainable, NP = non plastic			
75 um	55		Dispersion: methanide hydrometer: g/l			
hydrometer values			ESD/gs received			
44 um	54		Material properties			
22 um	52		GRAVEL CONTENT =			26 %
15 um	51		SAND CONTENT =			19 %
11 um	49		SILT CONTENT =			22 %
8 um	46		CLAY CONTENT =			33 %
1 um	31

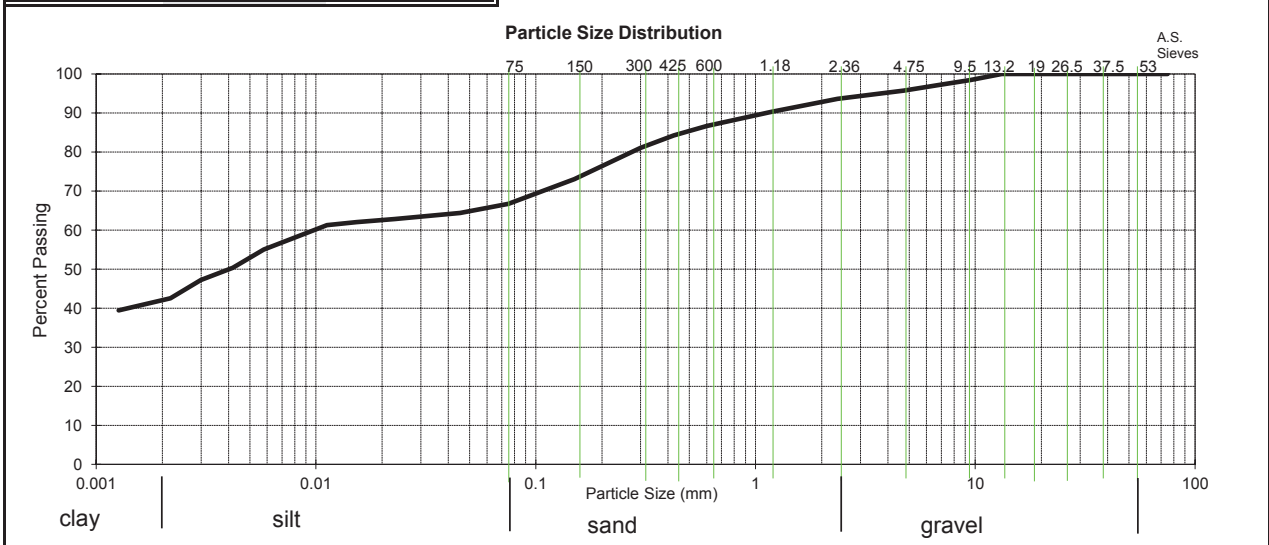
2.36 mm	94		Linear Shrinkage	% AS1289 3.4.1	ND	
1.18 mm	90		Moisture Content	% AS1289 2.1.1	43.0	
600 um	87		Sample History:			Oven Dried
425 um	84		Dispersion Method:			Dry sieved
300 um	81		Cracking / Curling of linear shrinkage:			Curling
150 um	73		Linear shrinkage mould length:			-
75 um	67		Notes: ND = not determined, NO = not obtainable, NP = non plastic			
hydrometer values			Material properties			
45 um	64		GRAVEL CONTENT =			6 %
23 um	63		SAND CONTENT =			27 %
15 um	62		SILT CONTENT =			24 %
11 um	61		CLAY CONTENT =			43 %
8 um	58					
1 um	39
