**Edge Chalets Unit Trust
C/- Incore Developments
Geotechnical Assessment - Lots 22, 24, 26 and 31, Hotplate Drive,
Mount Hotham
754-MELGE227984AB Rev 2**

26 May 2021

Lots 22, 24, 26 and 31, Hotplate Drive, Mount Hotham

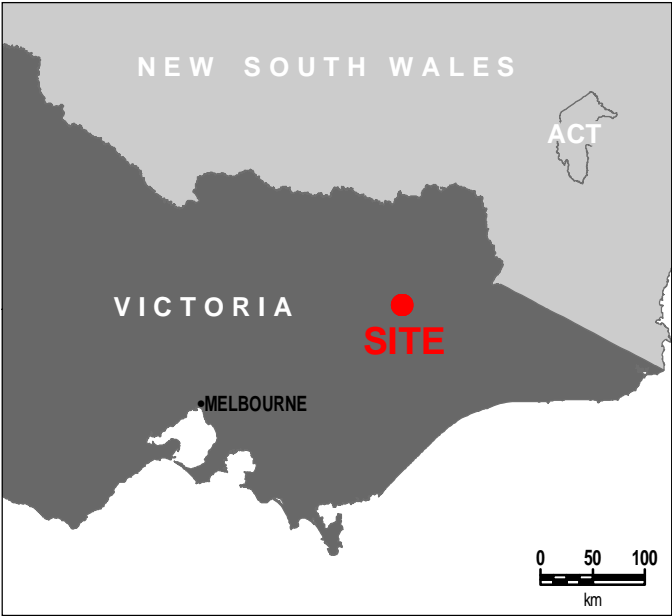
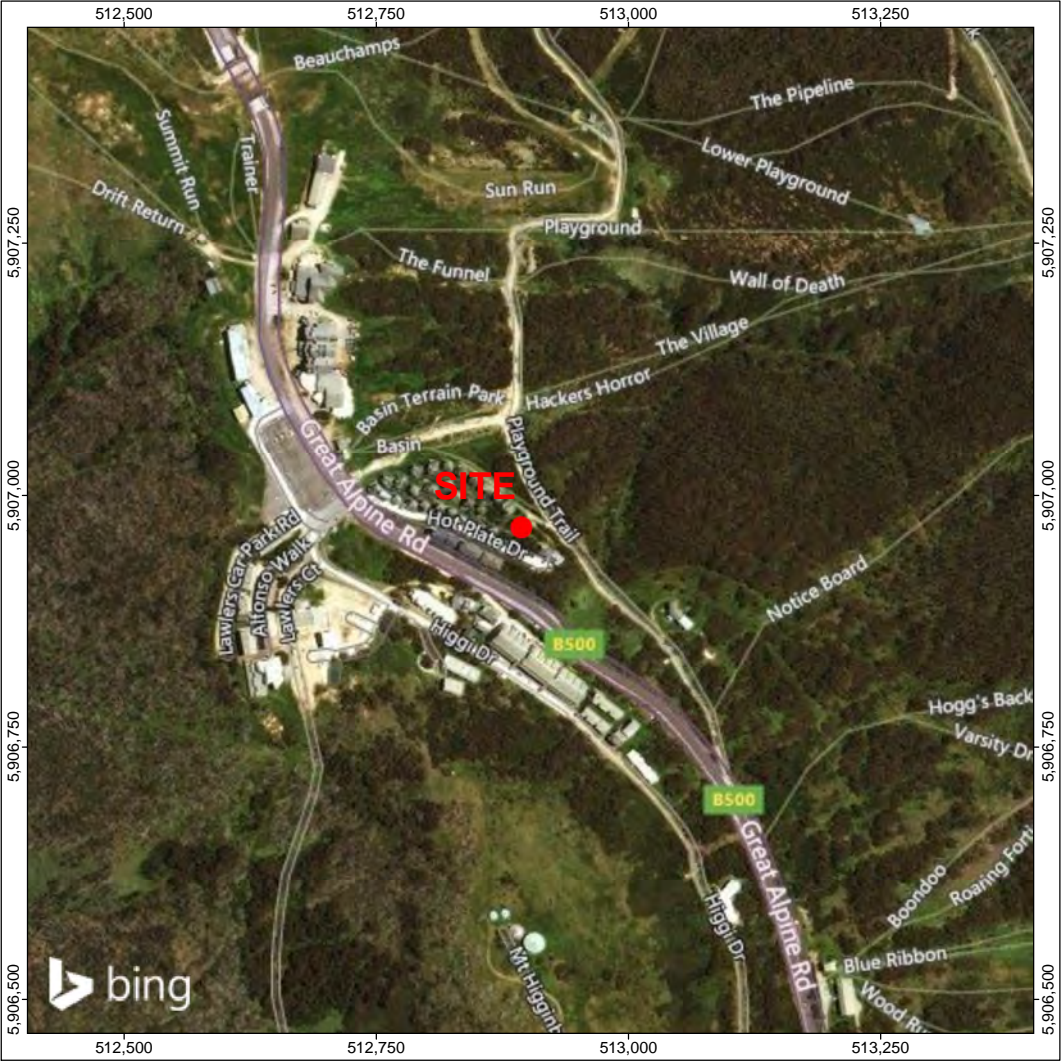
EDGE CHALE IS UNIT TRUST OF ANCORE DEVELOPMENTS		
project: LOTS 22, 24, 26, 27 AND 29 HOTPLATE DRIVE, MOUNT HOTHAM		
title: SITE LOCALITY PLAN		
project no: 754-MELGE227984AB	figure no: FIGURE 1	rev: A

Hand auger boreholes were conducted across the site due to access issues of an excavator and where access was not restricted by underground services or vegetation. The site locality and the approximate locations of the boreholes are shown on Figure 1 and Figure 2.

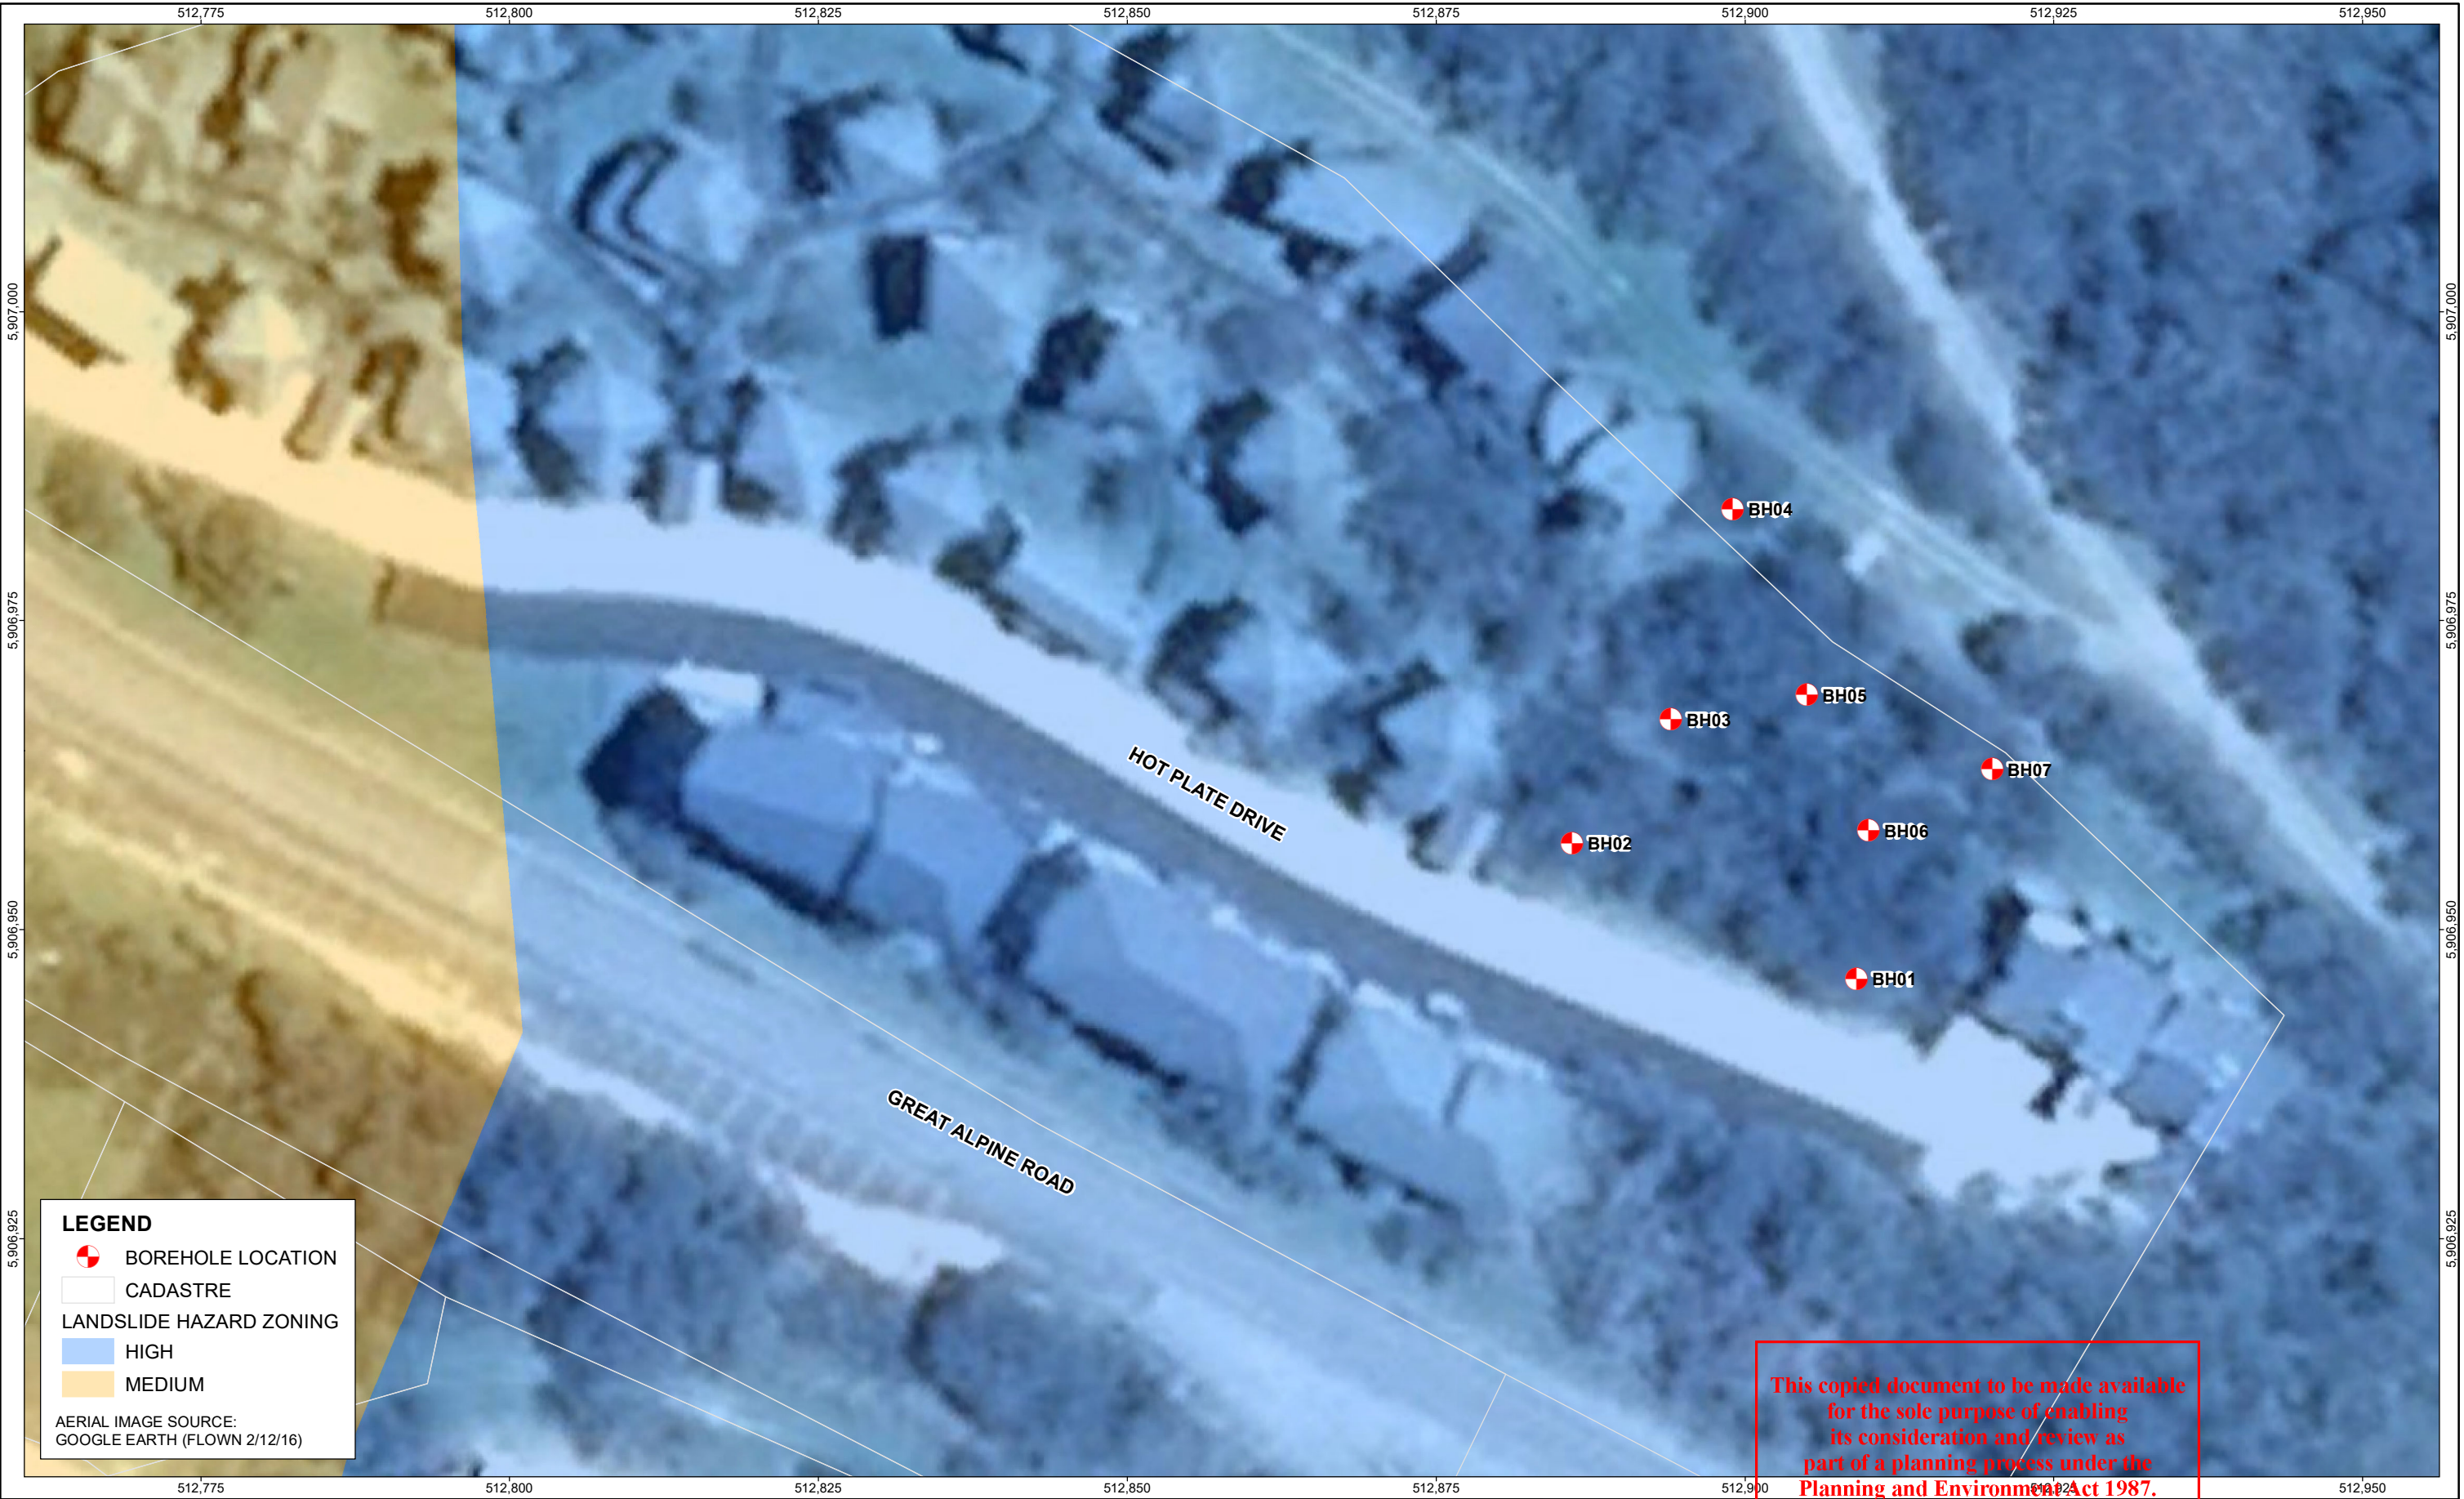
EDGE CHALETS UNIT TRUST OF INCORE DEVELOPMENTS		
LOTS 22, 24, 26, 27 AND 29 HOTPLATE DRIVE, MOUNT HOTHAM		
title: LANDSLIDE HAZARD MAP		
project no:	754-MELGE227984AB	figure no: FIGURE 3
		rev: A

SMEC completed a stability review and hazard assessment of sites in Alpine areas in 1999. The results of the assessment for these sites have been shown as a Landslide Hazard Zoning Map as partially presented in Figure 3. Along Hotplate Drive, the assessed hazard rating for landslide ranged as 'high'.
