## Geotechnical Desktop Study

# Geotechnical Desk Study

## Cobden Battery Energy Storage System (BESS)

### Cobden BESS Pty Ltd

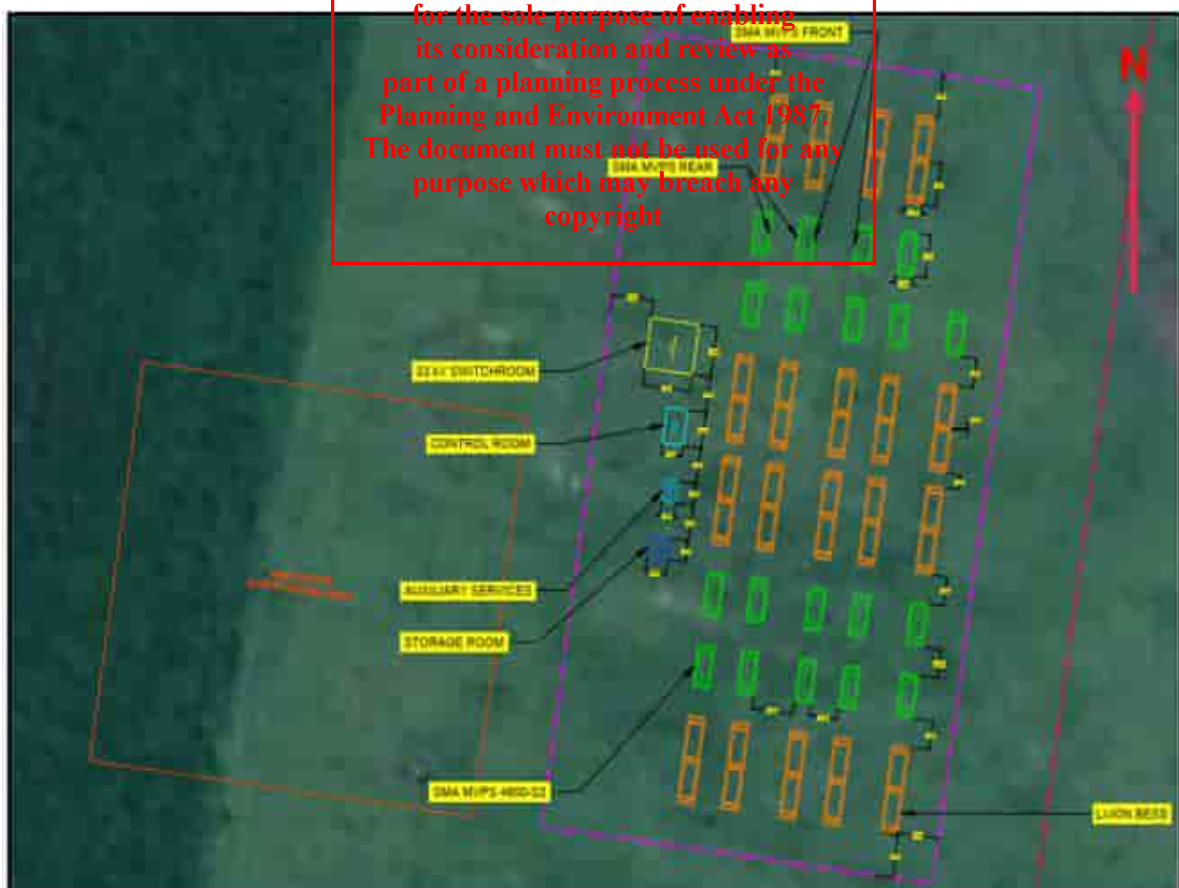
**Figure 2 Proposed BESS development layout**

The proposed site layout plan is presented in Appendix B, with an extract from the plan presented in Figure 2.

With reference to the proposed layout plan, there are a maximum of 19 no. LI-ION BESS units and 19 no. SMA MVPS 4600-S2 units expected to be installed at the site.

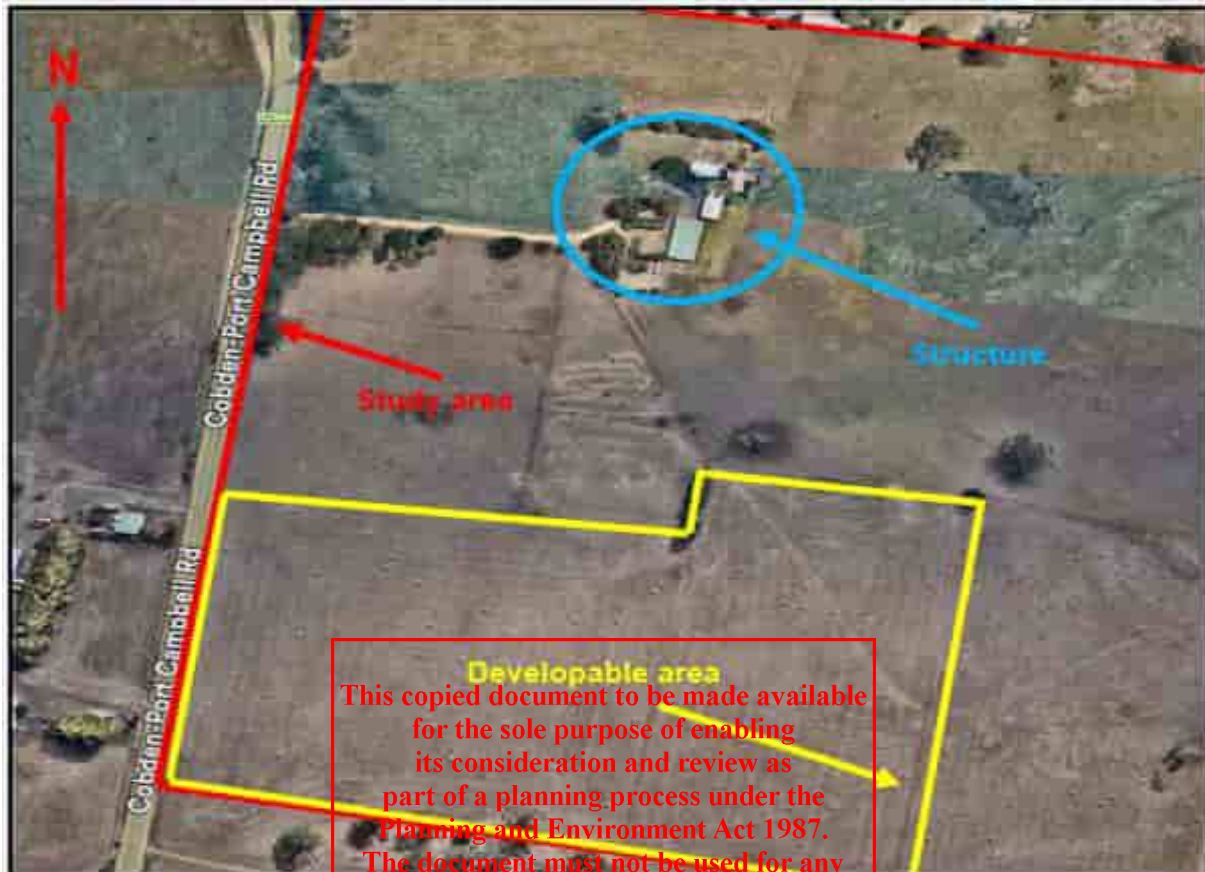
**Figure 7 Existing structures within the study area**

Within the northern area of Lot 2/TP863659, building structures are present within the study area. The location of these structures is presented in Figure 7.

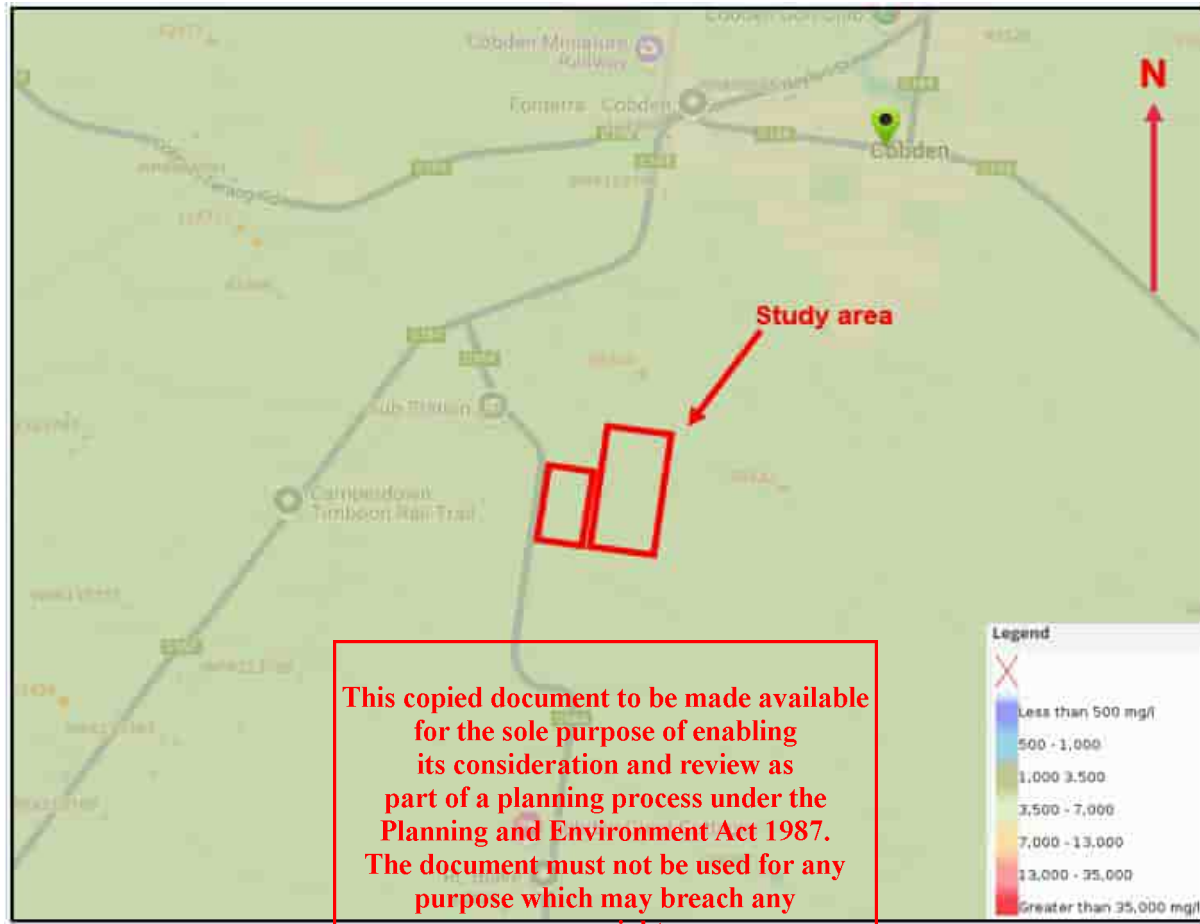
**Figure 9 Groundwater salinity**

Visualising Victoria's Groundwater database, accessed on 6<sup>th</sup> February 2025, and the Lotsearch report suggests that the site is within an area where groundwater salinity is 1201 mg/l to 3100 mg/l, as presented in Figure 9.

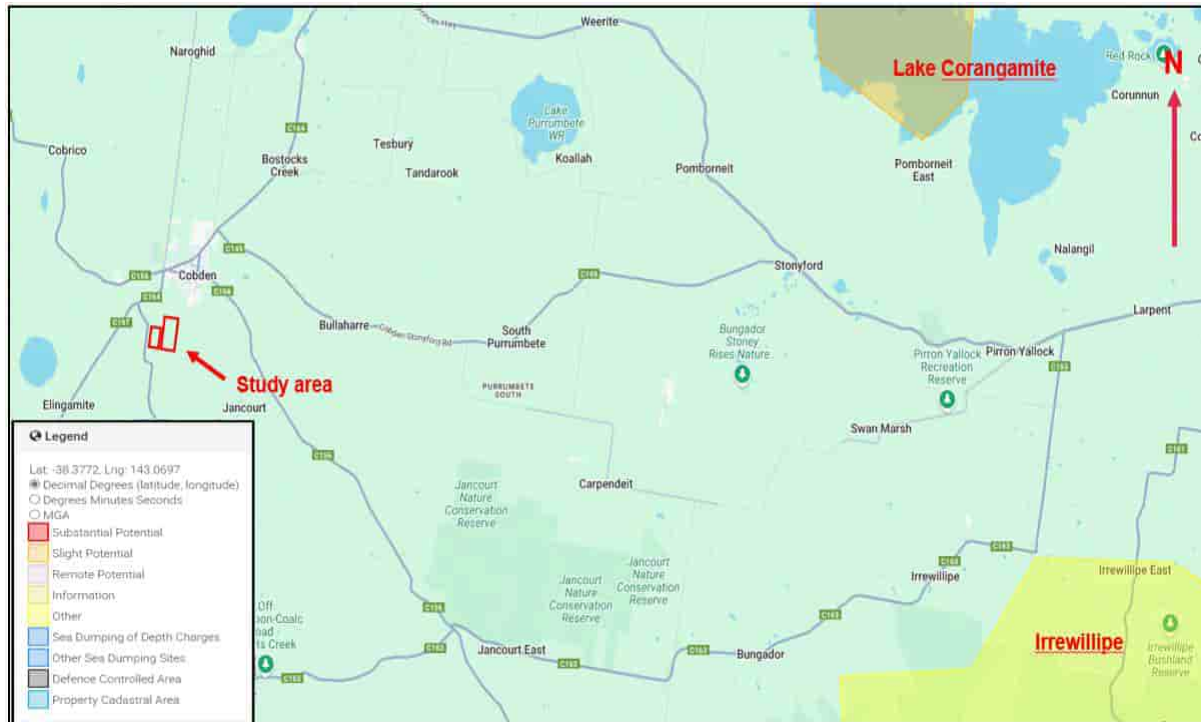
**Figure 10 UXO map**

The Department of Defence mapping, unexploded ordnance (UXO) mapping layer, (web-based, accessed on 6<sup>th</sup> February 2025) for the local area suggests that there is very low risk from UXO within the study area. The Lake Corangamite area, approximately 30 km to the northeast, and the Irrewillipe area, approximately 25 km to the east, are the closest areas to the site where UXO risk is highlighted, see Figure 10.
