JACMAX Developments

May 2025

Preliminary Risk Screen Assessment

18 to 24 Scott Street,
Dandenong, Victoria

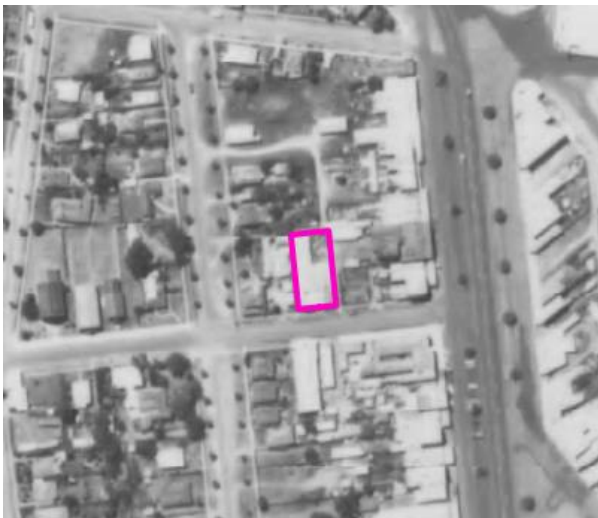
<p>1951</p> <p>A large or several buildings appear to exist covering the majority of the southern and north-western portions of the site.</p> <p>Surrounding land generally consists of residential to the north, west and south with commercial buildings visible to the immediate east of the site along both sides of Lonsdale Street, and further south of the site. A football oval is visible to the northeast of the site.</p>

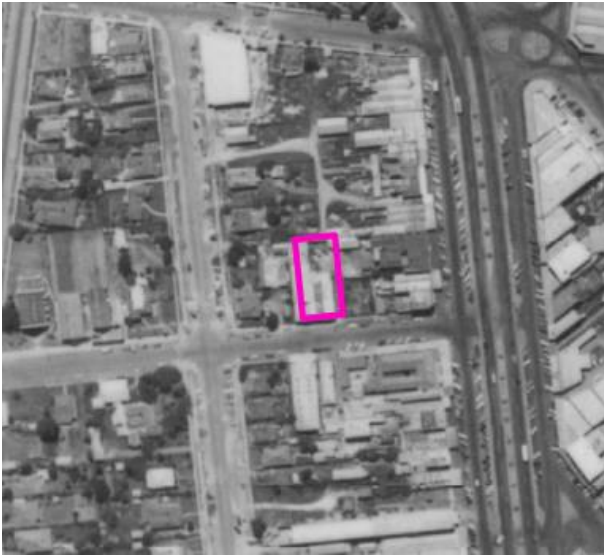
<p>1956</p> <p>No significant changes to the site are visible. Vehicles appear present within the north-eastern corner of the site.</p> <p>Minor residential development appears to have occurred within the broader surrounding areas with further commercial development to the east along Lonsdale Street and surrounding blocks immediately to the north and south of the site.</p>

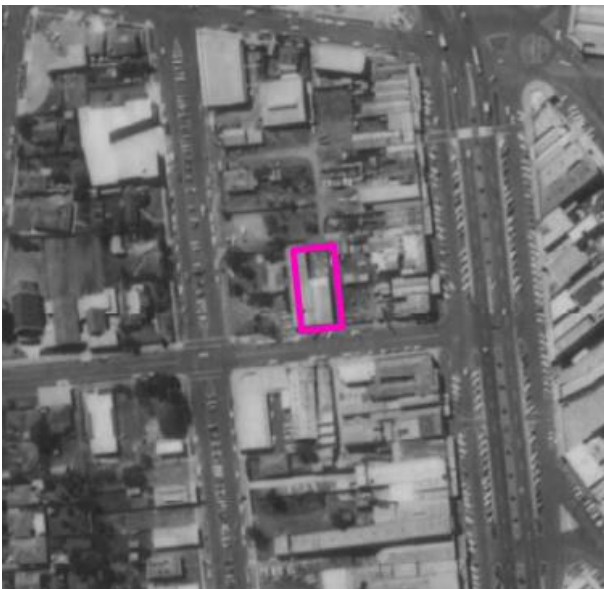
<p>1962</p> <p>No significant changes to the site are visible.</p> <p>Further residential development appears to have occurred within the broader surrounding areas. Several residential buildings have been removed to allow for further commercial development to the north and south of the site and broader areas. Additional commercial development has occurred to the east along Lonsdale Street.</p>

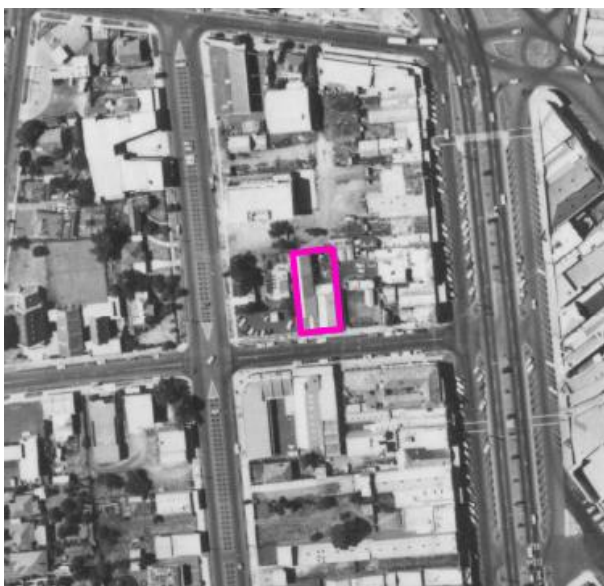
<p>1968</p> <p>No significant changes to the site are visible.</p> <p>Further commercial development has occurred immediately adjacent to the west and north of the site and surrounding areas. A portion of the football field to the northeast of the site has been removed with construction of several buildings adjoining.</p> <p>ADVERTISED PLAN</p>

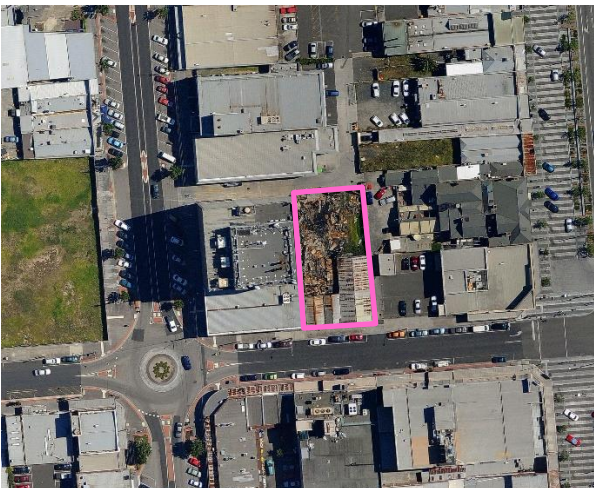
<p>2012 (January) – NearMap</p> <p>Demolition works appear to be in progress with the rear portion of the western building partially demolished.</p> <p>The site was clear of all above-ground infrastructure by February 2013.</p>

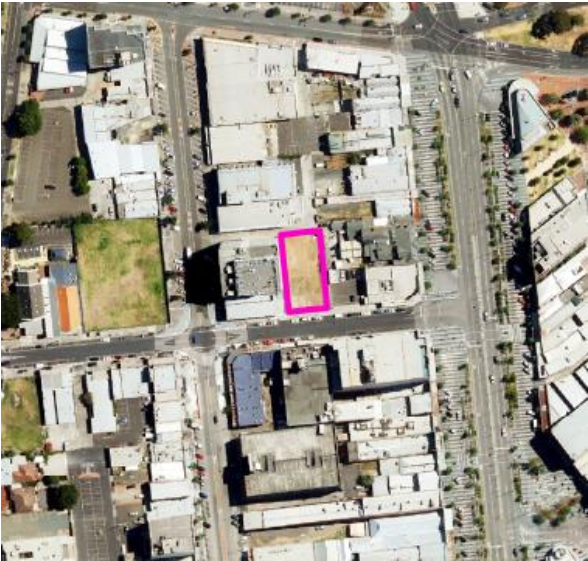
<p>2014</p> <p>The site appears vacant with all above-ground infrastructure removed and comprises grass vegetation cover.</p>

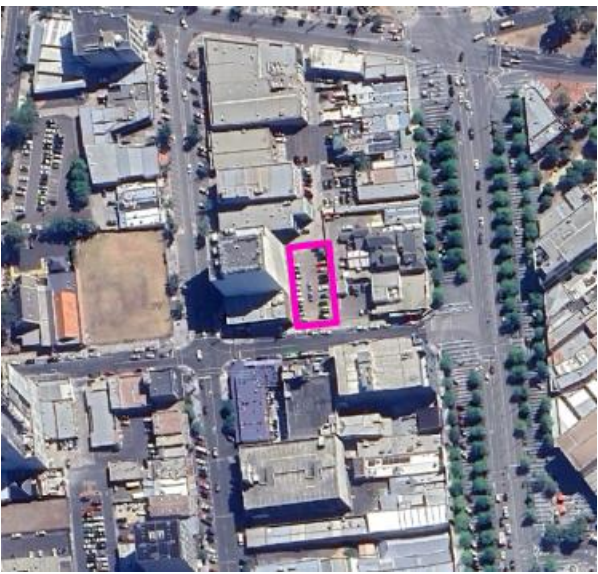
<p>2025</p> <p>The site appears to be used for car parking purposes consistent with the current site configuration and use.</p>
 	<p>1932</p> <p>(C. D. Pratt, photographer, State Library of Victoria collection.)</p> <p>The site and buildings are visible and broadly consistent with observations from 1951 aerial (vertical) image. No chimney or other emission stacks are visible from the site buildings.</p> <p>No additional (to those already noted for vertical imagery) indication of industrial or other potentially contaminating land use is noted in the immediate vicinity of the site.</p>
