JACMAX Developments

May 2025

Preliminary Risk Screen Assessment

18 to 24 Scott Street,
Dandenong, Victoria

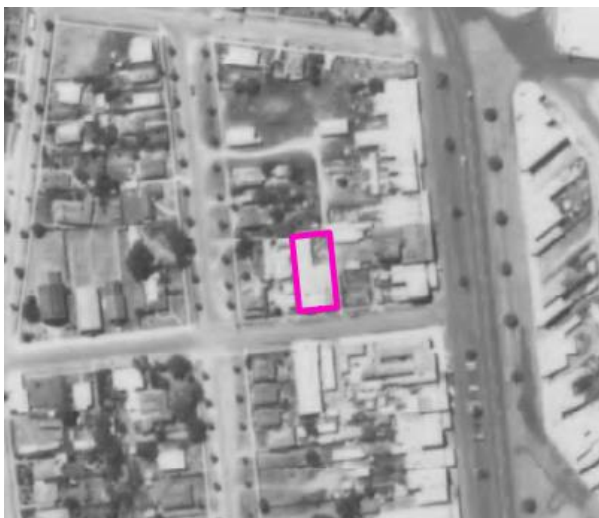
<p>1951</p> <p>A large or several buildings appear to exist covering the majority of the southern and north-western portions of the site.</p> <p>Surrounding land generally consists of residential to the north, west and south with commercial buildings visible to the immediate east of the site along both sides of Lonsdale Street, and further south of the site. A football oval is visible to the northeast of the site.</p>

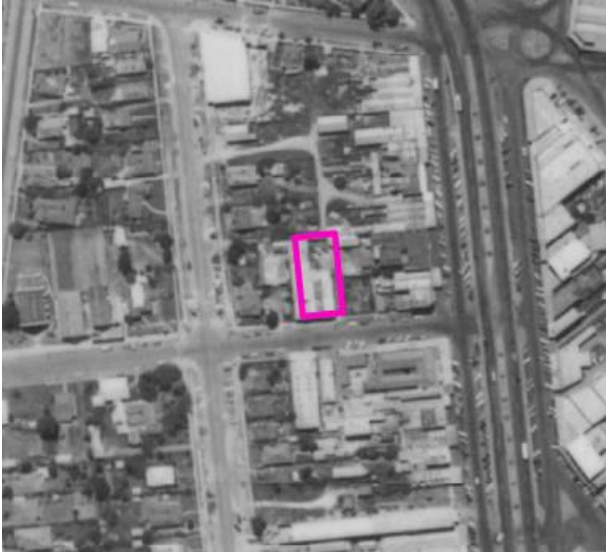
<p>1956</p> <p>No significant changes to the site are visible. Vehicles appear present within the north-eastern corner of the site.</p> <p>Minor residential development appears to have occurred within the broader surrounding areas with further commercial development to the east along Lonsdale Street and surrounding blocks immediately to the north and south of the site.</p>

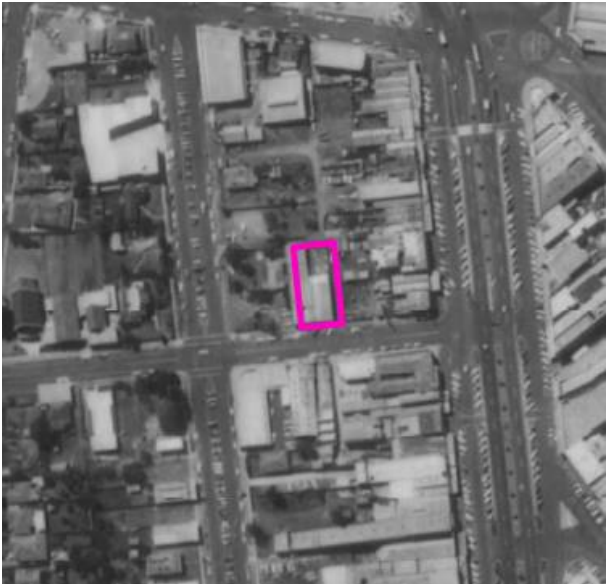
<p>1962</p> <p>No significant changes to the site are visible.</p> <p>Further residential development appears to have occurred within the broader surrounding areas. Several residential buildings have been removed to allow for further commercial development to the north and south of the site and broader areas. Additional commercial development has occurred to the east along Lonsdale Street.</p>

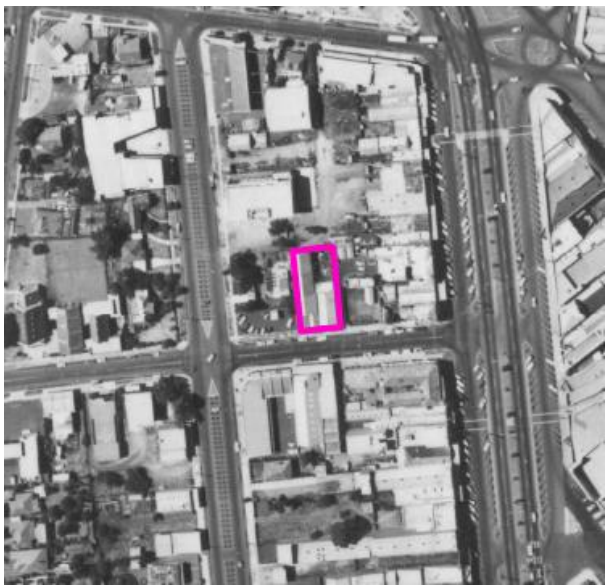
<p>1968</p> <p>No significant changes to the site are visible.</p> <p>Further commercial development has occurred immediately adjacent to the west and north of the site and surrounding areas. A portion of the football field to the northeast of the site has been removed with construction of several buildings adjoining.</p>

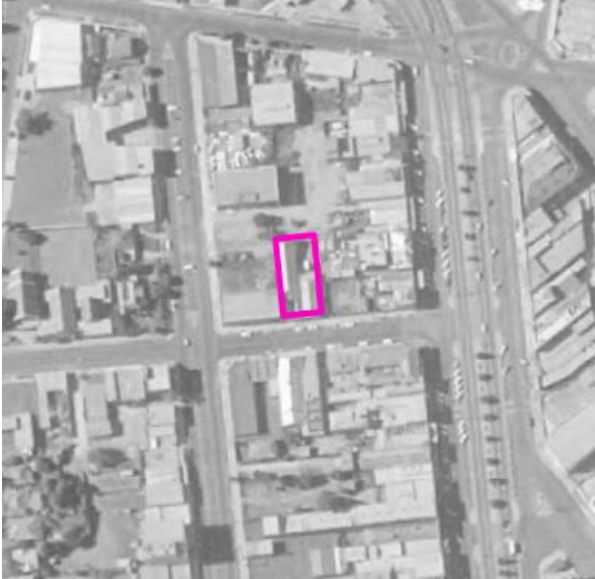
<p>1974</p> <p>No significant changes to the site are visible.</p> <p>Removal of several buildings have occurred on adjacent land to the site.</p>

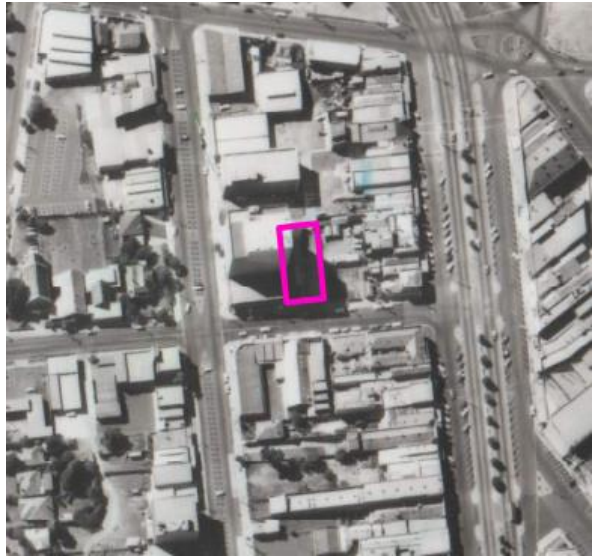
<p>1978</p> <p>No significant changes to the site are visible.</p> <p>Several high-rise buildings have been constructed in the immediate vicinity of the site, including immediately adjacent property to the west with further commercial development to the south and east.</p>

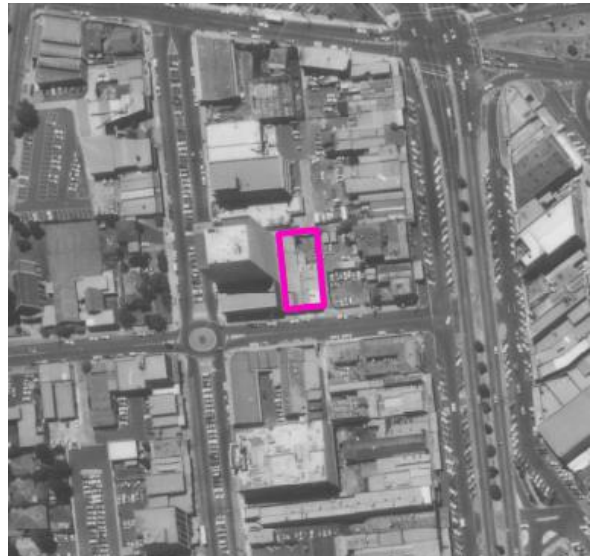
<p>1984</p> <p>No significant changes to the site are visible.</p> <p>Further off-site commercial development appears to have occurred.</p>

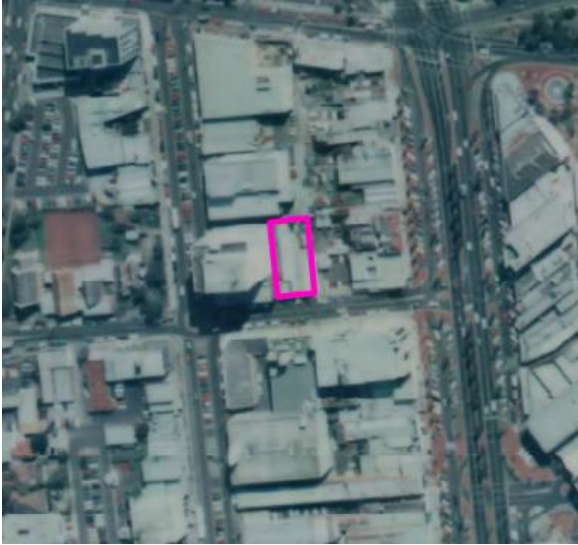
<p>1991</p> <p>No significant changes onsite appear visible.</p> <p>Further commercial development appears visible within nearby surrounding areas of the site.</p>

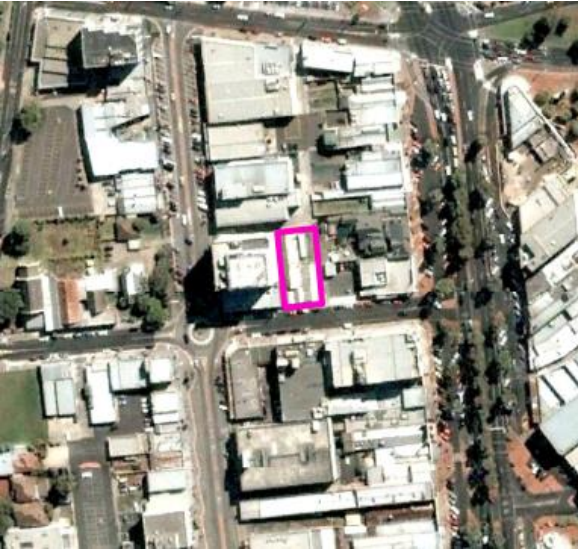
<p>2005</p> <p>Presence of a rectangular structure inferred shipping container appears visible within north-eastern portion of site to the rear of the eastern building structure.</p>

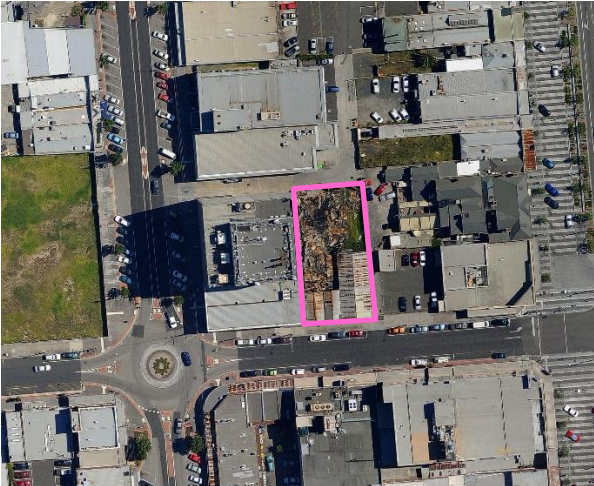
<p>2012 (January) – NearMap</p> <p>Demolition works appear to be in progress with the rear portion of the western building partially demolished.</p> <p>The site was clear of all above-ground infrastructure by February 2013.</p>

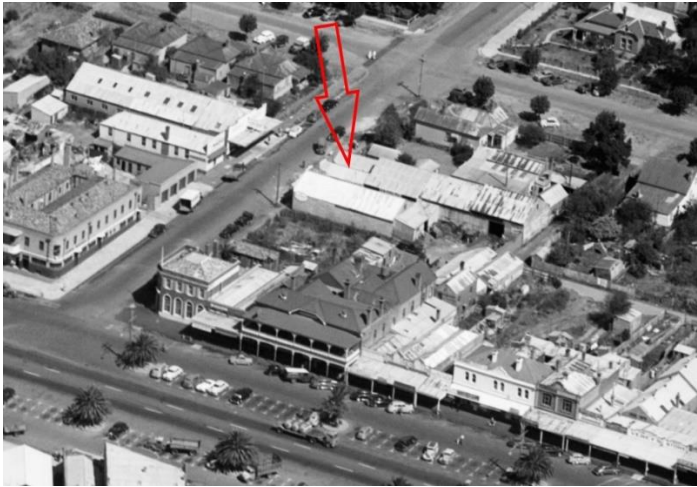
<p>1953</p> <p>(C. D. Pratt, photographer, State Library of Victoria collection.)</p> <p>The site and buildings are visible and broadly consistent with observations from 1950s aerial (vertical) images. No chimney or other emission stacks are visible from the site buildings. Yard visible behind the building on Lot 1 LP57871 (eastern parcel).</p> <p>No additional indication of industrial or other potentially contaminating land use is noted in the immediate vicinity of the site.</p>

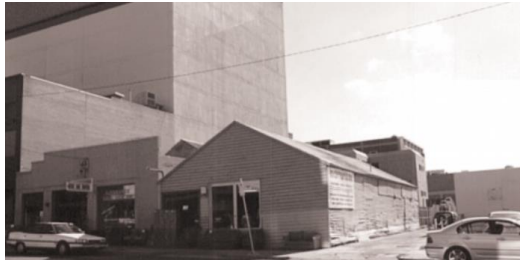
<p>Image date unknown (inferred 1990s) showing 18-24 Scott Street.</p>

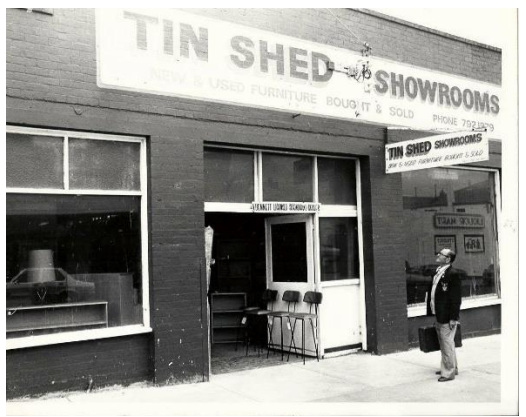
<p>Image date unknown showing 18-20 Scott Street.</p>

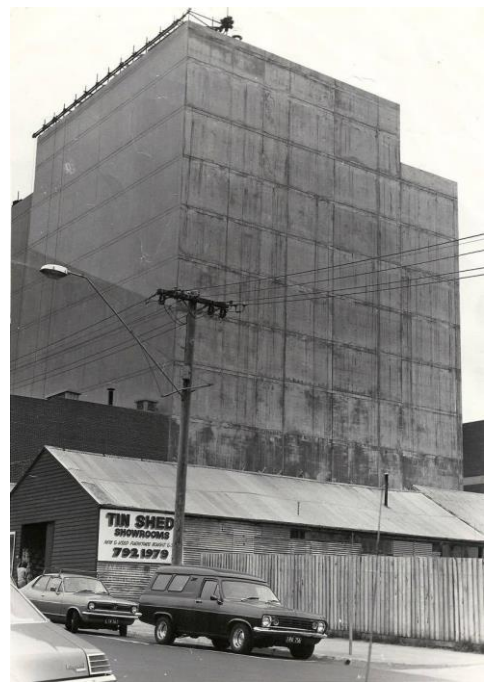
<p>Image date unknown showing 22-24 Scott Street.</p>

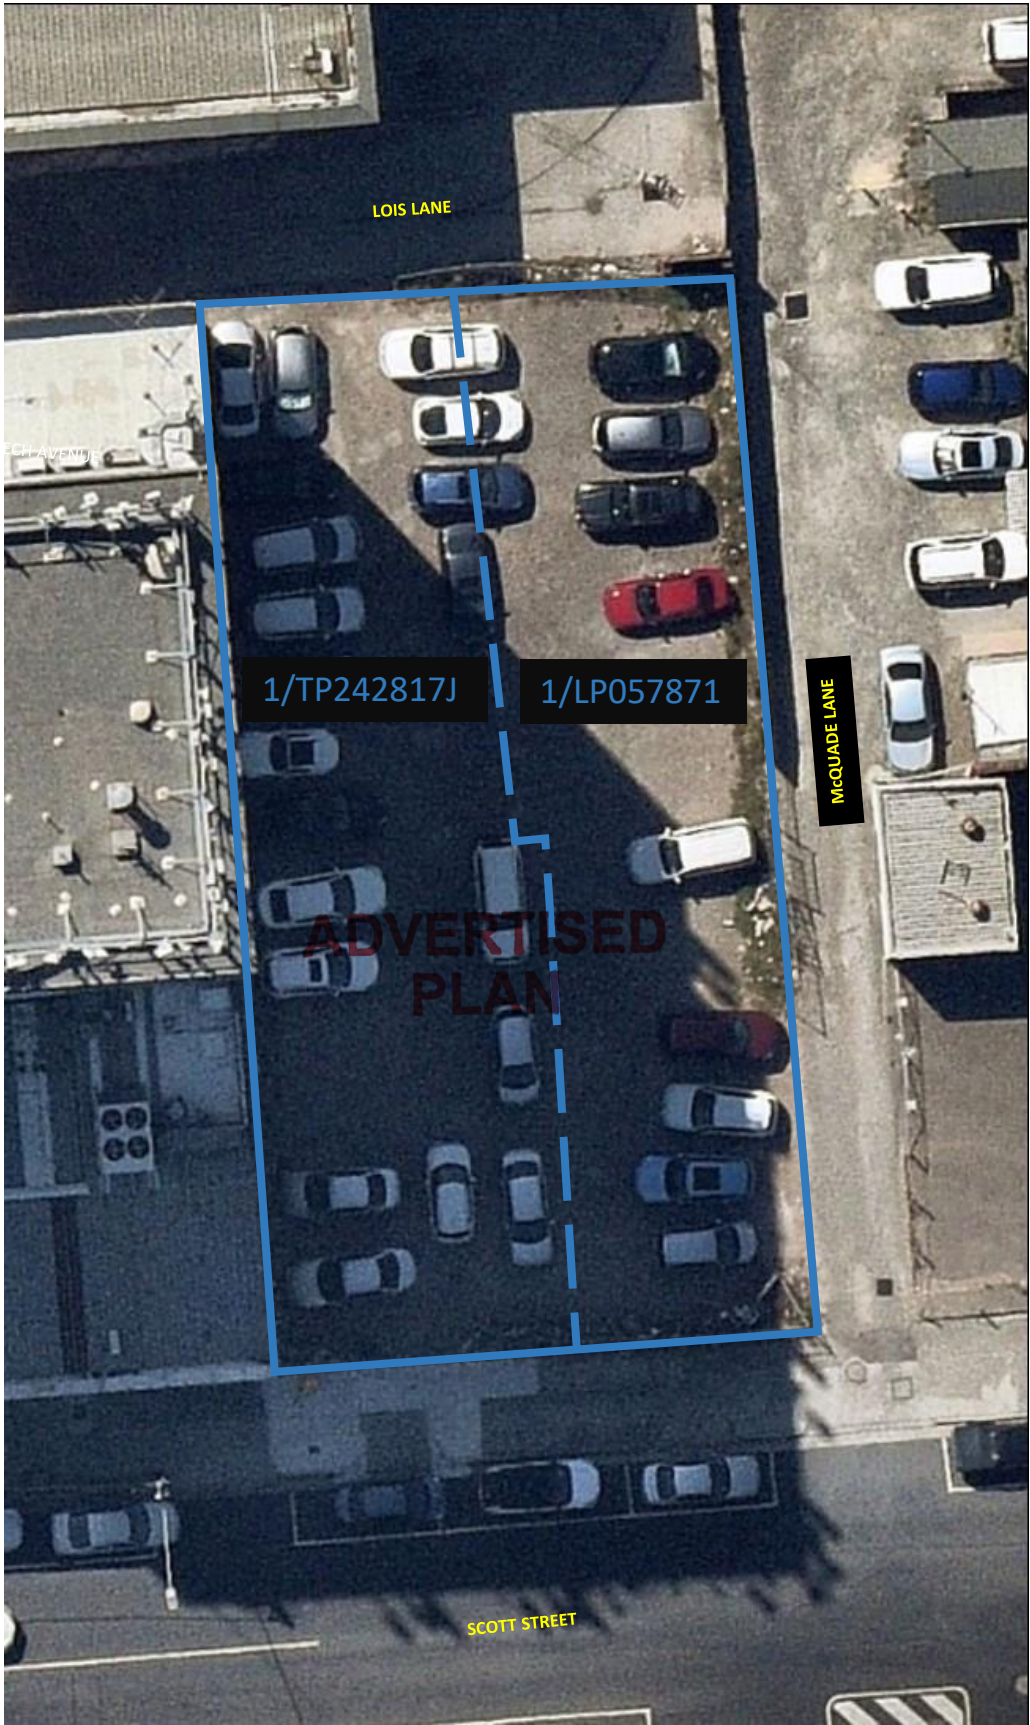
<div><div></div> PRSA SITE BOUNDARY (APPROX)</div> <div>SITE AREA: 830 sq.m</div>	 	Client: JACMAX Developments Pty Ltd	
		Project: 18-24 Scott Street, Dandenong, Victoria	
		Title: Site Location	
	Scale: NTS	Project no: PS222544	FIGURE 1

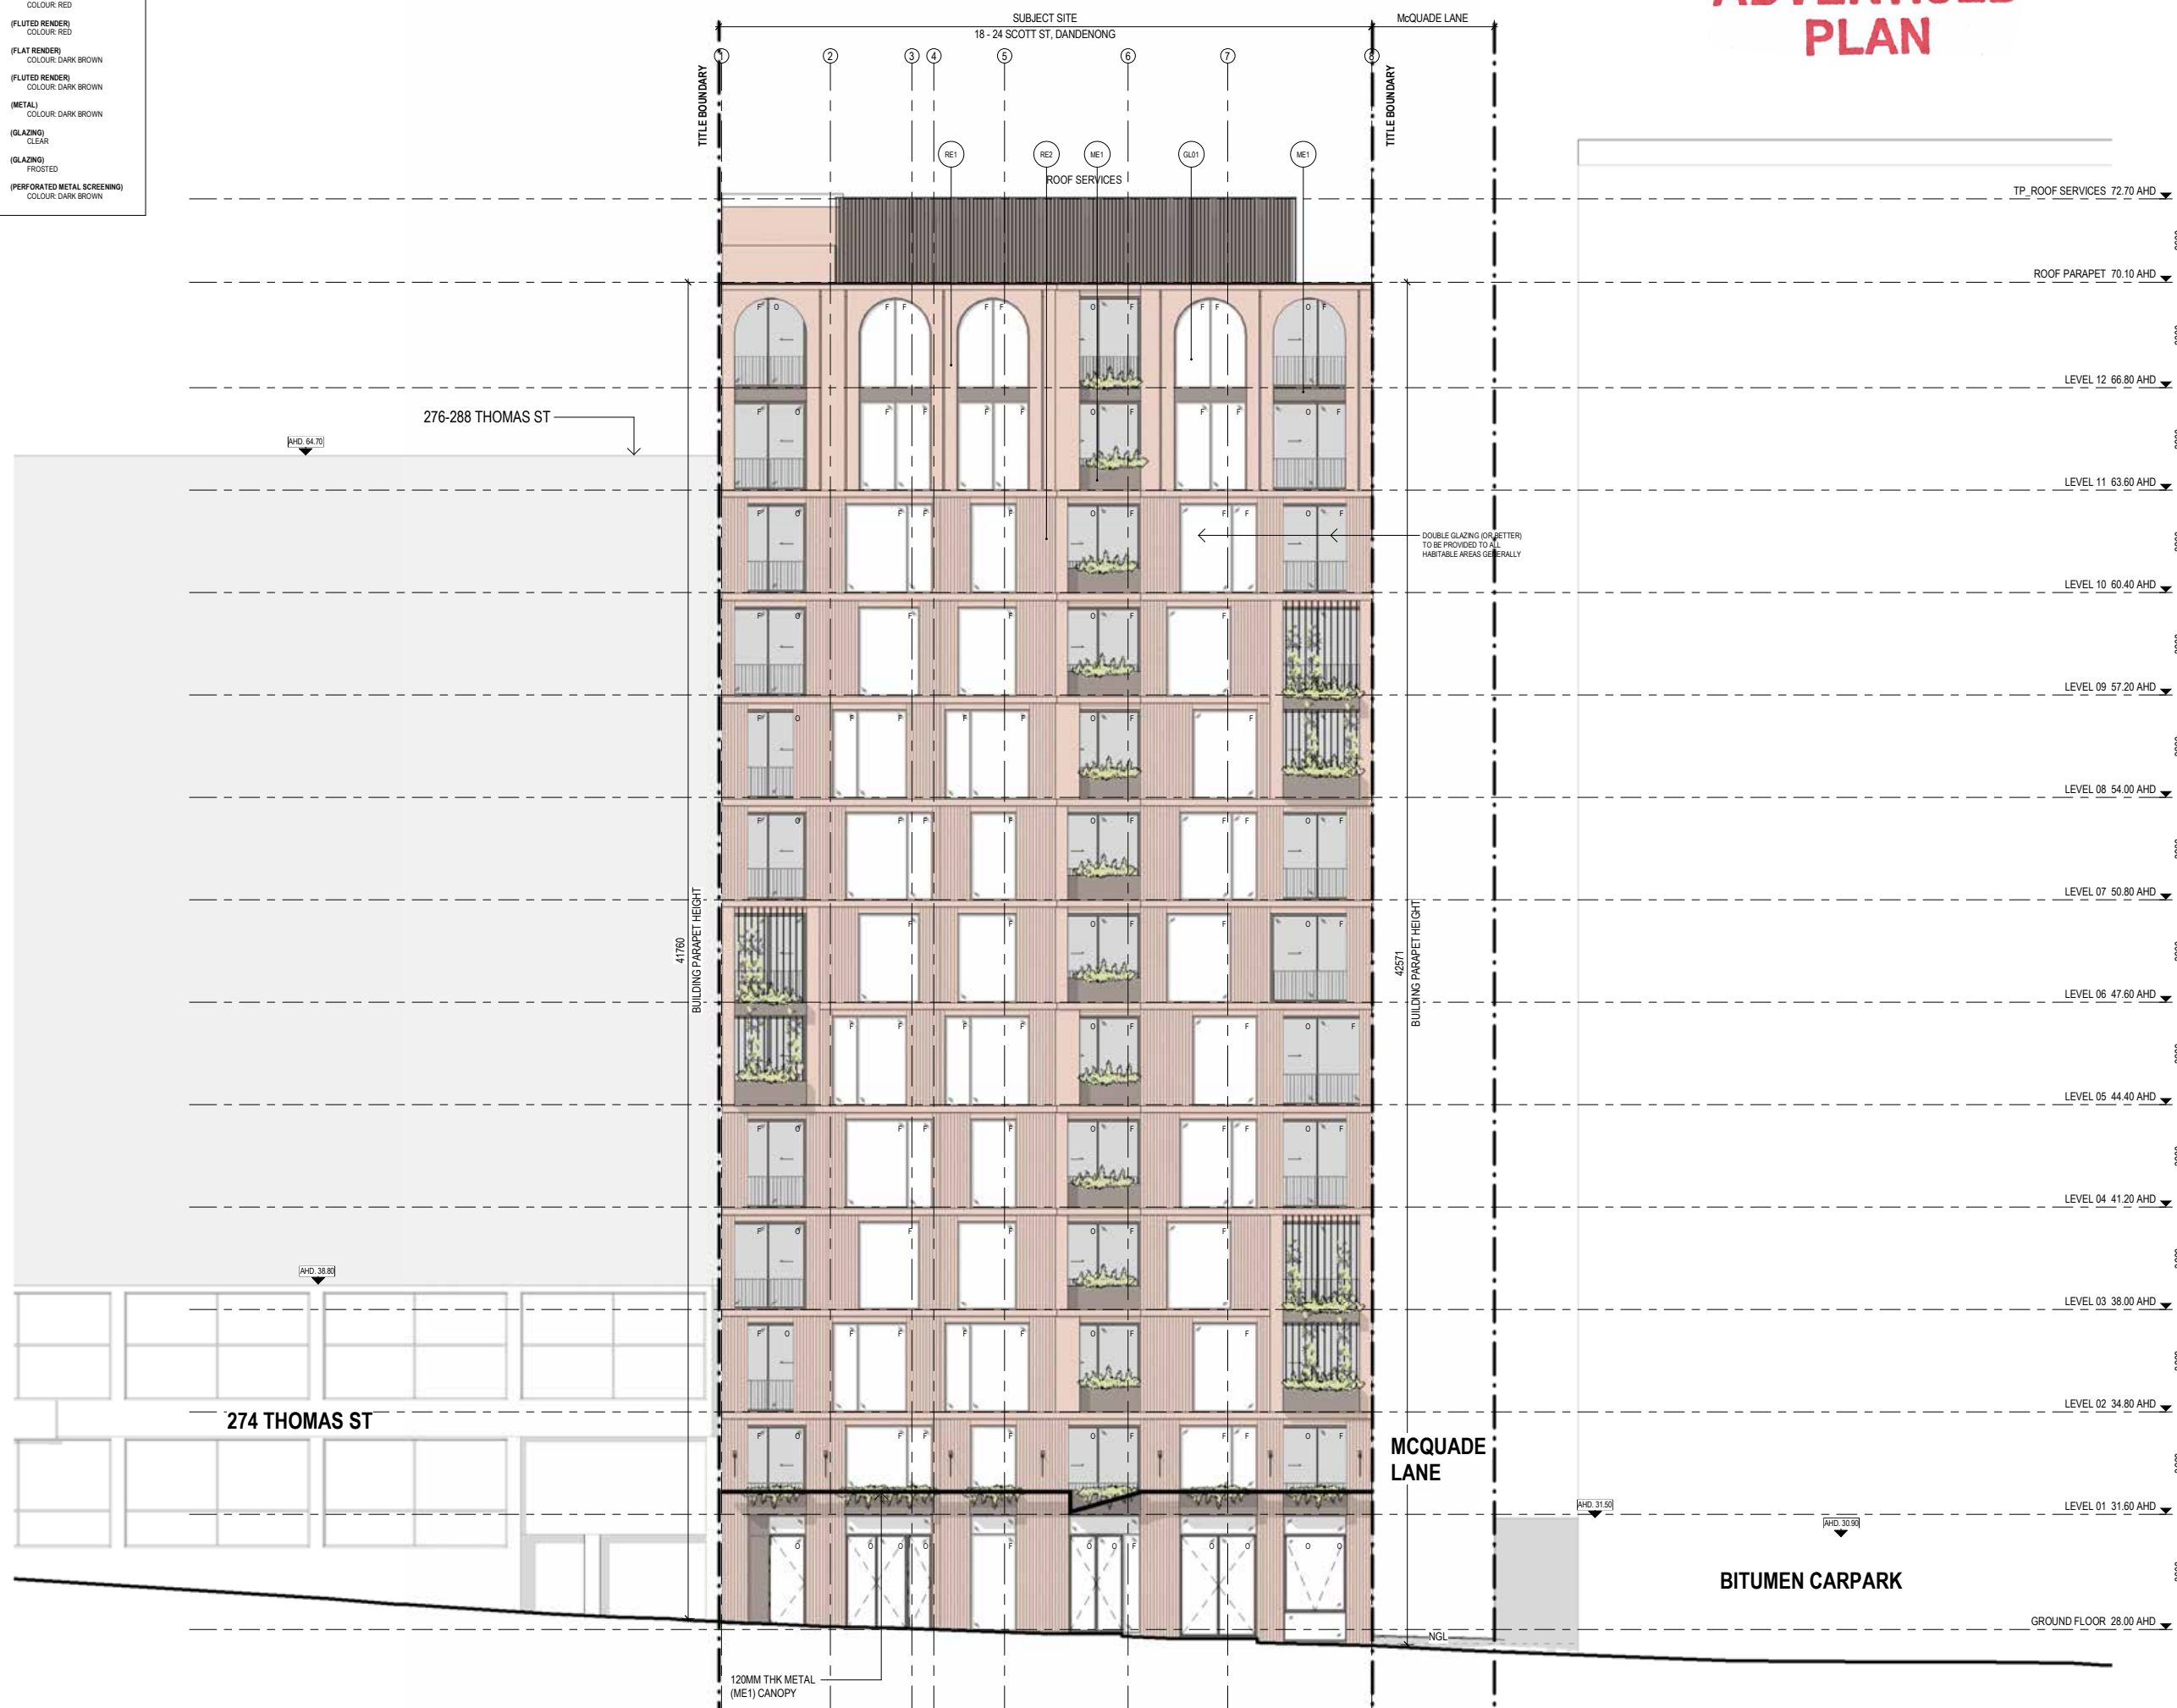
TP.2102

RE1	(FLAT RENDER) COLOUR: RED
RE2	(FLUTED RENDER) COLOUR: RED
RE3	(FLAT RENDER) COLOUR: DARK BROWN
RE2	(FLUTED RENDER) COLOUR: DARK BROWN
ME1	(METAL) COLOUR: DARK BROWN
GL1	(GLAZING) CLEAR
GL2	(GLAZING) FROSTED
PM1	(PERFORATED METAL SCREENING) COLOUR: DARK BROWN

SOUTH ELEVATION
