ARBORICULTURAL ASSESSMENT

427 – 441 Springvale Road, Springvale Vic, 3171 – Greater
Dandenong

Prepared For: Killester College – C/O Kalynda Davidson @ McIldowie Partners

Arbor Advocacy Reference # 1033

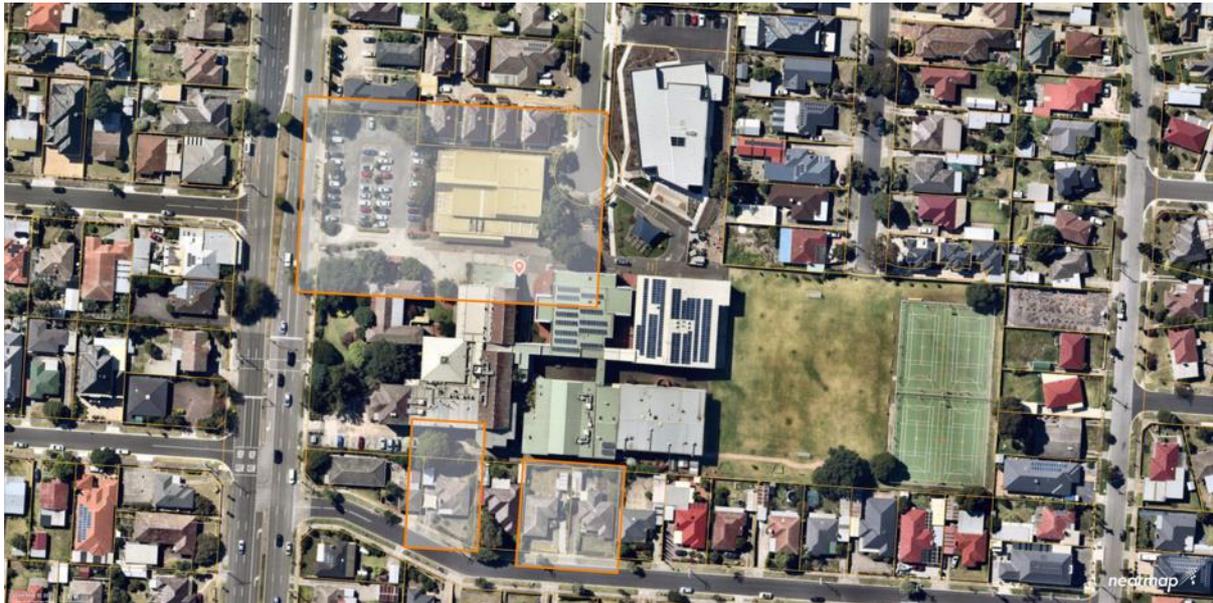
Image 9.1 – Killester College, Springvale

The shaded areas below are the areas in which the vegetation was assessed.

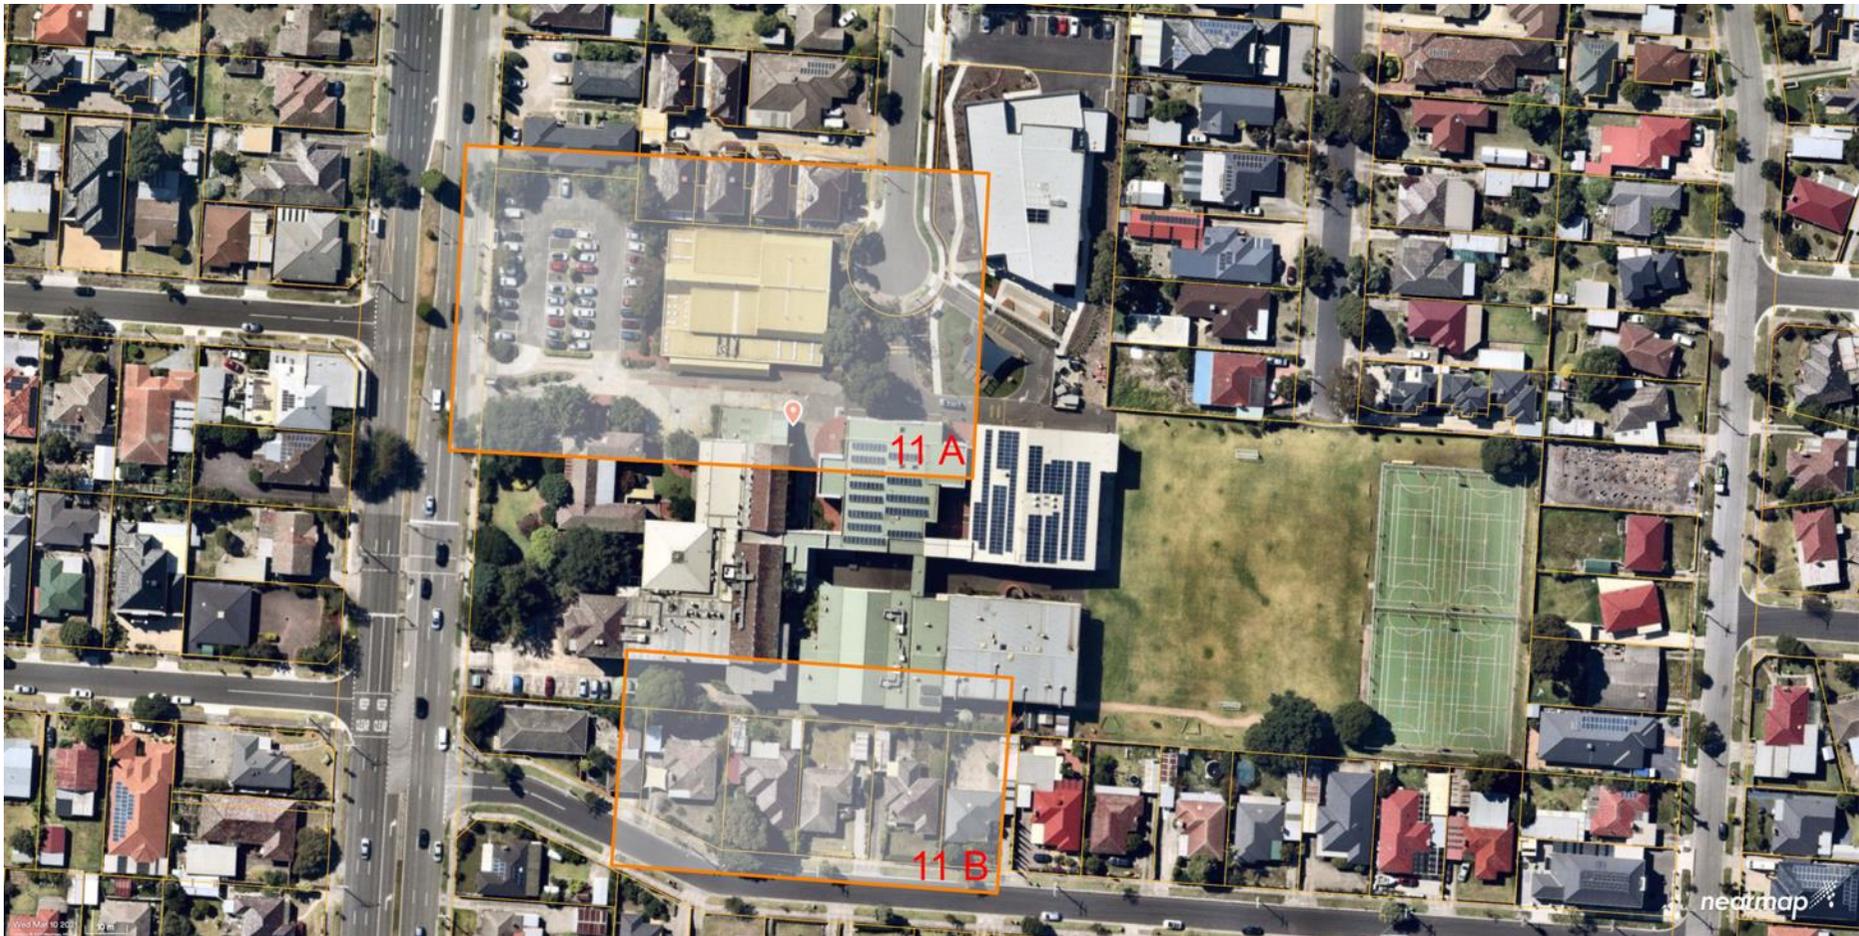
Image 11.1 – Tree Location Map Showing Sub Zones

Due to the size of the work zone the tree location map and TPZ & SRZ maps have been divided in 2 sub maps as illustrated below.

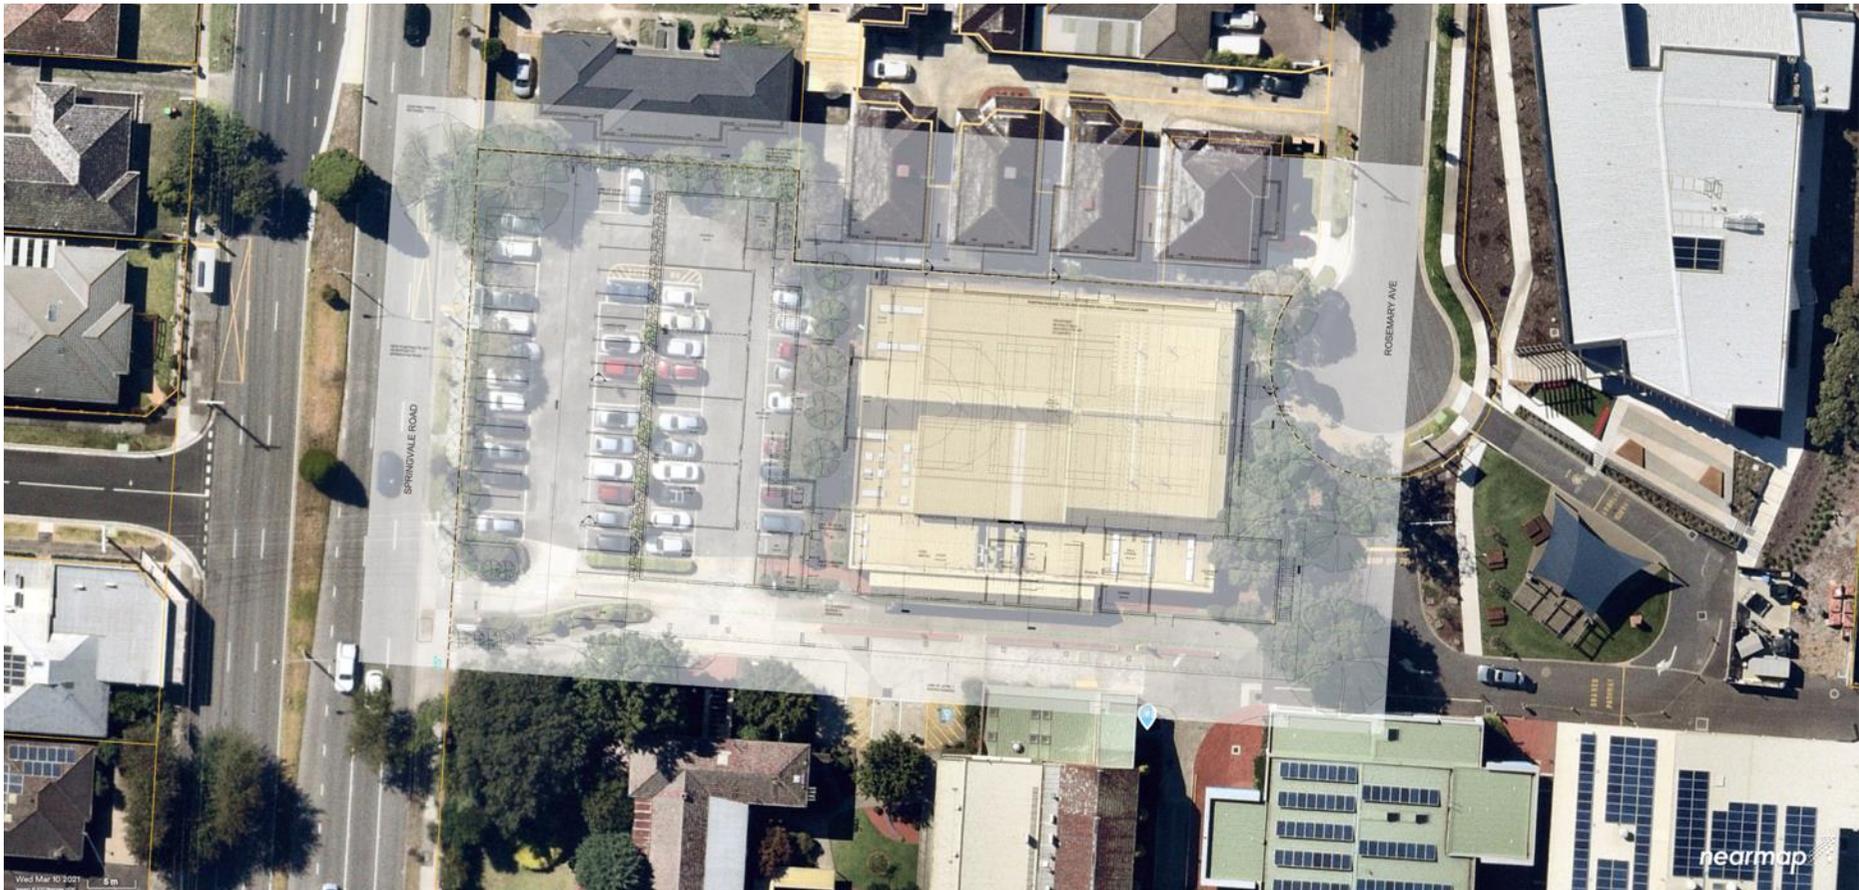
Image 12.1 – Proposed Design Overlapping Existing Site

The above overhead image with the overlay of the proposed development will form the basis of the decision for what trees can be retained and protected as well as what trees will need to be removed to facilitate the construction process around the gym and car park area.

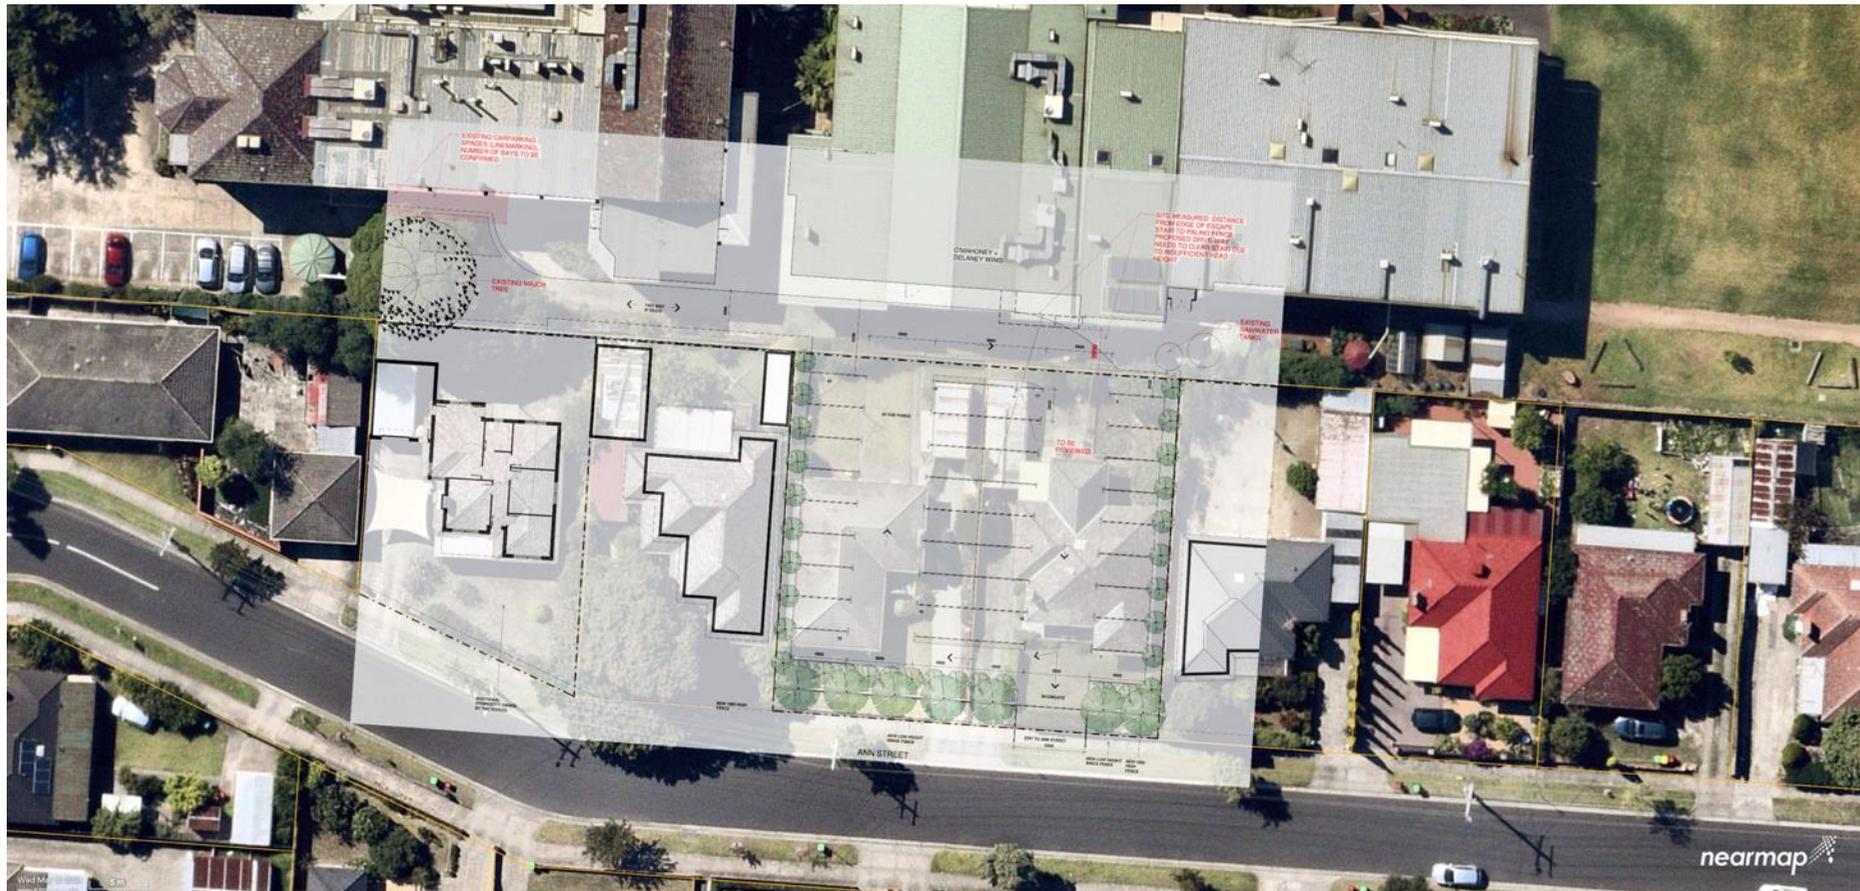
Image 12.2 – Proposed Design Overlapping Existing Site

The above overhead image with the overlay of the proposed development will form the basis of the decision for what trees can be retained and protected as well as what trees will need to be removed to facilitate the construction process around the Ann Street area.

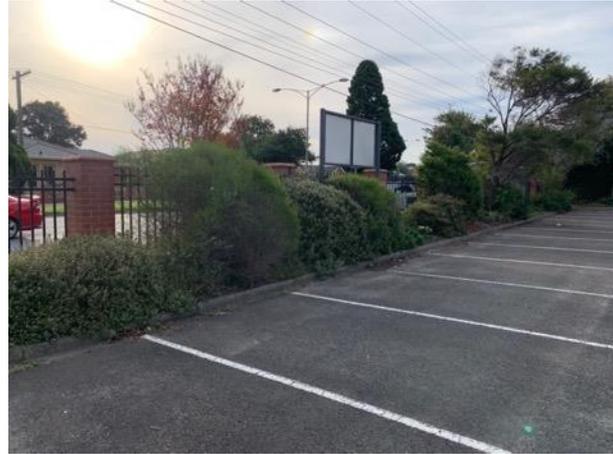
Image – 13.6 – Understorey shrubs to be removed

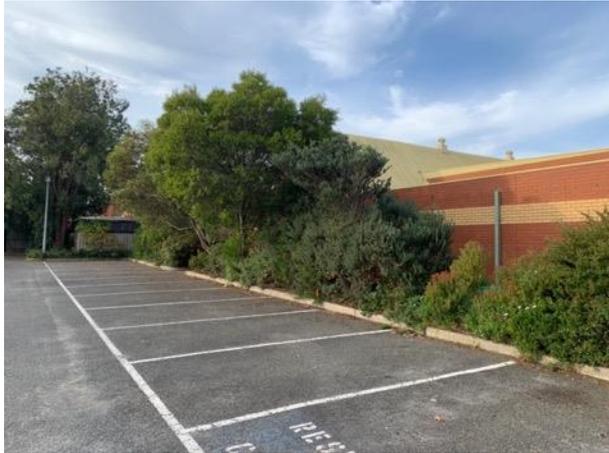
Image – 13.17 – All trees to be removed

If the supplied drawings are approved without change trees numbered 6, 7, 12, 13, 14, 15, 16, 17, 18, 19, 20, 21, 22, 23, 24, 25, 26, 27, 28 & 31 will need to be removed. As the land size is greater than 4000m² clause 52.17 Native Vegetation is triggered specifically, trees numbered 6, 7, 12, 13, 14, 15, 16, 17, 18, 21, 22, 23, 24, 25, 26 are native / indigenous vegetation that would require a permit under clause 52.17. However, table 52.17-7 Table of Exemptions contains a line item stating:

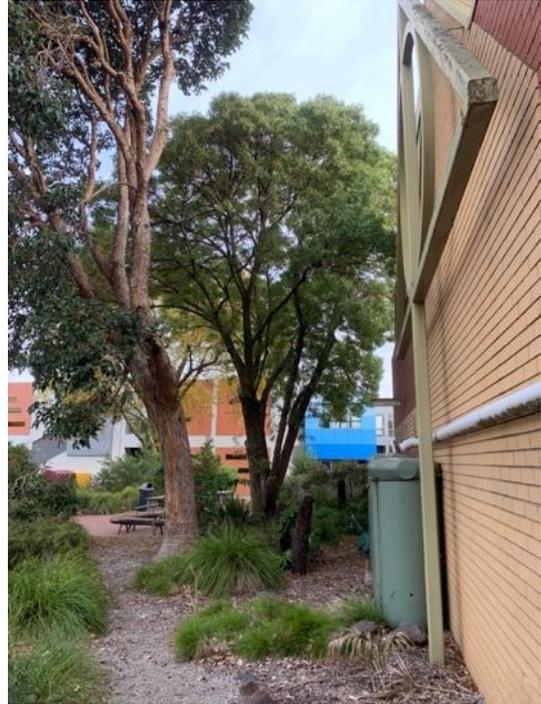
Image – 13.26 – Tree 31 & 32 Proximity to existing building

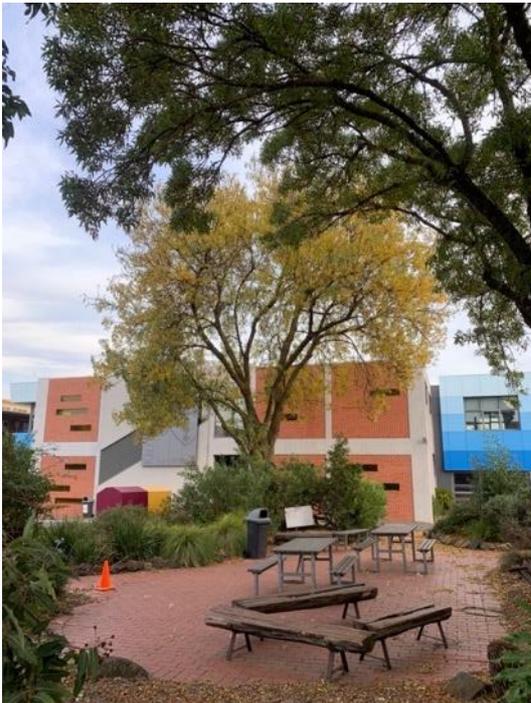
Image – 13.27 – Existing hardscaping under Tree 29

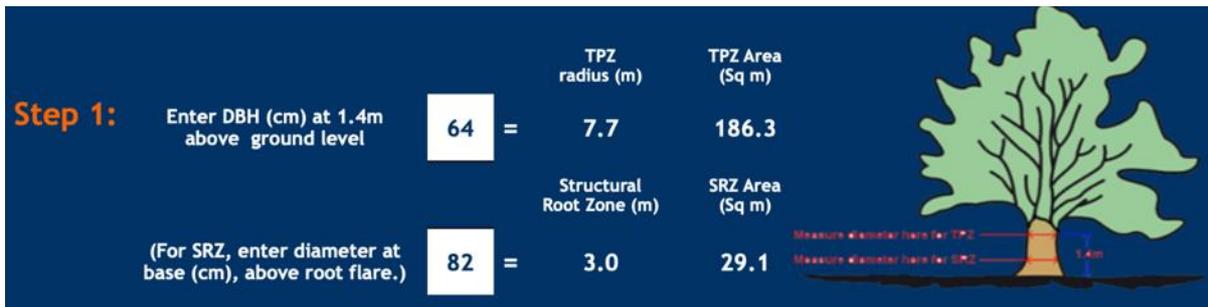
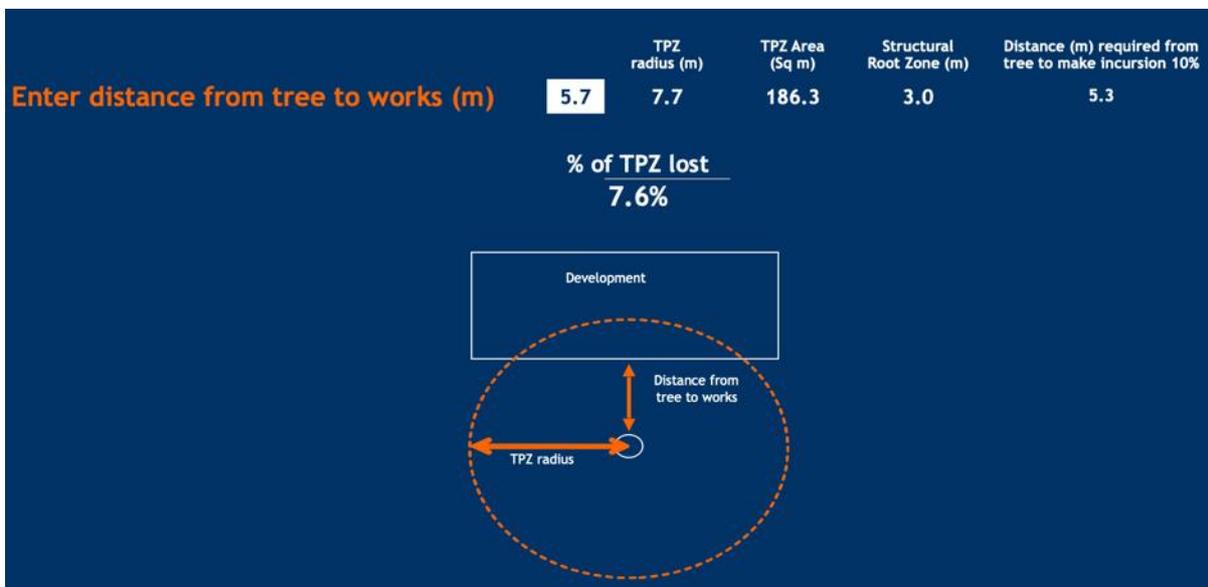
Tree 29 has had the following encroachment calculations performed for the proposed building development.

Image 14.1 – Encroachment percentage input data

Image 14.2 – Encroachment percentage result

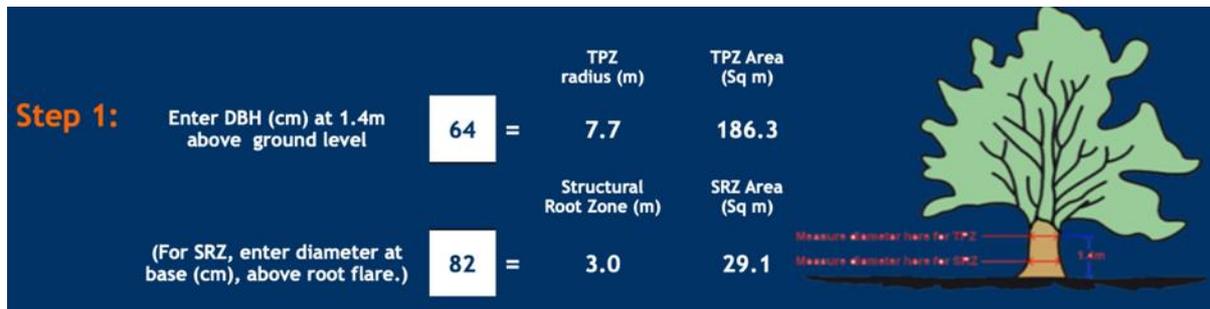
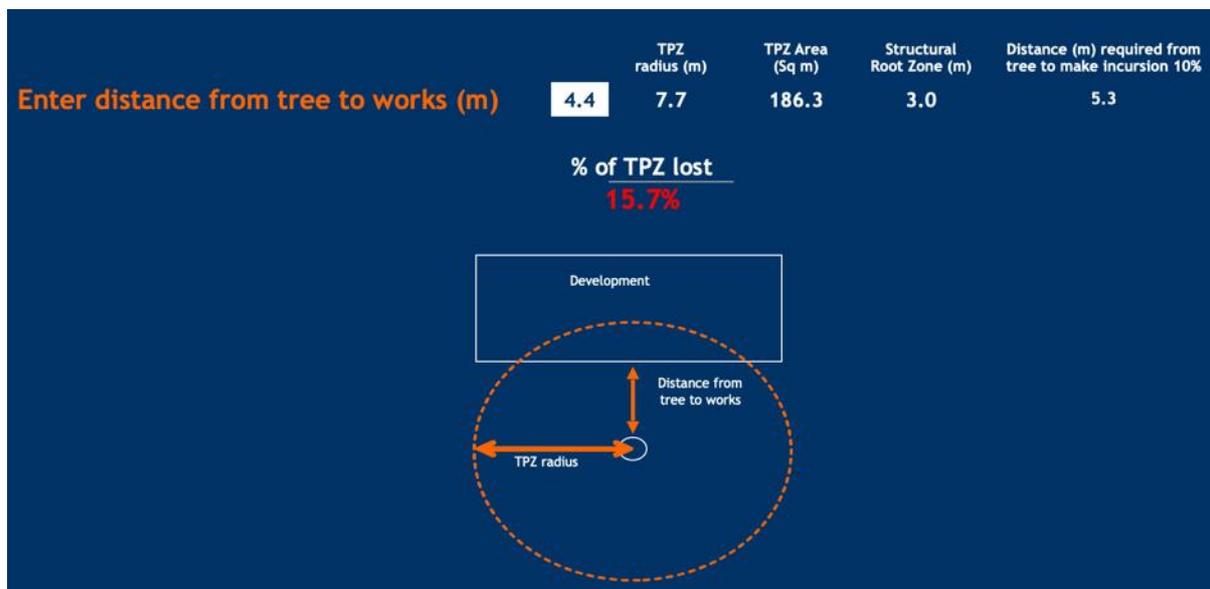
Tree 29 has had the following encroachment calculations performed for the sewer easement.

Image 14.3 – Encroachment percentage input data

Image 14.4 – Encroachment percentage result

The encroachment percentage of 26.8% is classified as major encroachment as it is more than 10% of the area of the TPZ and is inside the SRZ. Excavation for footings for the proposed development will need to take place inside the SRZ of this tree and as a result the tree will not be viable for retention. The tree should be removed prior to the construction of the proposed development. The encroachment for the new building adjacent to the existing gym has been represented by the red shaded area in image 14.3.

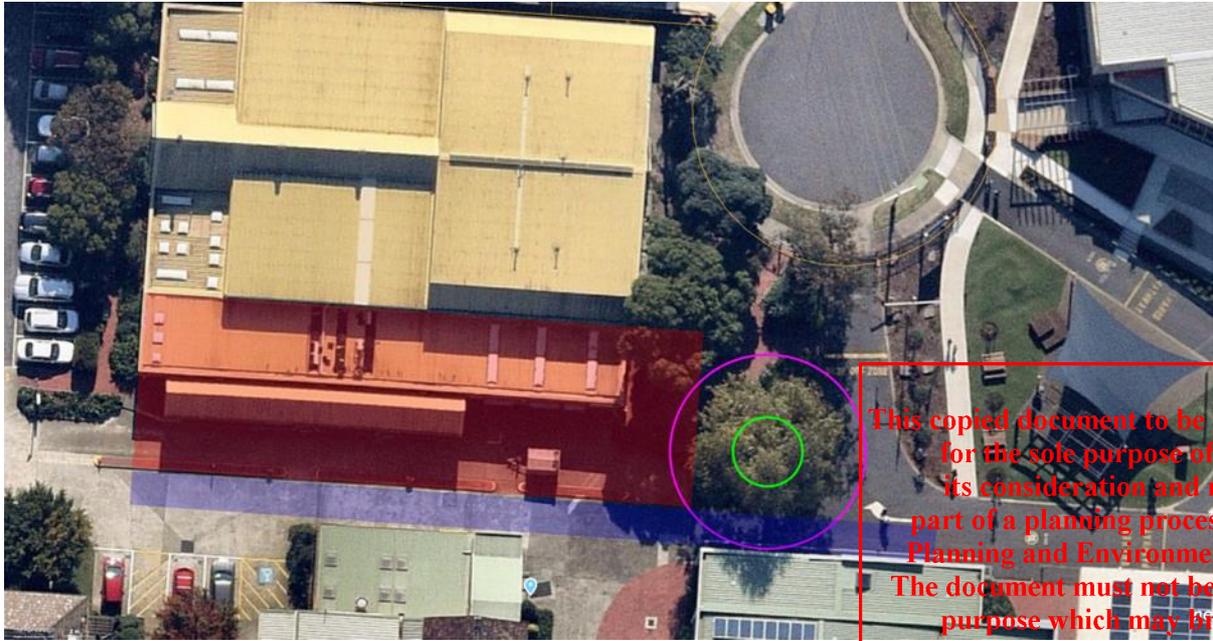
Image 14.5 – TPS and SRZ for tree 41

Image 14.5 shows both the new building envelope (red) and the proposed sewer easement (blue) along with the trees TPZ and SRZ.

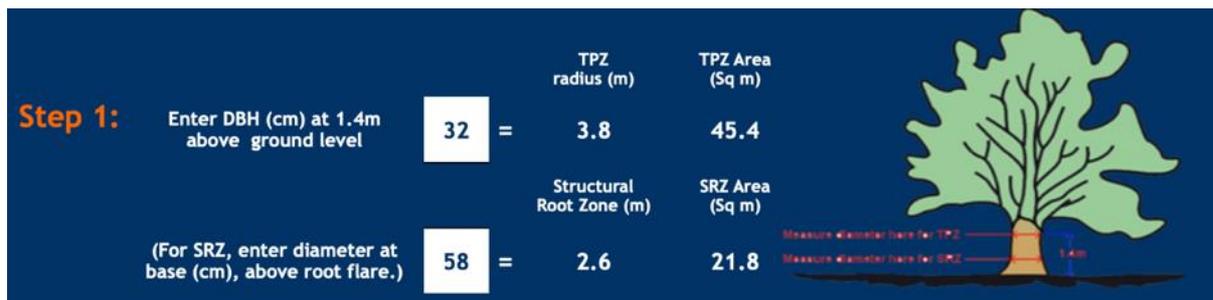
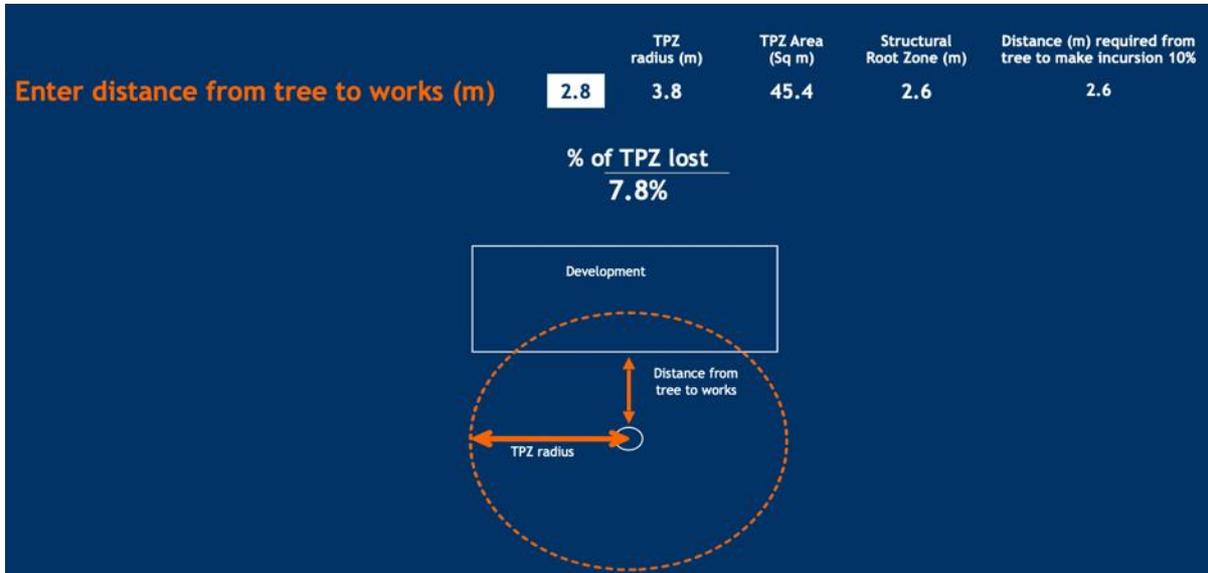
Tree 41 which resides inside property number 9 Ann Street, Springvale has had the following encroachment calculations performed.

Image 14.9 – Encroachment percentage input data

Image 14.10 – Encroachment percentage result

The encroachment percentage of 7.8% is classified as minor encroachment as it is less than 10% of the area of the TPZ and is outside the SRZ, detailed root investigations should not be required. This encroachment classification is defined by AS. 4970 – 2009 Protection of Trees on development sites.

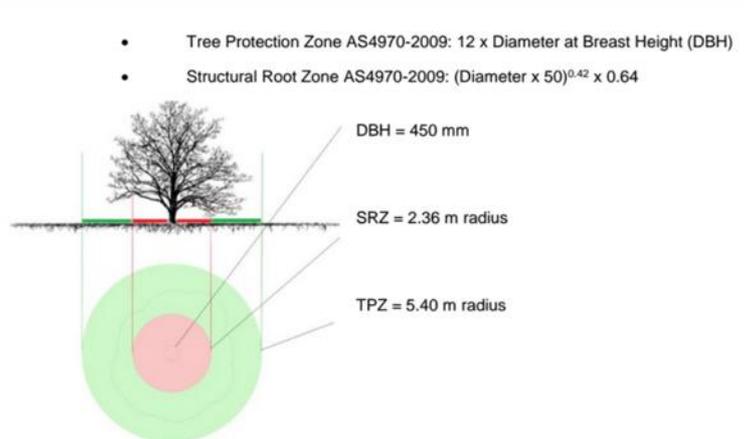
Data was collected for all trees onsite. This data has been used to recommend Tree Protection Zones based on The Australian Standard AS. 4970 - 2009 Protection of trees on development sites. The below diagram explains the methods used to determine the recommended TPZ for each tree being retained.

Image 12.1 – Tree Protection & Structural Root Zone

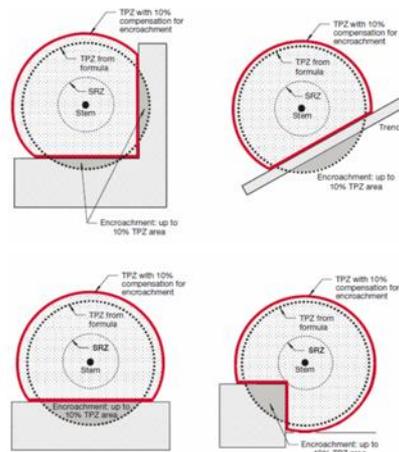
Where minor encroachment occurs and the protection measures are required, the loss of protection due to encroachment must be accounted for elsewhere and the dimensions of the TPZ adjusted accordingly. This can be seen in the below image App2.1.

Image App2.1 – Minor Encroachment Example

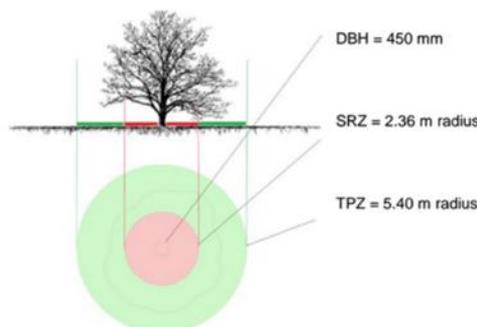
If major encroachment occurs, non-evasive root excavation using an Air Knife or similar may be required to ensure the protection of the trees root system, this is to be done under the supervision of the project arborist.

Image App2.2 – TPZ and SRZ Area Example

If roots need to be cut it is recommended roots no bigger than 25 mm are cut, and any roots that exceed 15 mm should be cut with sharp tools such as root cutting machine or secateurs and done with close supervision by the project Arborist.

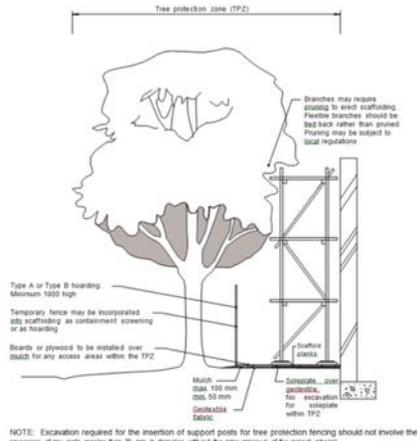
An example of scaffold erecting where the TPZ cannot be maintained can be seen in image APP2.3

Image App2.3 – Scaffold Erection within TPZ

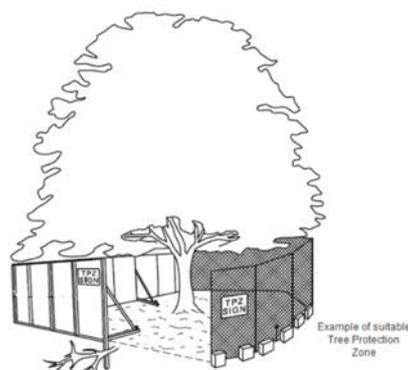
Tree protection Fencing example can be seen in image App2.4 below.

Image App2.4 – Tree Protection Zone
