**Industrial Development
618 Clayton Road
Clayton South**

**Engineering Services
Report**

Prepared For TROON GROUP

Report Number: R002 - C_23011

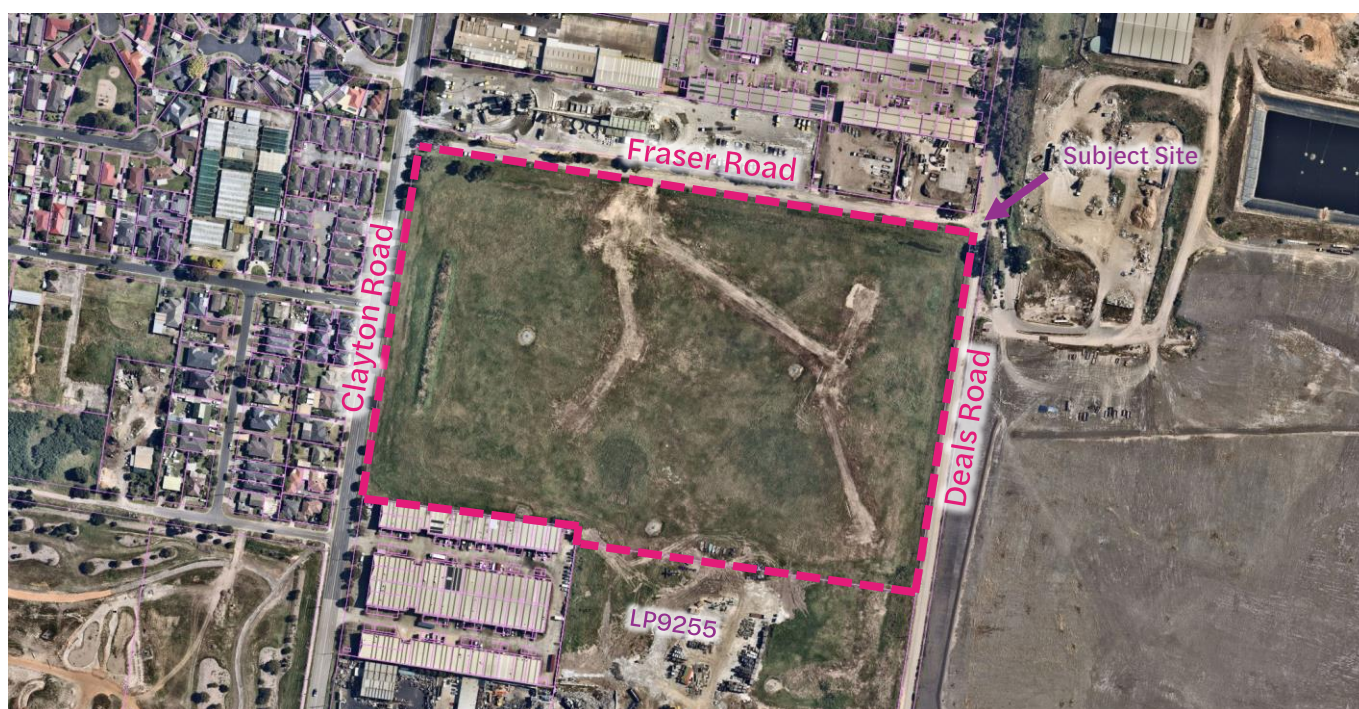
Figure 2-1: Site Location (Source: Nearmap)

Full details of the site topography and existing features are shown on the detailed survey in Appendix A. A general locality plan is presented in Figure 2-1 below.

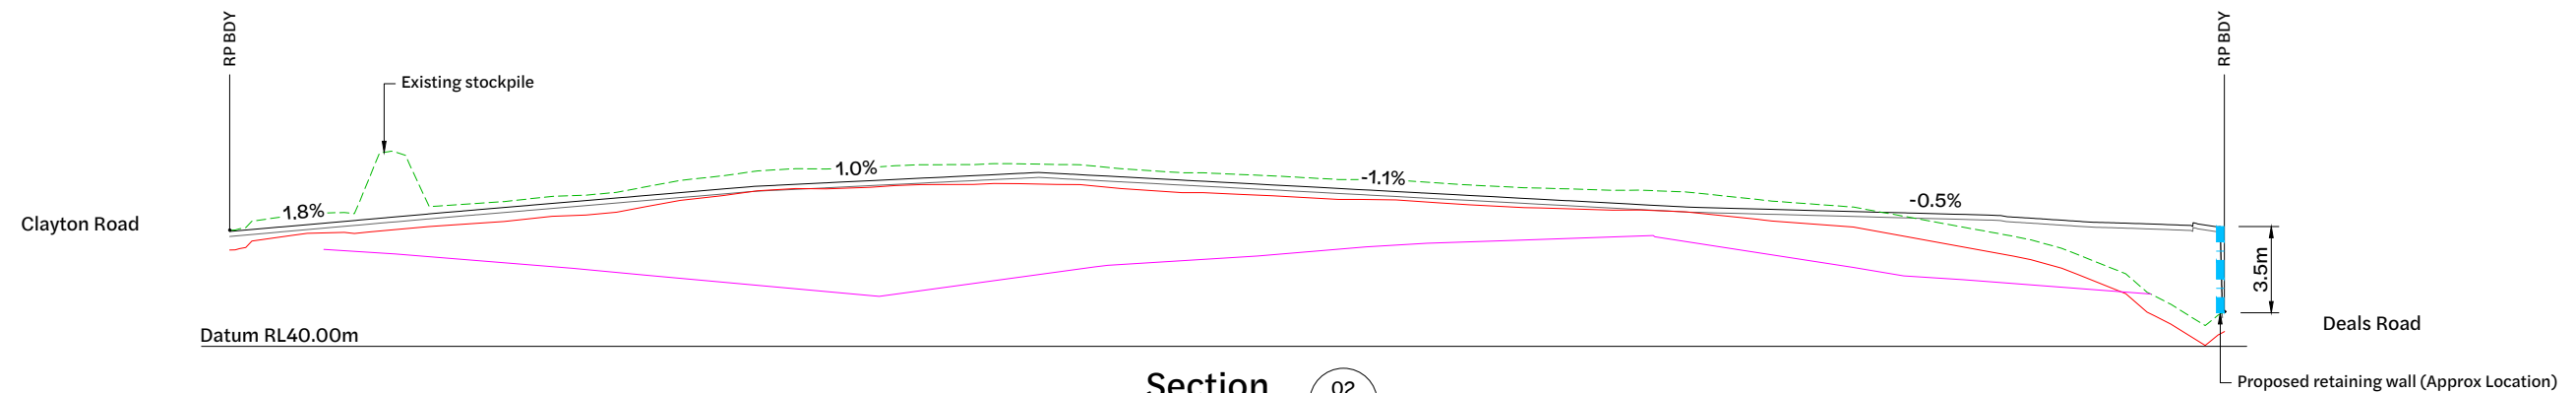
** Refer Clayton Road Landfill - Cap Soil Assessment by Resolve Environmental for depth of waste.

Section
Horizontal: 1:750
Vertical: 1:750

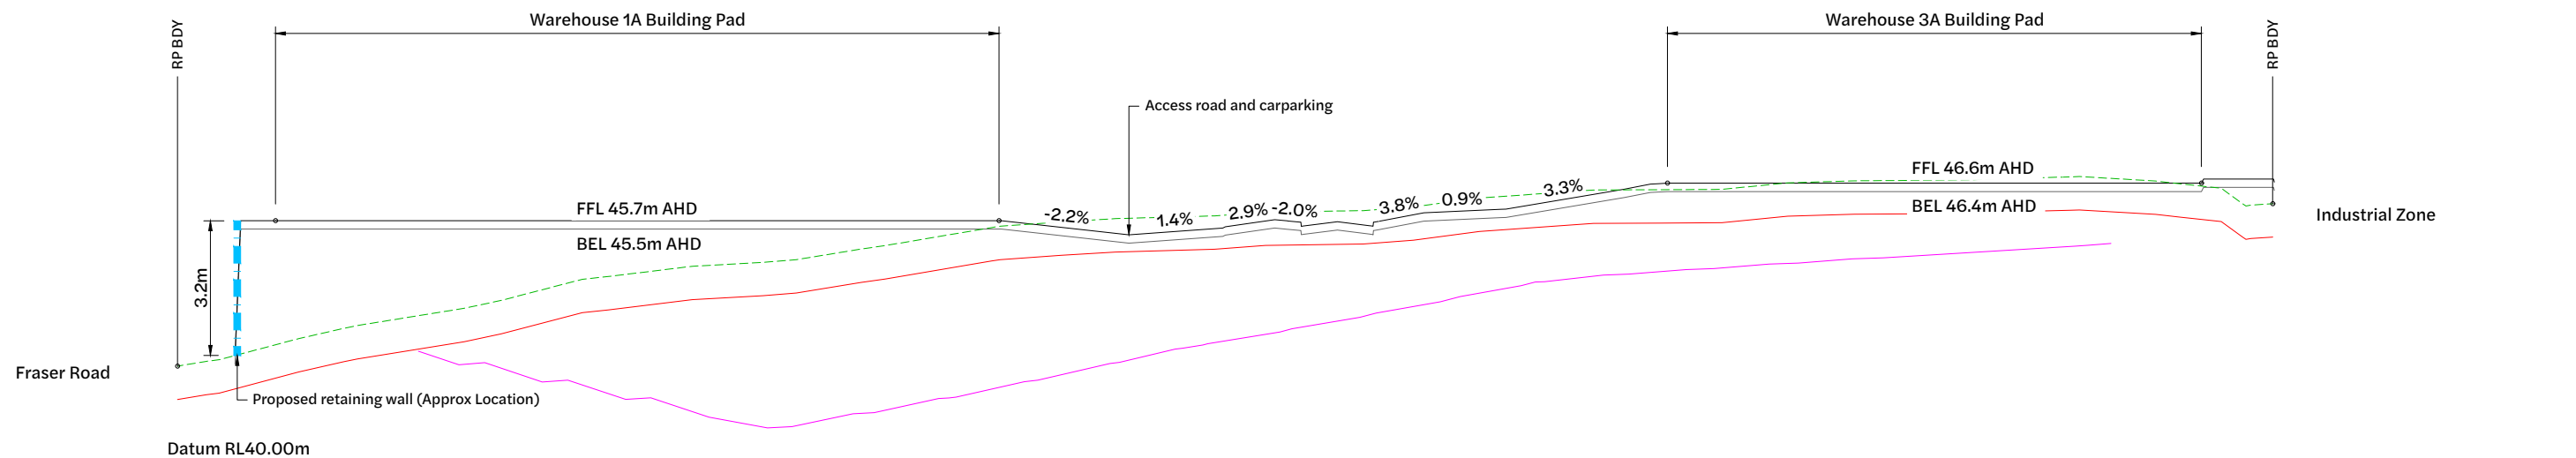
Section 04
Horizontal: 1:400 DA10
Vertical: 1:400

**** Refer Clayton Road Landfill - Cap Soil Assessment by Resolve Environmental for depth of waste.**

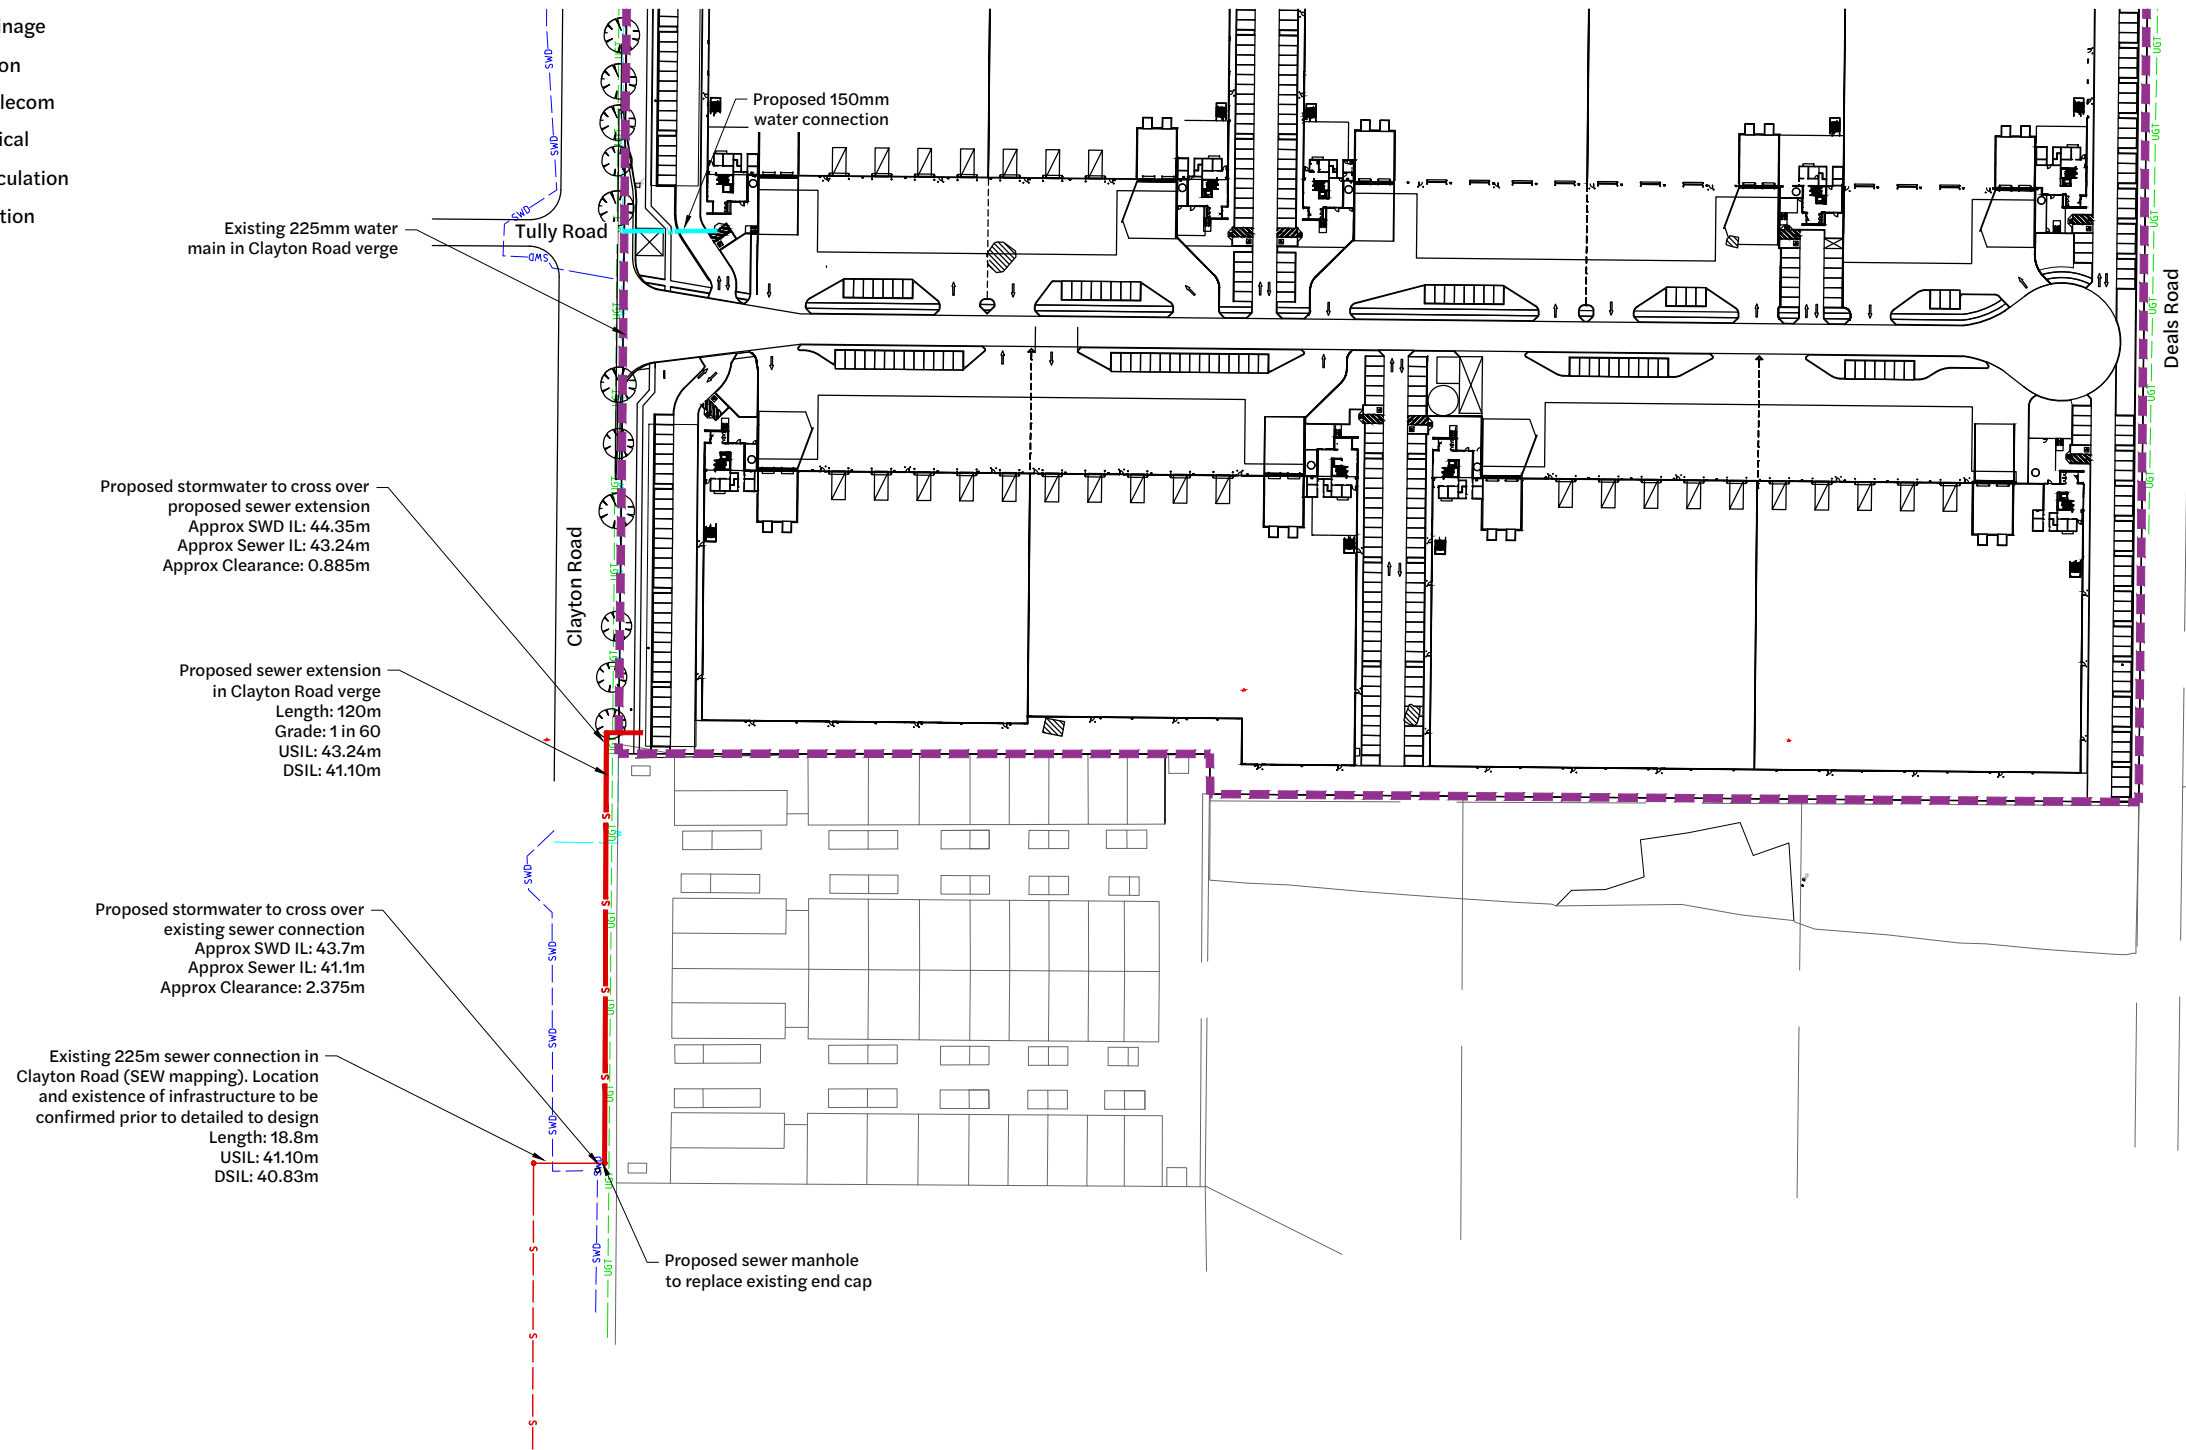
Sewer & Water Layout Plan
1:1000 Scale

- Property Boundary
- Existing Sewerage Reticulation
- Existing Stormwater Drainage
- Existing Water Reticulation
- Existing Underground Telecom
- Existing Overhead Electrical
- Proposed Sewerage Reticulation
- Proposed Water Reticulation

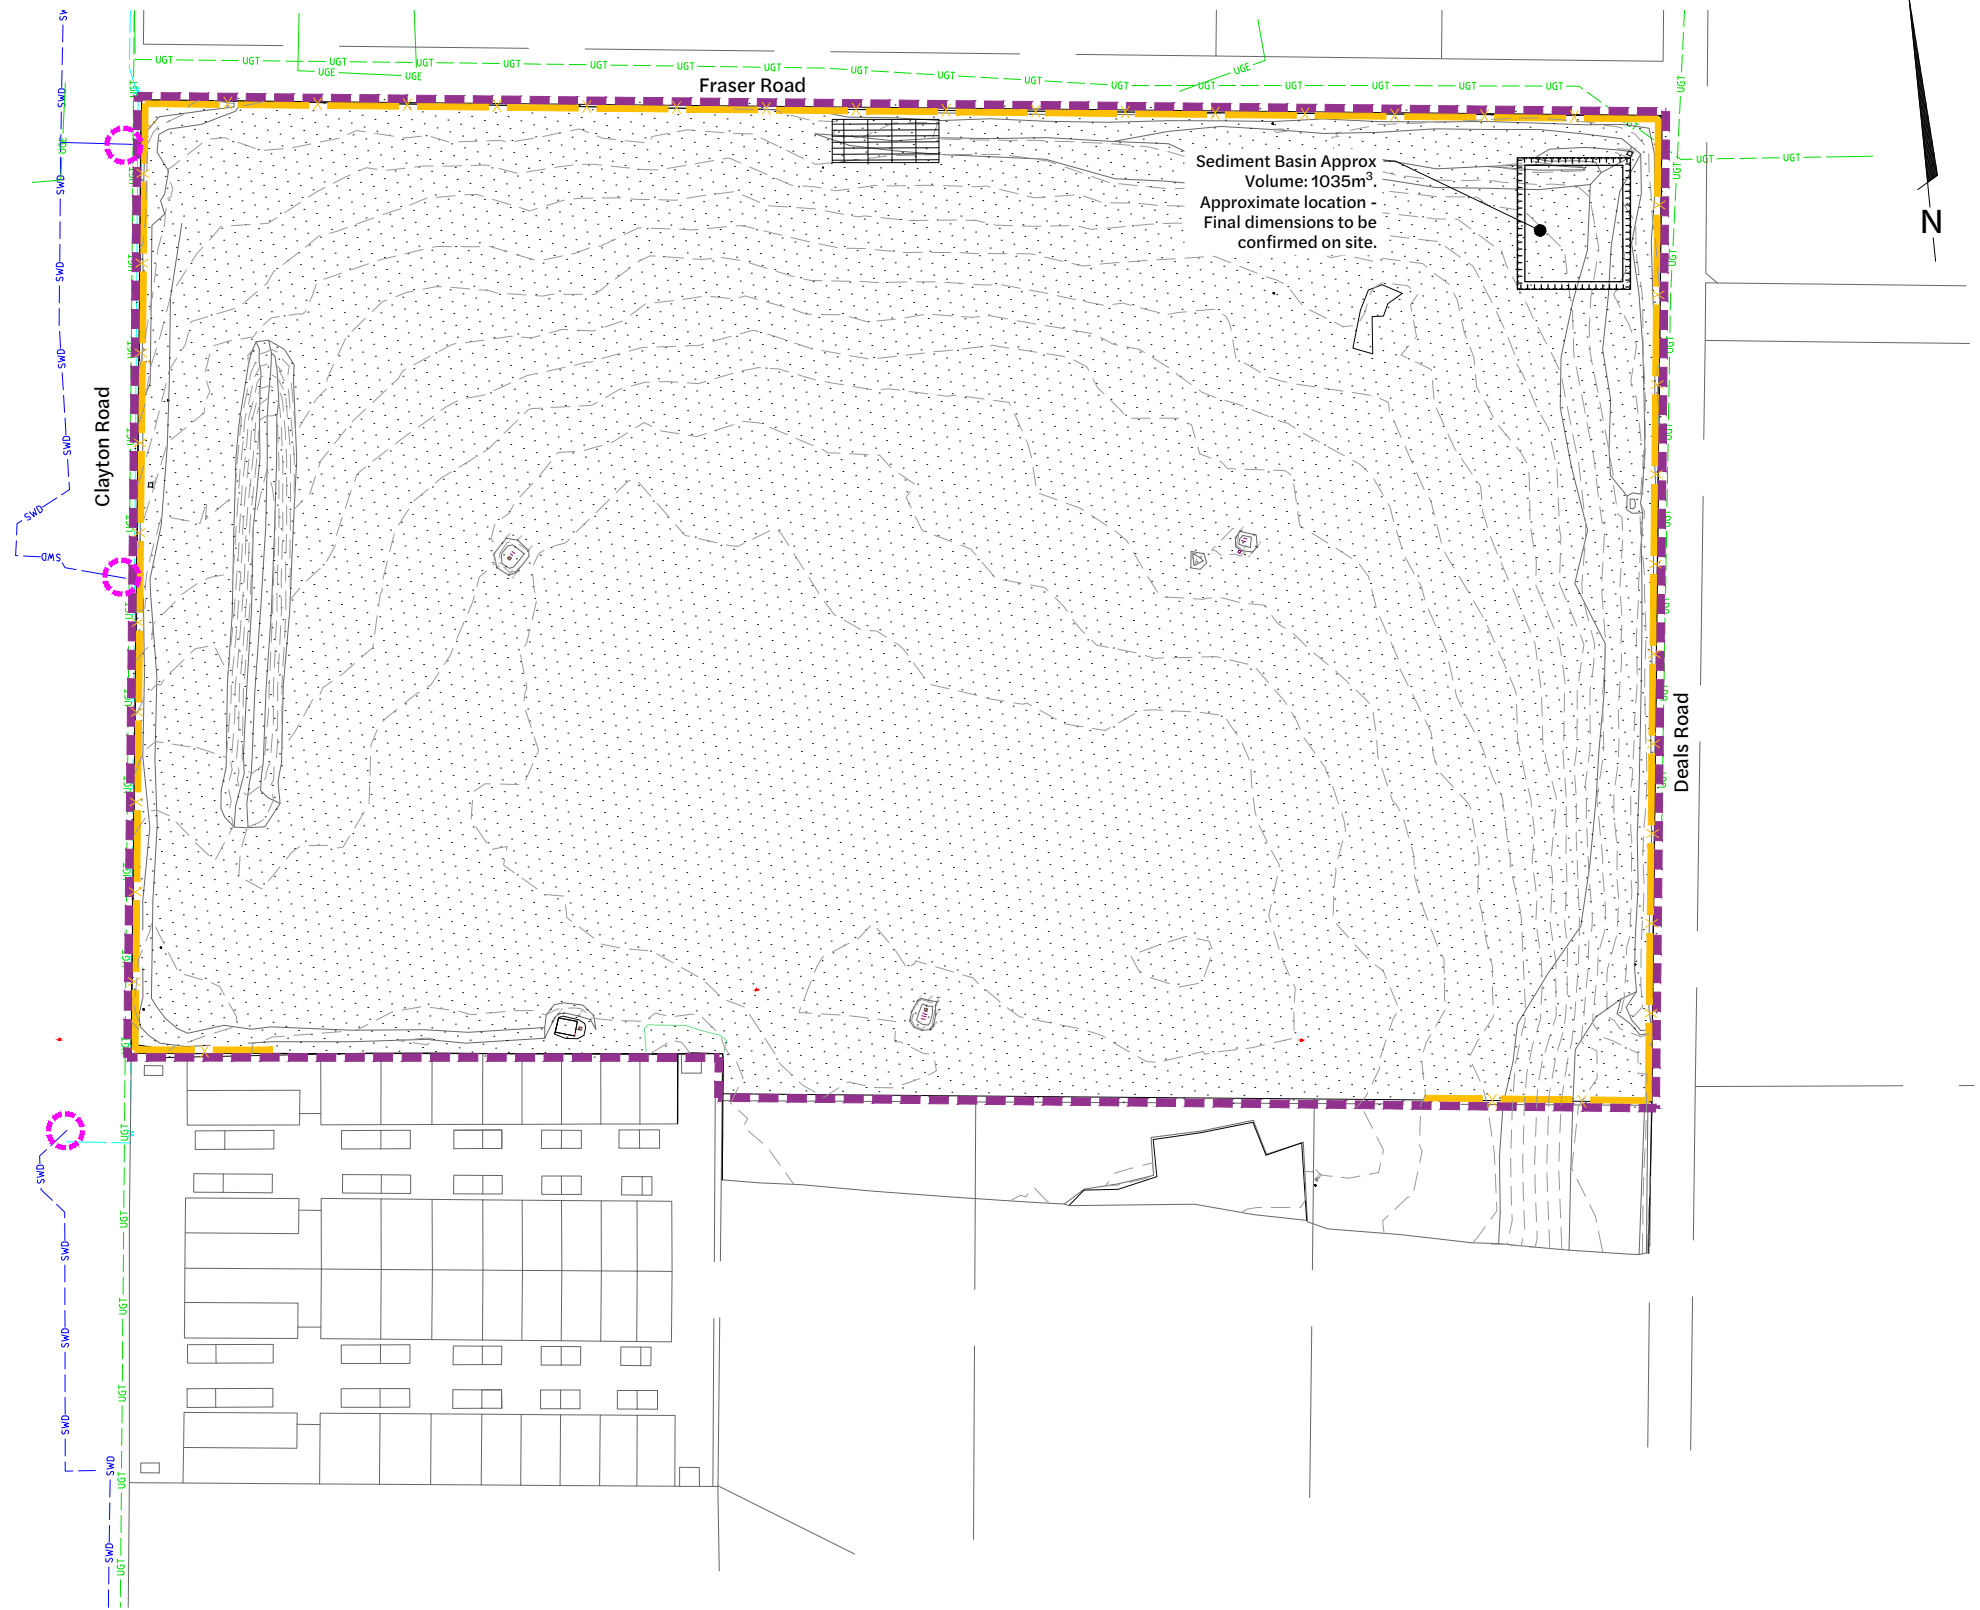
Erosion and Sediment Control Layout Plan
1:1000 Scale

- Property Boundary
- 0.5 Existing Surface Contour
- Existing Stormwater Drainage
- Existing Sewerage Reticulation
- Existing Water Reticulation
- Existing Gas
- Existing Overhead Electrical
- Proposed Sediment Fence (or As Directed by Site Superintendent)
- Temporary Exit Washdown Device - Refer Detail
- Proposed Area of Disturbance
- Inlet Protection

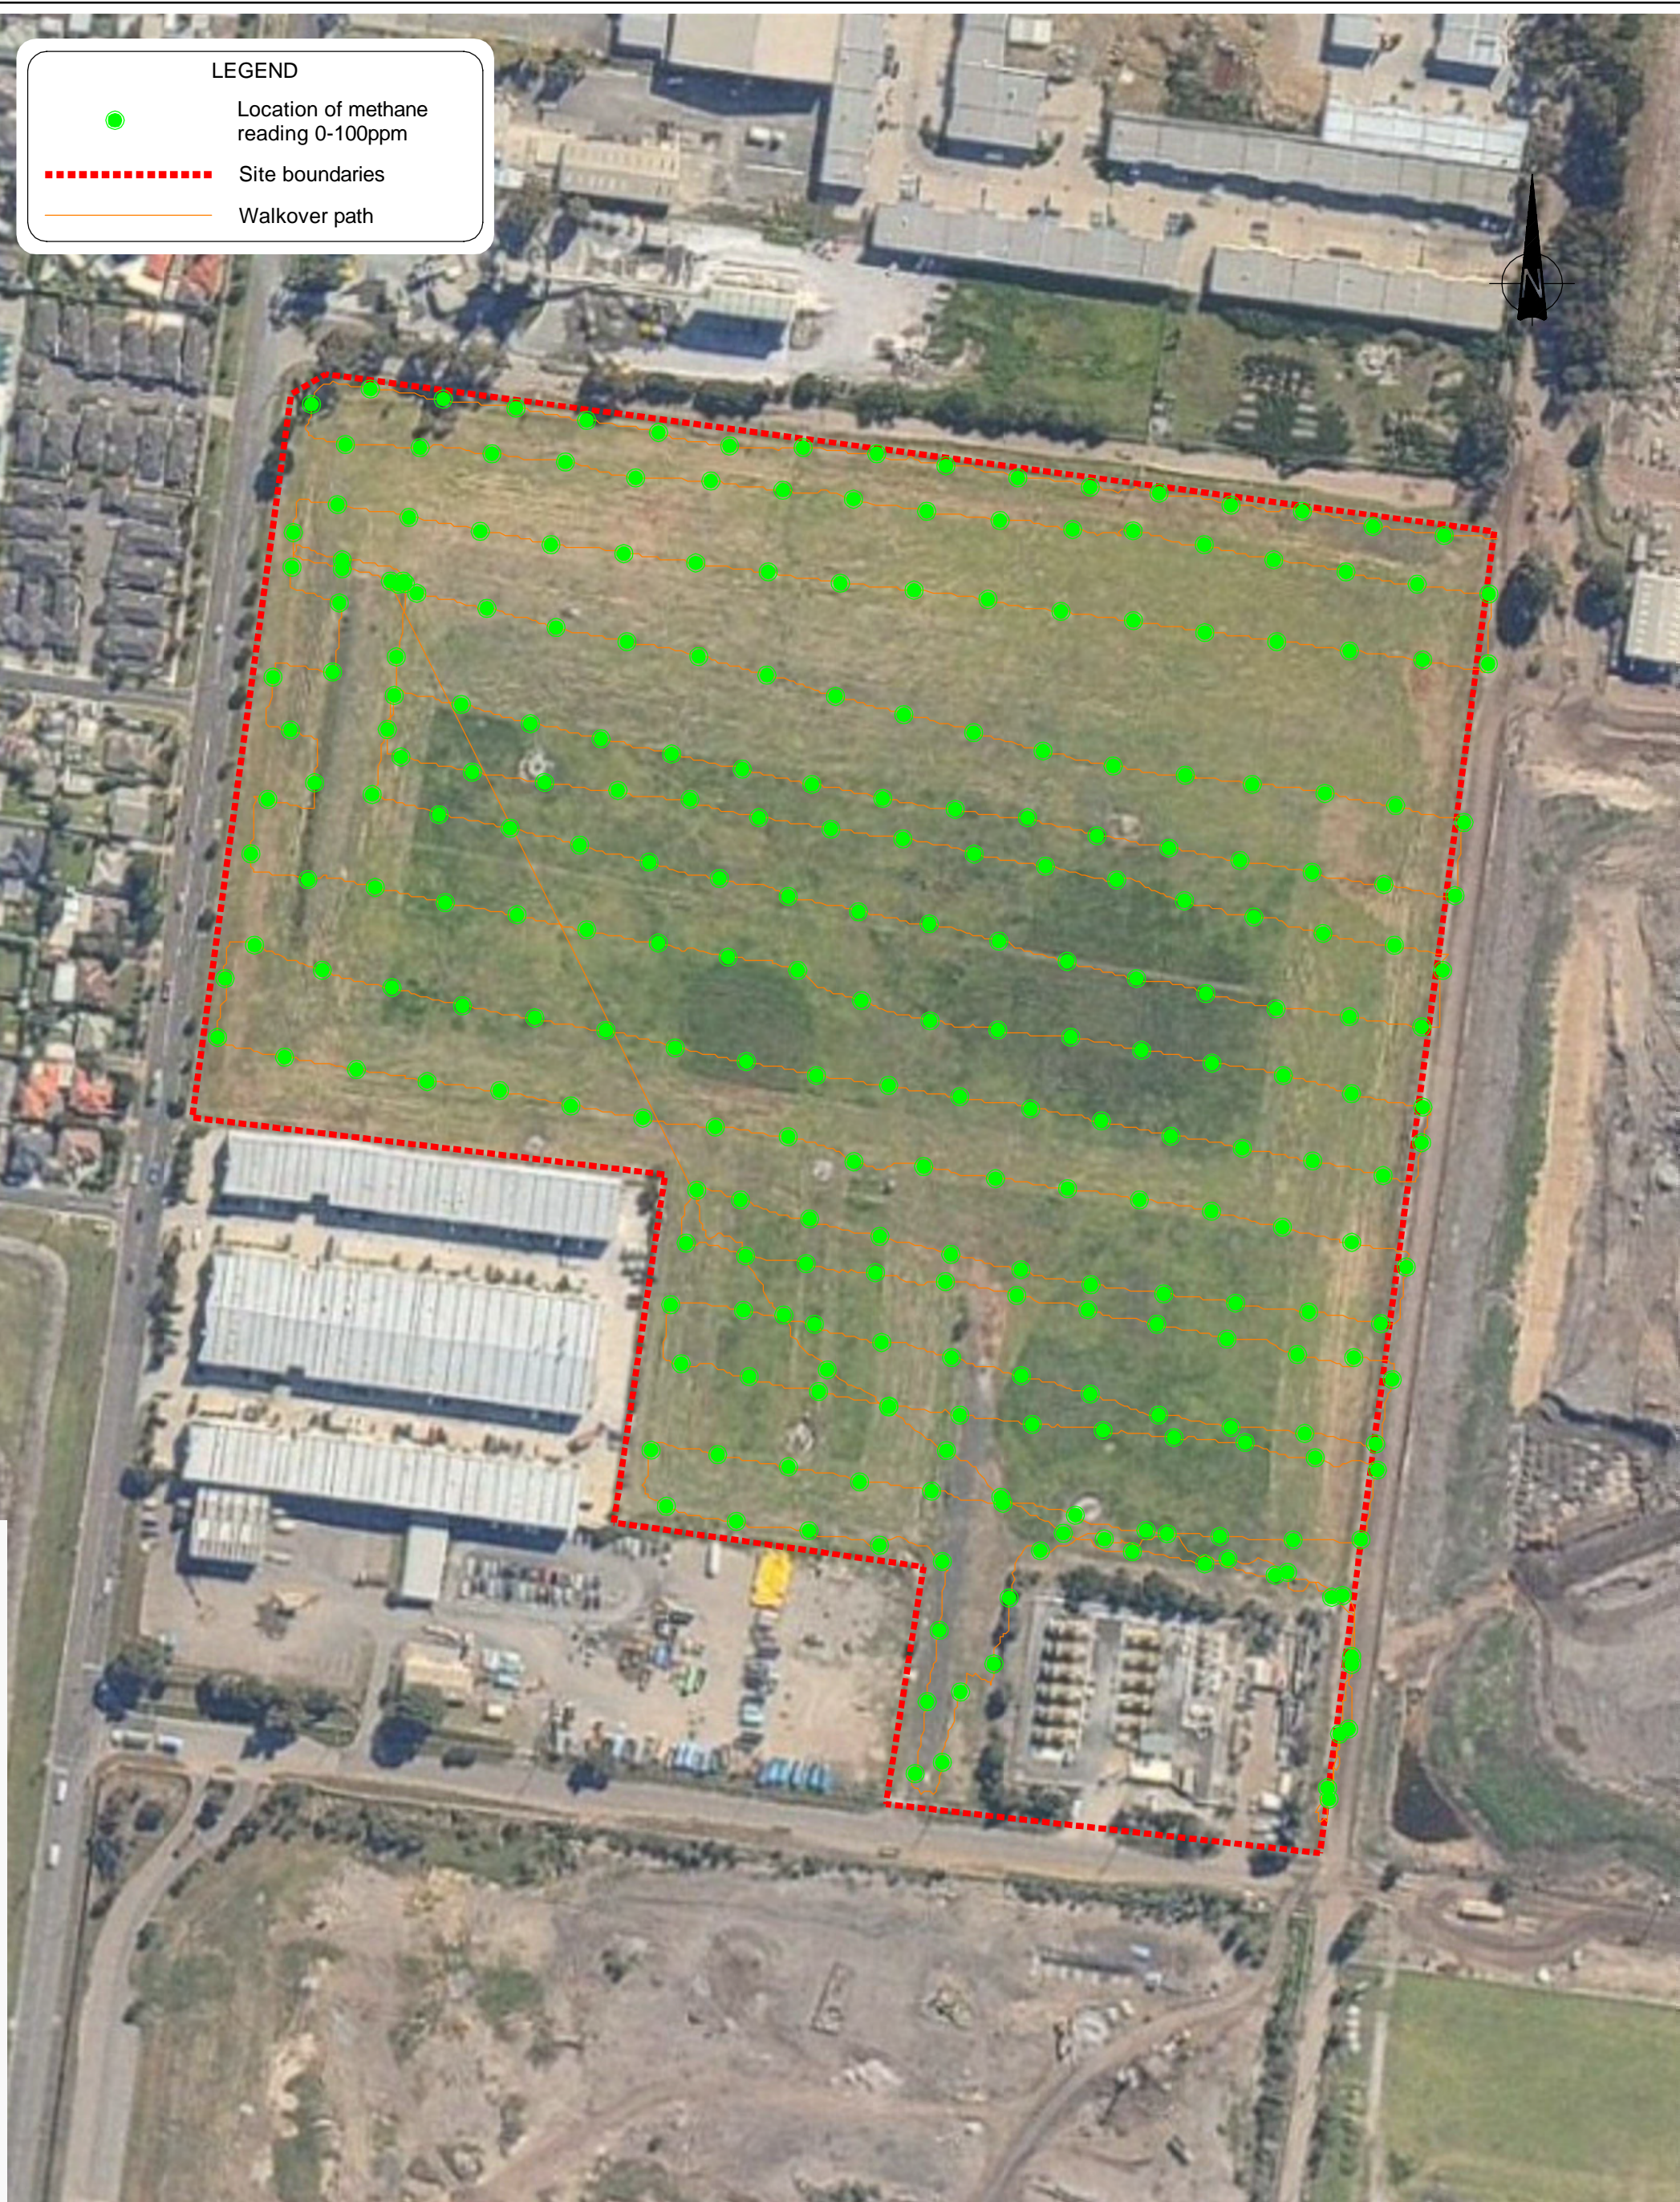
FIG. No. Figure 2

Walkover path

Aerial photo sourced from Nearmaps, flown 12-3-2012
